Report on
Preliminary Site Investigation (Contamination)

New Primary School in Googong
Aprasia Avenue, Googong

Project 203634.01
May 2021

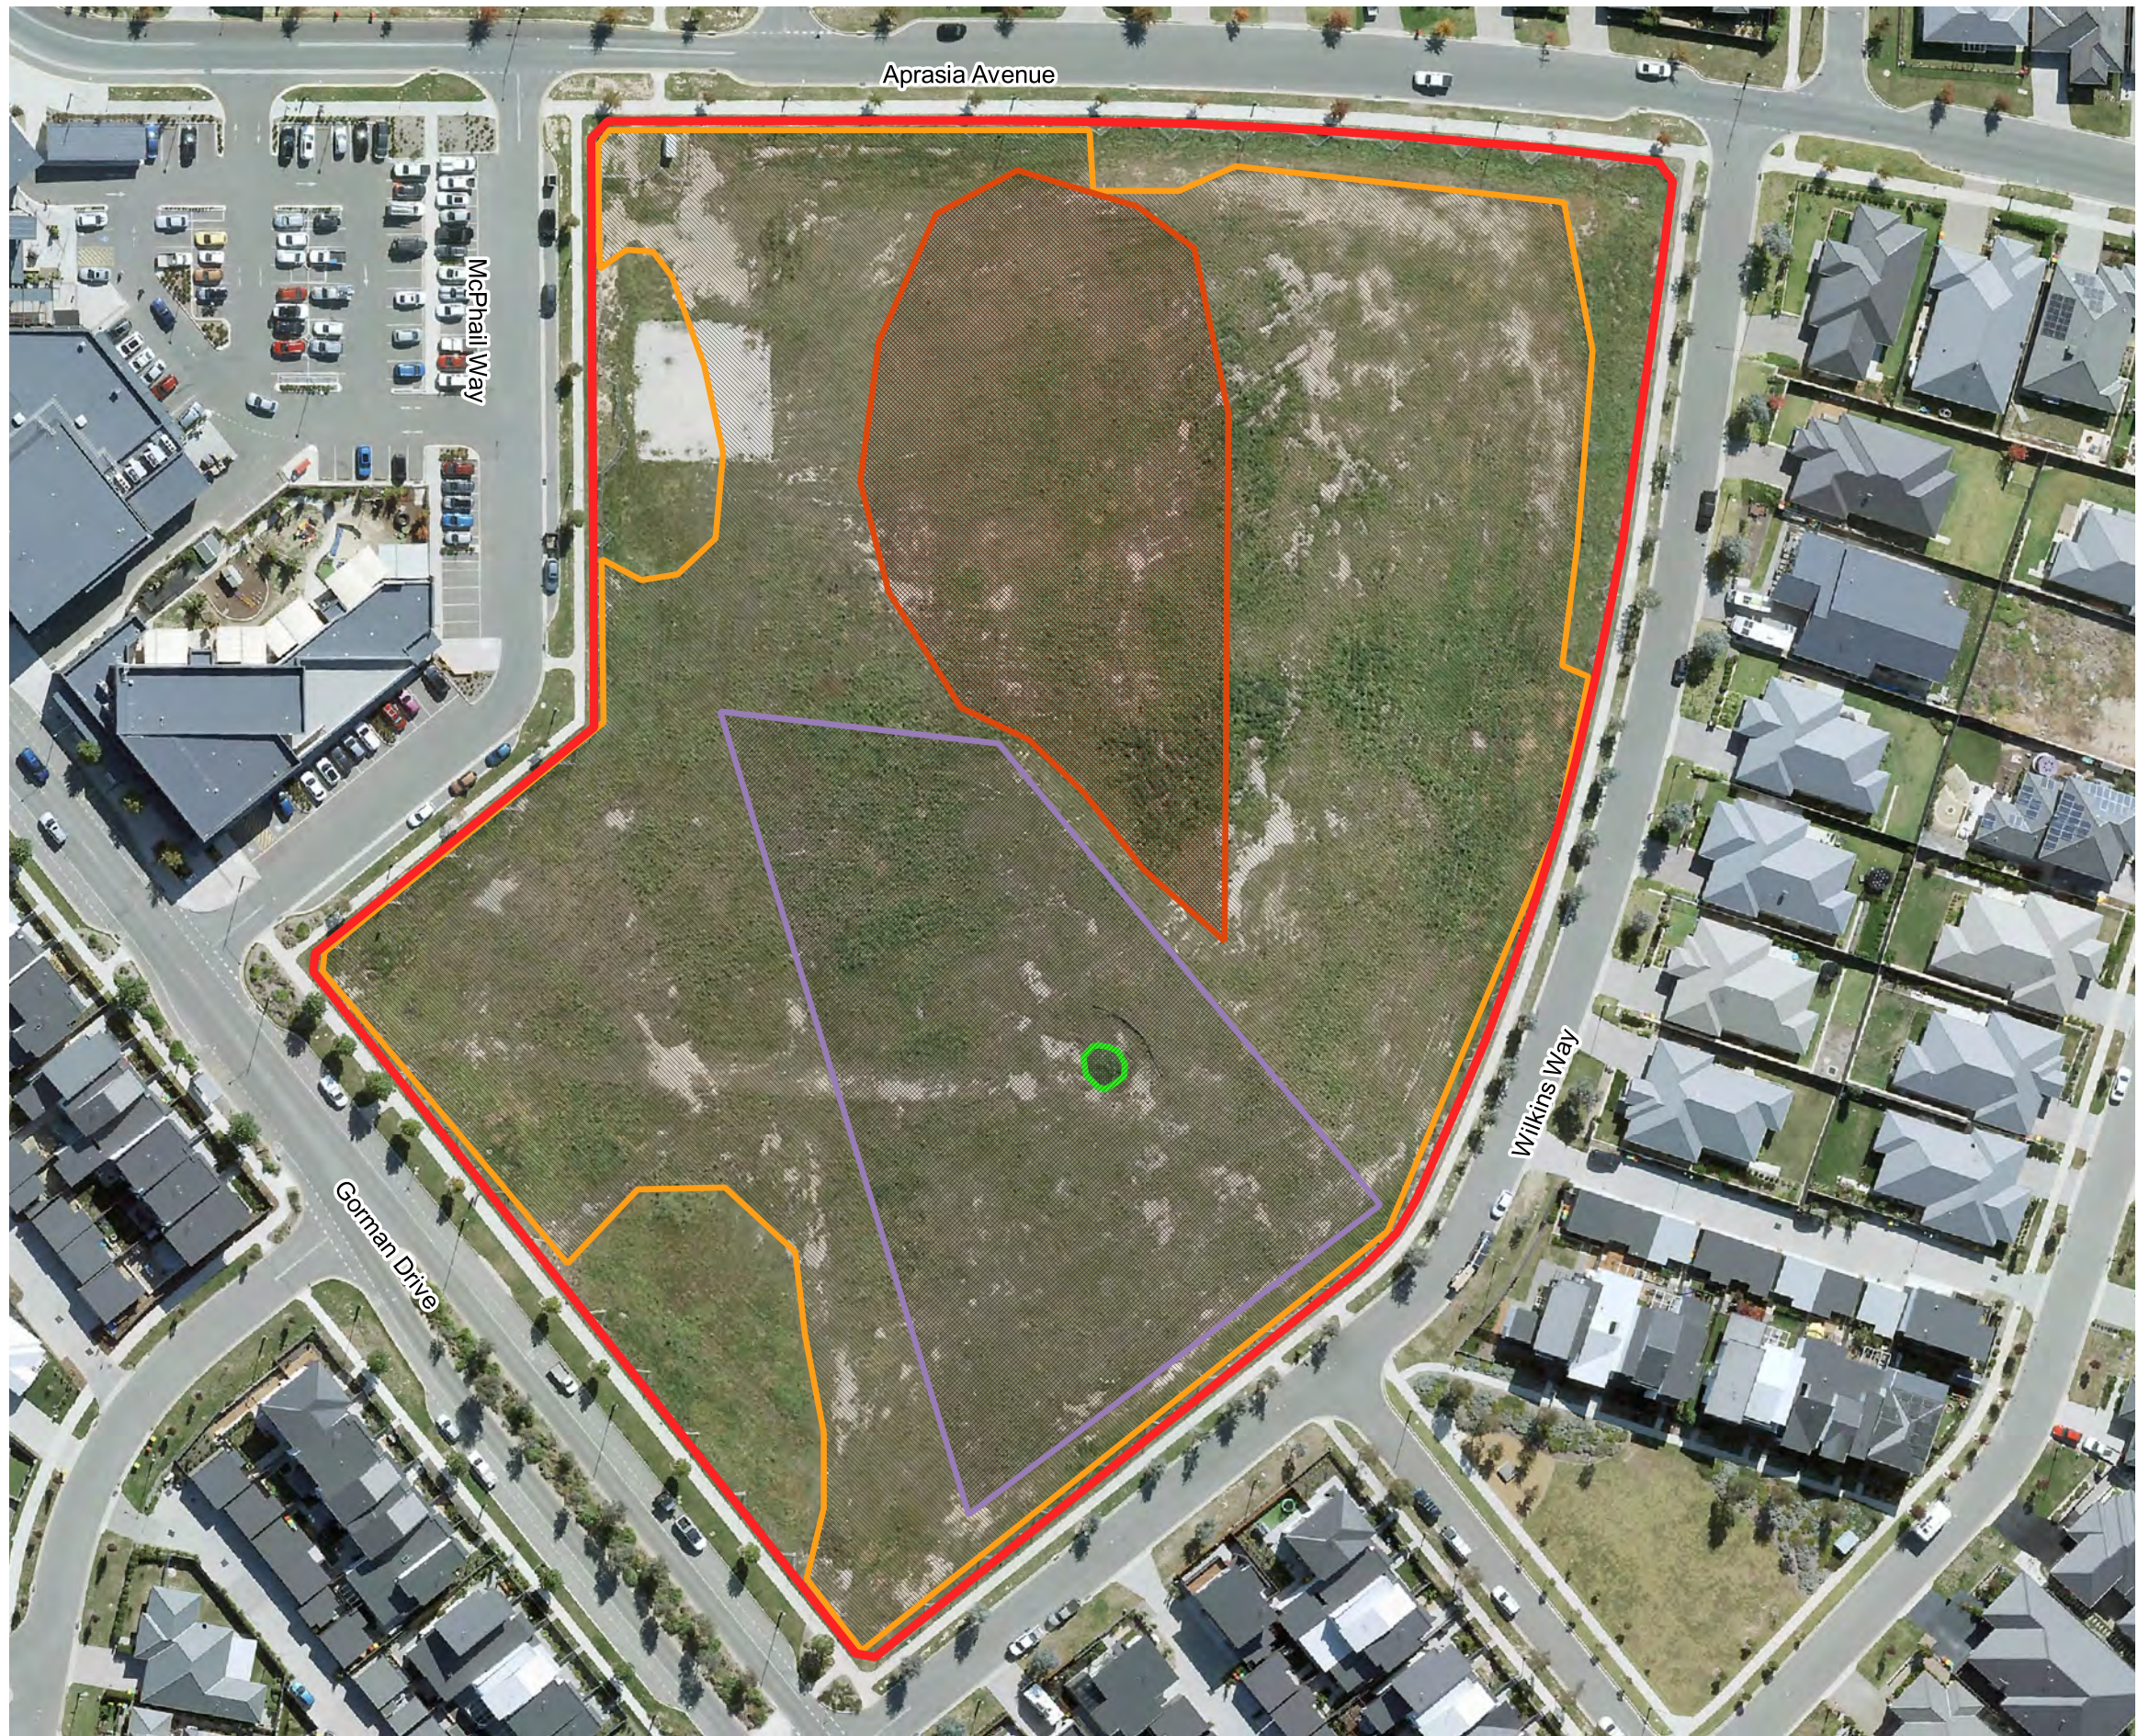
LOCALITY MAP

- Legend**
- Approximate Site Boundary
 - Areas of Environmental Concern
 - Approximate Construction Compound Location 2015
 - Approximate Stockpile Location 2015
 - Approximate Disturbed Ground Area 2015
 - Approximate Stockpile Location Present

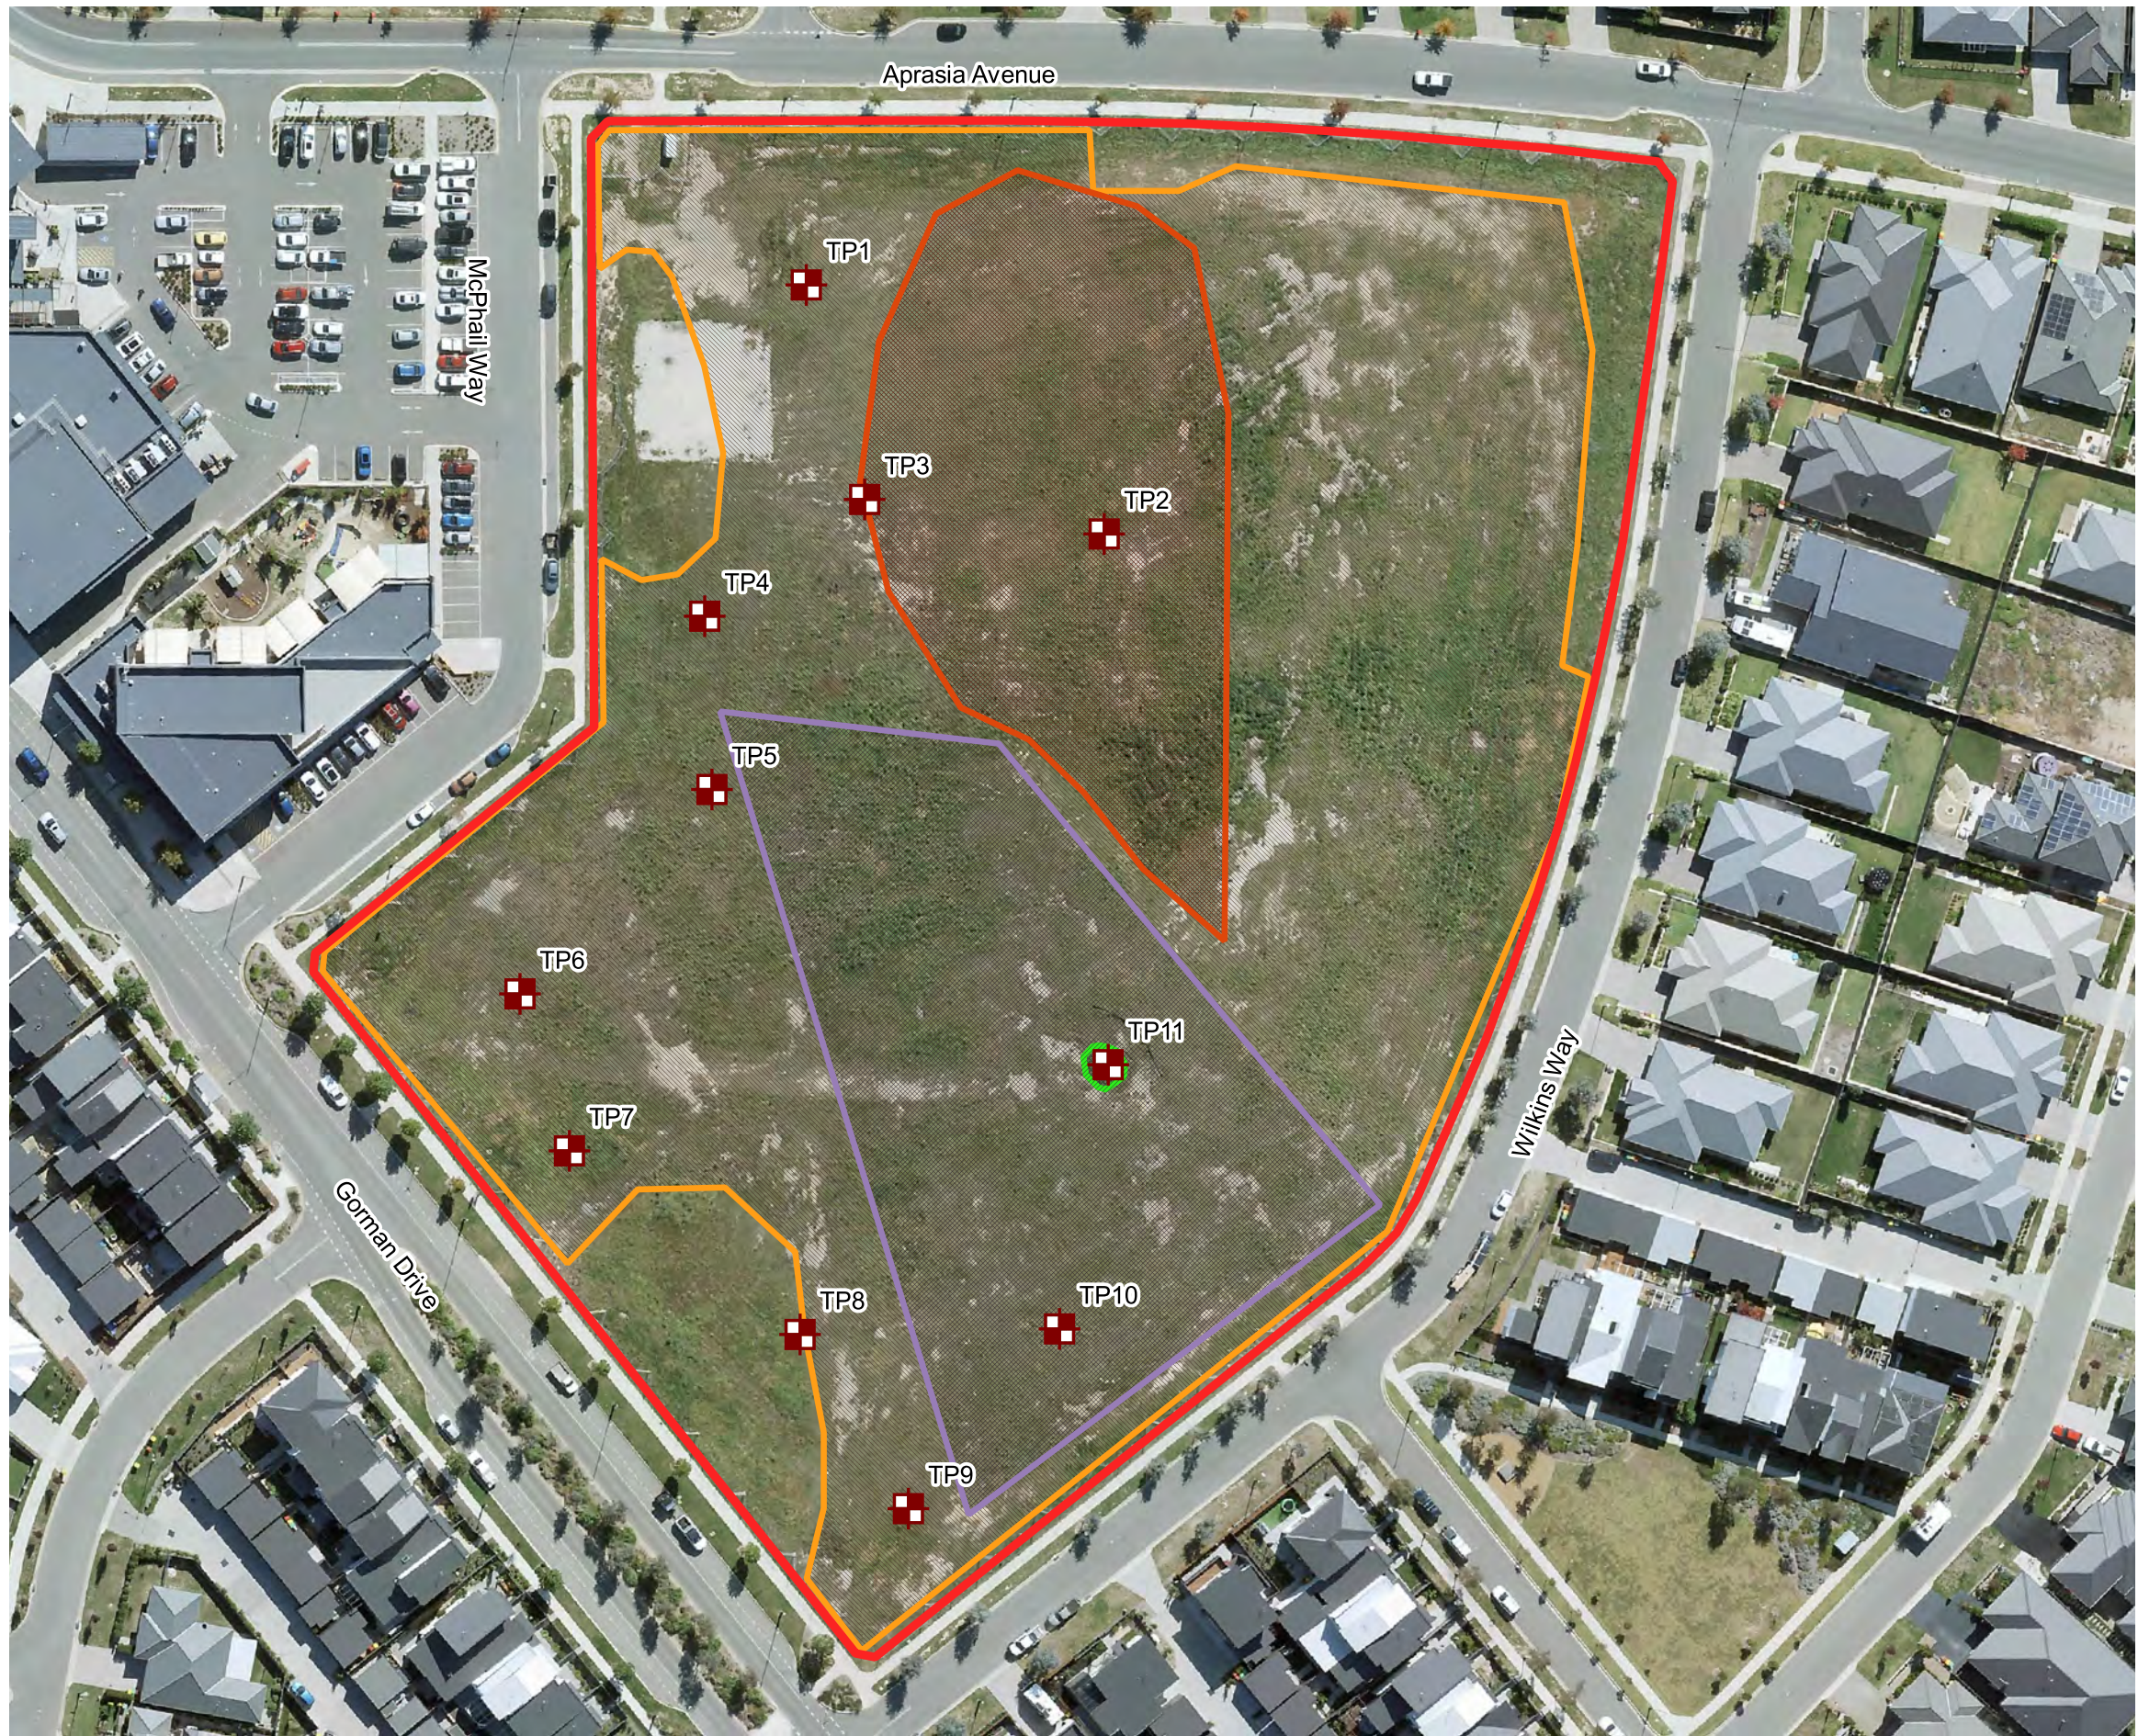
LOCALITY MAP

Notes:
 1. Basemap from metromap.com (dated 19/04/2021)
 2. Test Pit Locations are approximate only

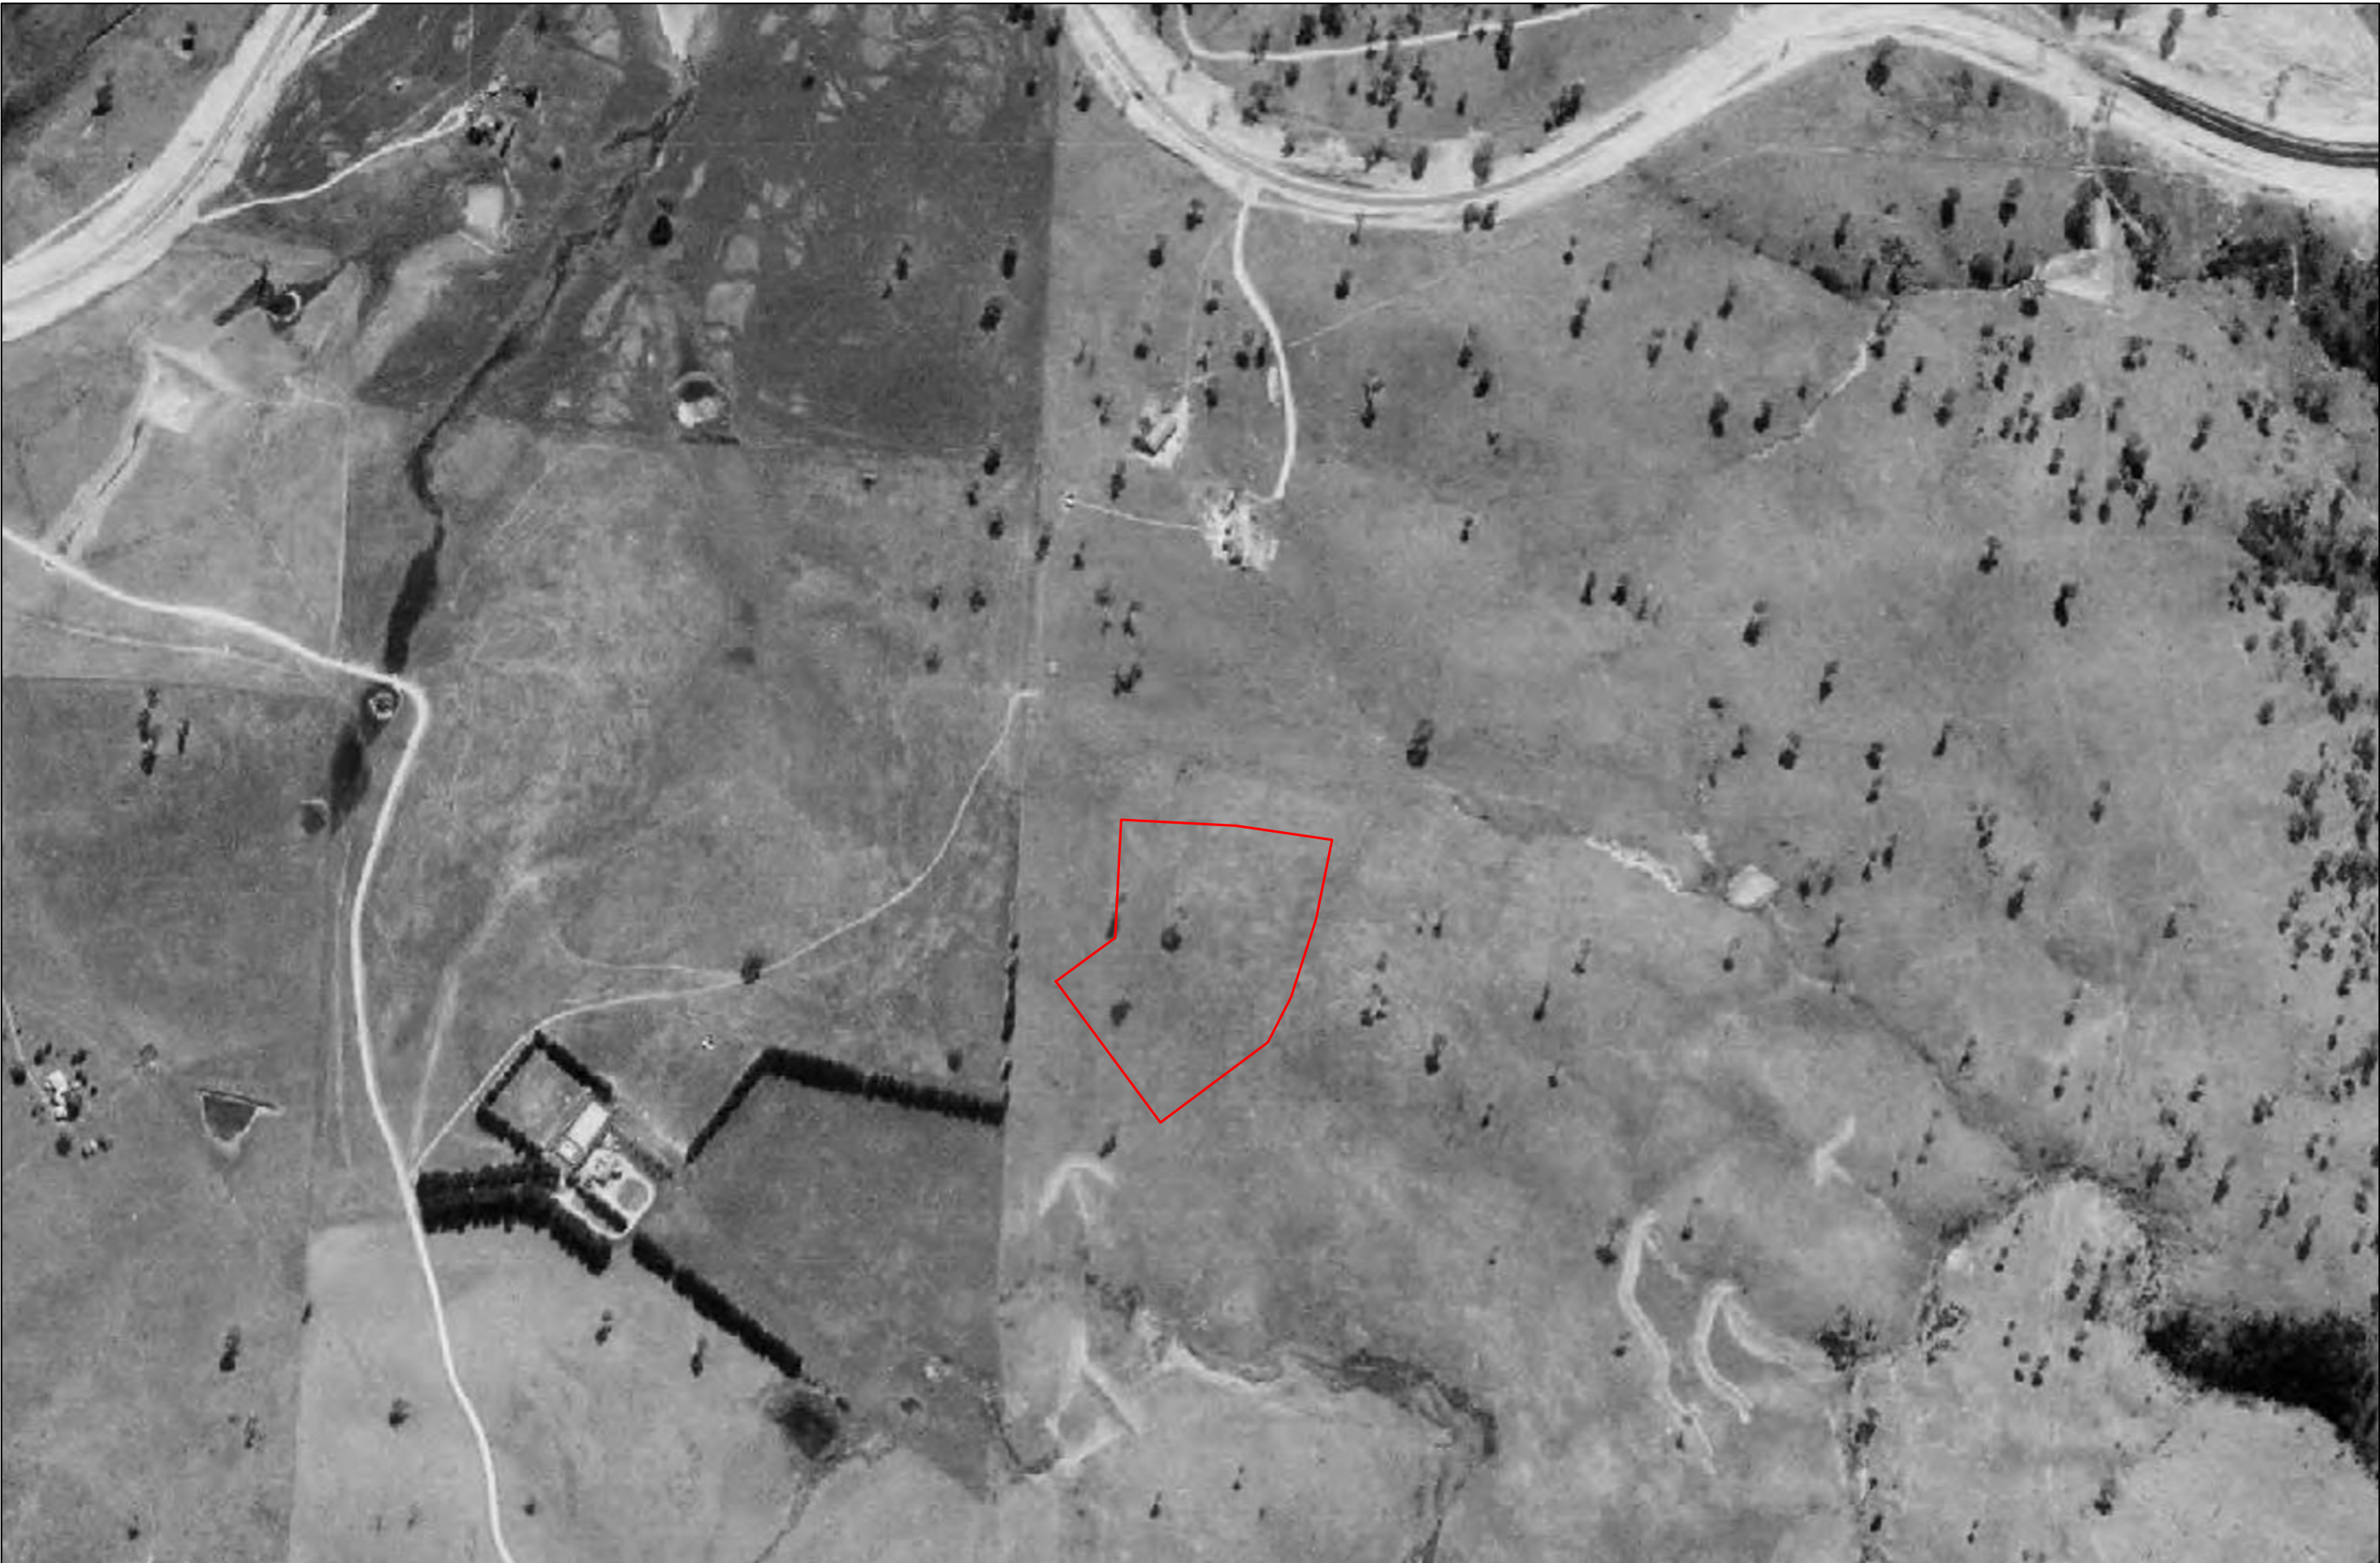
Douglas Partners <i>Geotechnics Environment Groundwater</i>	CLIENT: Hansen Yuncken Pty Ltd		TITLE: Aerial Photograph 1976 New Primary School in Googong Aprasia Avenue, Googong

Year	Site	Surrounding Land Use
1976	Largely unchanged from the previous photograph.	Largely unchanged from the previous photograph.
1986	Largely unchanged from the previous photograph.	Largely unchanged from the previous photograph.
1992	Largely unchanged from the previous photograph.	Largely unchanged from the previous photograph.
1998	Largely unchanged from the previous photograph.	Largely unchanged from the previous photograph.
2005	Largely unchanged from the previous photograph.	Largely unchanged from the previous photograph.
2013	Largely unchanged from the previous photograph. Disturbed ground was present in the north-eastern corner of the site.	Construction of Googong had begun. Topsoil had been striped to the north and west of the site and construction of roads had commenced.
2015	Almost the entire site surface was disturbed. A construction compound was present in the central portion of the site. The compound included temporary site buildings, storage of containers, materials and mobile plant. A large stockpile appeared to be present in the north-eastern portion of the site.	Construction of Googong had continued. Extensive placement of fill material had occurred in the surrounding area. Gullies present in the 1961 aerial photograph were no longer visible. Roads had been completed immediately adjacent to the site and houses had been constructed further away from the site.

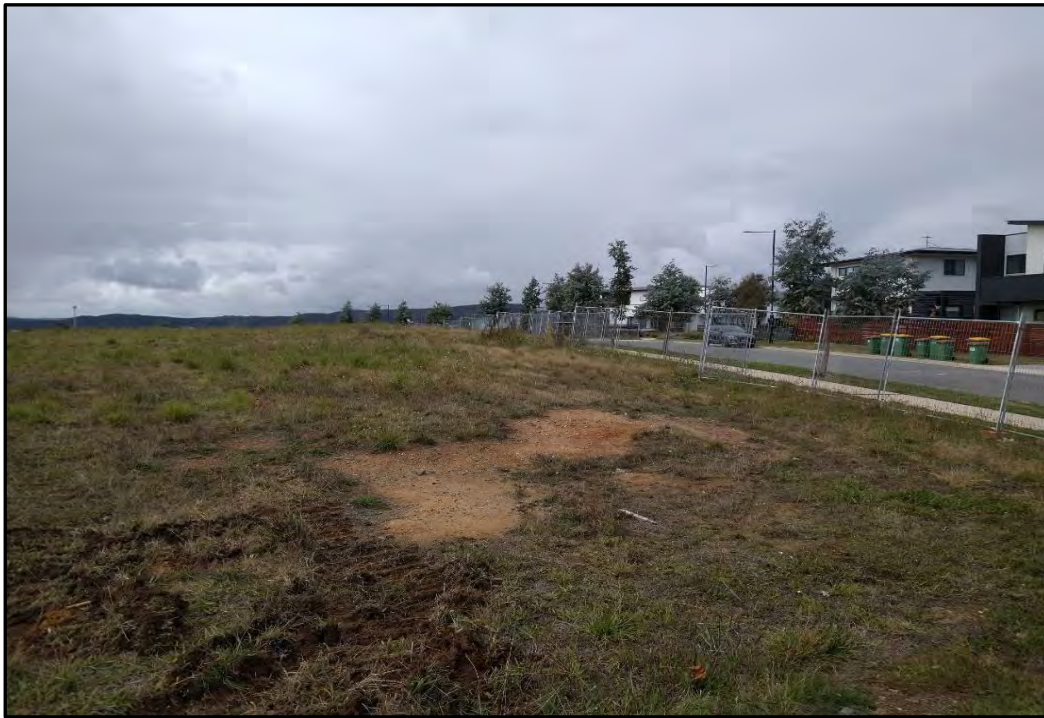
Photo 1: General View of the Site, looking north-east

- The site has an intermittent cover of thin, ground vegetation;
- Fill was observed to be present across most of the site. Various gravels were visible on the site surface and was observed to be consistent over the whole site;

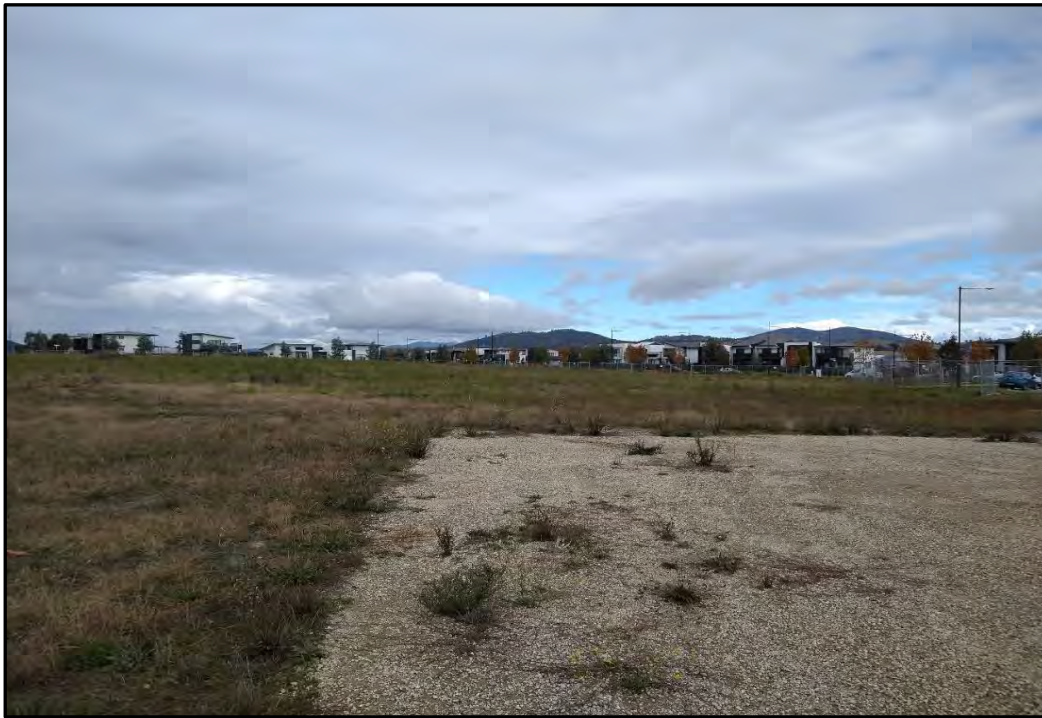
Photo 5: View of gravel pad in the north-western portion of the site

- The site was fenced with temporary fencing restricting access to the site.
- No evidence of chemical storage was noted during the site walkover;
- A small square gravel pad (approximately 20 m square) was located in the north-western portion of the site;

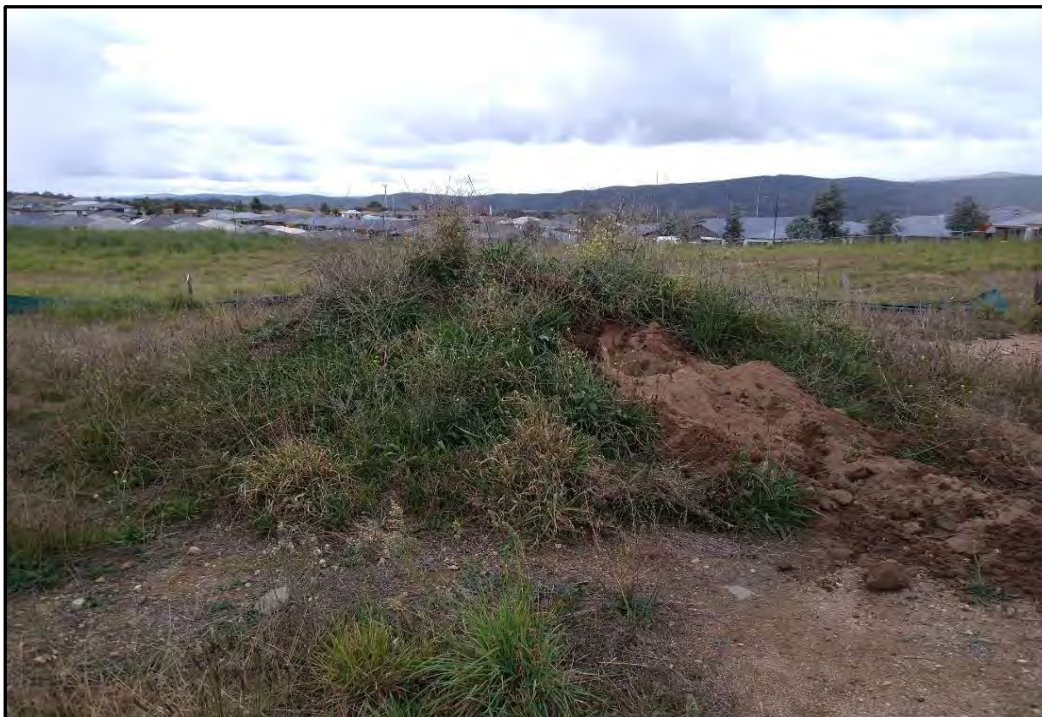
Photo 6: View of stockpile in the central portion of the site

- A small electrical distribution box was located in the north-western corner of the site;
- A stockpile was present in the central southern portion of the site of the site. It was approximately 1 m in height, 6 m long and 5 m wide. The stockpile was covered in vegetation, which appeared to be in good condition;
