InterContinental Sydney

Waste Management Plan

August 2020

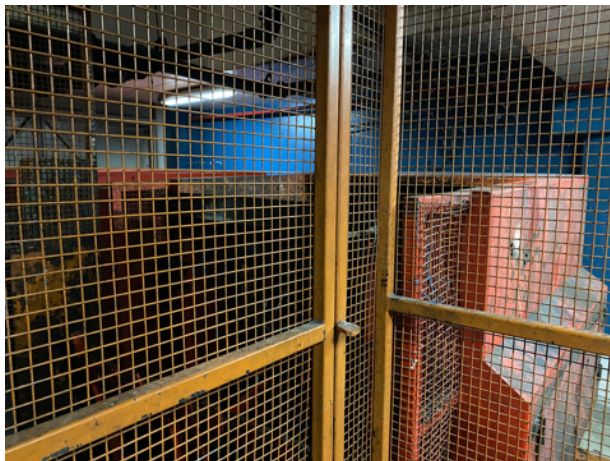
It was mentioned by the Hotel's Director of Operations during our site visit on 6/7/20 that the compactor is an old and inefficient unit, and subject to hydraulic leaks and breakdowns. This was apparent from visual inspection of the compactor unit and storage room (see photo below), with cracks in the compactor body and evidence of leakage.

The existing compactor is not being used to optimum efficiency and is being collected with an average weight (based on June 2019-February 2020 Cleanaway invoicing data) of 3.23 tonnes. 83 collections were performed during this period, with a total of 266.60 tonnes collected and a maximum weight of 5.84 tonnes recorded on 2/12/19.

If this maximum weight had been regularly achieved by extending the time between collections, then the same tonnage could have been removed in 46 collections, which would have produced a significant financial saving for the Hotel. It should also be noted that an efficient compactor of this size (23 cubic metre capacity) should be able to hold at least 8 tonnes of material.

Waste Audit will provide the InterContinental Sydney with a separate report on options for a new general waste compactor, with equipment recommendations and a detailed financial analysis of capital and operating costs.

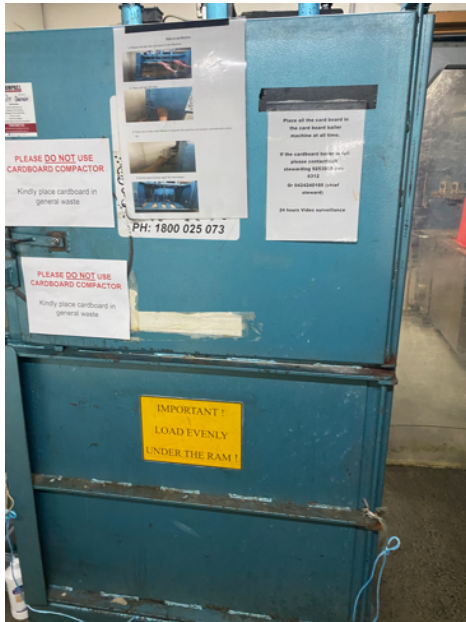
The existing baler shown in the first photo is also a relatively old piece of equipment, and not in use due to the COVID-19 pandemic and attendant risks to staff in handling cardboard material, as of the time of writing; all cardboard is currently going into the general waste compactor.

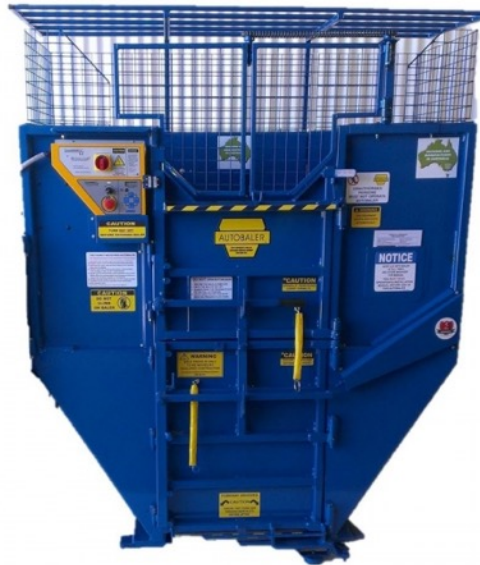
An automated top-loading baler of the type shown in the second photo would be a more operationally efficient system than the current one, and also reduce manual handling. Waste Audits' separate report will provide a detailed analysis of this option.

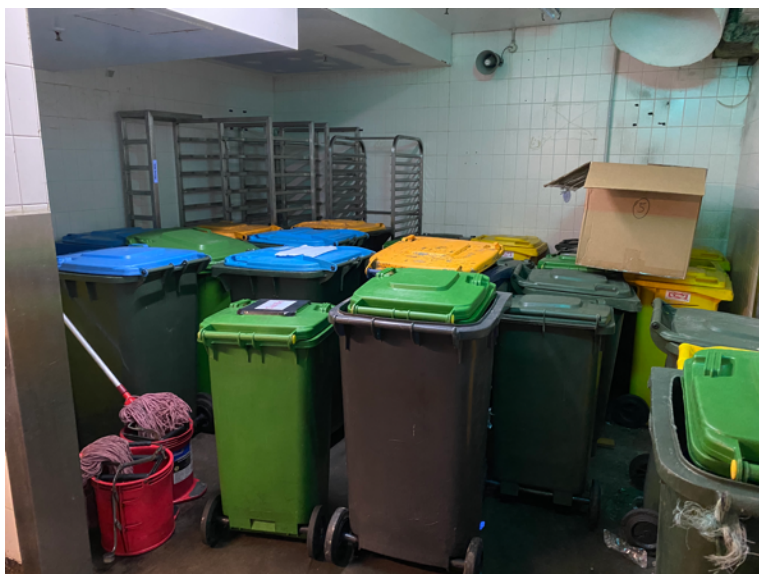
The photo below shows the existing bin storage area on Level 3. The finishes upgrade which will take place as part of the proposed development should include installation of suitable signage, with bins stored in designated zones and properly colour-coded, based on the examples shown in Section 7.2.

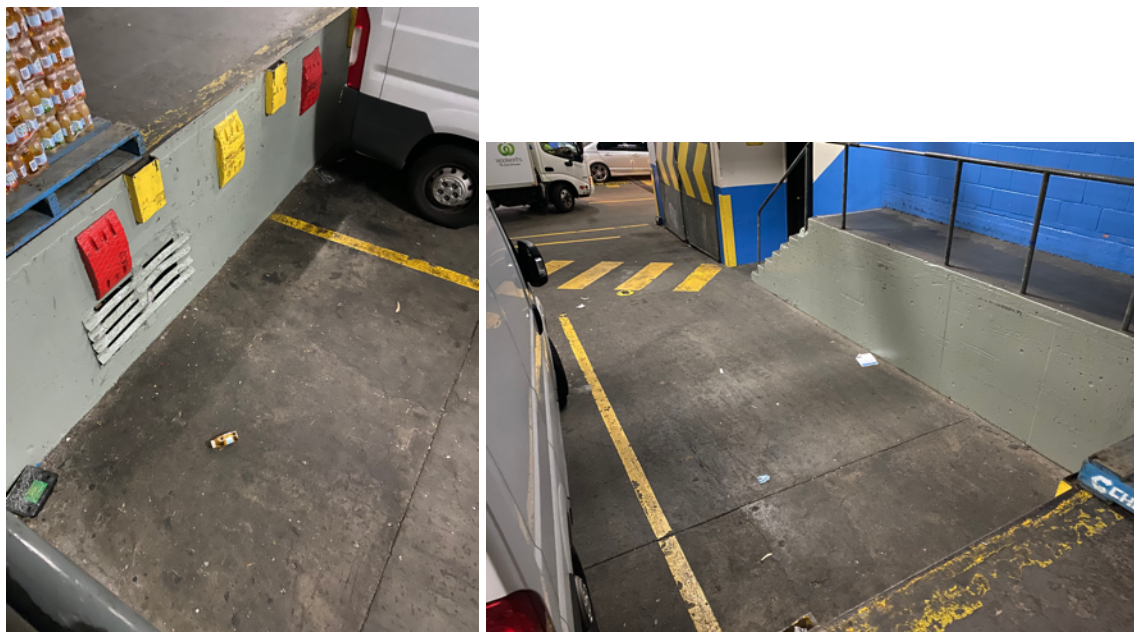
To facilitate loading of bins onto standard rear lift collection vehicles, a dock leveller should be installed in the area shown below. Options and cost estimates for this will be provided in our separate report.

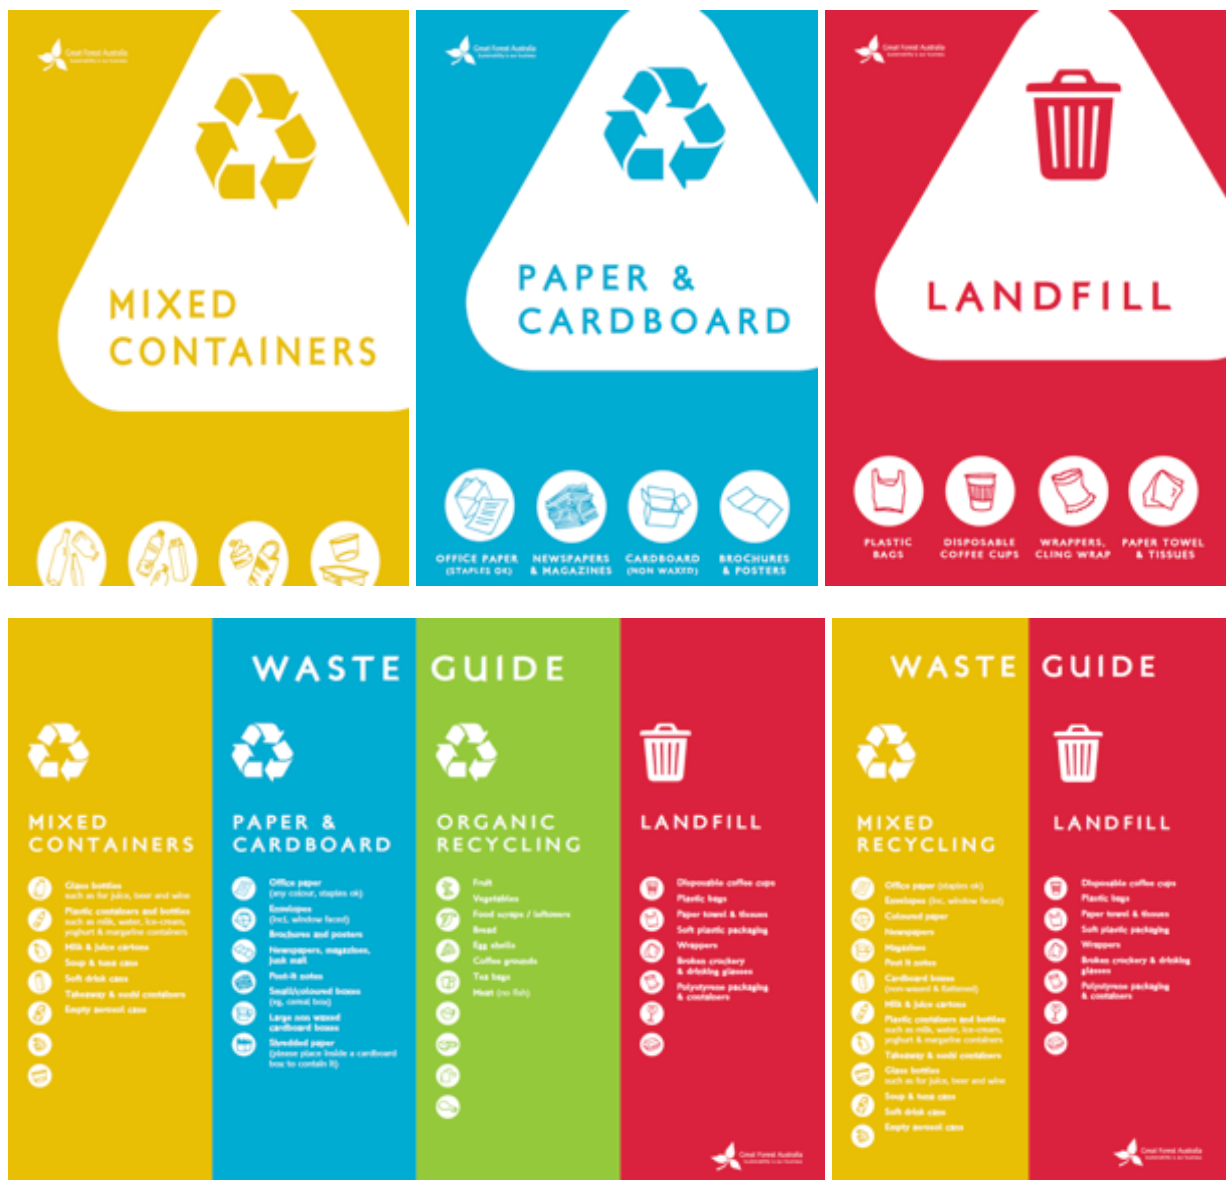
The signage examples on the following page are for illustration purposes only. Actual signage should include suitable Hotel/IHG branding.

All waste and recycling containers will be clearly differentiated through appropriate signage and colour coding to reflect the materials contained, with each stream located in a designated area within storage rooms, with large and clear signage to assist in easy identification by users, as shown in Appendix C. Other best practice standards for storage and handling areas include:
