**The Forest High School –
Allambie Road, Allambie
Heights, NSW 2100**

Remedial Action Plan

NSW Department of Education

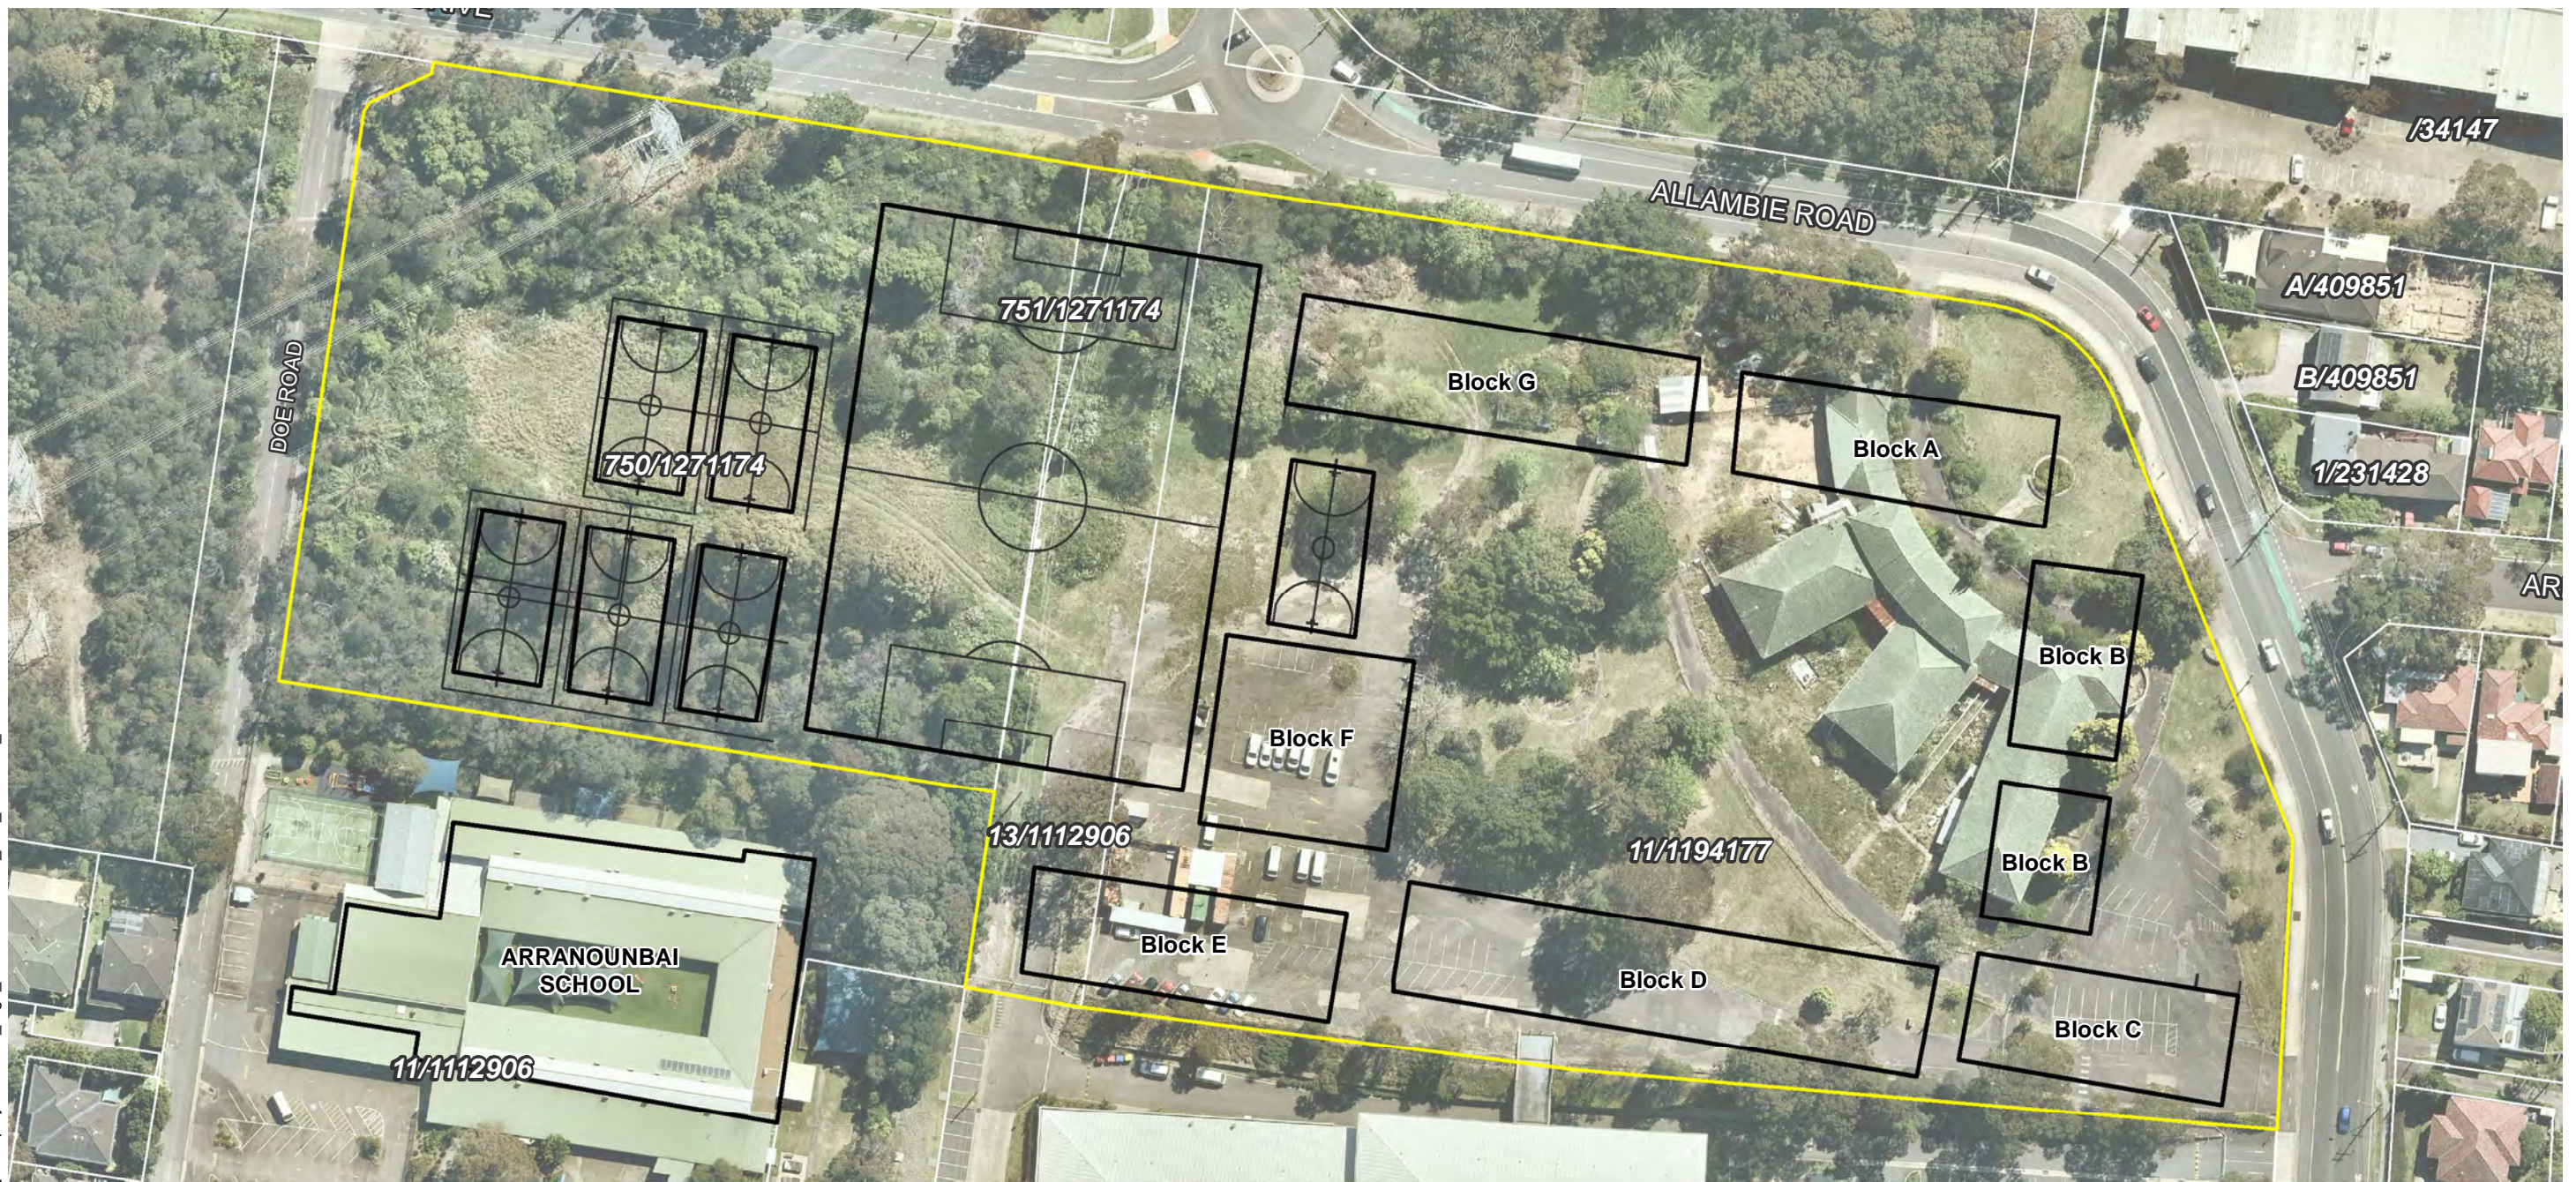
FIGURE 2: Site Overview and Site Plan Design

- Site boundary
- Design features
- Cadastre

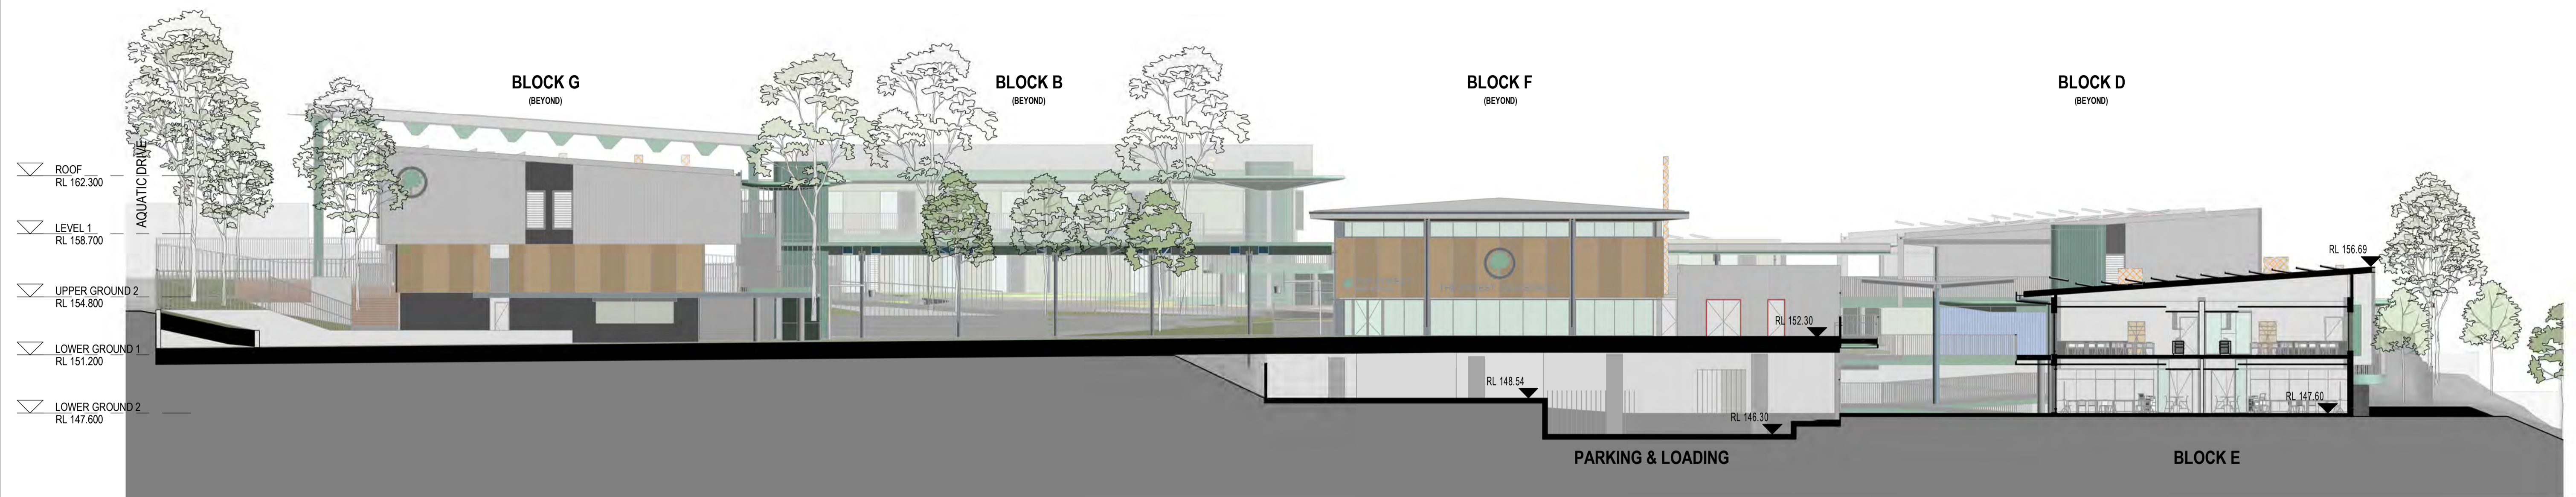
1 SITE SECTION 1
SCALE: 1:200

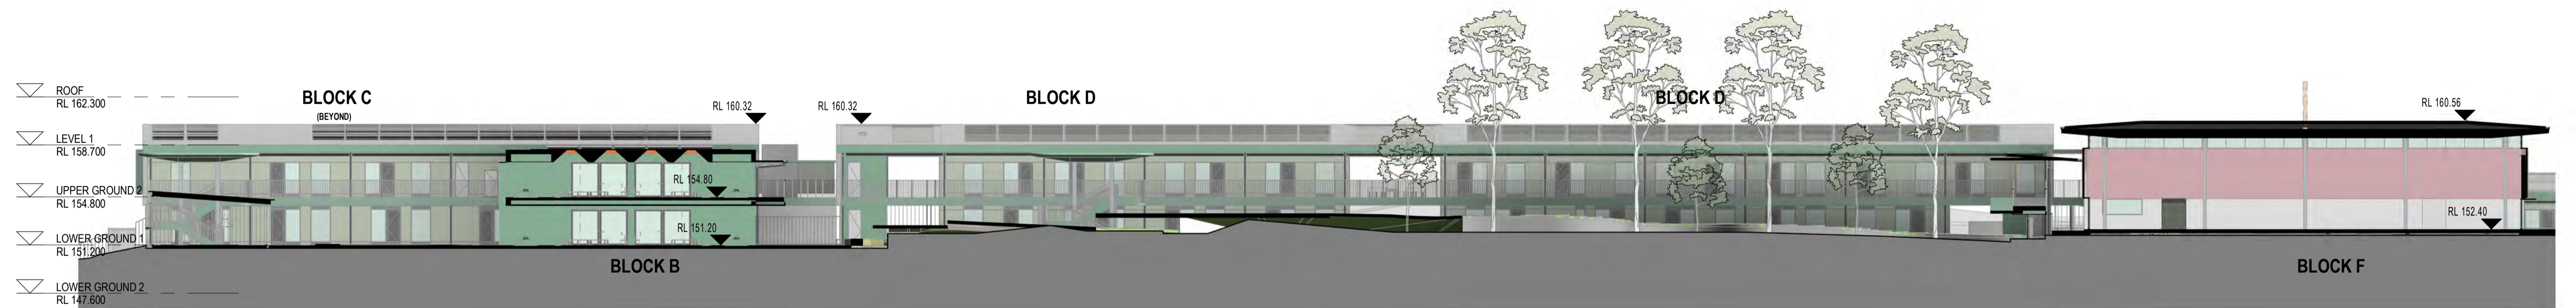
2 SITE SECTION 2
SCALE: 1:250
