Memorandum

Subject: An assessment of potential radioactivity associated with the Crescent Head ilmenite stockpile

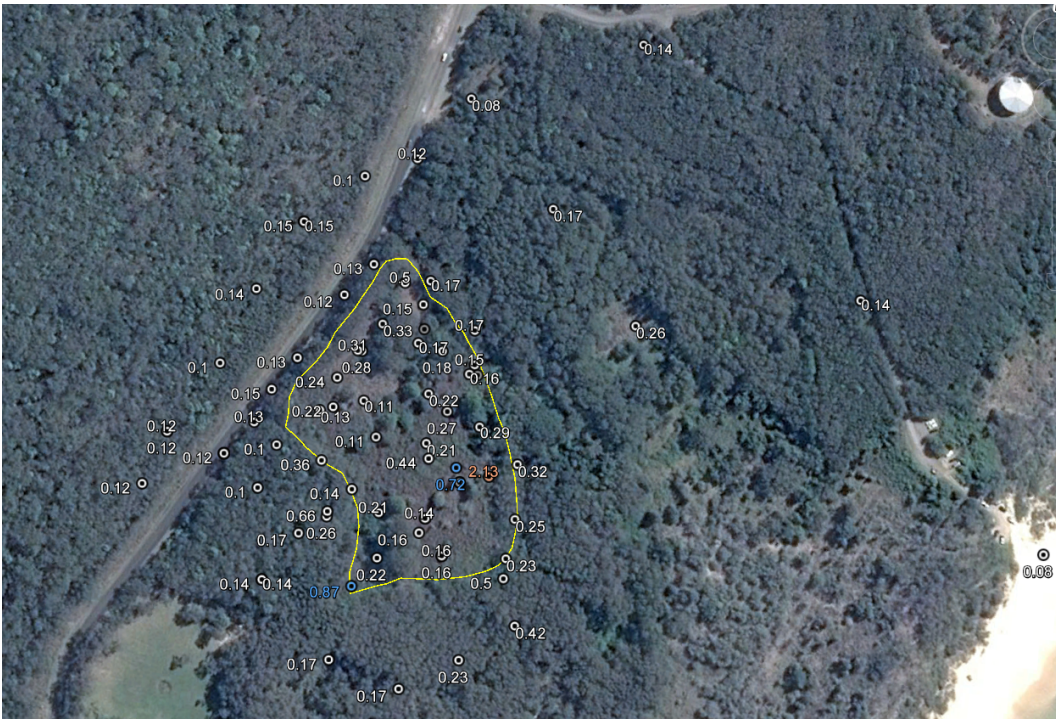
Figure 1. Overview of Crescent Head stockpile site and background field gamma readings ($\mu\text{Sv}/\text{hour}$), with approximate stockpile outline shown in yellow.

A field survey was been carried out by Pandanus Solutions in February 2018 using a RadEye B20-ER Survey Meter from ADM Nuclear Technologies. The instrument was calibrated prior to use. Readings were taken one meter above ground level on the stockpile, from off-stockpile (background), as well as from the nearby township of Crescent Head. Readings on the stockpile were taken on roughly 20m distances, with locations dependent on thickness of vegetation overgrowth. The survey results are summarised in Table 1 below, and illustrated in Figures 1 and 2. Results are tabulated in Appendix 1.

Location Description	Number of measurements	Gamma radiation level (µSv/hour)	
		Range	Average
Ilmenite stockpile	55	0.10 - 2.13	0.27±0.30
Background	20	0.08 - 0.26	0.14±0.05
Crescent Head township	2	0.11 - 0.80	0.46±0.49

The survey results summarised in Table 1 confirm that the ilmenite material located at the Crescent Head site contains very low concentrations of thorium and uranium, and no specific radiation protection measures would be required in the process of dealing with the material during its removal.

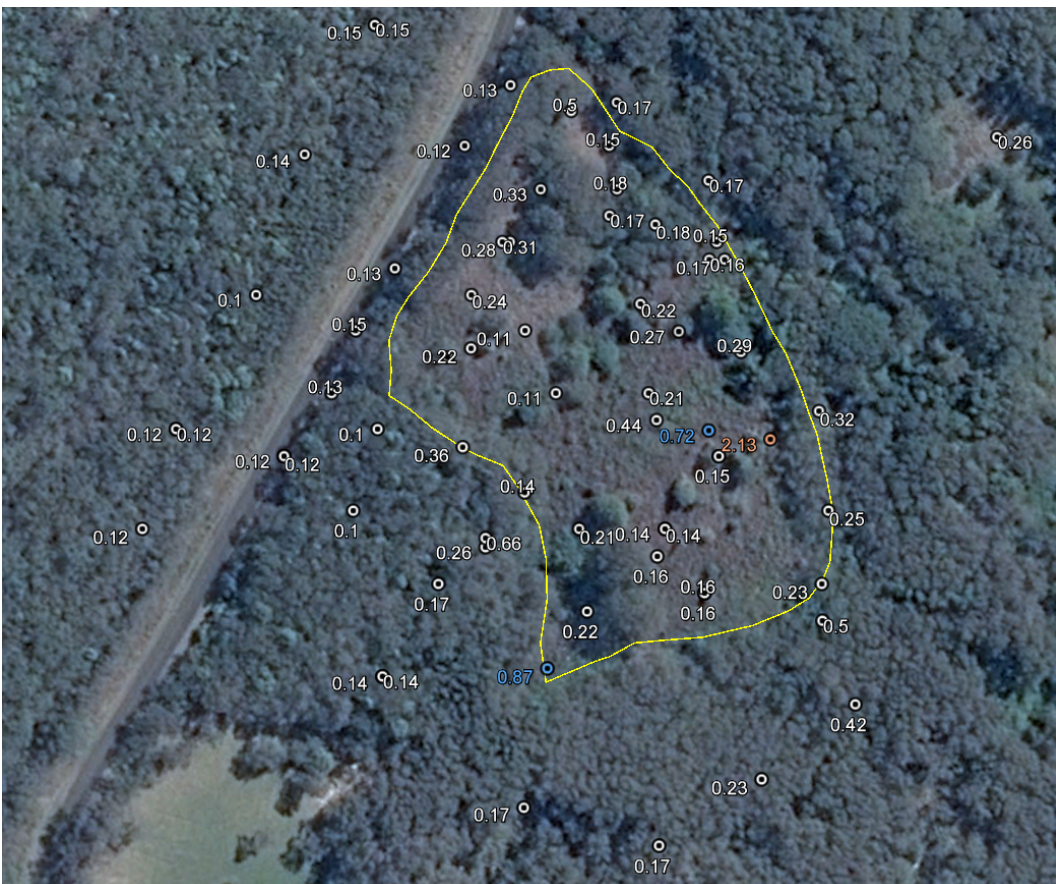
Figure 2. Detail view of Crescent Head ilmenite stockpile and background field gamma readings ($\mu\text{Sv}/\text{hour}$), with approximate stockpile outline shown in yellow.

Additionally, because several point locations on the stockpile exhibit levels of gamma radiation that are significantly higher than the background values, the following approach is recommended during remediation of the site:

1. Point locations where gamma radiation levels are 0.72, 0.87 and 2.13 $\mu\text{Sv}/\text{hour}$ are signposted and dealt with in the first instance, by blending with low gamma level material to produce a gamma radiation level preferably no higher than 0.3 $\mu\text{Sv}/\text{hour}$. If practicable, it is also recommended to deal with point locations showing 0.50, 0.50 and 0.66 $\mu\text{Sv}/\text{hour}$ at the same time and in the same manner.
