**Figure 24 Shrub Swamp Localities in Angus Place, Angus Place East, Springvale and Springvale South Extension and Burralow Formation Outcrop**

### *I. Japan Shrub Swamp*

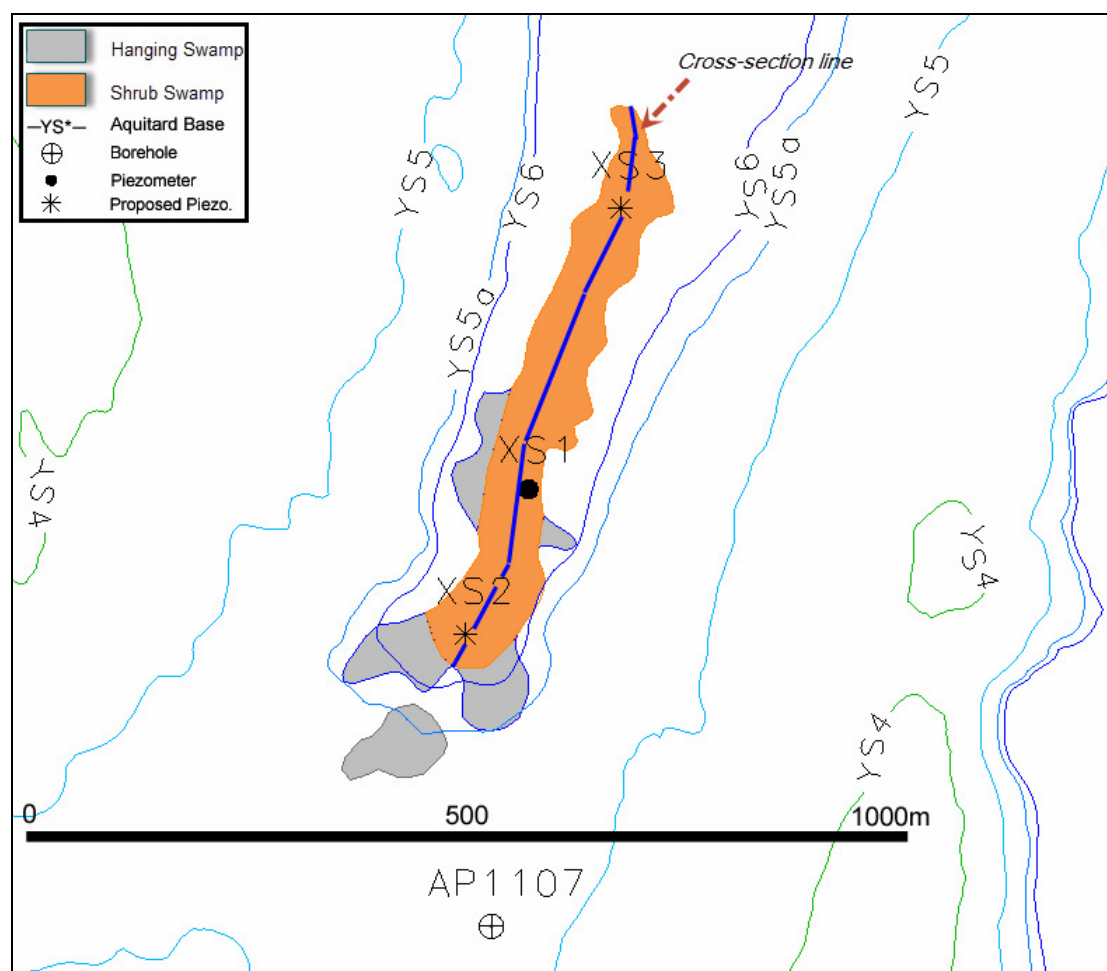
**Figure 26 Plan of Japan (Trail 6) Shrub Swamp**

Japan Shrub Swamp (also known as Trail 6 Swamp) trends approximately north-south, with a length of 750 metres and a maximum width of 75 metres (Figure 26). It has a fall of 32 metres, is wholly contained within the Banks Wall Sandstone and is distal from any known structure zones (Figure 4). The gully in which Japan shrub swamp lies forms part of the extreme upper reaches of a tributary of the Wolgan River and overlies longwalls LW1016 and LW1017.

This swamp was subsequently ground truthed by R. Lembit (2010) and vegetation patterns were found to concur with geological findings, with Lembit reporting the presence of hanging swamps in the upper reaches of the host gully, and along side valleys as indicated in Figure 26.

Aquitards YS6 and YS5a are sufficiently developed in thickness to permit a change in hydrological gradient to form the hanging swamps at the headwaters of Japan Shrub Swamp as well as along the down-dip western side of the gully (Figure 26).

Figure 29 shows piezometric data from January 2012 to late July 2014. Piezometer XS1 is situated roughly in the middle reaches of this swamp and overlies the pillar between longwalls LW1016 and 1017. Piezometer readings display consistently high groundwater levels over above period. The negative spikes represent regular groundwater sampling. The pronounced dips in August 2012 and November 2013 are due to data sampling problems (D. Hilyard pers.com). The negative spike on February 10, 2014 is due to purging and sampling of hole (J.Carr pers.com.). Overall, Japan Shrub Swamp at this locality displays typical groundwater-dependent shrub swamp characteristics. In order to capture the overall hydrological characteristics of the upper and lower reaches of this swamp, additional piezometers are suggested at XS2 and XS3 as shown in Figure 26.

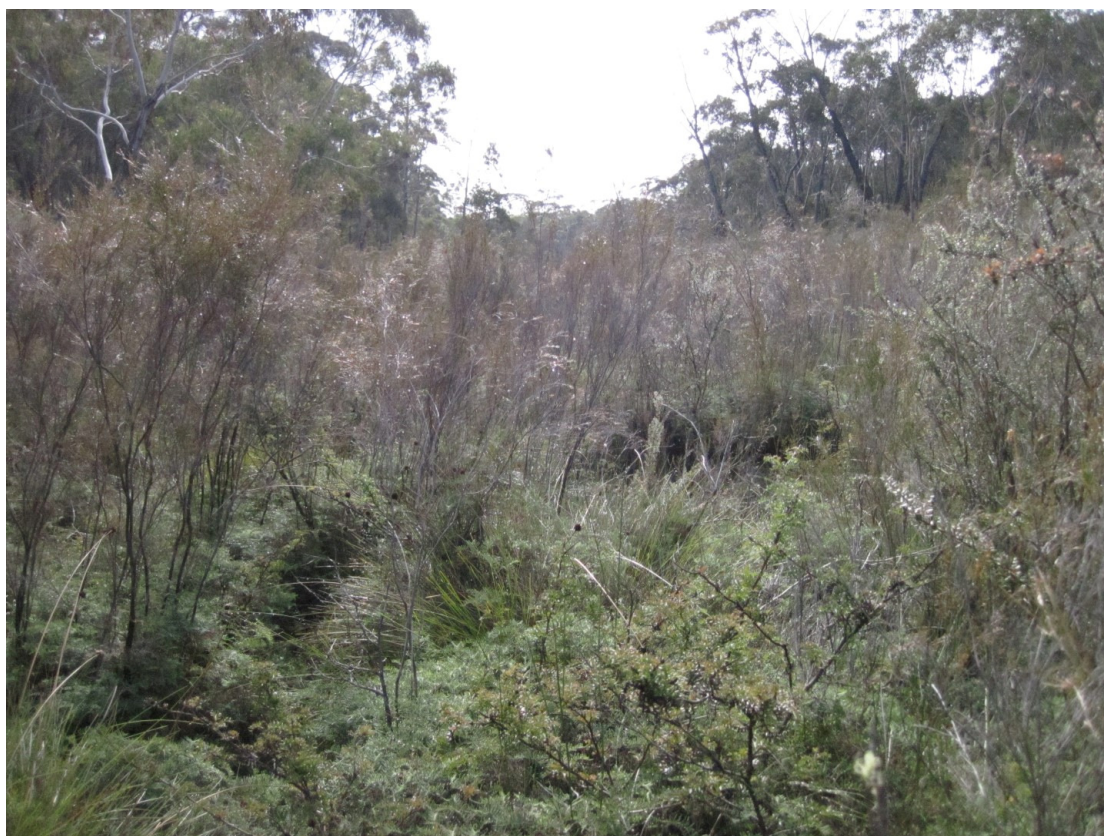
**Figure 27 View of Japan Swamp (Trail 6)**

Figure 27 was taken in the middle of the drainage line of the swamp, oriented in a northerly (downstream) aspect approximately one-third of the way from the upper reaches of the host gully. This photo gives an indication of the relative narrowness of this swamp compared to Burrell-type shrub swamps described previously. This swamp is wholly underlain by the Banks Wall Sandstone and thus the morphology differs significantly from shrub swamps with Burrell Formation substrates.

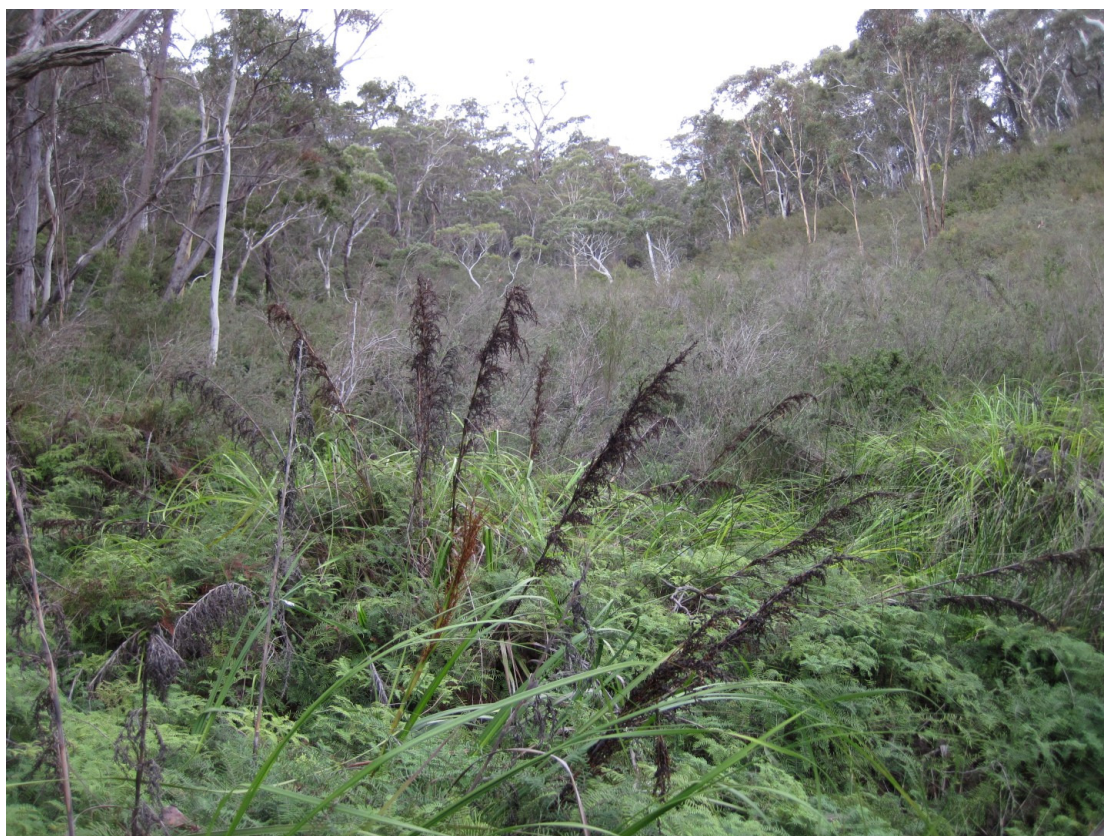
**Figure 32 View along eastern extent of Twin Gully Shrub Swamp**

Figure 32 was taken from 236 523E/ 6 308 783N GDA which is located almost half way along the eastern fork of Twin Gully swamp and close to the modelled boundary between the Banks Wall Sandstone and the Burralow Formation (Figure 30). This photo illustrates the relatively narrow morphology of the main drainage line of Twin Gully as compared to the more open expanses of the Burralow-type swamps in the Springvale area. While vegetation types are similar in both swamp types (Lembit, 2013), the Banks Wall Sandstone substrate at this location results in a more confined swamp width.

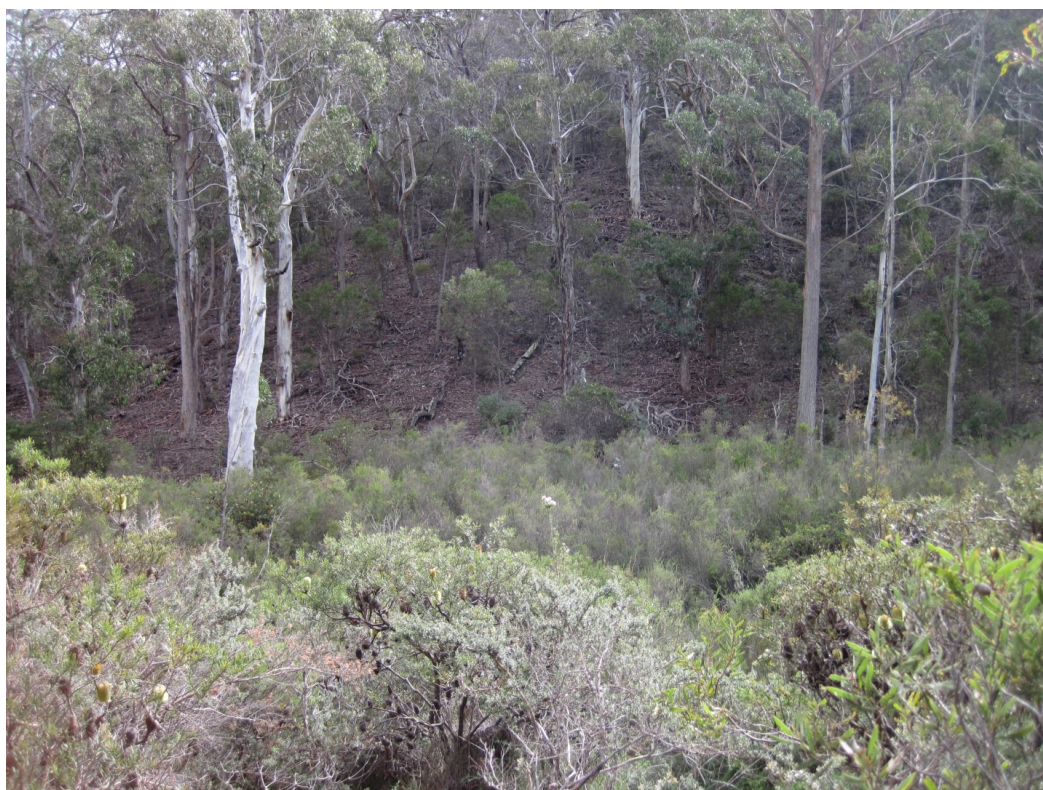
**Figure 36 View across north-eastern arm of Tri-Star Shrub Swamp**

Figure 36 shows a view looking north-west across the north-eastern tributary of Tri-Star swamp taken from 237 284E / 6 307 061N GDA. As with Twin Gully described above, swamp width is restricted due to the dominant Banks Wall Sandstone substrate as compared to Burralow-type shrub swamps. The steep north-western flank of the gully can be clearly seen. This photo location is adjacent to the modelled boundary between the Banks Wall Sandstone and the Burralow Formation.
