121204 3A-C02 P1

**STAGE 3A  
EROSION AND SEDIMENT  
CONTROL PLAN**

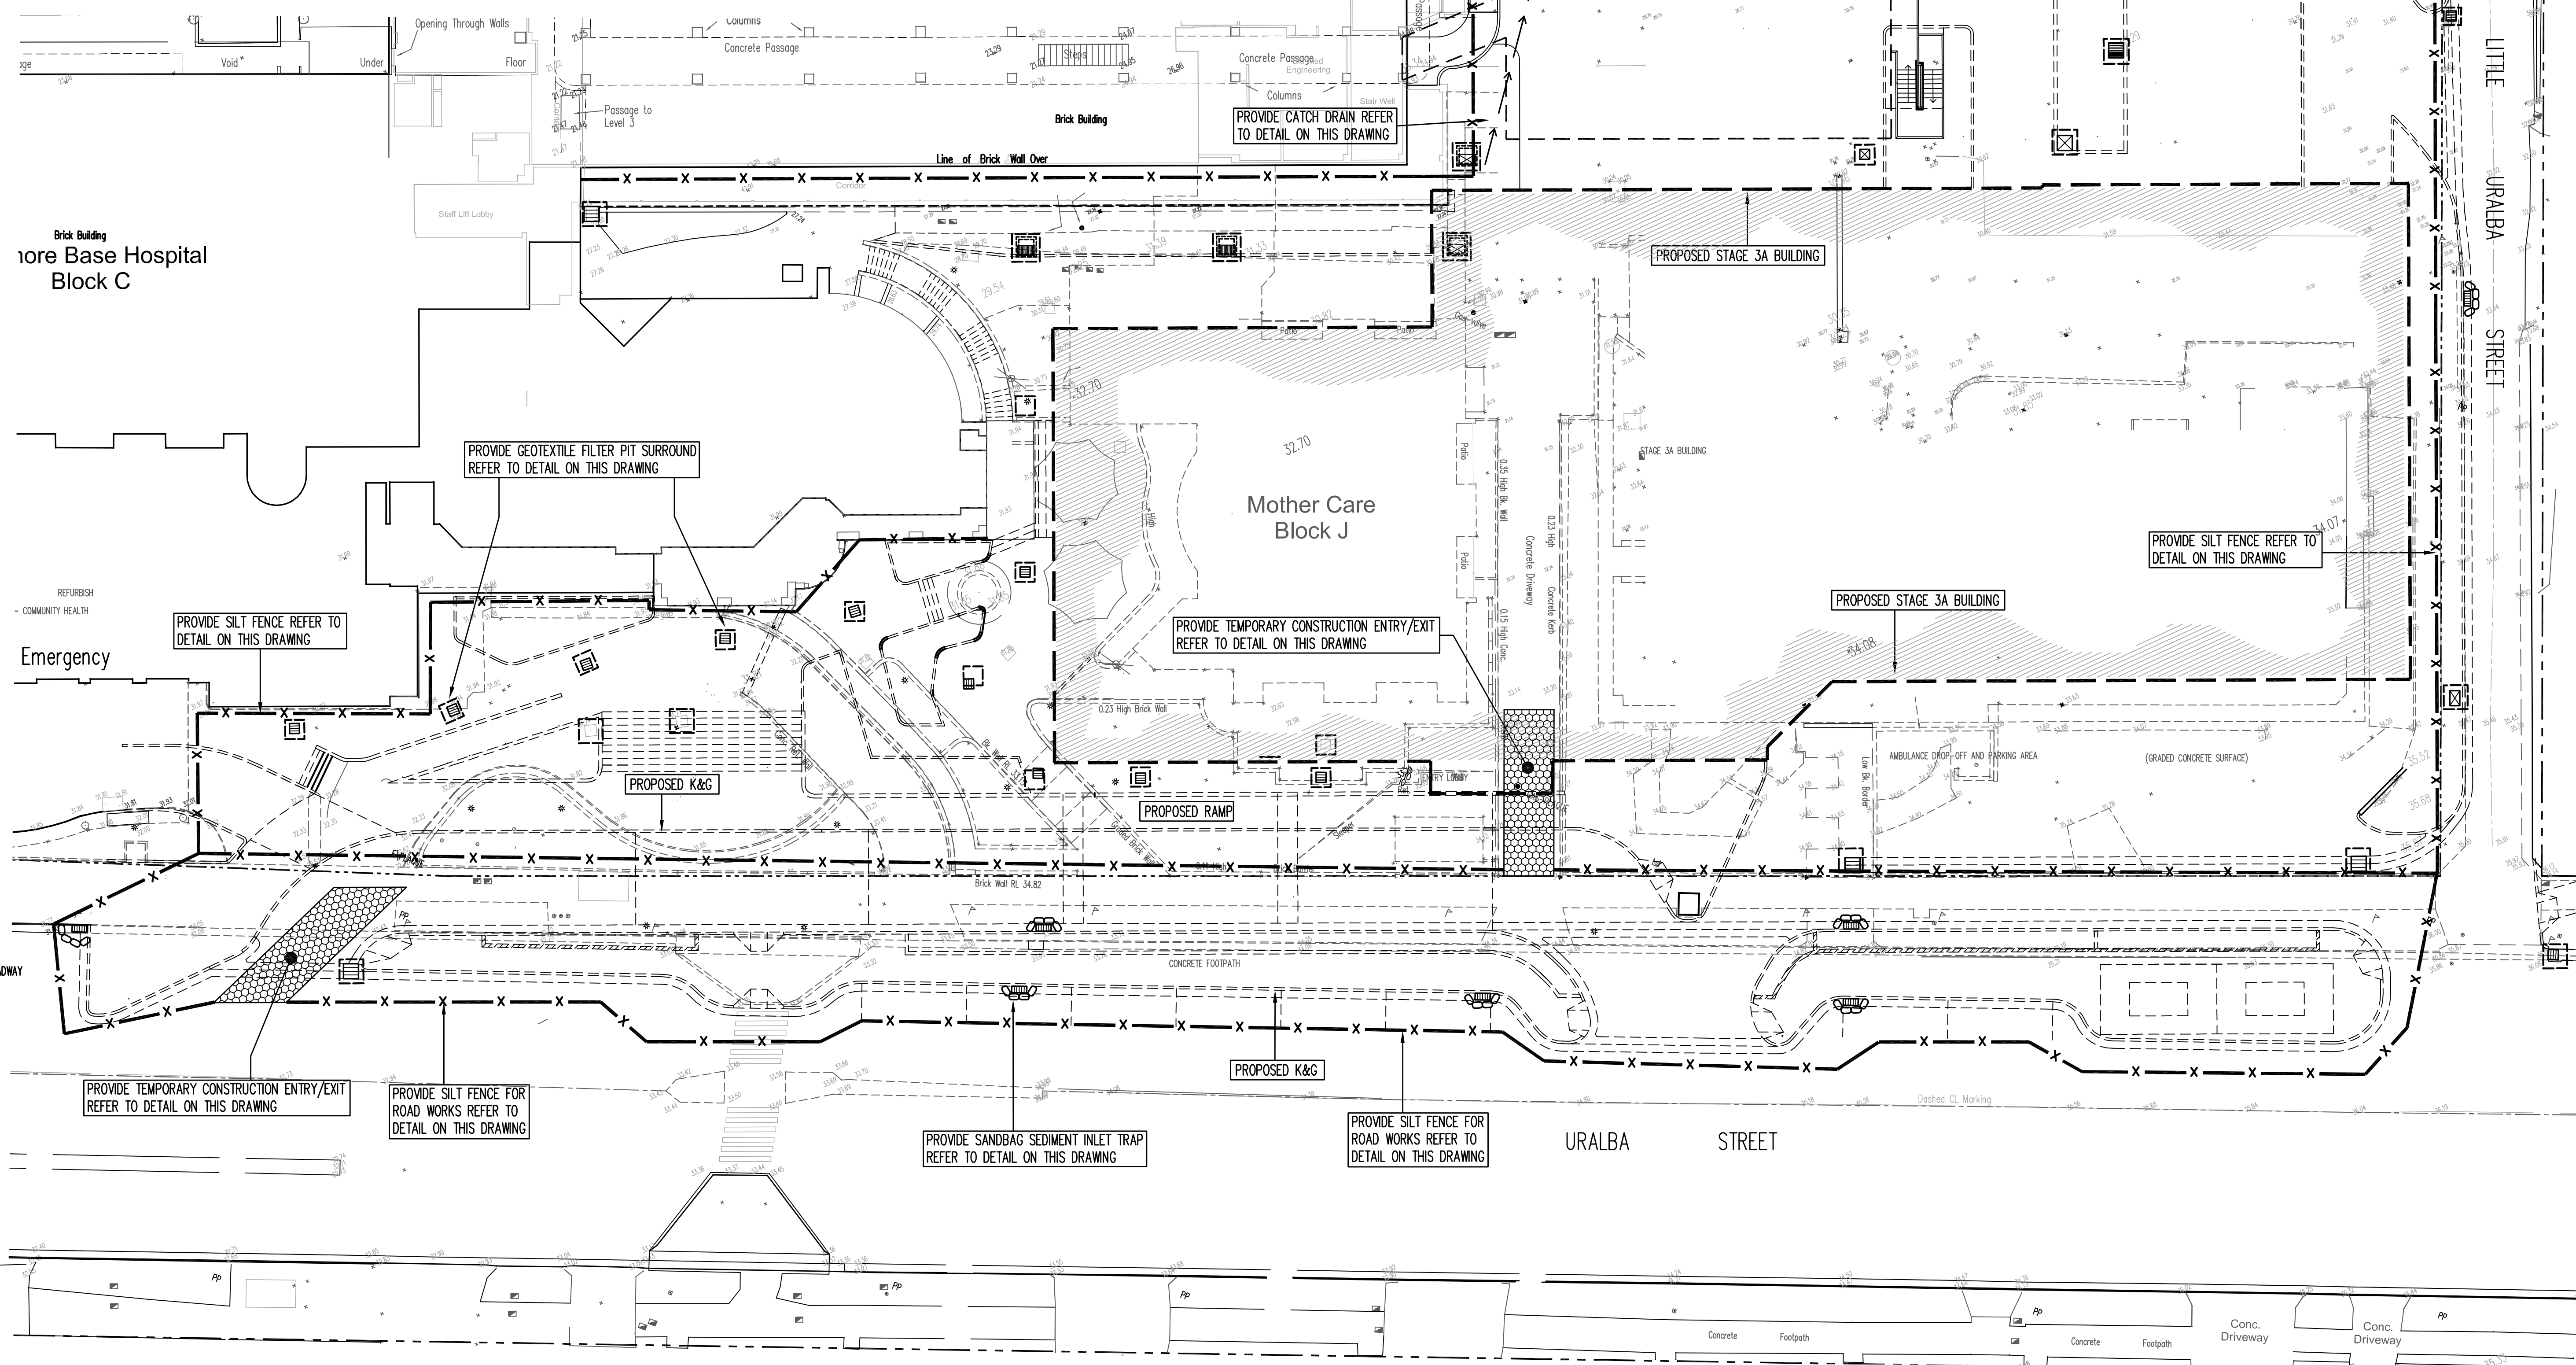
PLAN  
SCALE 1: 200

Siltation fence  
 Stormwater pit with Geotextile filter surround  
 Hay bale barriers  
 Sandbag sediment trap  
 Catch drain
