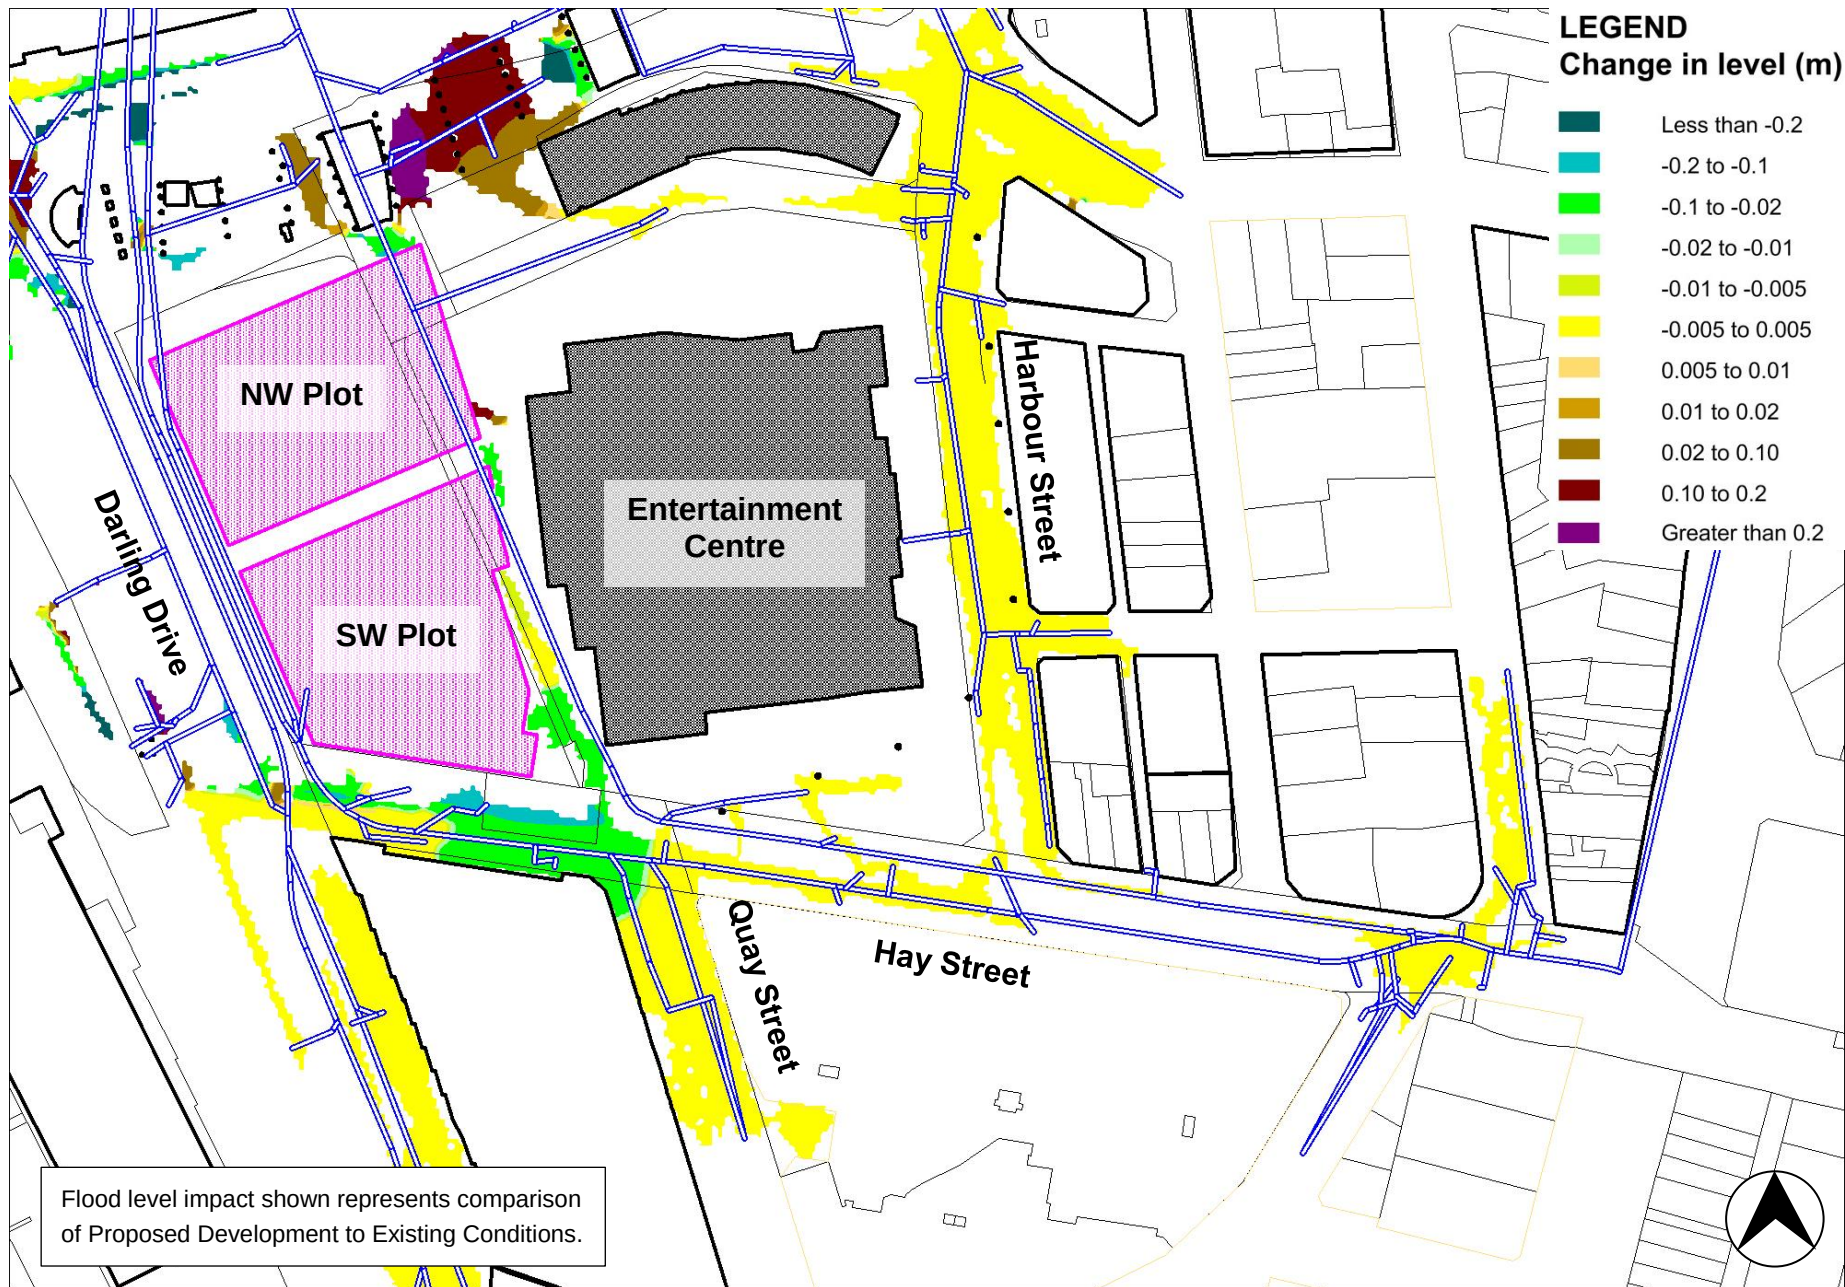
**Figure D2** - 5 Year ARI Flood Level Impact 100mm gap under hoarding with 4m<sup>2</sup> inlet pit (50% blockage applied) with amplification and overland flow path

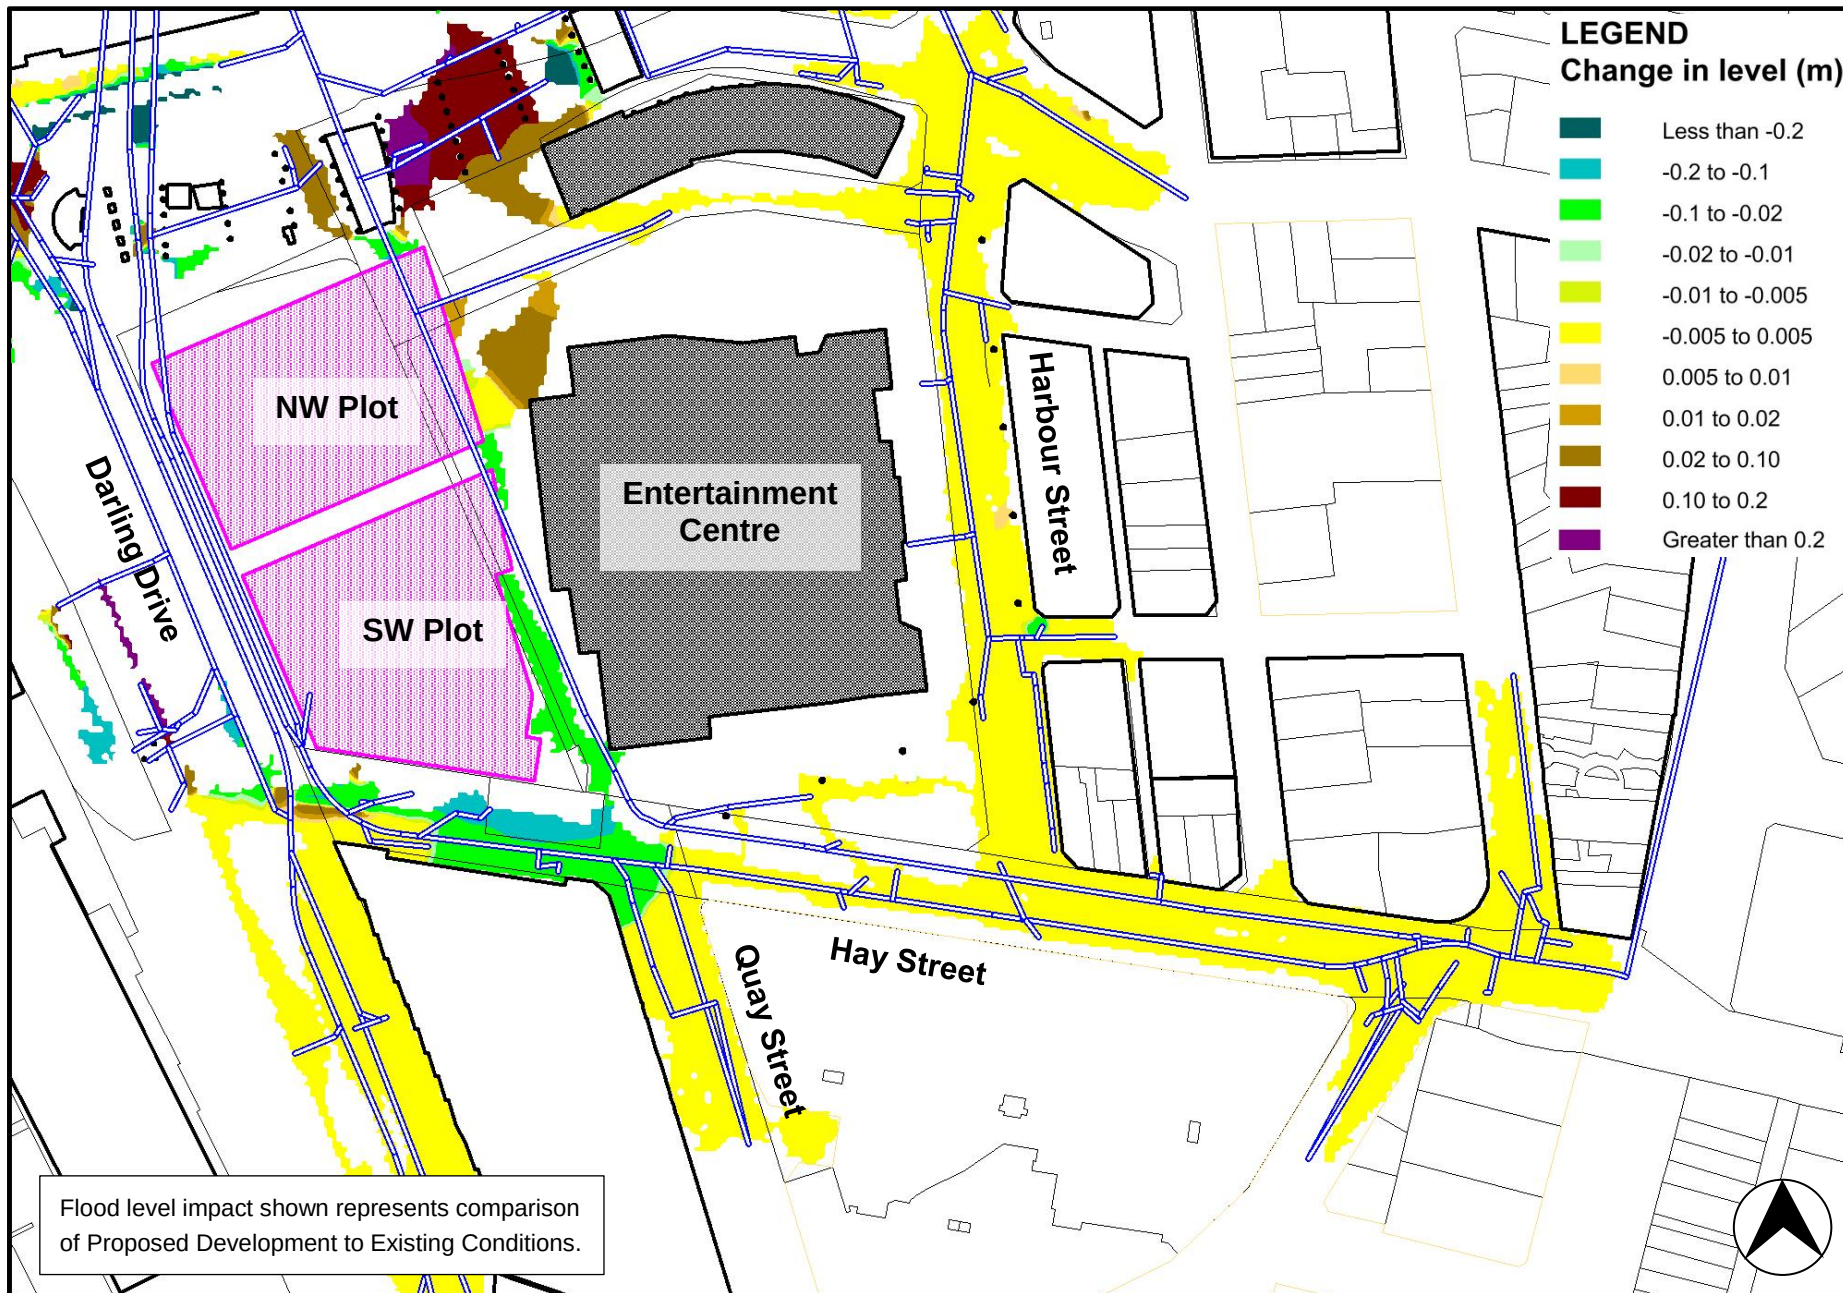
**Figure D3** - 20 Year ARI Flood Level Impact 100mm gap under hoarding with 4m<sup>2</sup> inlet pit (50% blockage applied) with amplification and overland flow path

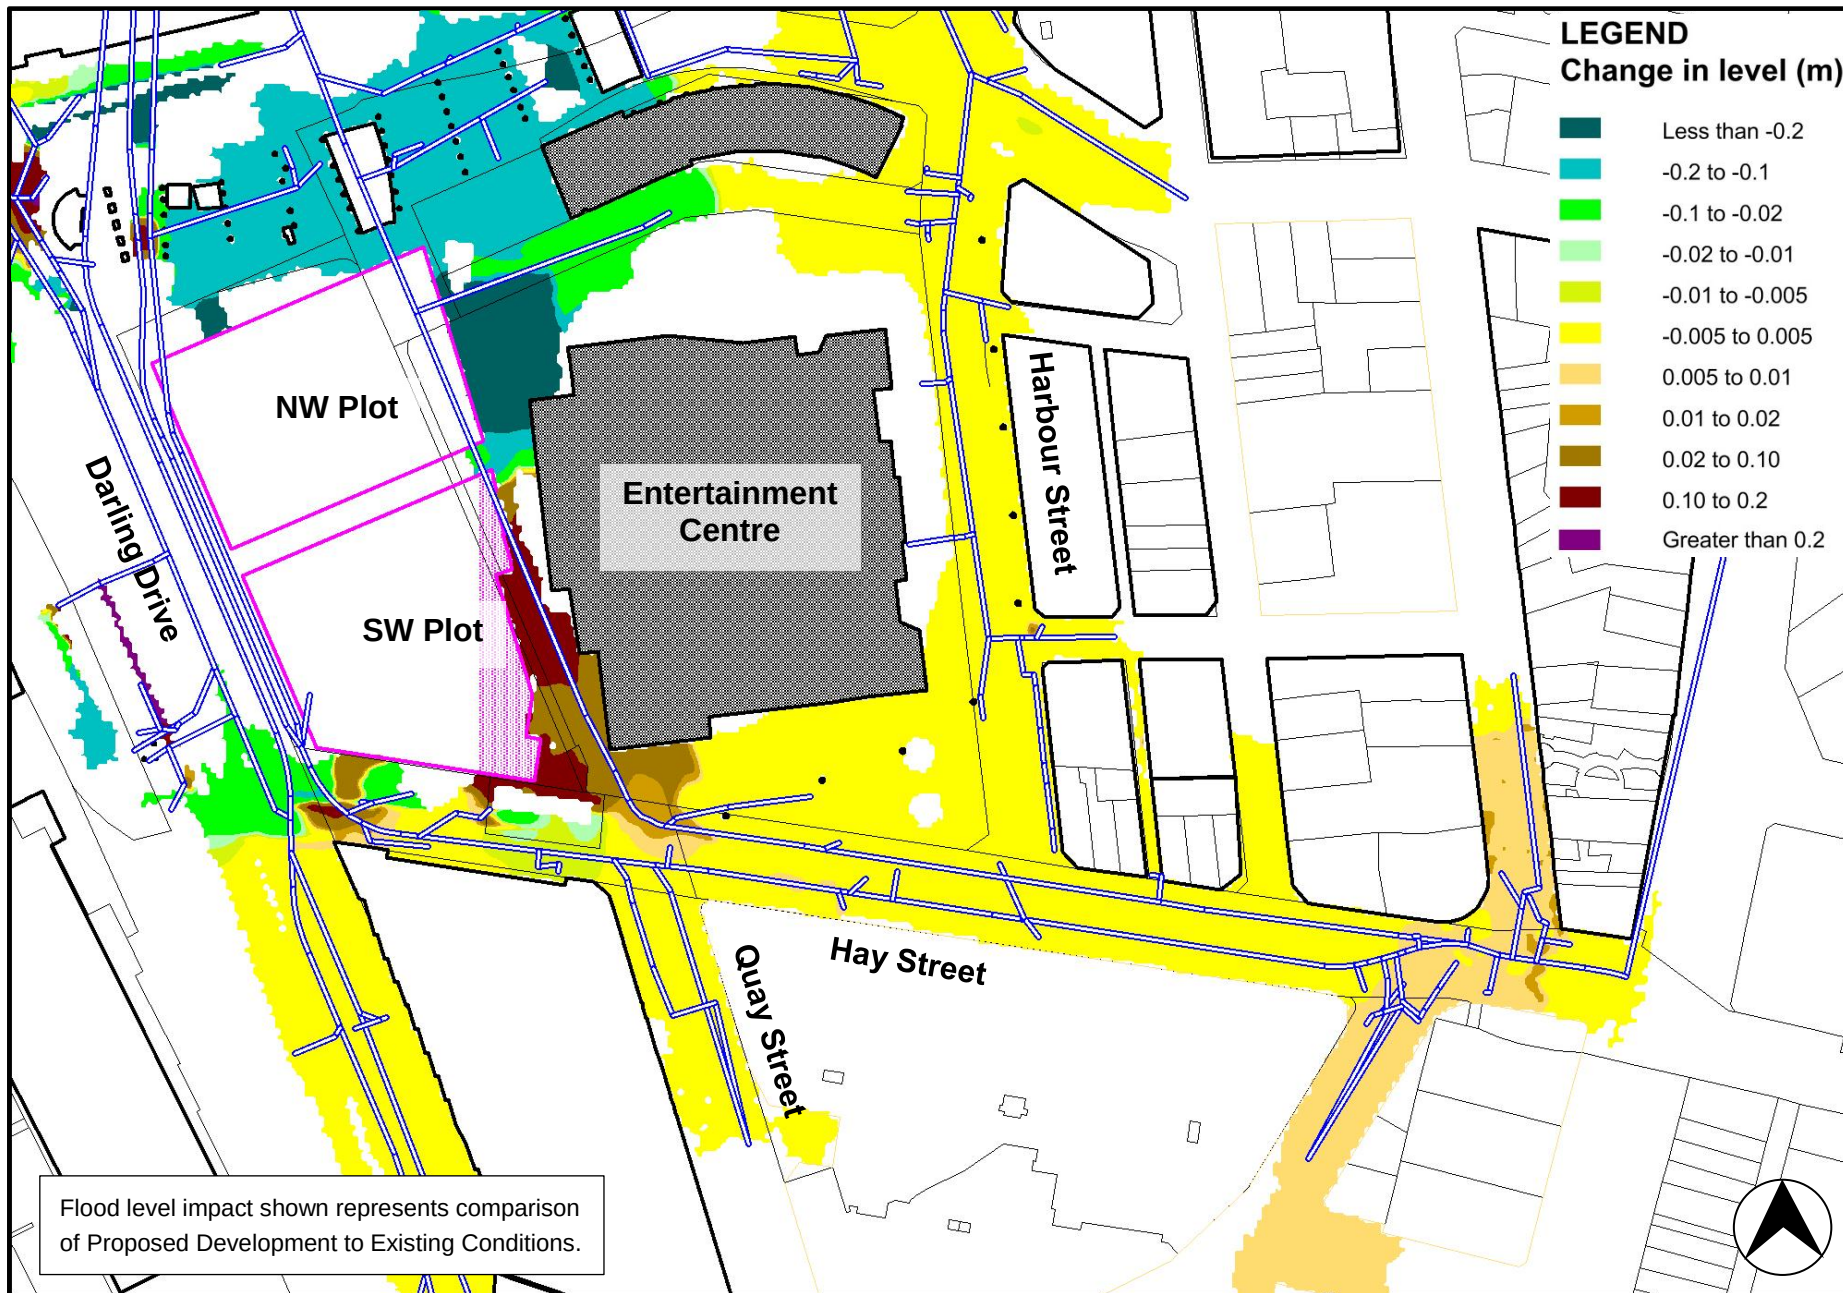
**Figure D4** - 100 Year ARI Flood Level Impact 100mm gap under hoarding with 4m<sup>2</sup> inlet pit (50% blockage applied) with amplification and overland flow path
