## Preliminary Hazard Analysis

Deniliquin East BESS

BESS Arctic Pty Ltd c/o Gransolar Development Australia

**Riskcon Engineering Pty Ltd**

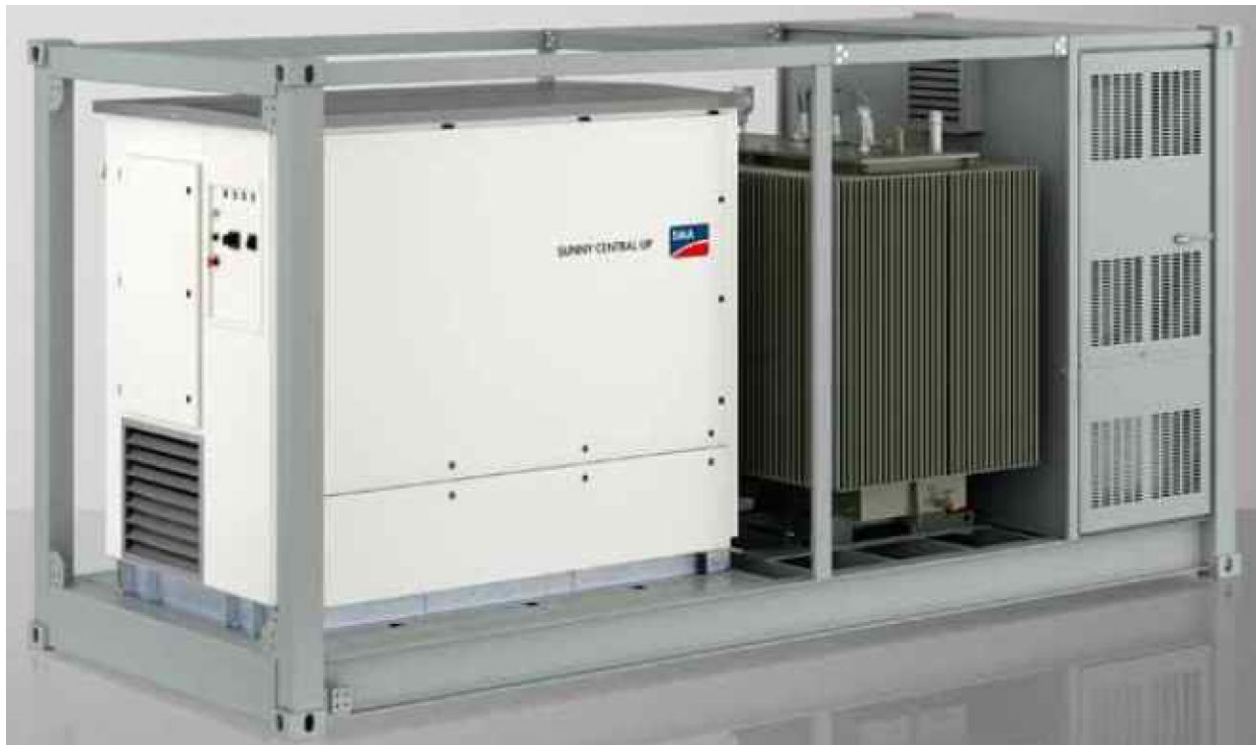
The inverters convert the Direct Current (DC) to Alternating Current (AC), while the transformers increase the voltage from Low Voltage to a Medium or High Voltage, as required for the electricity grid connection. MPVS are a compact, containerised product, with each unit measuring approximately 2.5 metres wide by 3 metres high, with a depth of 6 metres. **Figure 3-5** provides an example of a typical MVPS.

**Figure 3-5: Typical MVPS**

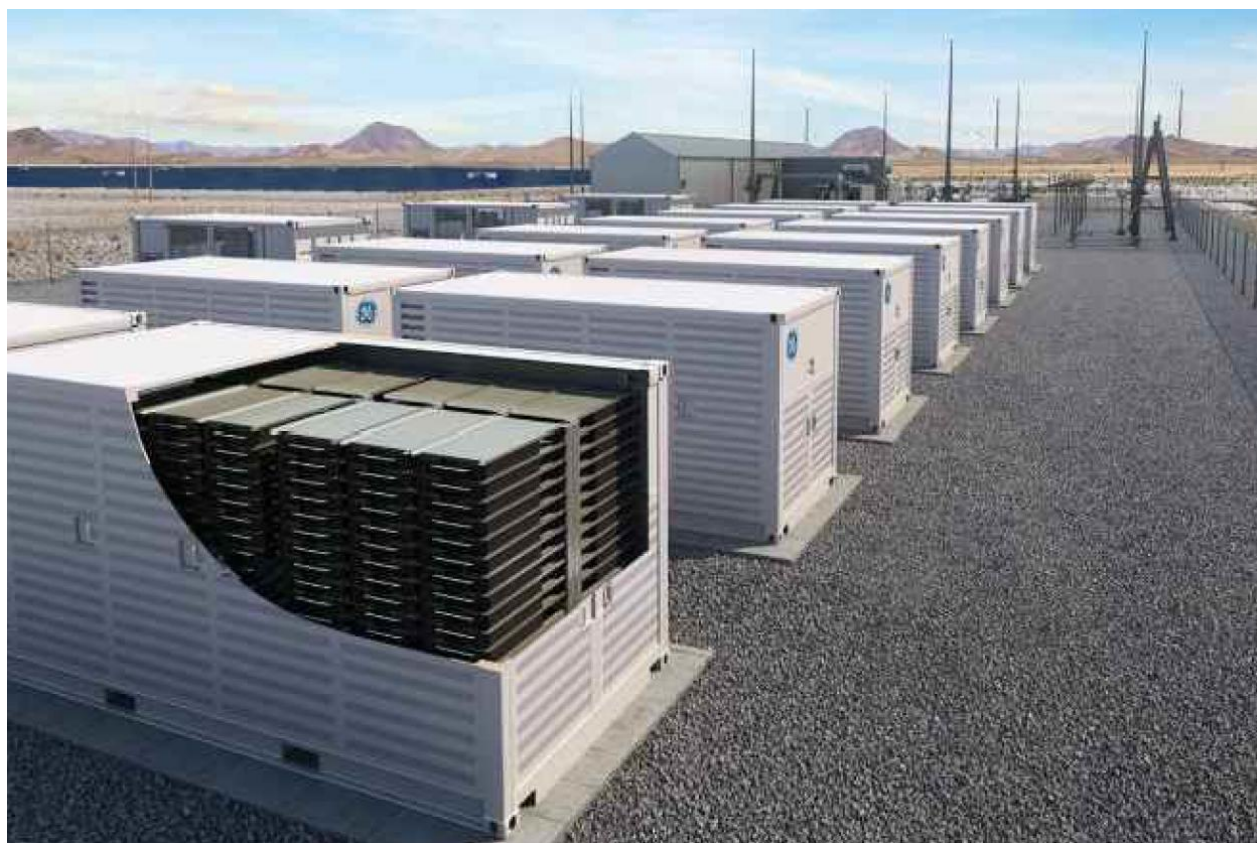
The BESS will be located within the site compound, laydown and substation footprint area. The BESS converts electrical energy into chemical energy and stores the energy internally. It may also provide additional network support such as Frequency Control Ancillary Services (FCAS) assisting with transmission network grid stability. A typical BESS is shown in **Figure 3-6**.

**Figure 3-6: Typical BESS Arrangement**
