REPORT TO  
**TTW**

ON  
**GEOTECHNICAL INVESTIGATION**

FOR  
**PROPOSED S5 DATA CENTRE**

AT  
**269 LANE COVE ROAD, MACQUARIE PARK, NSW**

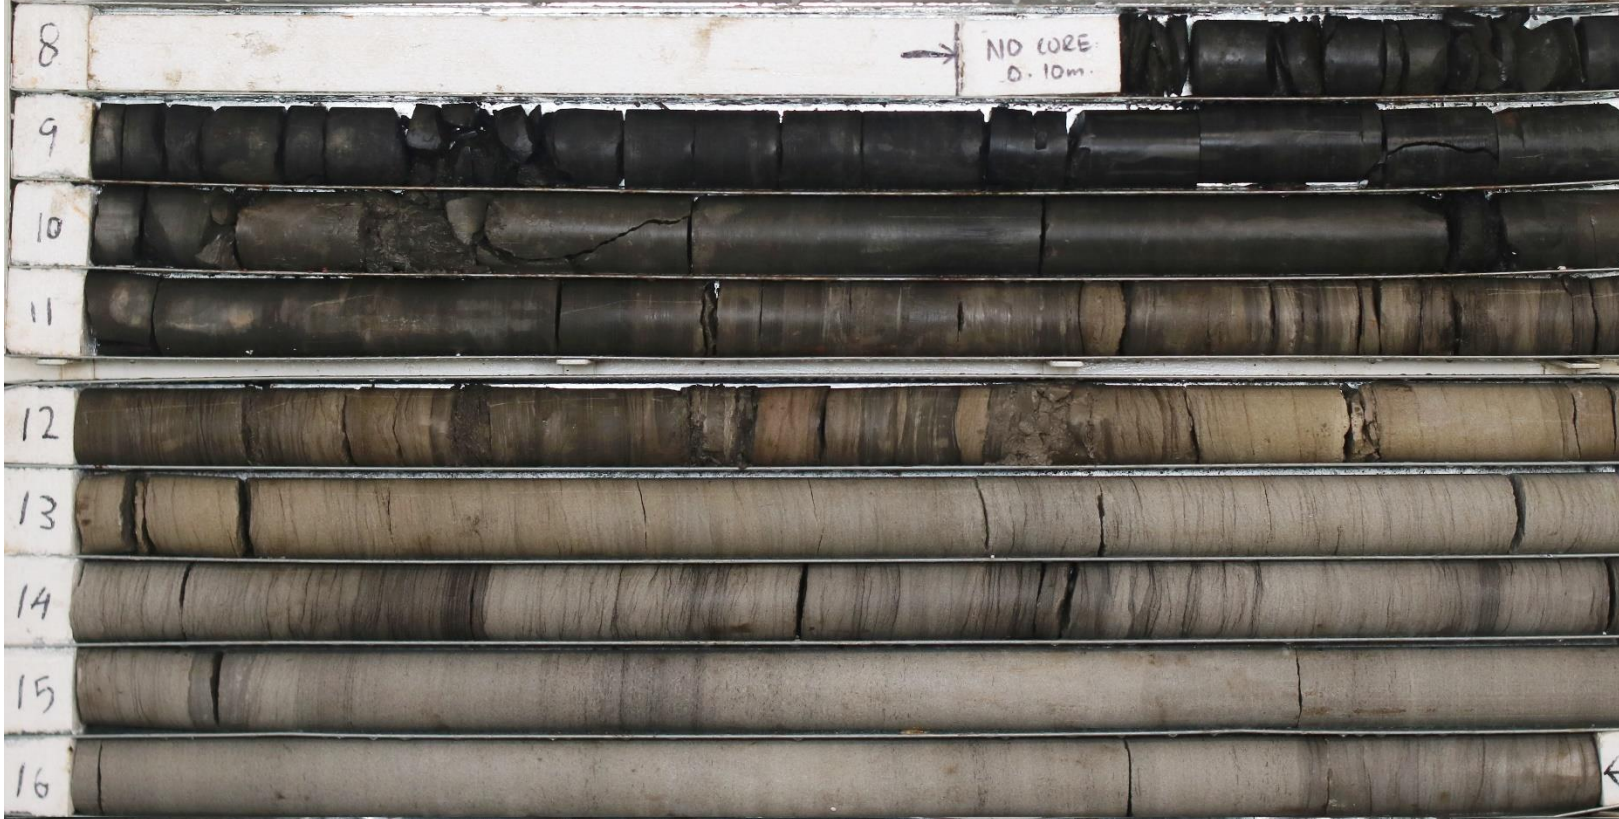
Job No: 36466BF  
Borehole No: BH5  
Depth: 8.56m to 16.98m

36466BF BH5 START CORING AT 8.56 m.

END OF BOREHOLE AT 16.98m
