Preliminary Hazard Analysis

Wattle Creek Solar Farm Project – SSD-63344210

Spark Renewables Pty Ltd
Document No. RCE-24004_Umwelt_PHA_Final_12Mar25_Rev(3)
Date 12/03/2025

Riskcon Engineering Pty Ltd

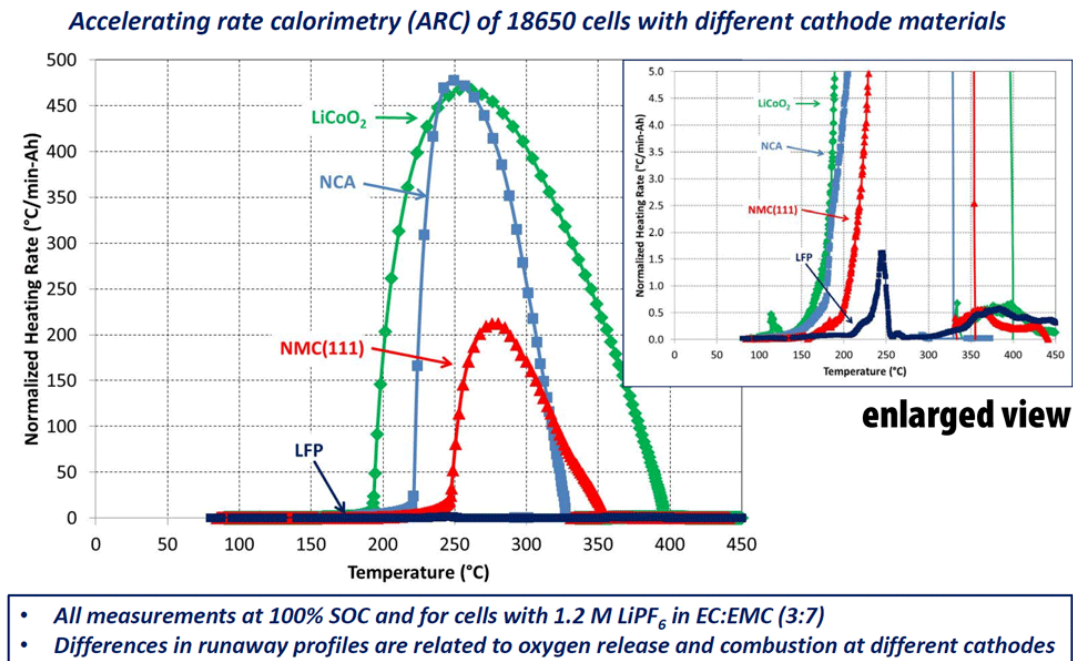
Figure 4-2: Temperature Rise of Lithium-Ion Battery Chemistries (Ref. [8]).

The preliminary battery product considered for the purposes of a preliminary hazard analysis for the project is a BESS with LFP technology. A UL9540A report has been completed for this product but is unable to be shared due to privacy reasons.
