Potential Impact to historical relics from current UoN piling plan:

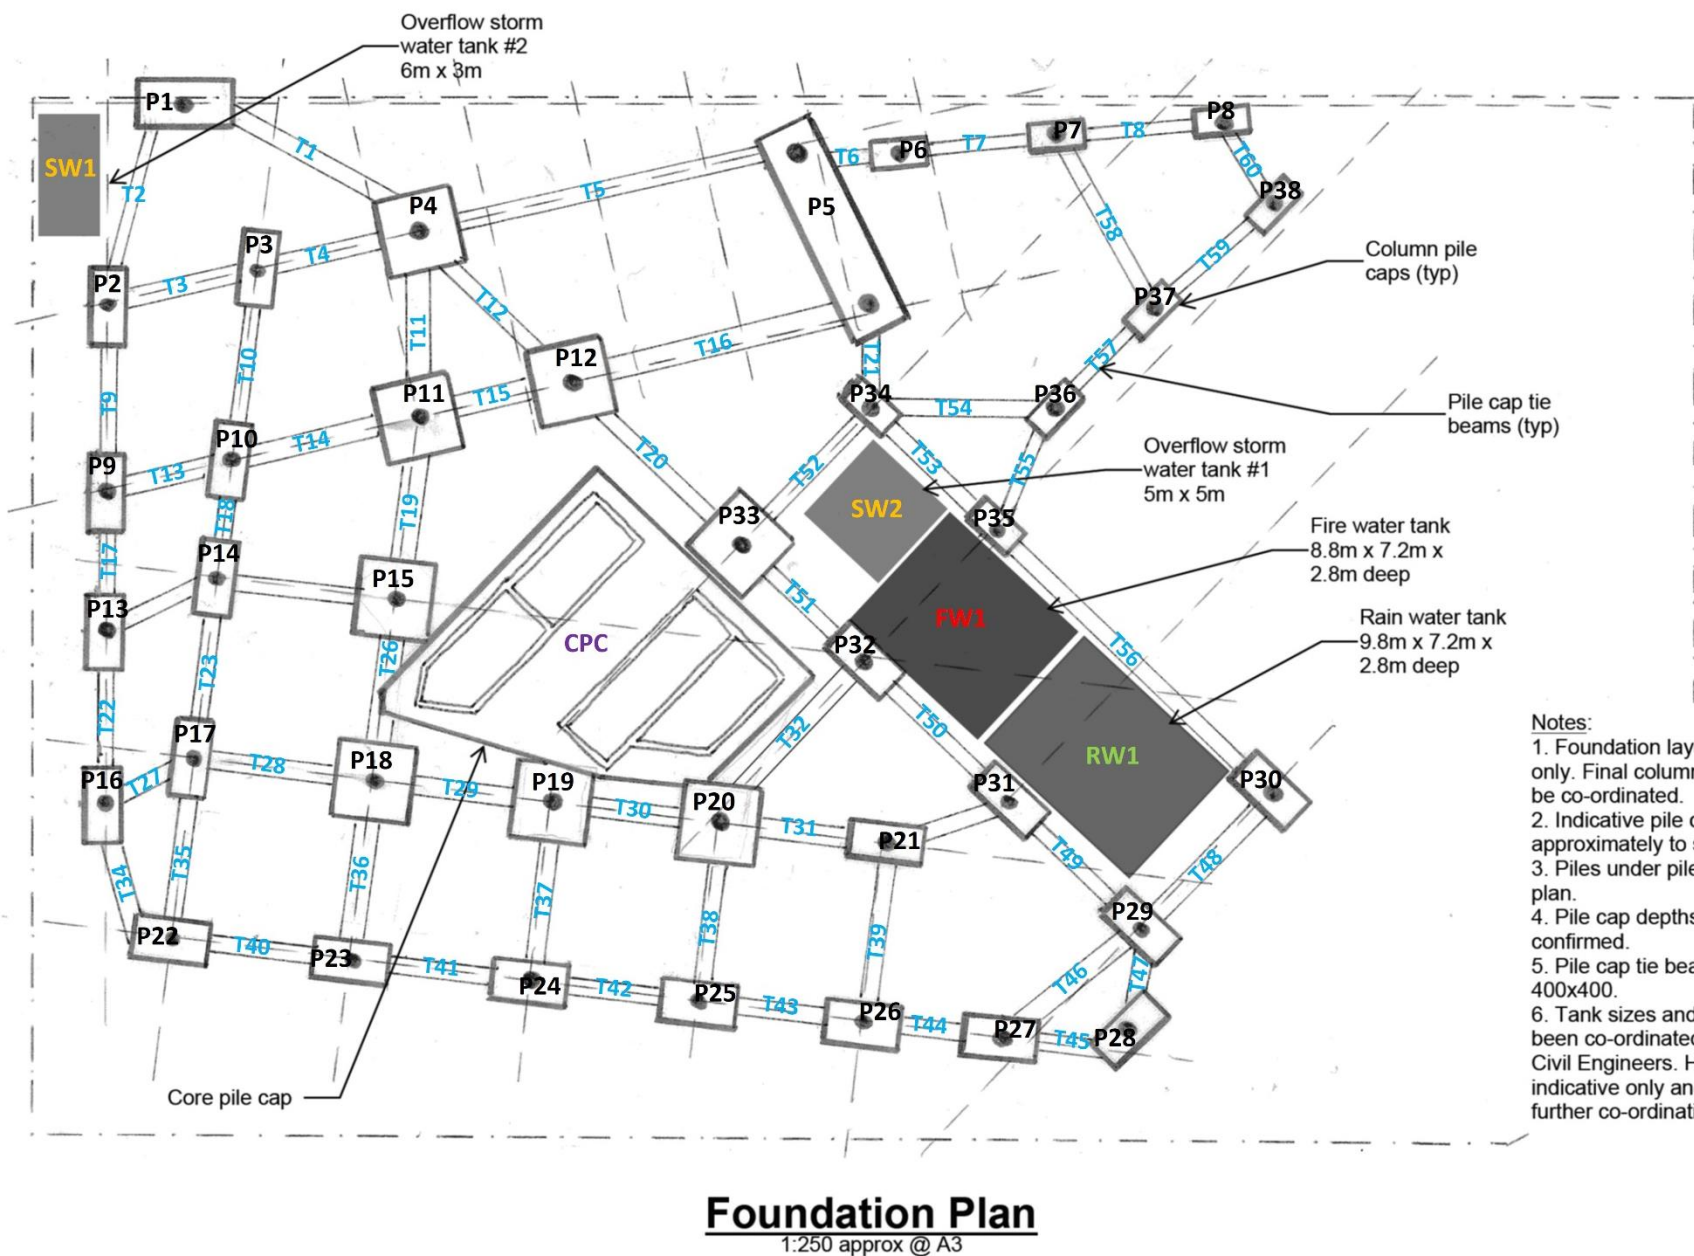
*Refer to plan for location of each specific piling hole (P) and Tie Beam (T) in reference to the numbering system within the table.
Archaeological test trenches are outlined and numbered in purple.

Figure 1 Foundation plan, showing the numbering system for each impact feature.
