Long Term Environmental Management Plan Hunter Indoor Sports Centre State Significant Development (SSD-66595459)

2 Monash Road and 24 Wallarah Road, New Lambton, NSW

26000852.001A

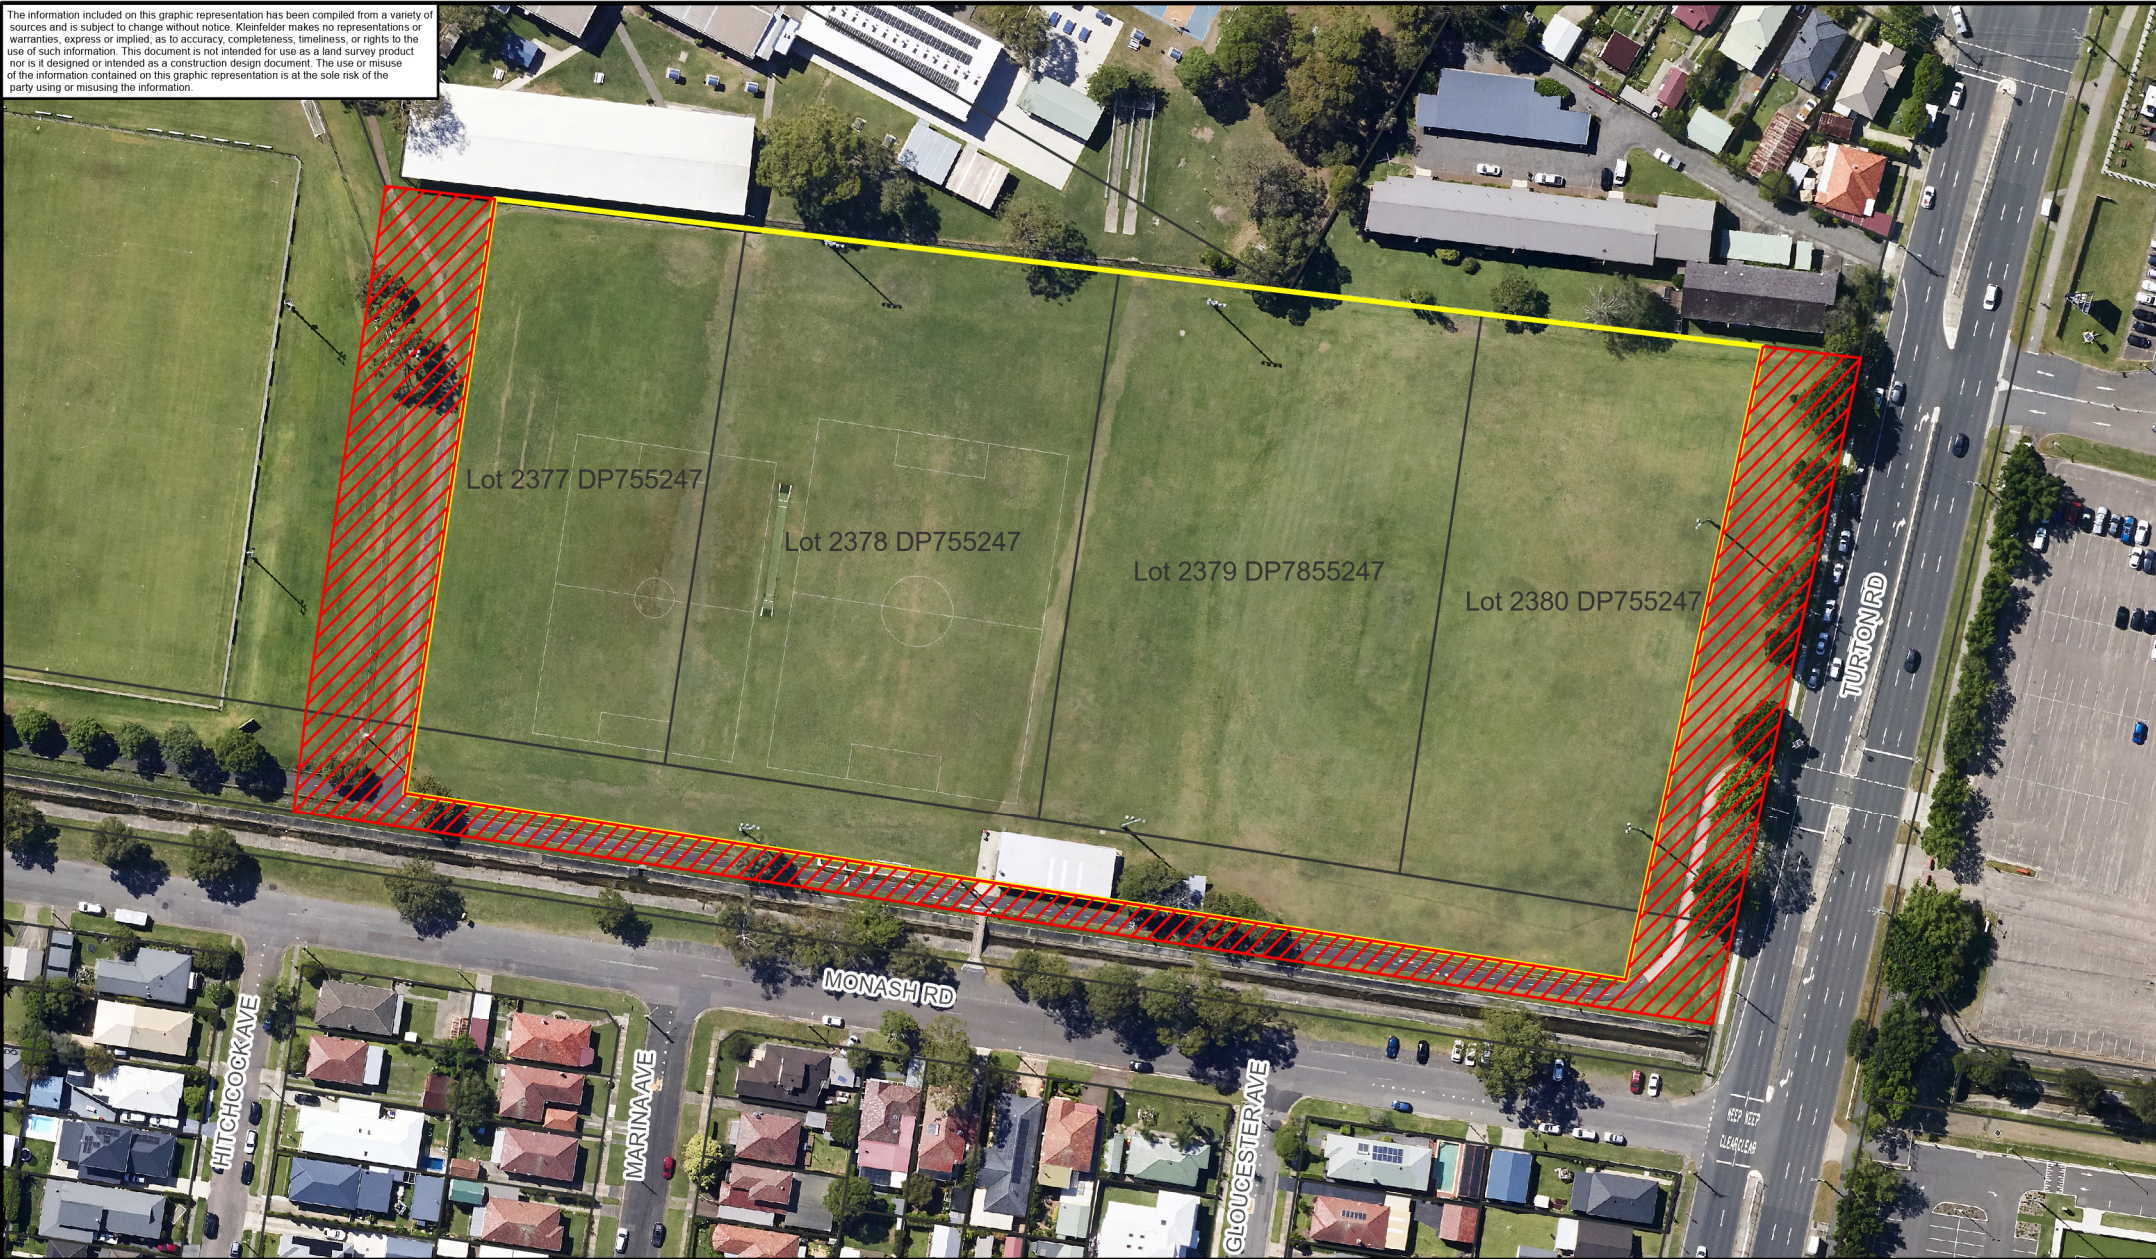
- Legend**
- Investigation Area
 - Extended Site Area
 - Lot Boundaries

The RAP noted that previous investigations did not include an investigation of areas within the red hatched area, as depicted in **Appendix A**. These areas were included as part of the overall site design following the completion of previously completed investigations undertaken by Kleinfelder. As such, the findings of previous investigations may not be reflective of conditions within this area.

Given the proximity to previous investigation areas (as depicted in **Appendix A**), the RAP noted that the soil profile within the expanded site area would likely be comparable to that which has previously been defined. However, it was recommended that this is confirmed via additional intrusive investigations within the expanded site area prior to the commencement of site development, in accordance with the NSW EPA, 2022. *Sampling Design Part 1 – Application, Contaminated Land Guidelines*, to confirm that the nature and extent of contamination in the expanded site area is consistent with the findings of the Kleinfelder (2024a) and Kleinfelder (2024b) investigations.
