| Sheet Subject | TURNING PATH PLAN<br>SHEET 3 OF 3 |

### **Acid Sulfate Soils Letter**

**PROPOSED GOSFORD HOSPITAL AND STAGE 1 OF HEALTH AND WELL  
 BEING PRECINCT  
 ACID SULPHATE SOIL**

**Proposed Health and Wellbeing Precinct  
(Formerly Identified as Proposed Entry Hub)  
Holden Street, Gosford**

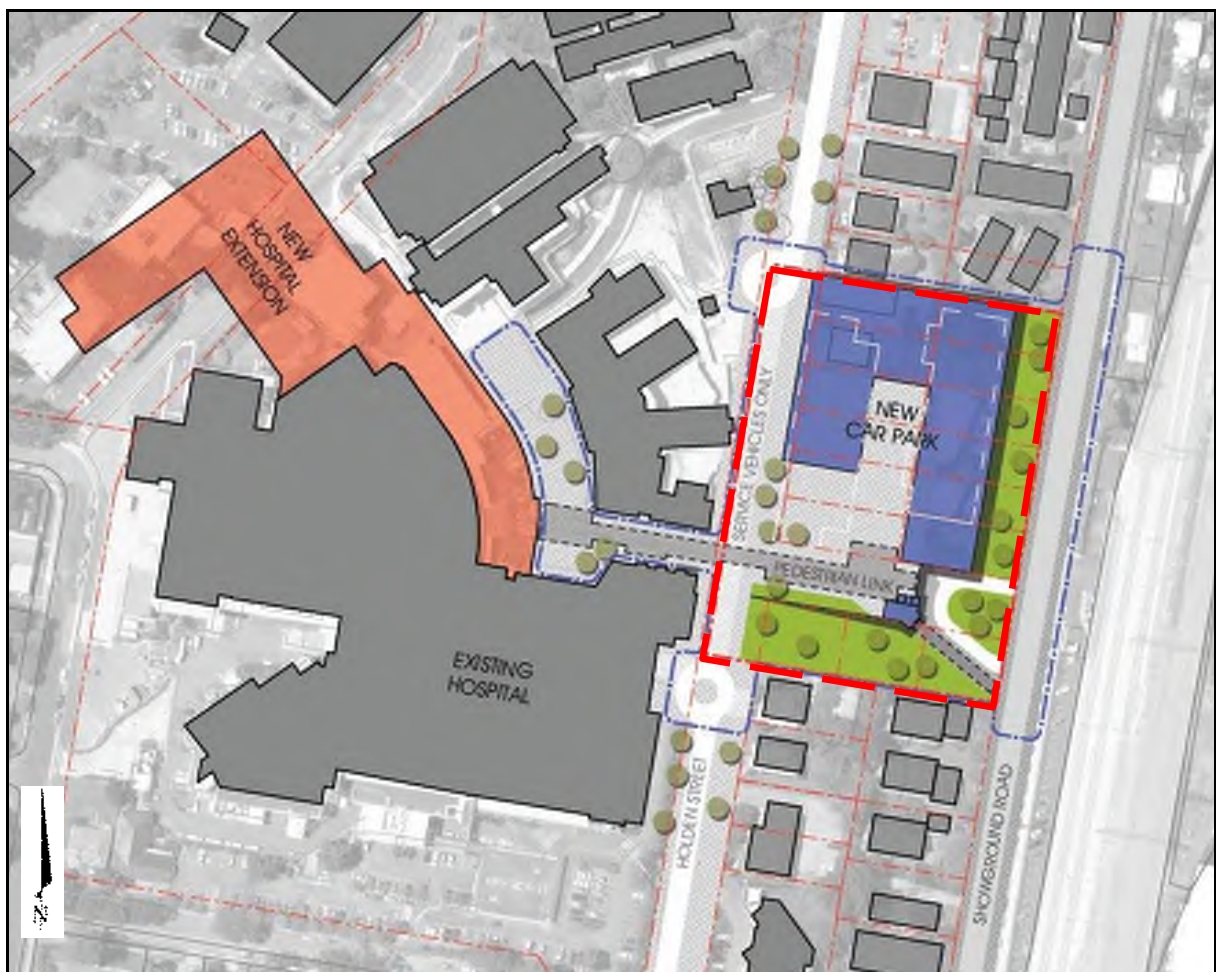
The revised development area is identified on a concept design drawing prepared by Fitzpatrick + Partners (Project 21421, Drawing SK-02, Issue 02). An excerpt of this drawing is shown below.

**Figure 1: Area of proposed Health and Wellbeing Precinct (red dashed outline)**

The revised area now includes 66 – 78 Showground Road, which is along the eastern side of the HWP site.

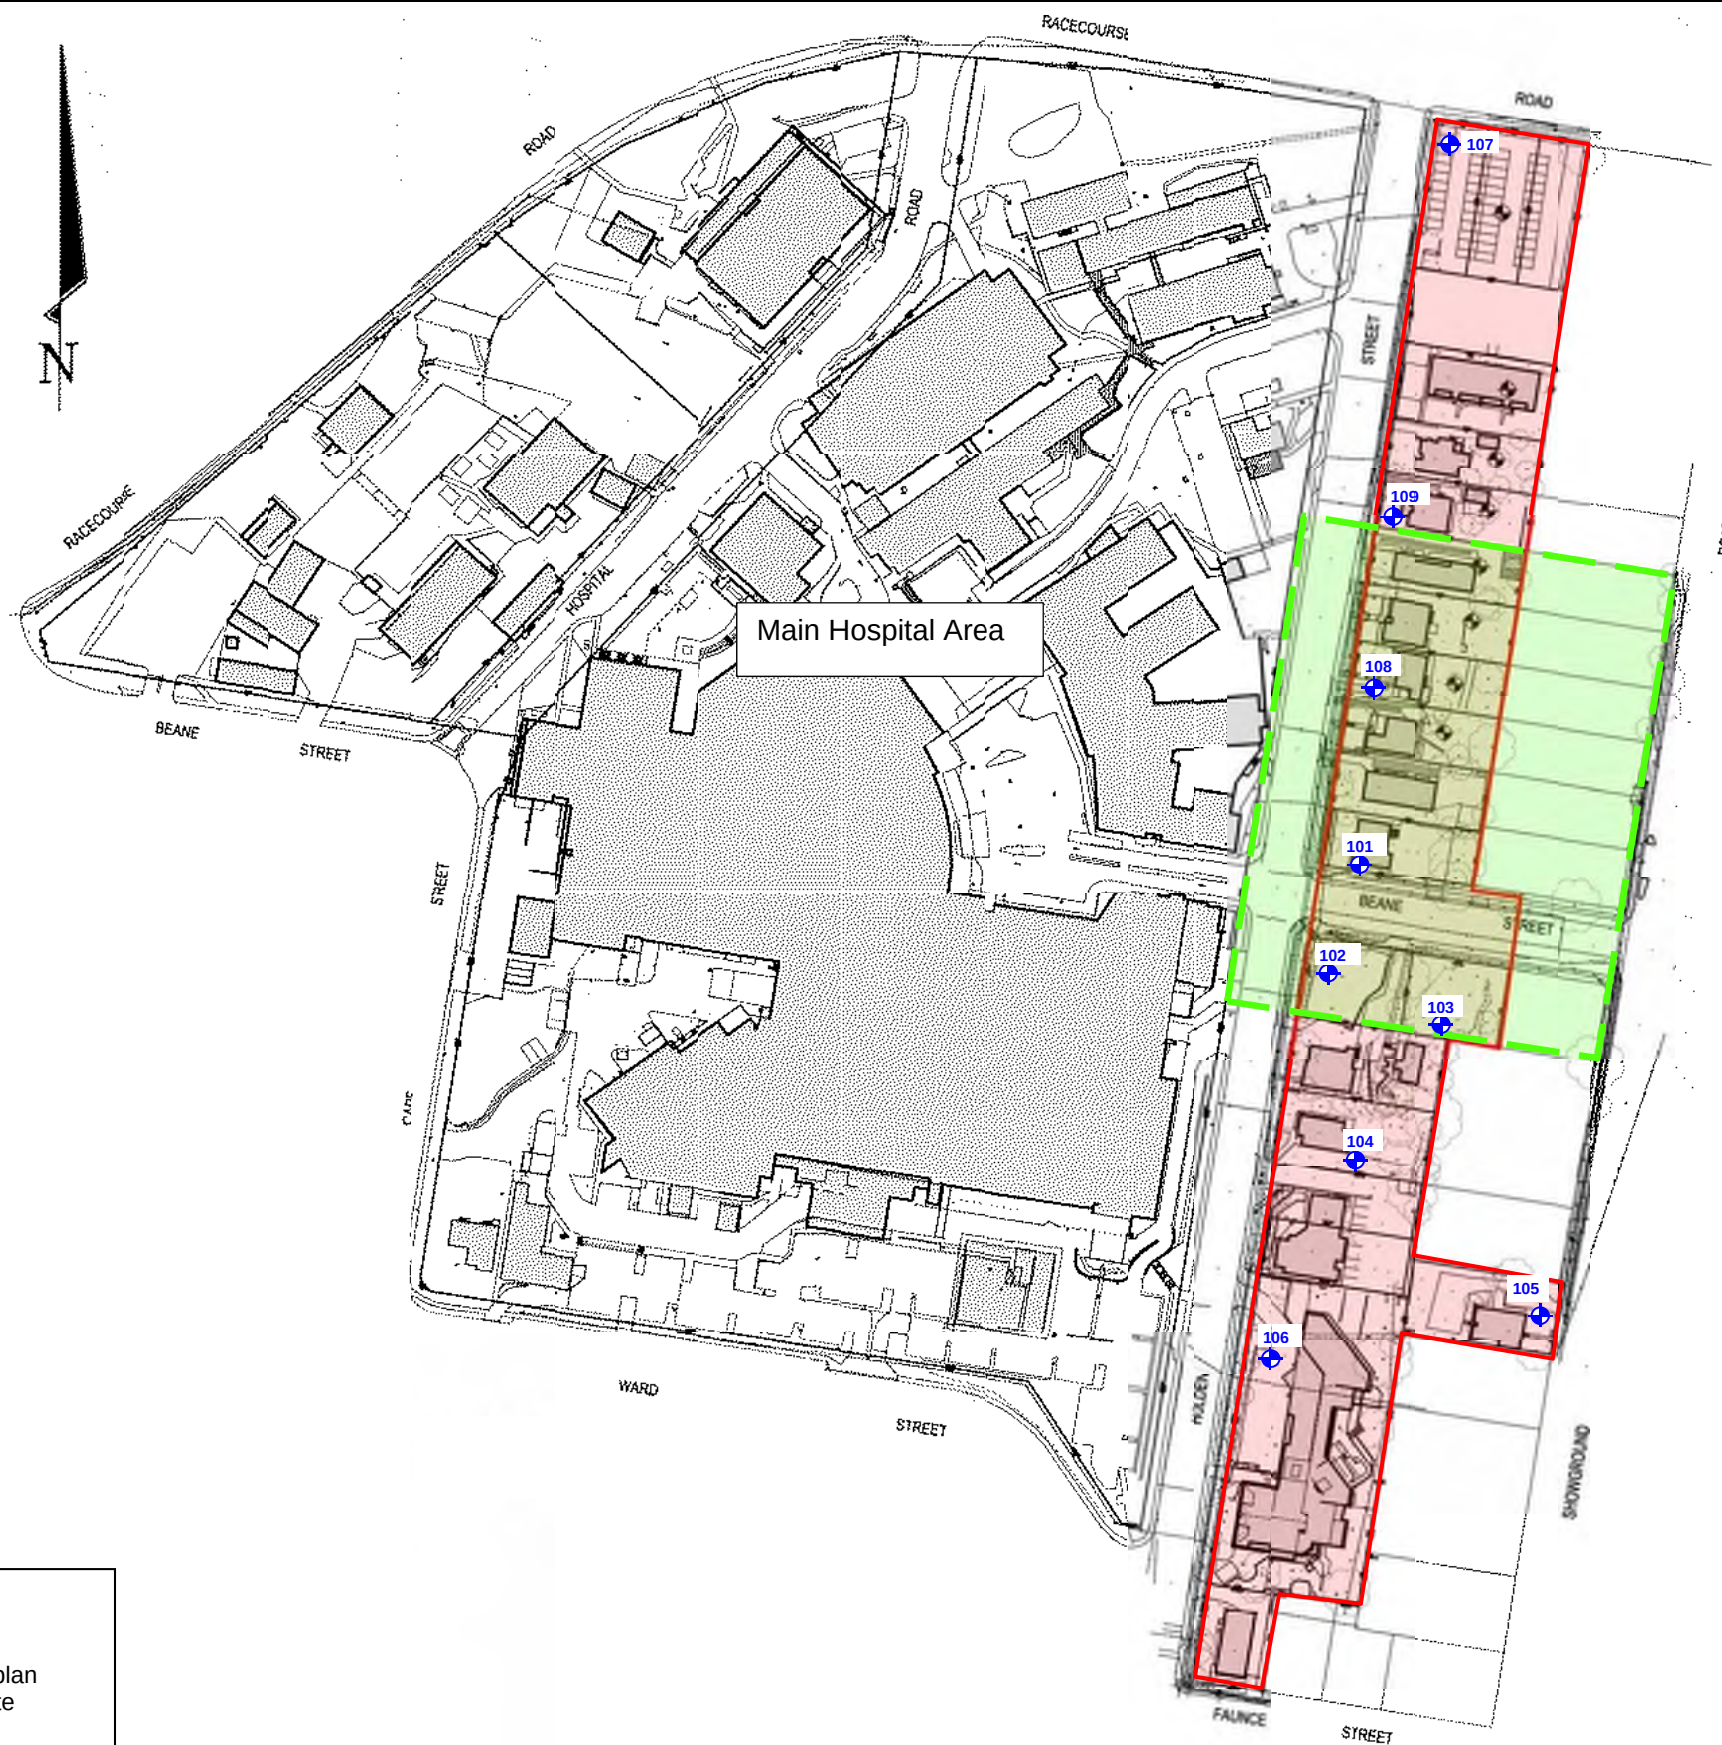
**Attachments:**  
Drawing 1 – Locations of Tests

- Location of Douglas Partners Borehole
- Approximate Area of Former Proposed Entry Hub Redevelopment
- Area of Proposed Health and Wellbeing Precinct

| | CLIENT: Health Infrastructure | | <b>TITLE: Locations of Tests</b><br><b>Proposed Health and Wellbeing Precinct – Gosford Hospital</b><br><b>Holden Street, Gosford</b> | PROJECT No: 75799.01 |

The original development area understood by DP at the time of preparing the earlier reports is identified in Drawing 1 (attached). At the time of conducting the investigations for the proposed “Entry Hub”, the area consisted of lots that mainly fronted onto Holden Street. The attached drawing was sourced from the PSI report but has been amended to show the current proposed HWP area.

Section 6.3 of the report (Ref 2) that DP issued for the geotechnical investigation provides a summary of the subsurface conditions encountered in the boreholes that were drilled in the area to the east of Holden Street. Of these boreholes, Bores 101 – 103, 108 and 109 were drilled in the vicinity of the proposed HWP. Reference can be made to the borehole logs that were included in Appendix B of the earlier report (Ref 1) for details of the subsurface profile at these particular locations. Drawing 1, attached, shows the locations of the previous boreholes, together with the area of the proposed Health and Wellbeing Precinct.
