Dean Dallwitz  
Senior Project Manager, Barangaroo South  
Lend Lease Building  
30 The Bond, 30 Hickson Road, Millers Point

24 August 2015

**Barangaroo South - Stage 1B Basement and Residential Towers, SEPP 55 Letter, Hickson Road, Millers Point. State Significant Development Applications SSD 6960, 6964, 6965 & 6966**

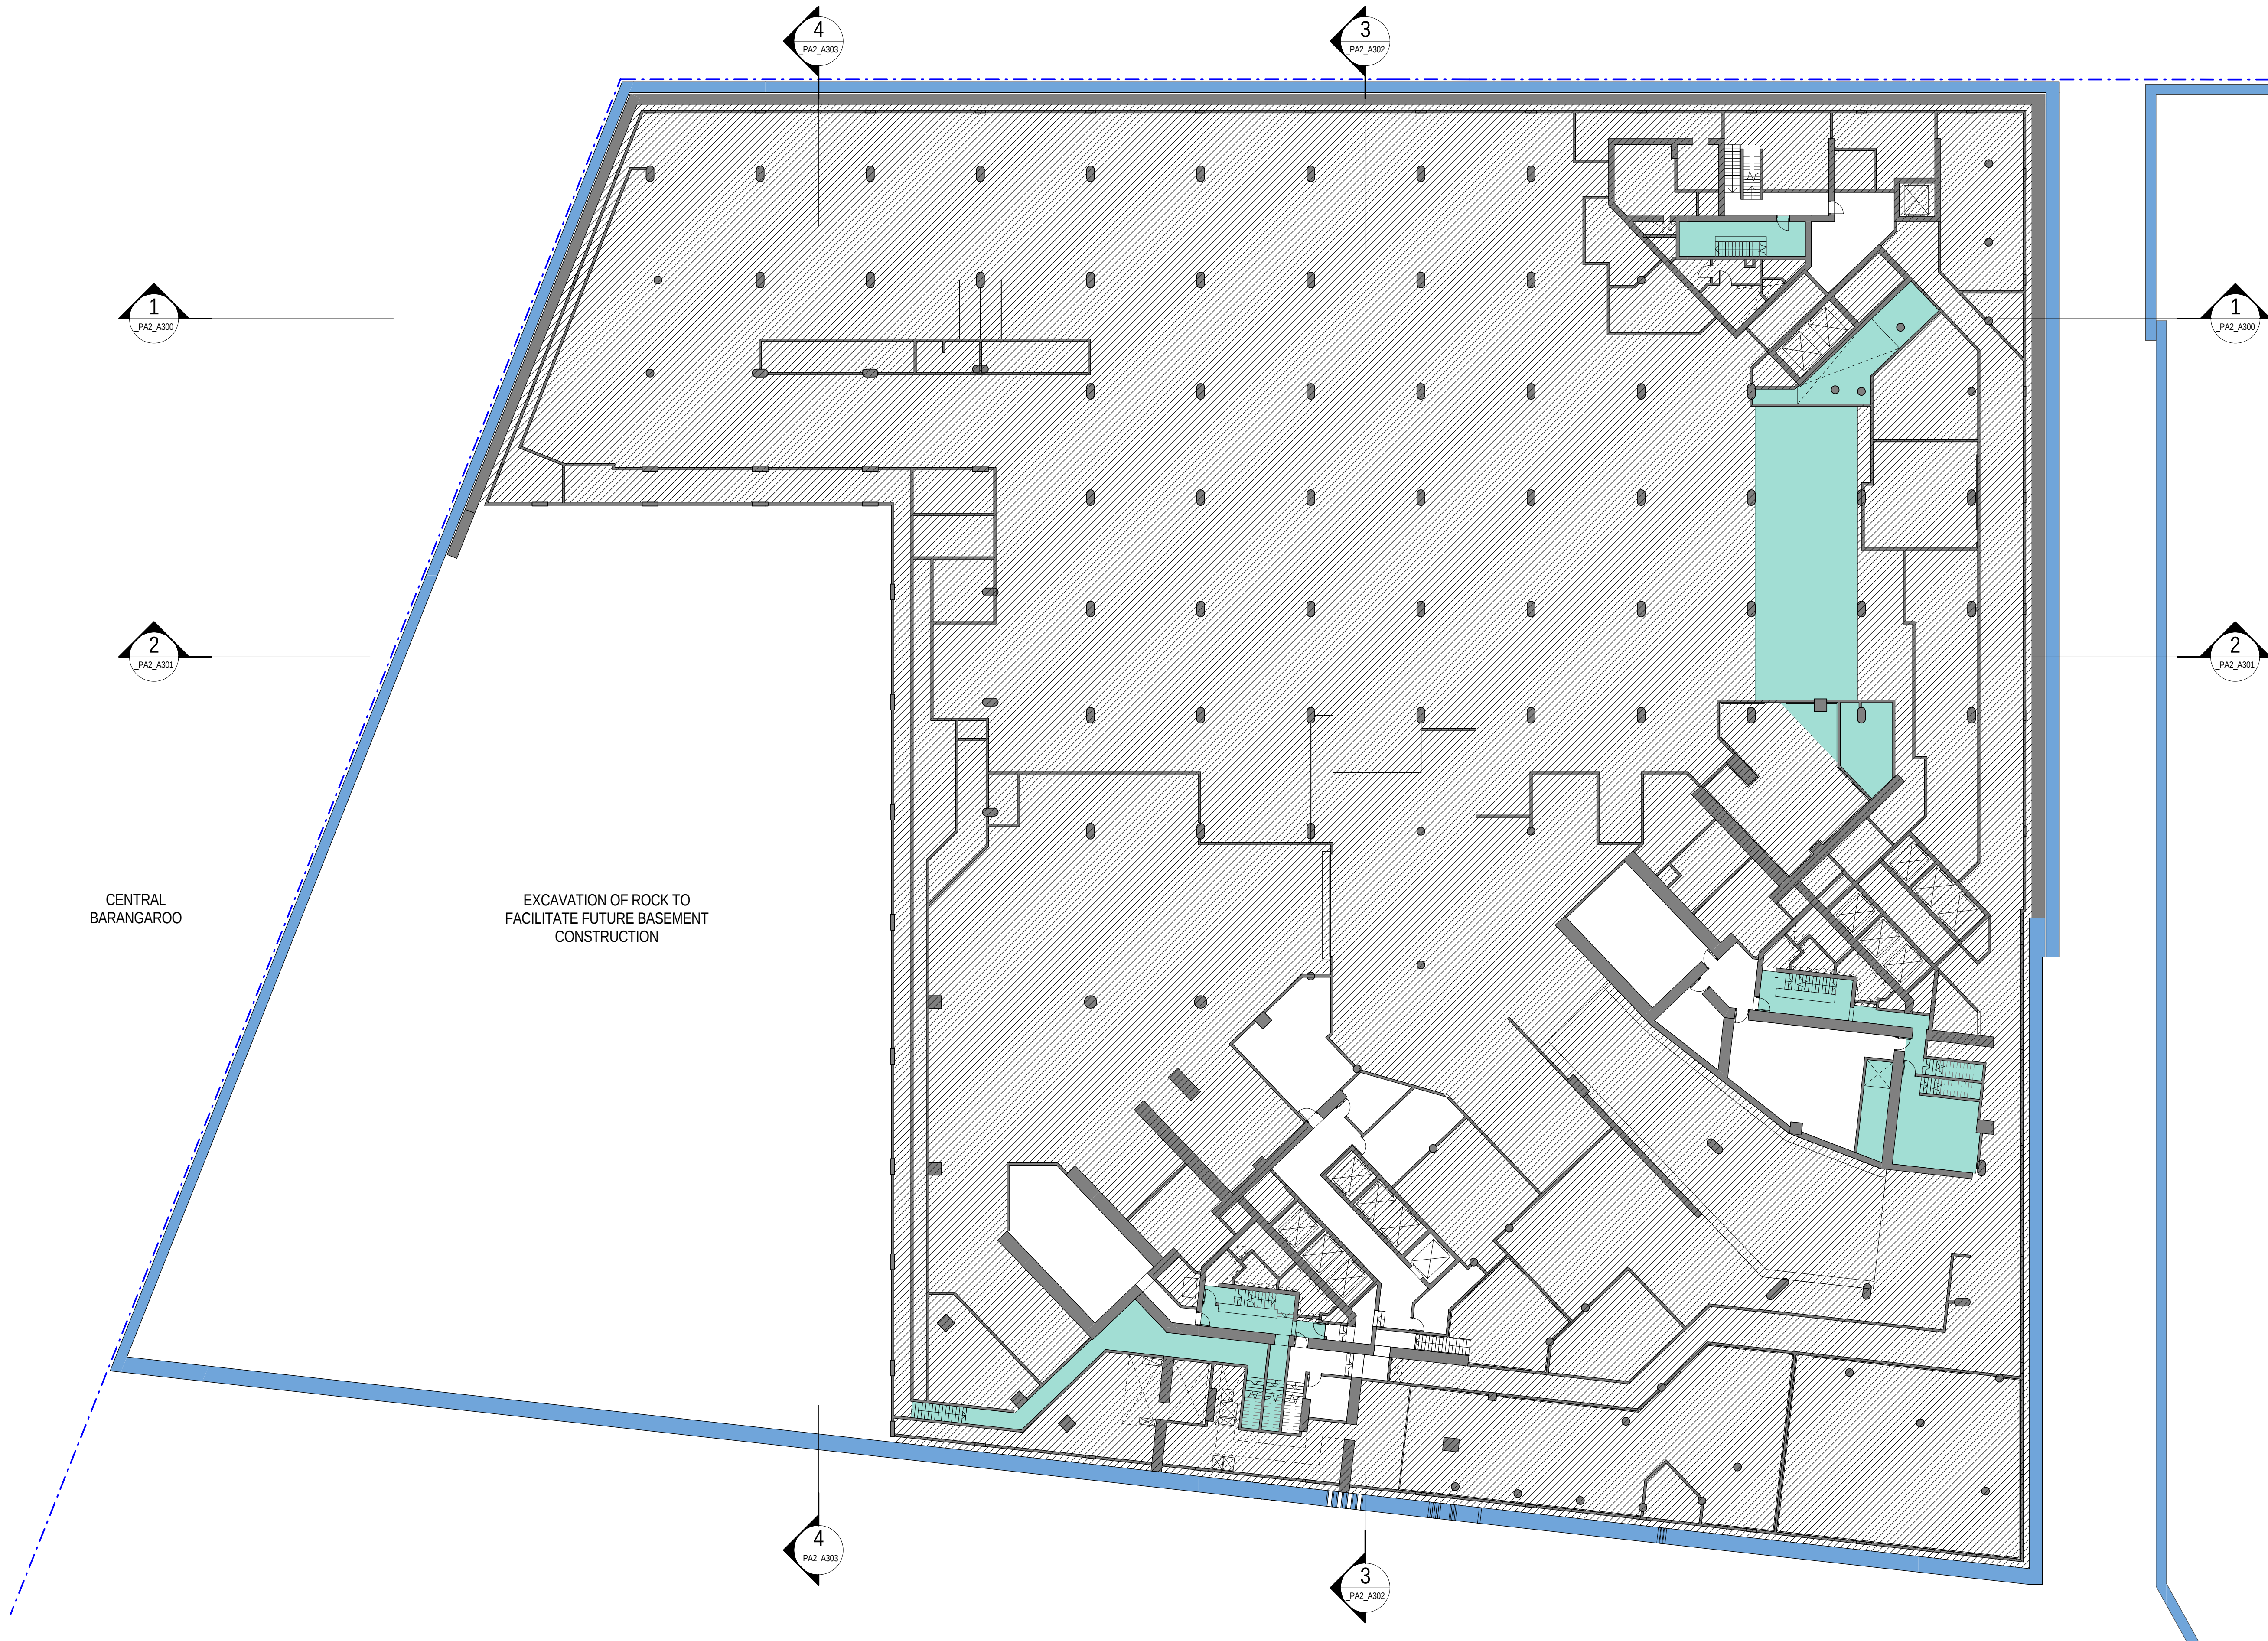
Figure 2

As illustrated in **Figure 2, Attachment 1**, the ORWN Services Zone is located directly adjacent to the proposed Stage 1B basement wall and extends approximately 30 m to the west.

As illustrated in **Figure 2, Attachment 1**, the ORWN Interim Public Domain is located directly adjacent to the proposed Stage 1B basement wall and extends approximately 20 m to the west.
