## **Marulan South Limestone Mine | SSD 7009**

# **Historic Heritage Management Plan**

Prepared for Boral Cement Limited | 22 September 2022

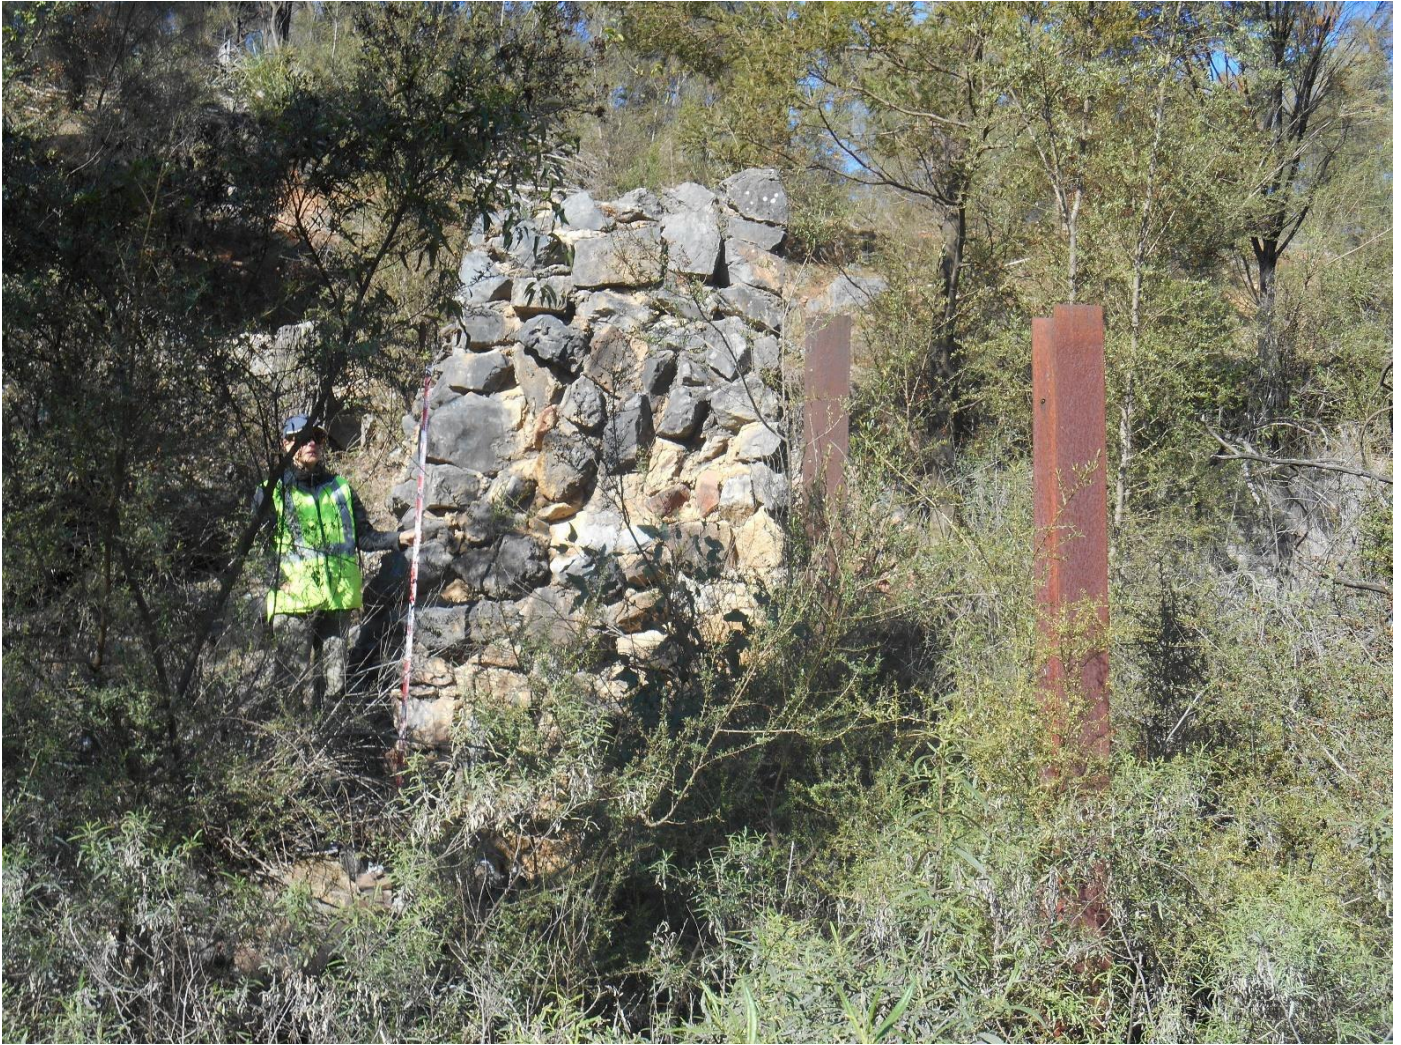
**Plate 2.1** Example of the lime kilns

The kilns were constructed of stone and built into the banks or side of steep hills. Only portions of the rear stone wall, which was built against the hill, and the side buttresses remain. It is this group of kilns that are those most likely built by Hogg. The kilns in Area A are in poor condition but the ramps that connected the road to the kiln survive. The area is overgrown with thick woody weeds that will have to be removed for clear access.

Kiln Area B (refer to HHA) consists of two kilns located on a hill slope approximately 100 m east from Kiln Area A, adjacent to a track. The remains of the kilns consisted of bricks, earthworks, wooden beams and stones with evidence of firing and burning. Glass, ceramic and metal has been dumped in the area around the kilns. Based on the historical research in Section 2 of the historical heritage assessment (EMM Consulting 2020) (Appendix B of the HHMP) the kilns at Kiln Area B are D or round type kilns.

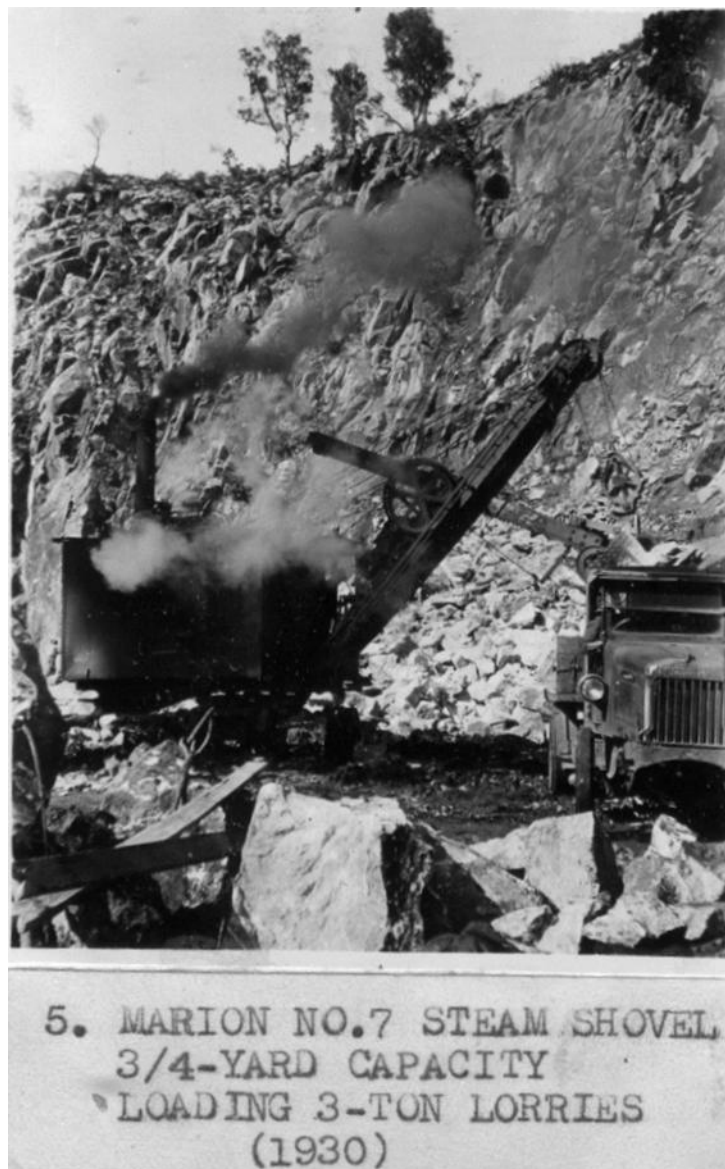
**Plate 2.14** An example of the steam shovel and lorries used in the mine in the 1930s (Boral Cement Limited 2015).

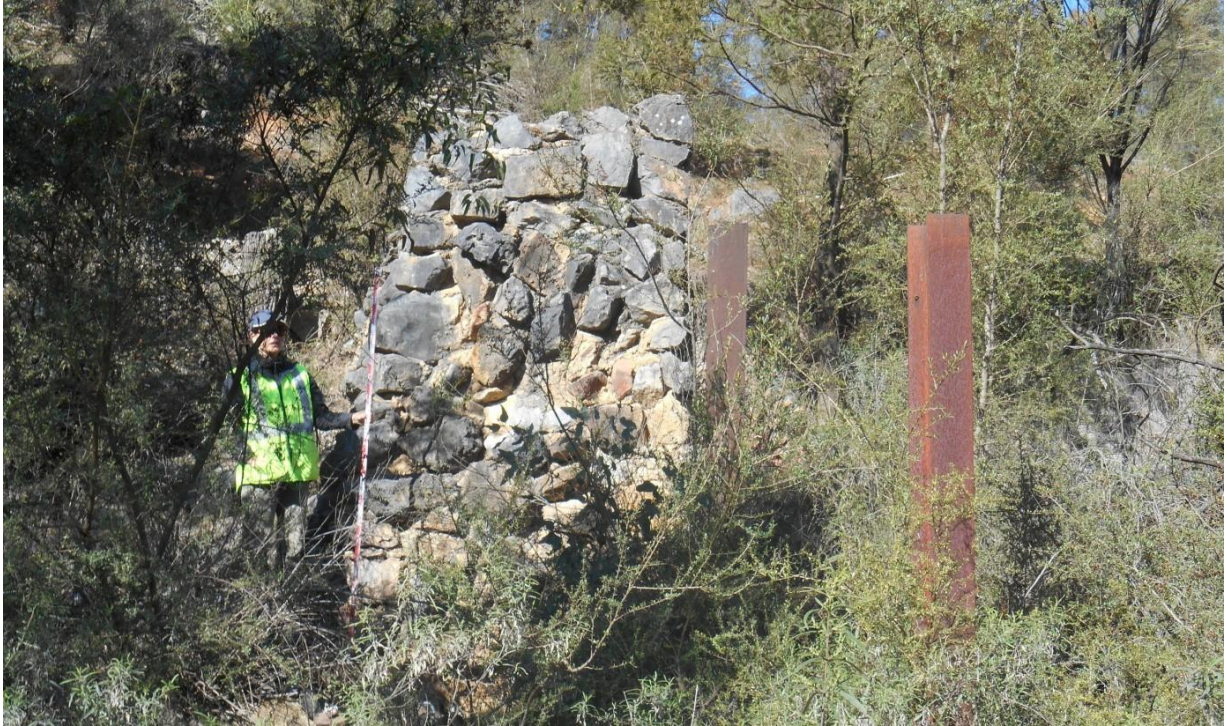
**Plate 3.1** Kiln Area A showing one remnant kiln and associated iron beams (DSCN2491).

Kiln Area A (refer to HHA) consisted of kiln towers of local stone, brick and mortar, and wooden and iron beams, all with evidence of firing and burning. A road, areas of slag slipping down the road embankment, landscape modification for water management, and areas of glass, ceramic and metal were identified around the kilns. The road is the terminus of Lime-kiln Road, which underwent a name-change to Marulan South Road and was redirected approximately 1.3 km to its north.

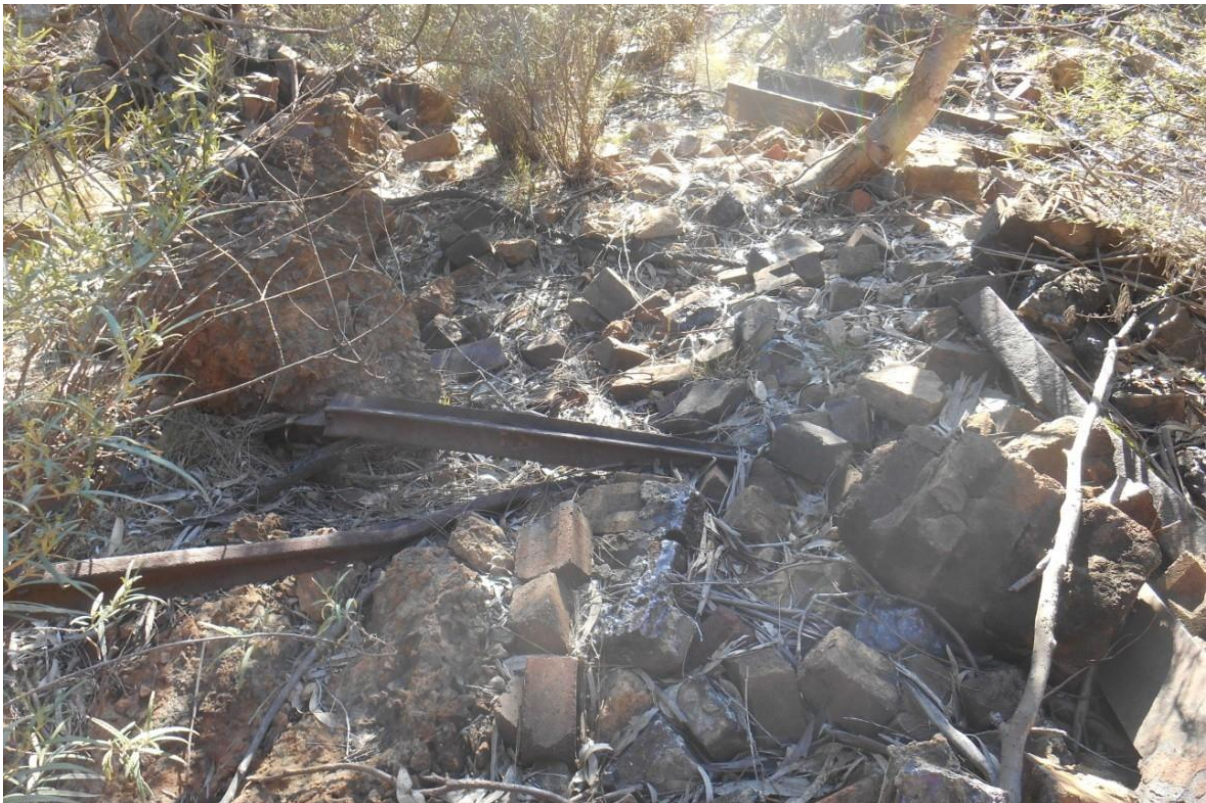
**Plate 3.2** Kiln Area A showing remnants of a kiln including bricks, iron and timber beams (DSCN2498).

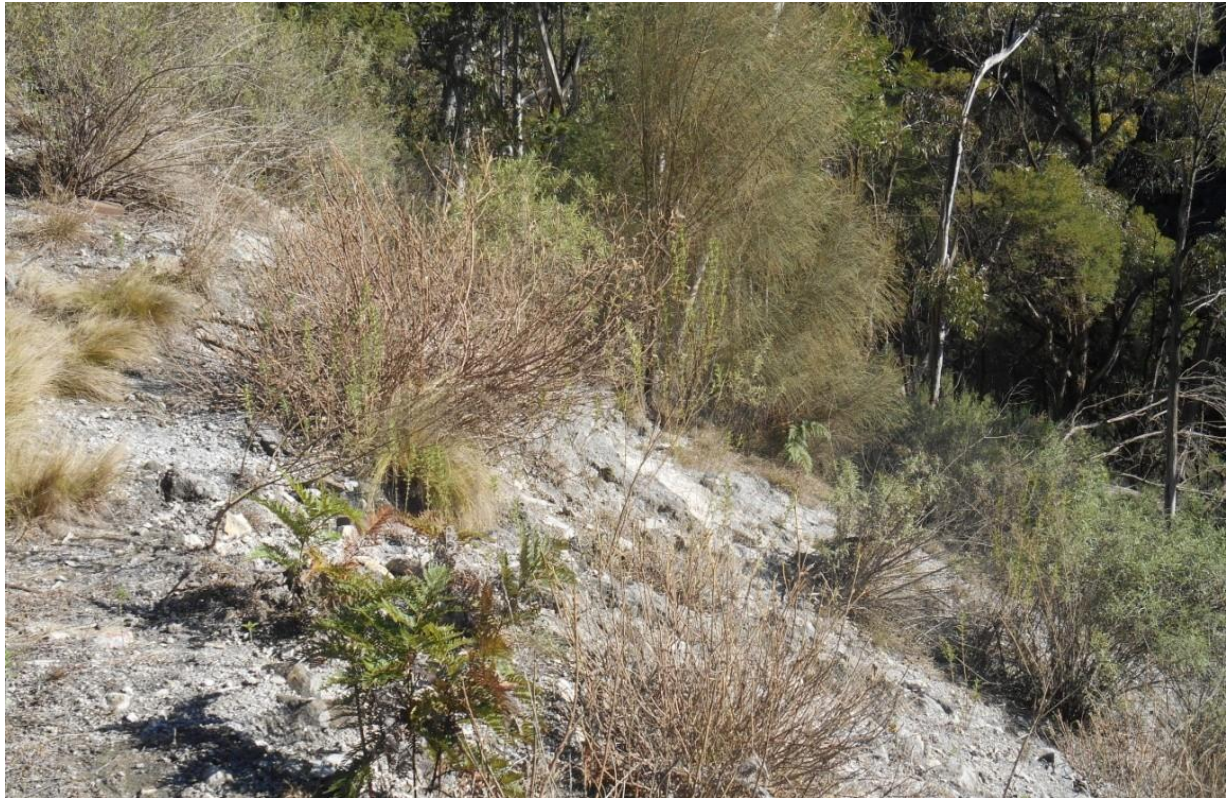
**Plate 3.3** Kiln Area A showing slag slipping down slope and slope towards the creek (DSCN2492).

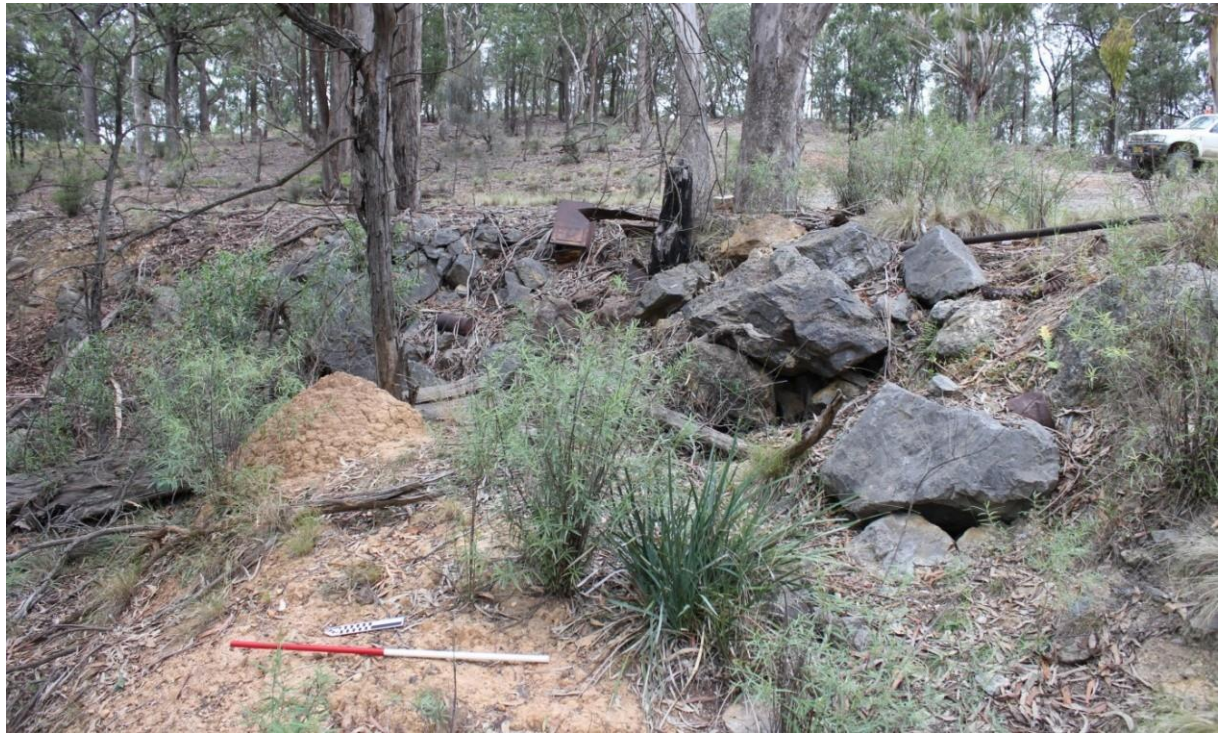
**Plate 3.4** Kiln Area B showing landscape modification and metal elements (IMG\_8996).

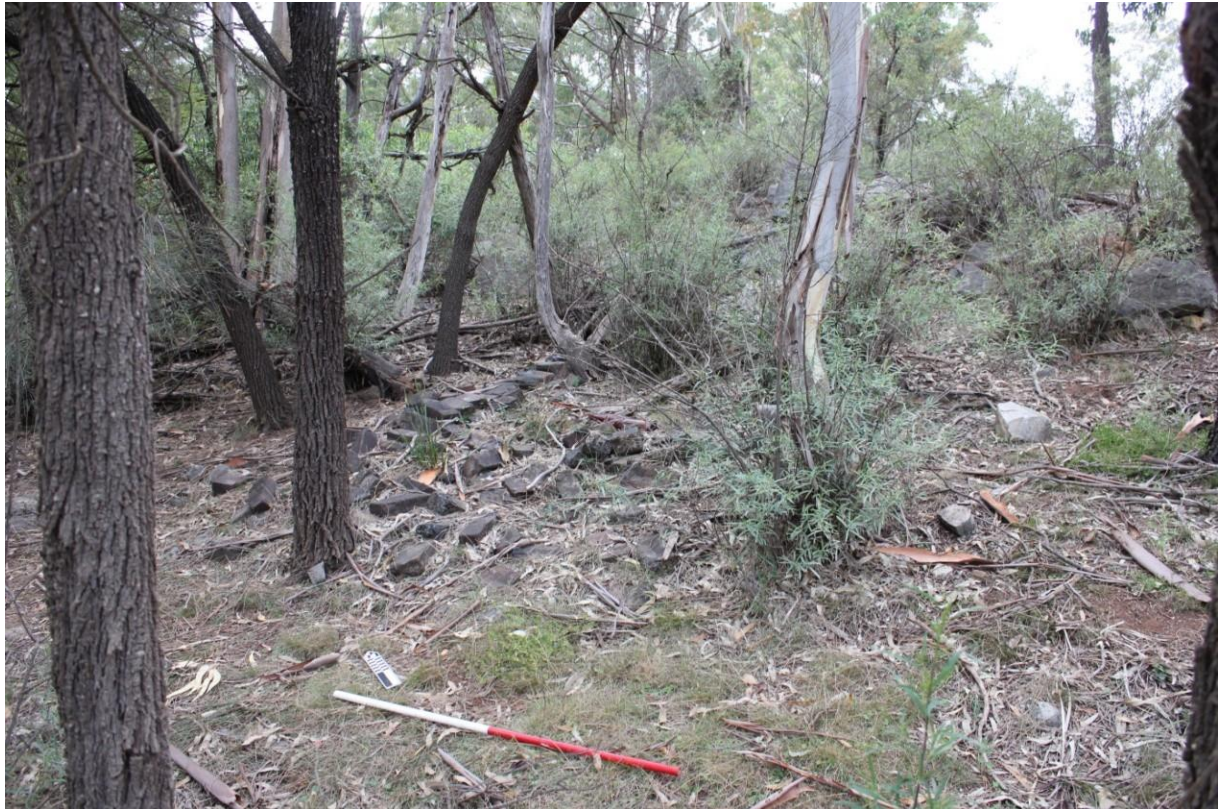
Plate 3.5 Kiln Area B showing an example of burnt bricks that form part of lime kilns (IMG\_9004).

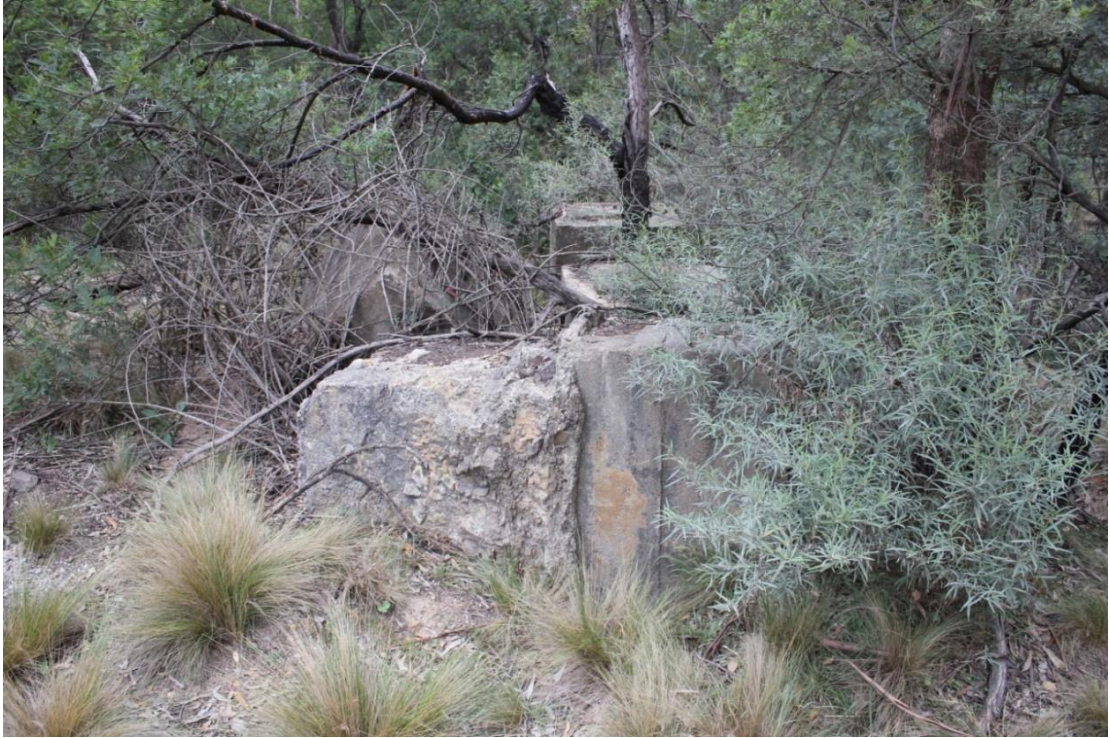
**Plate 3.8** Example of an upturned concrete plinth showing both above and below ground sections (IMG\_8992).

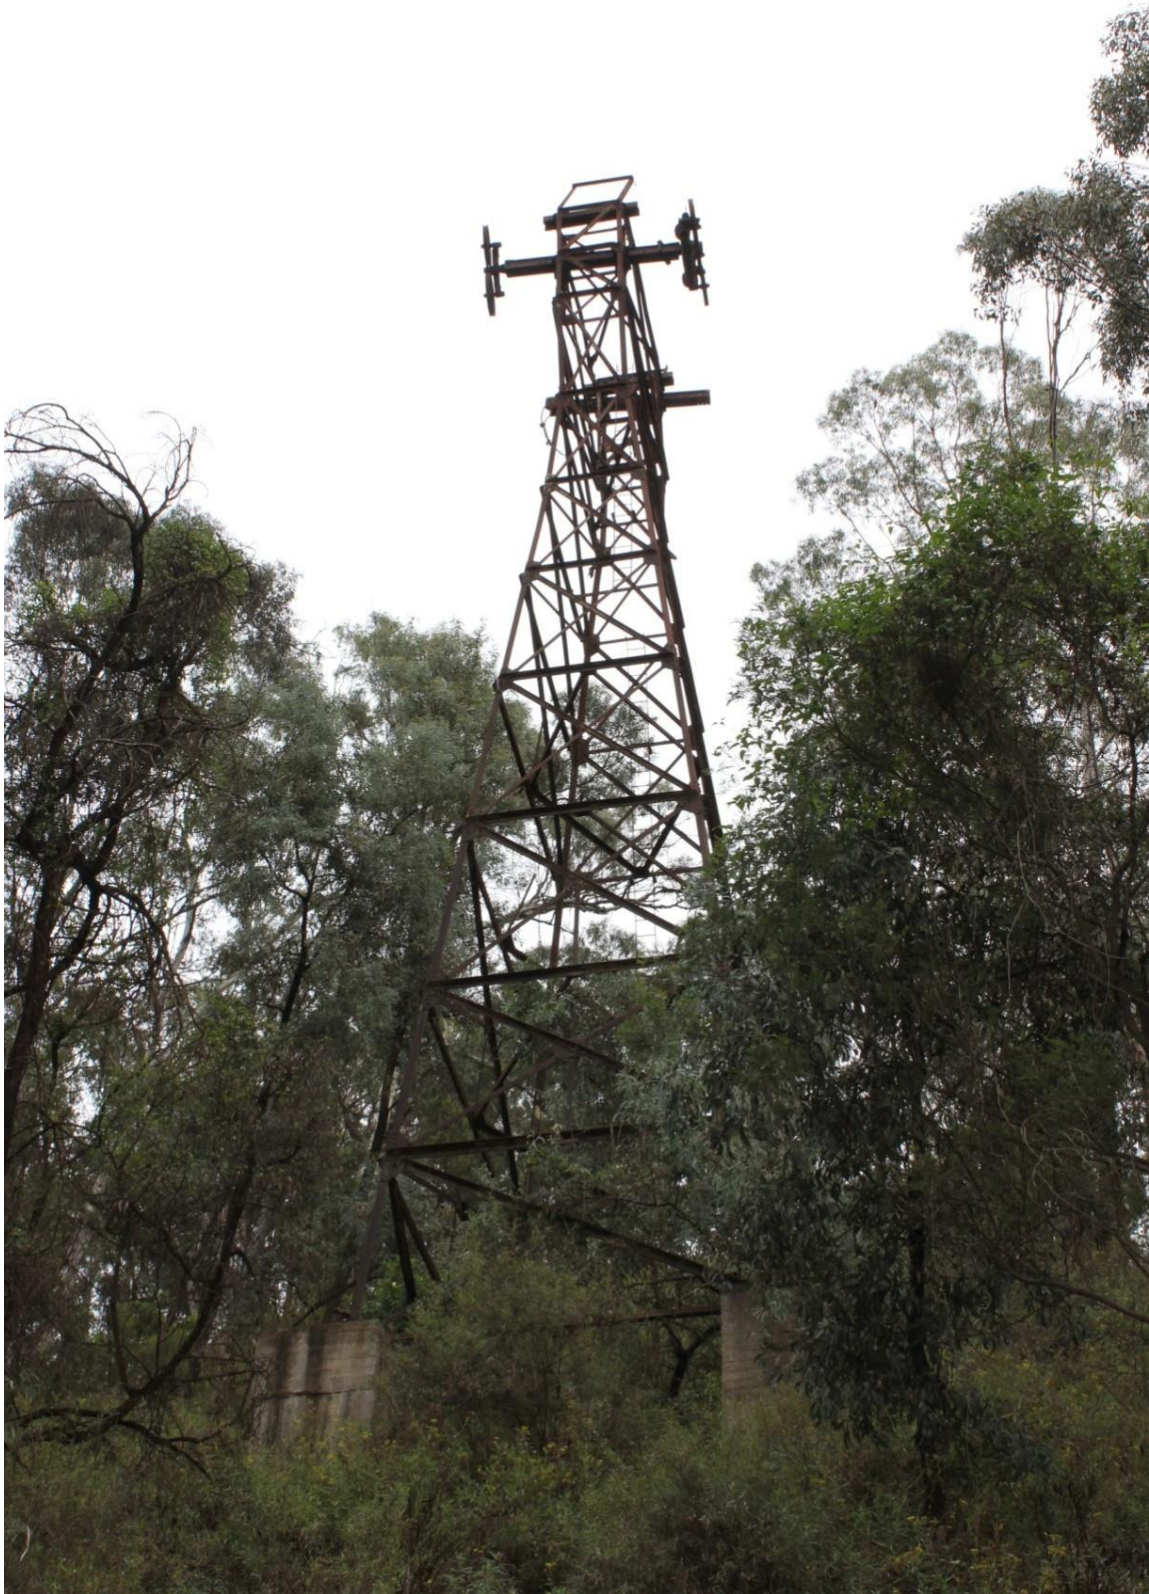
Plate 3.9

Tower 1 (MS04\_2) is an example of a complete pulley tower. This tower is directly opposite the lime kiln group (refer to Figures 3.1 and 5.1 and is the only surviving complete and standing tower (IMG\_9030).

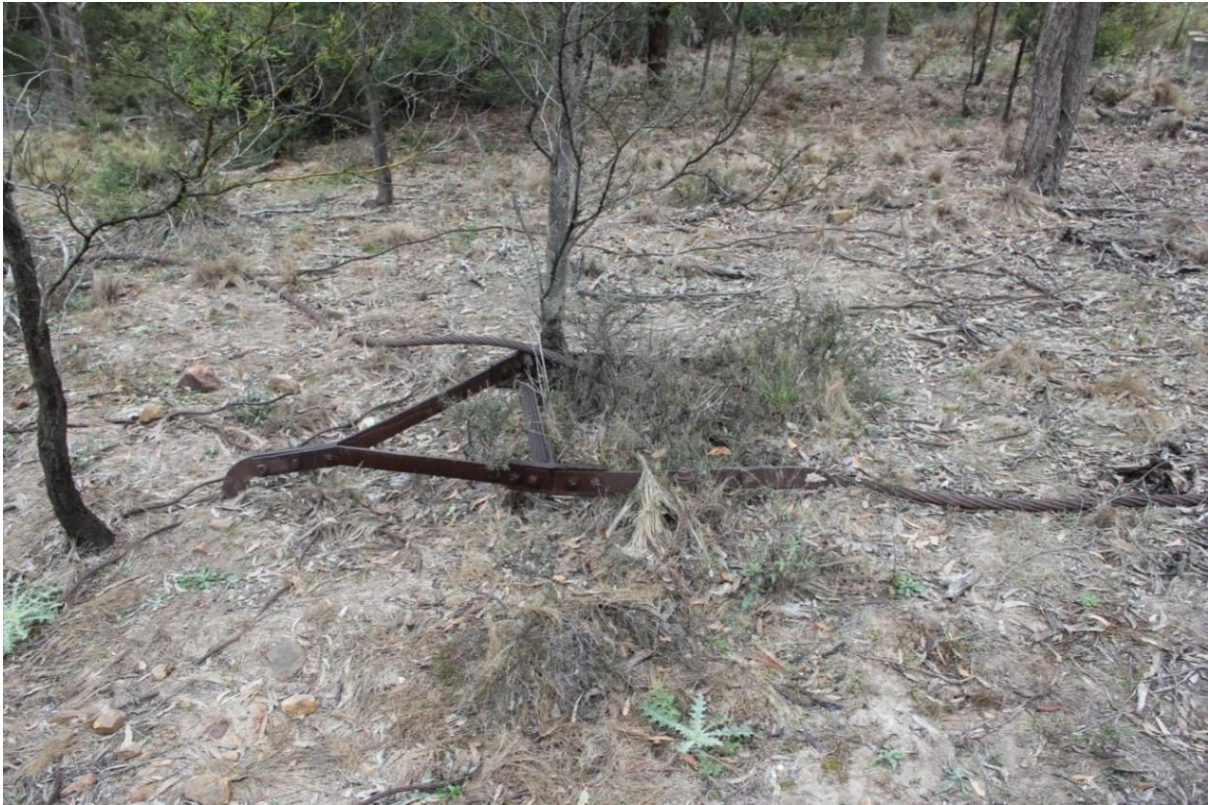
**Plate 3.10** Example of cables and the upper element of a Carrier (IMG\_8988); (refer also to figure 2.11).

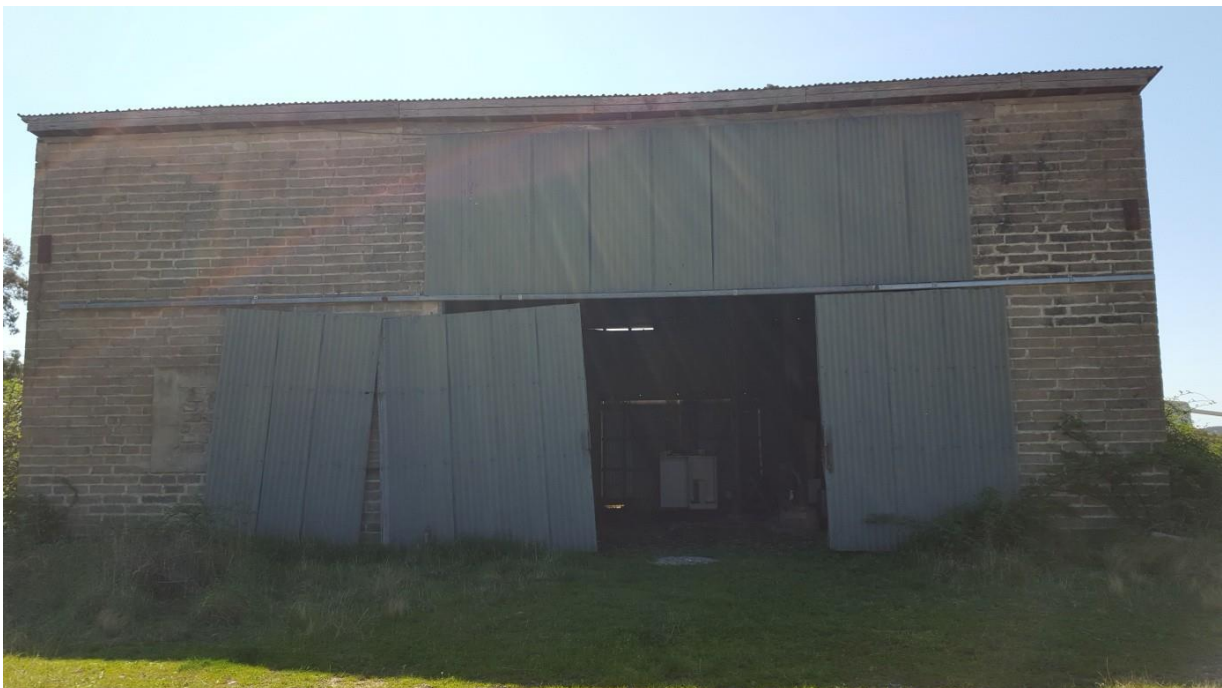
**Plate 3.11** Front of the control room (MS04\_11), facing west, showing the corrugated iron rolling doors which would have opened to let out heat (at the base) and for the rope to rotate (top) (20151006\_144642).

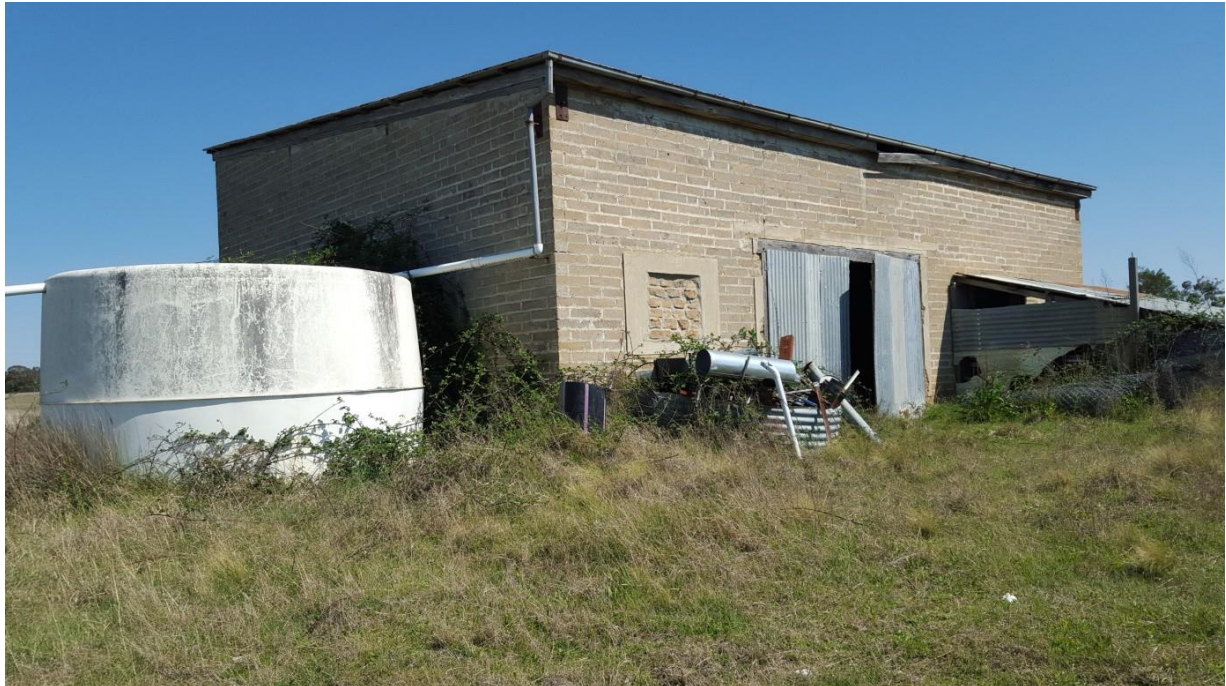
**Plate 3.12** Rear of the control room showing corrugated iron engine housing, doors, bricked in openings and a water tank (20151006\_145129).

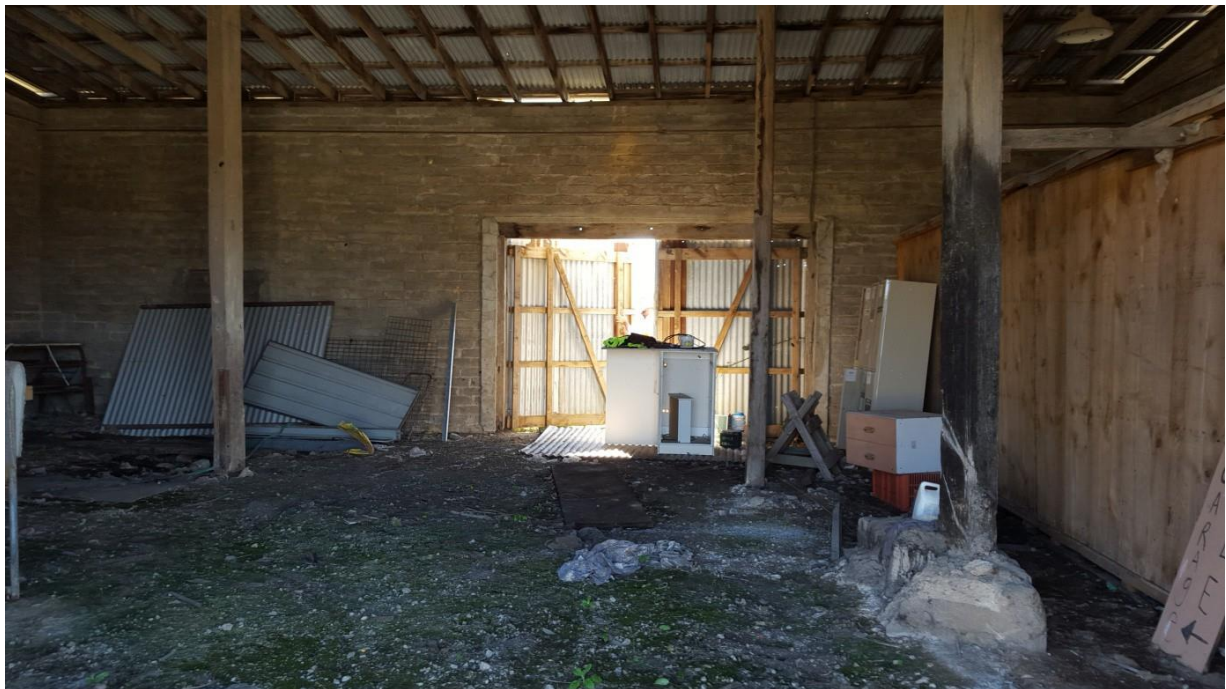
**Plate 3.13** Interior of control room showing wooden beams for piles and roof, concrete foundations and dirt floor (20151006\_144957).

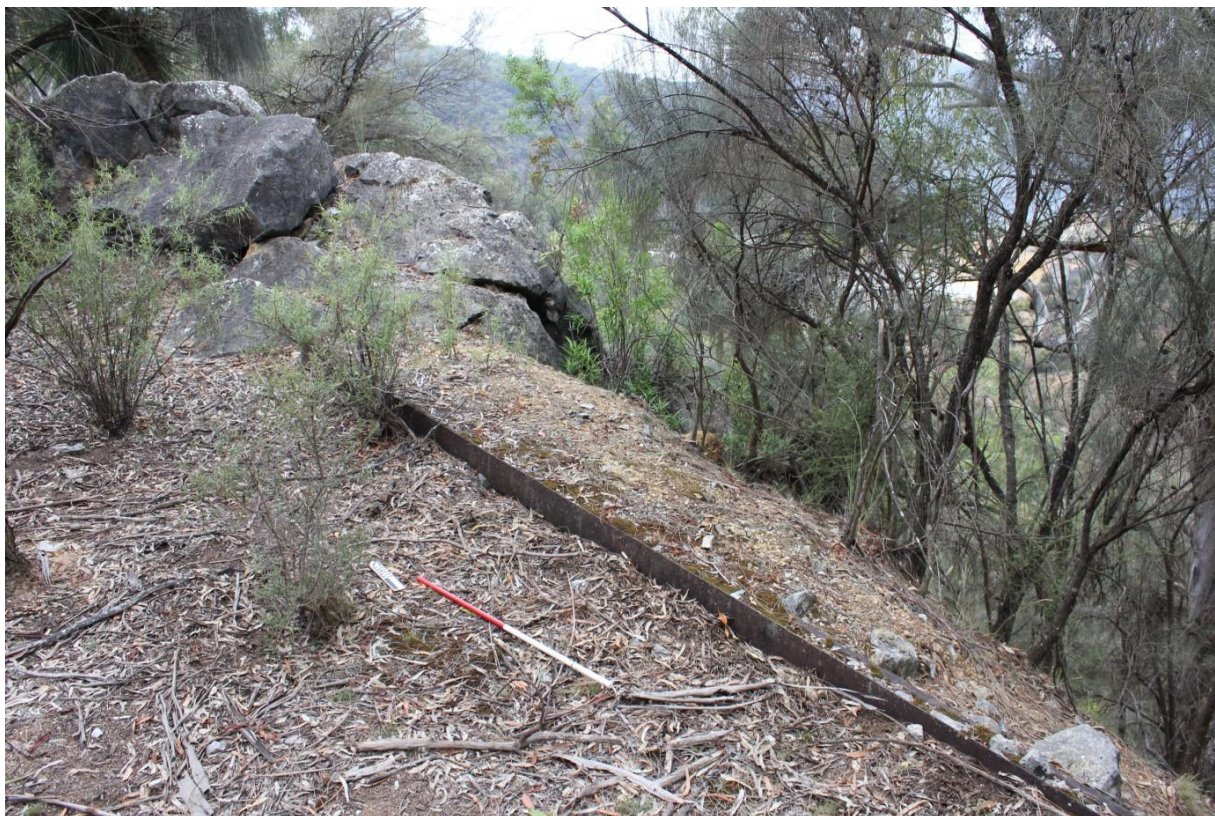
**Plate 3.16** Mt Frome mining area showing the rail track used to transport product down the mountain (IMG\_9058).

An area of early mine workings was identified on Mt Frome including tracks from a short rail line (Plates 3.15 to 3.16 and Plate 2.13), which was used to haul offcuts for disposal downslope.

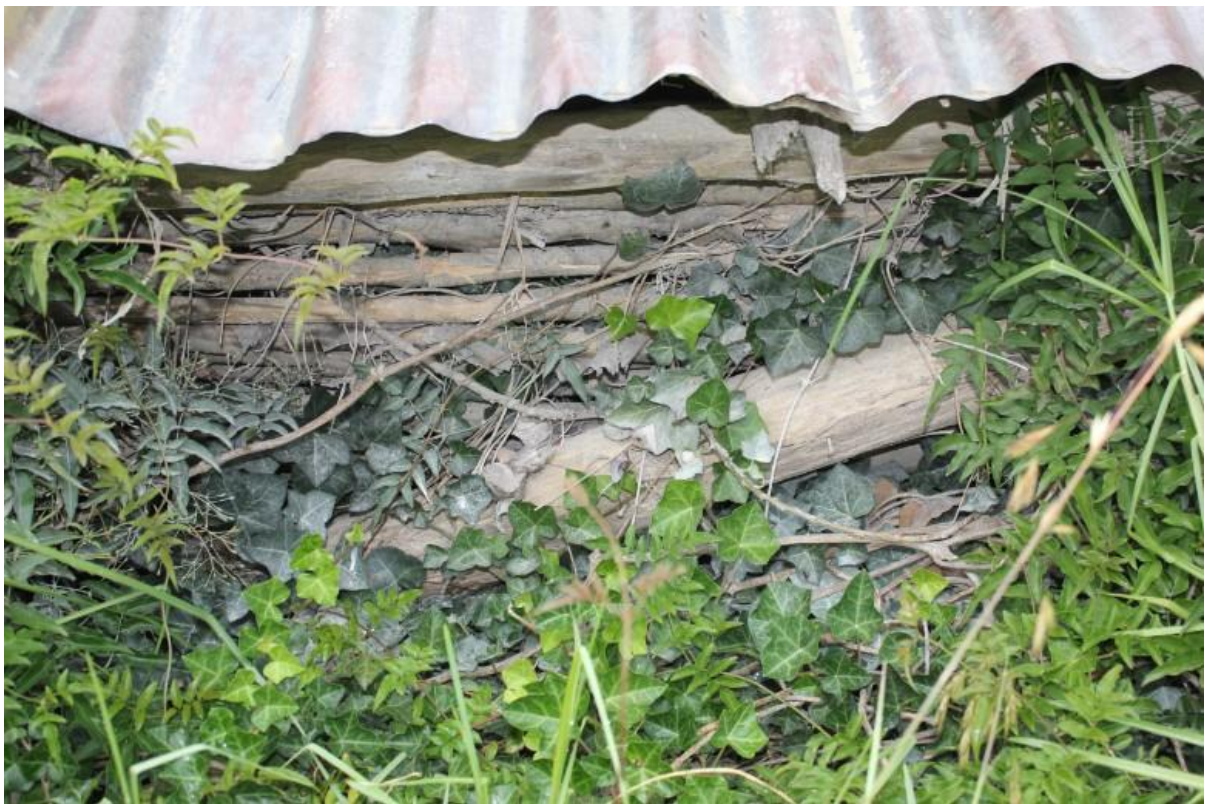
Plate 3.20 MS02 detail of the dilapidated building (above) showing possible wattle and daub construction (IMG\_8951).

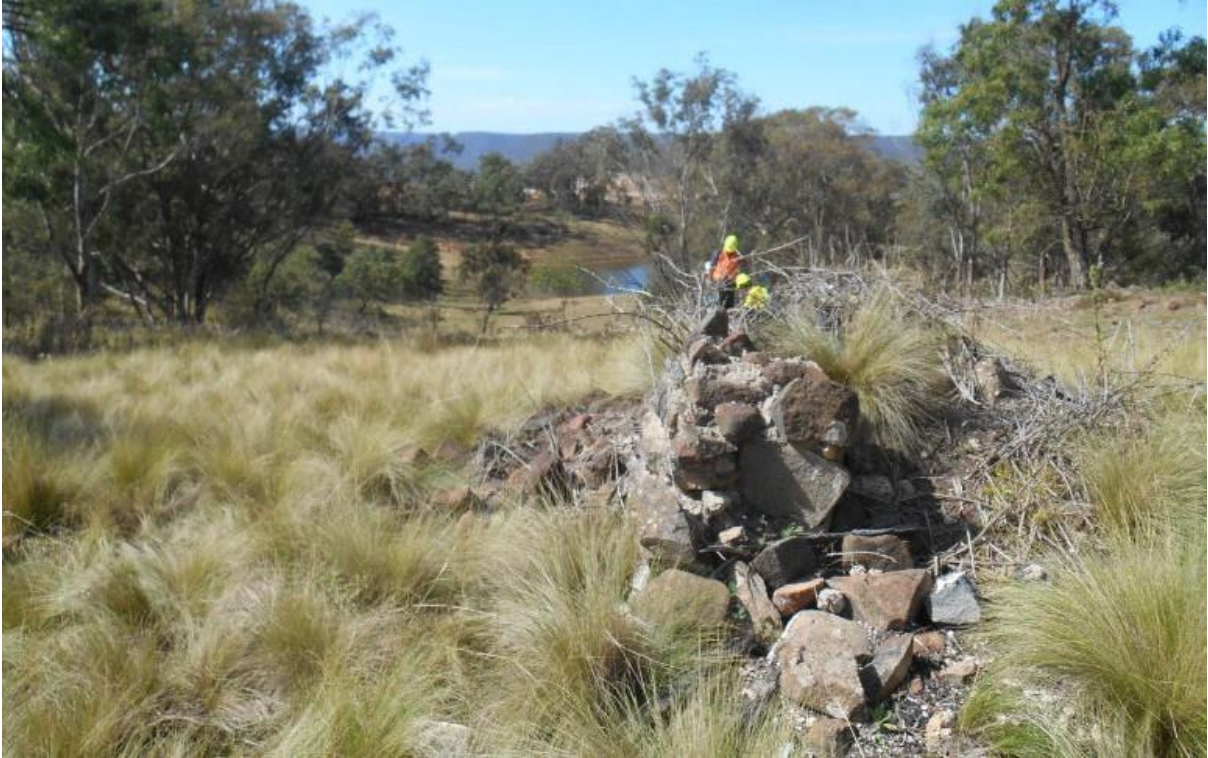
**Plate 3.28** MS14 a view of the element considered to be part of a chimney with the dam and mine in the background (DSCN1250). View east.

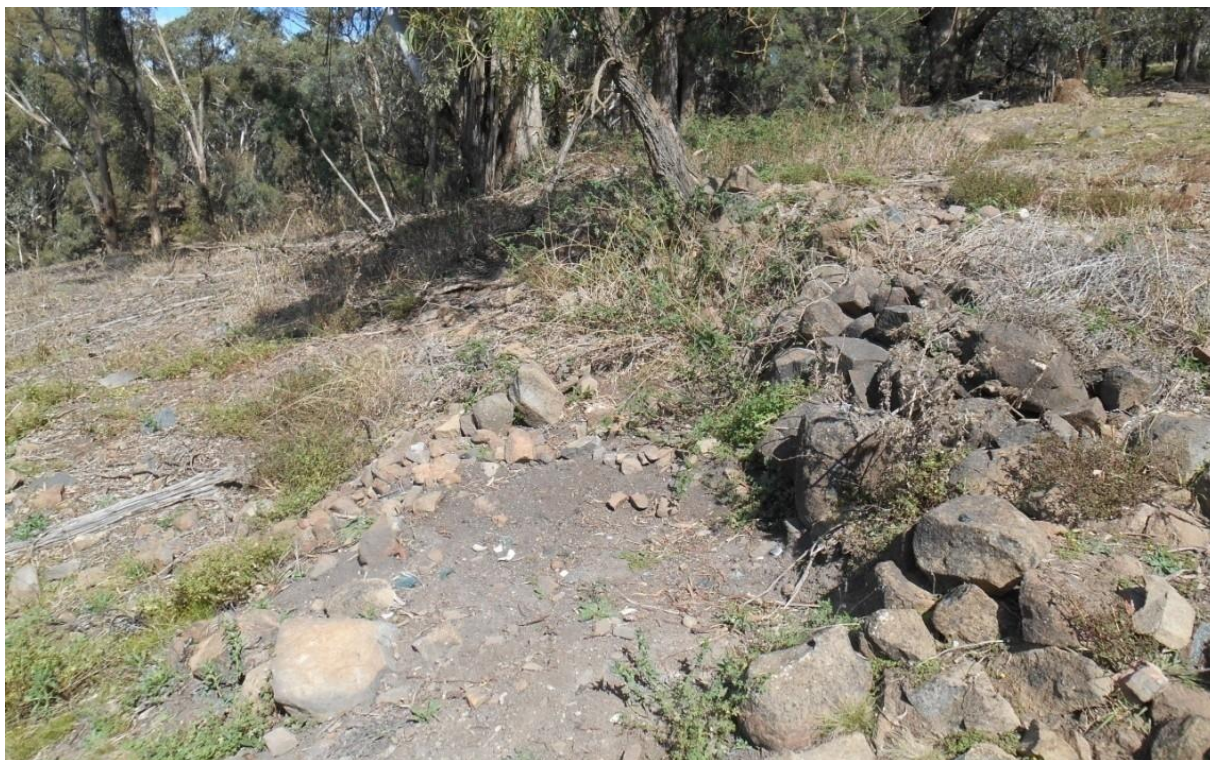
**Plate 3.30** MS14 showing close up of possible retaining wall and dump of glass and ceramic (DSM1261). View south.

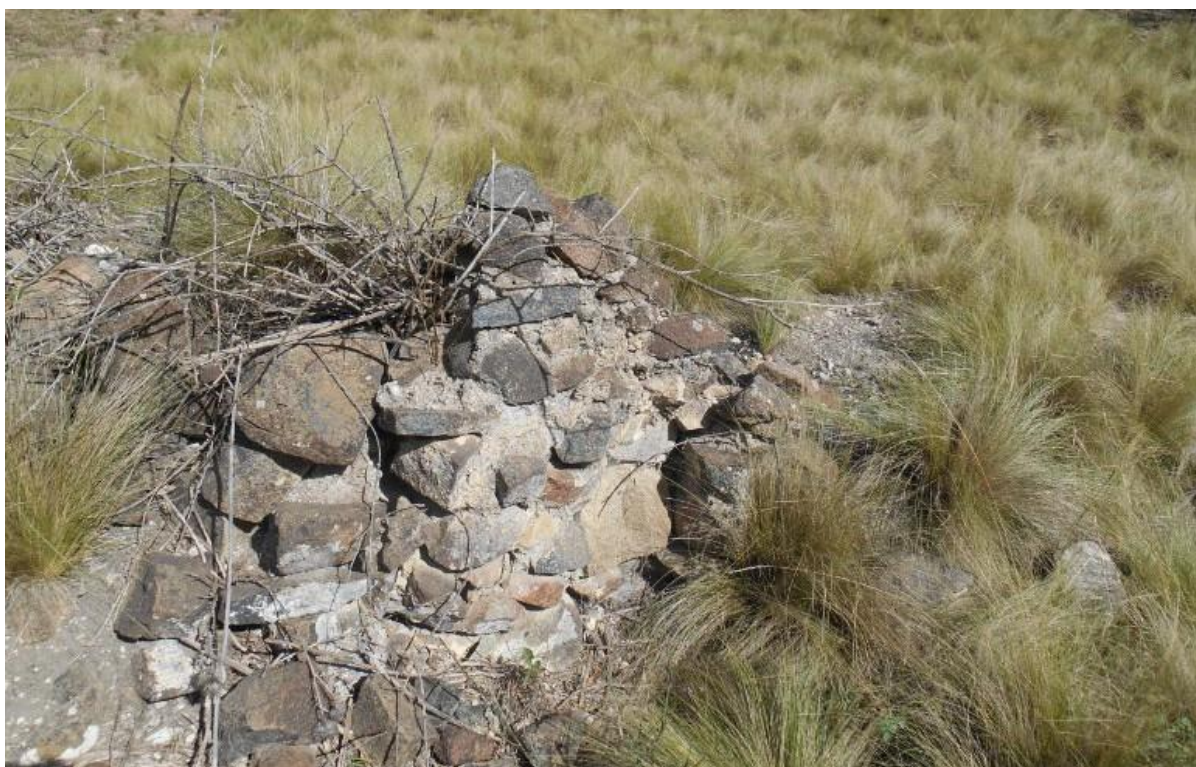
**Plate 3.31** MS14 close-up of what appears to be a chimney (DSCN1248). View south-west.

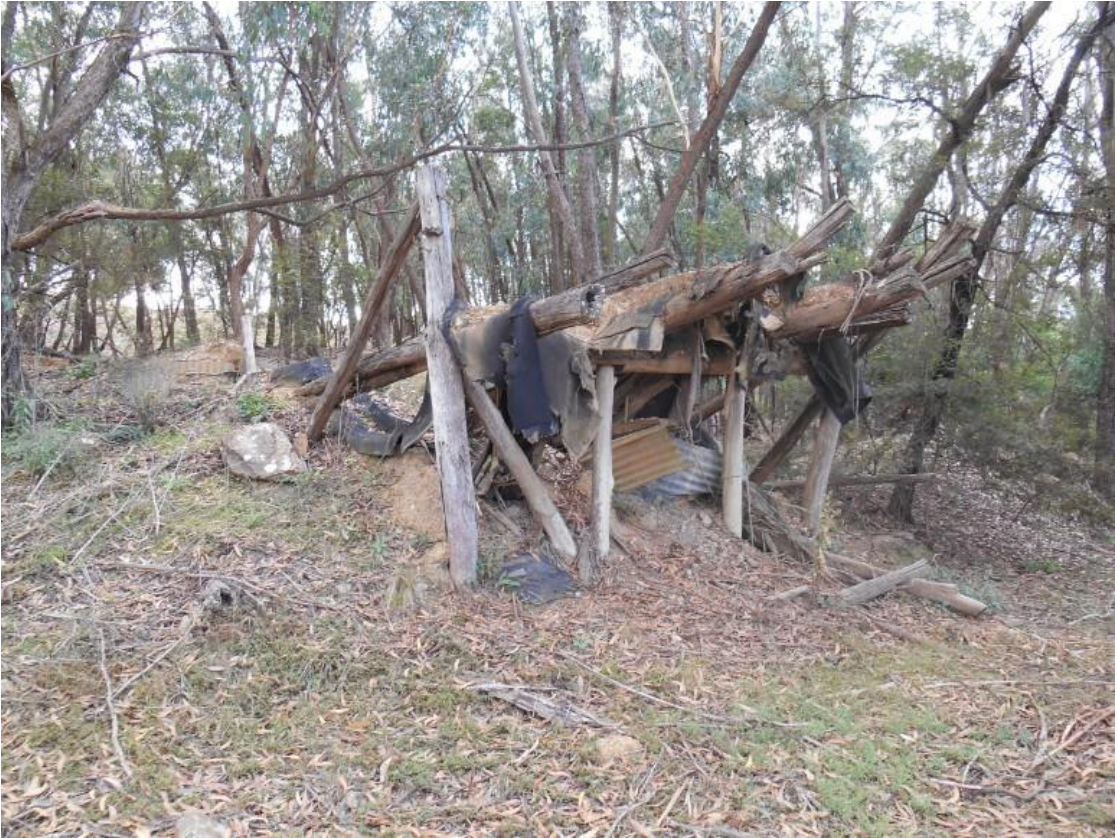
Plate 3.37 MS11 loading ramp (DSCN1067). View north-west.

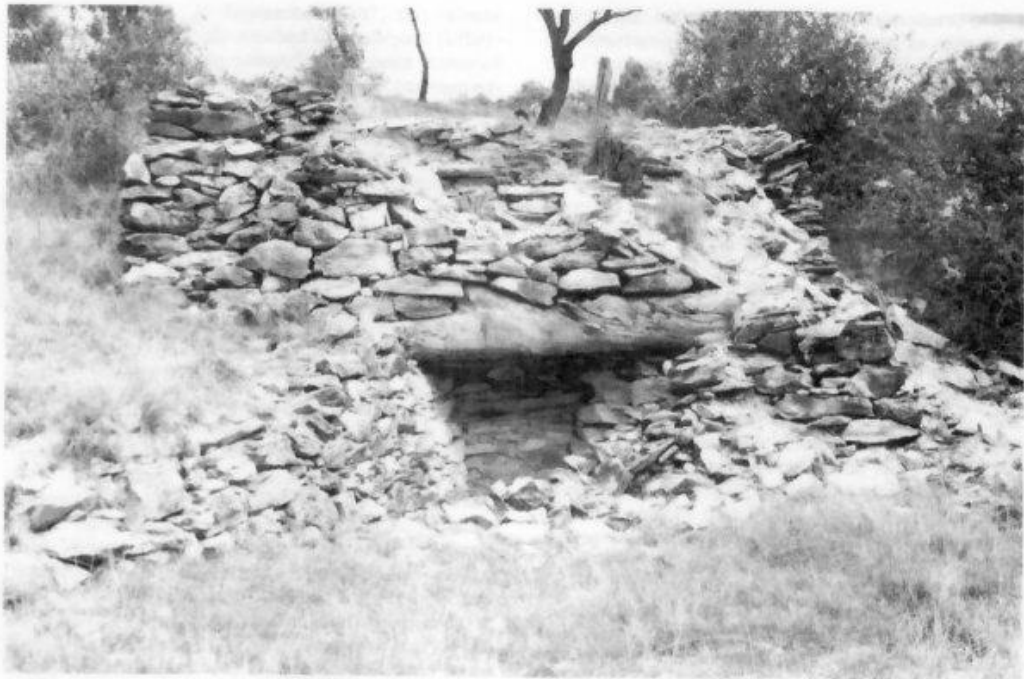
Moses Morley's 1870s kiln on Stringybark Hill south of Queanbeyan. The massive tree trunk supporting the upper part of the kiln's front wall probably helped to stabilise it during the burning process. The front walls of kilns tended to bulge outward with the intense heat. (Photograph by author).

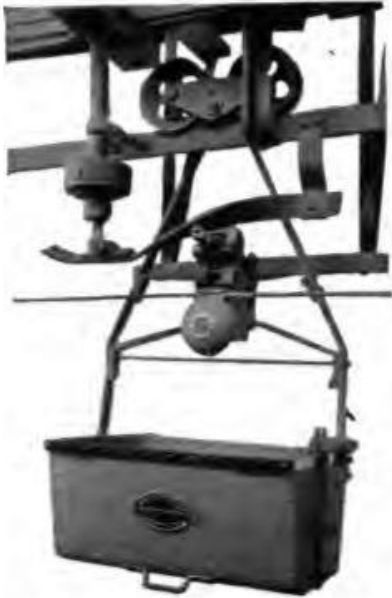
Fig. 9. Carrier, with Webber Patent Compression Grip, showing Patent Automatic Attacher.
