Remediation Action Plan

DHL Stage 2  
Part of 1953 - 2109 Elizabeth Drive, Badgerys Creek

Prepared for  
DHL Supply Chain (Australia) Pty Limited

Project 86548.20  
September 2024

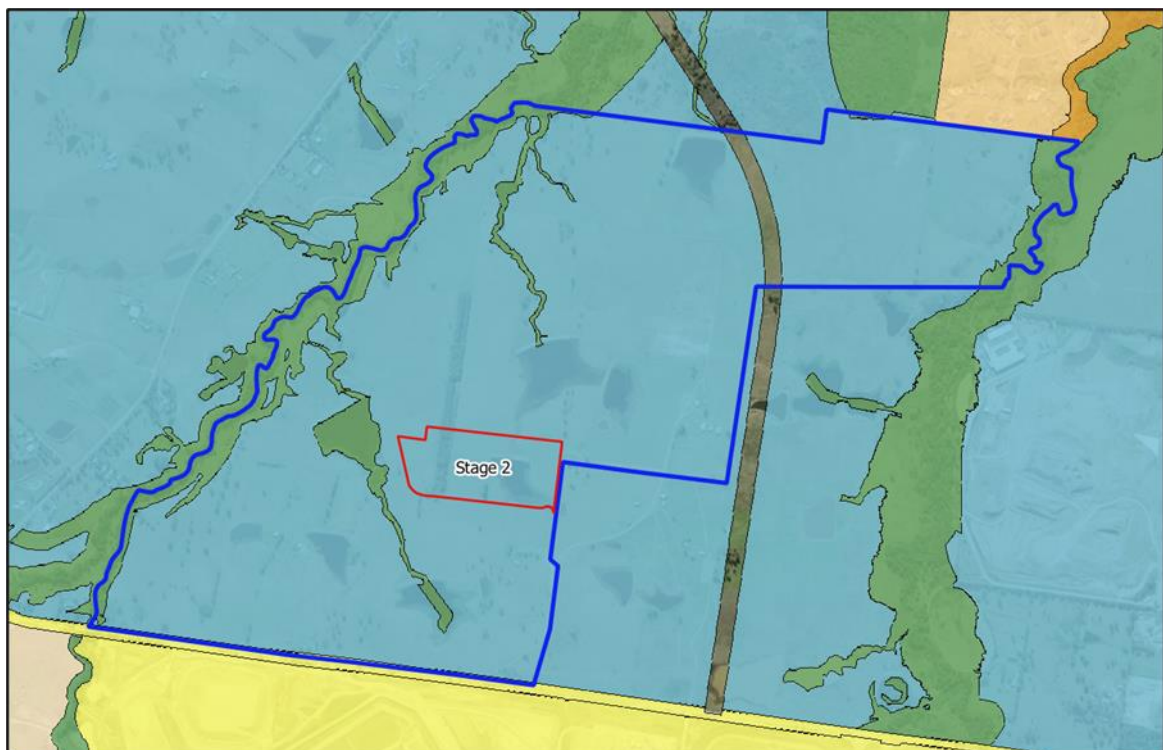
**Figure 1: Current zoning including ENT Enterprise (blue) and ENZ Environment and Recreation (green) – site boundary in red, TNG boundary in blue.**

The site boundary is shown in Figure 1.

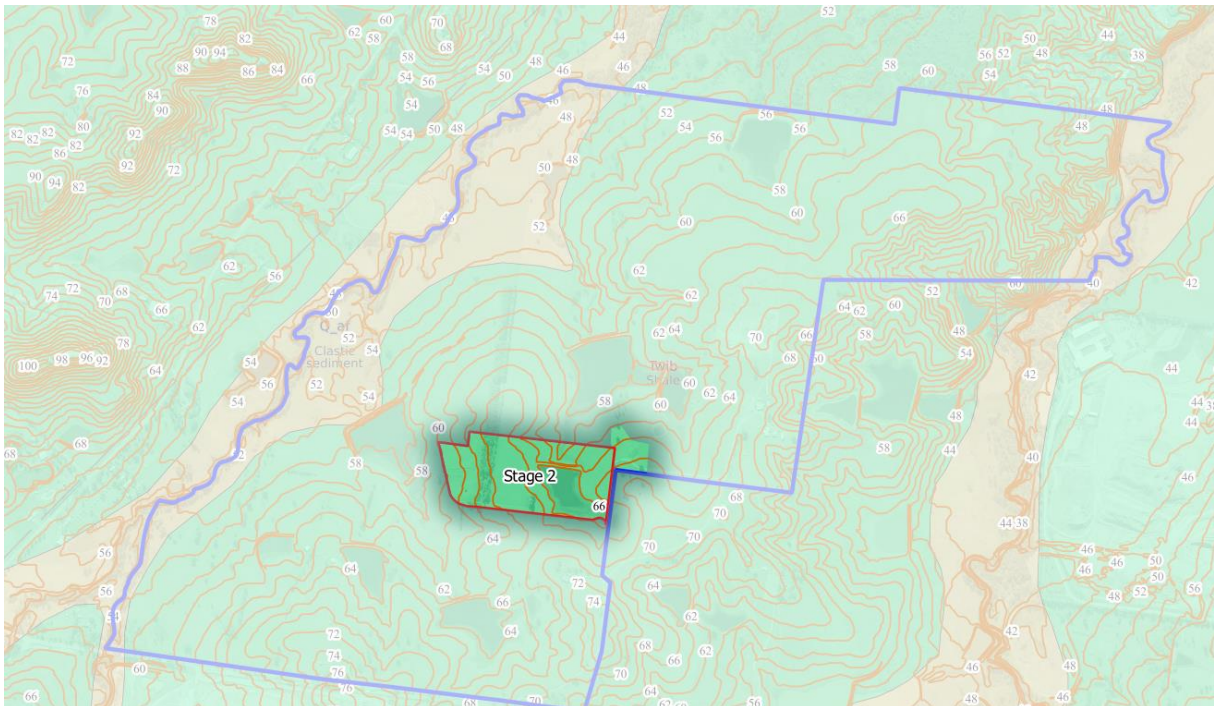
**Figure 1: Geology Landscape Mapping**

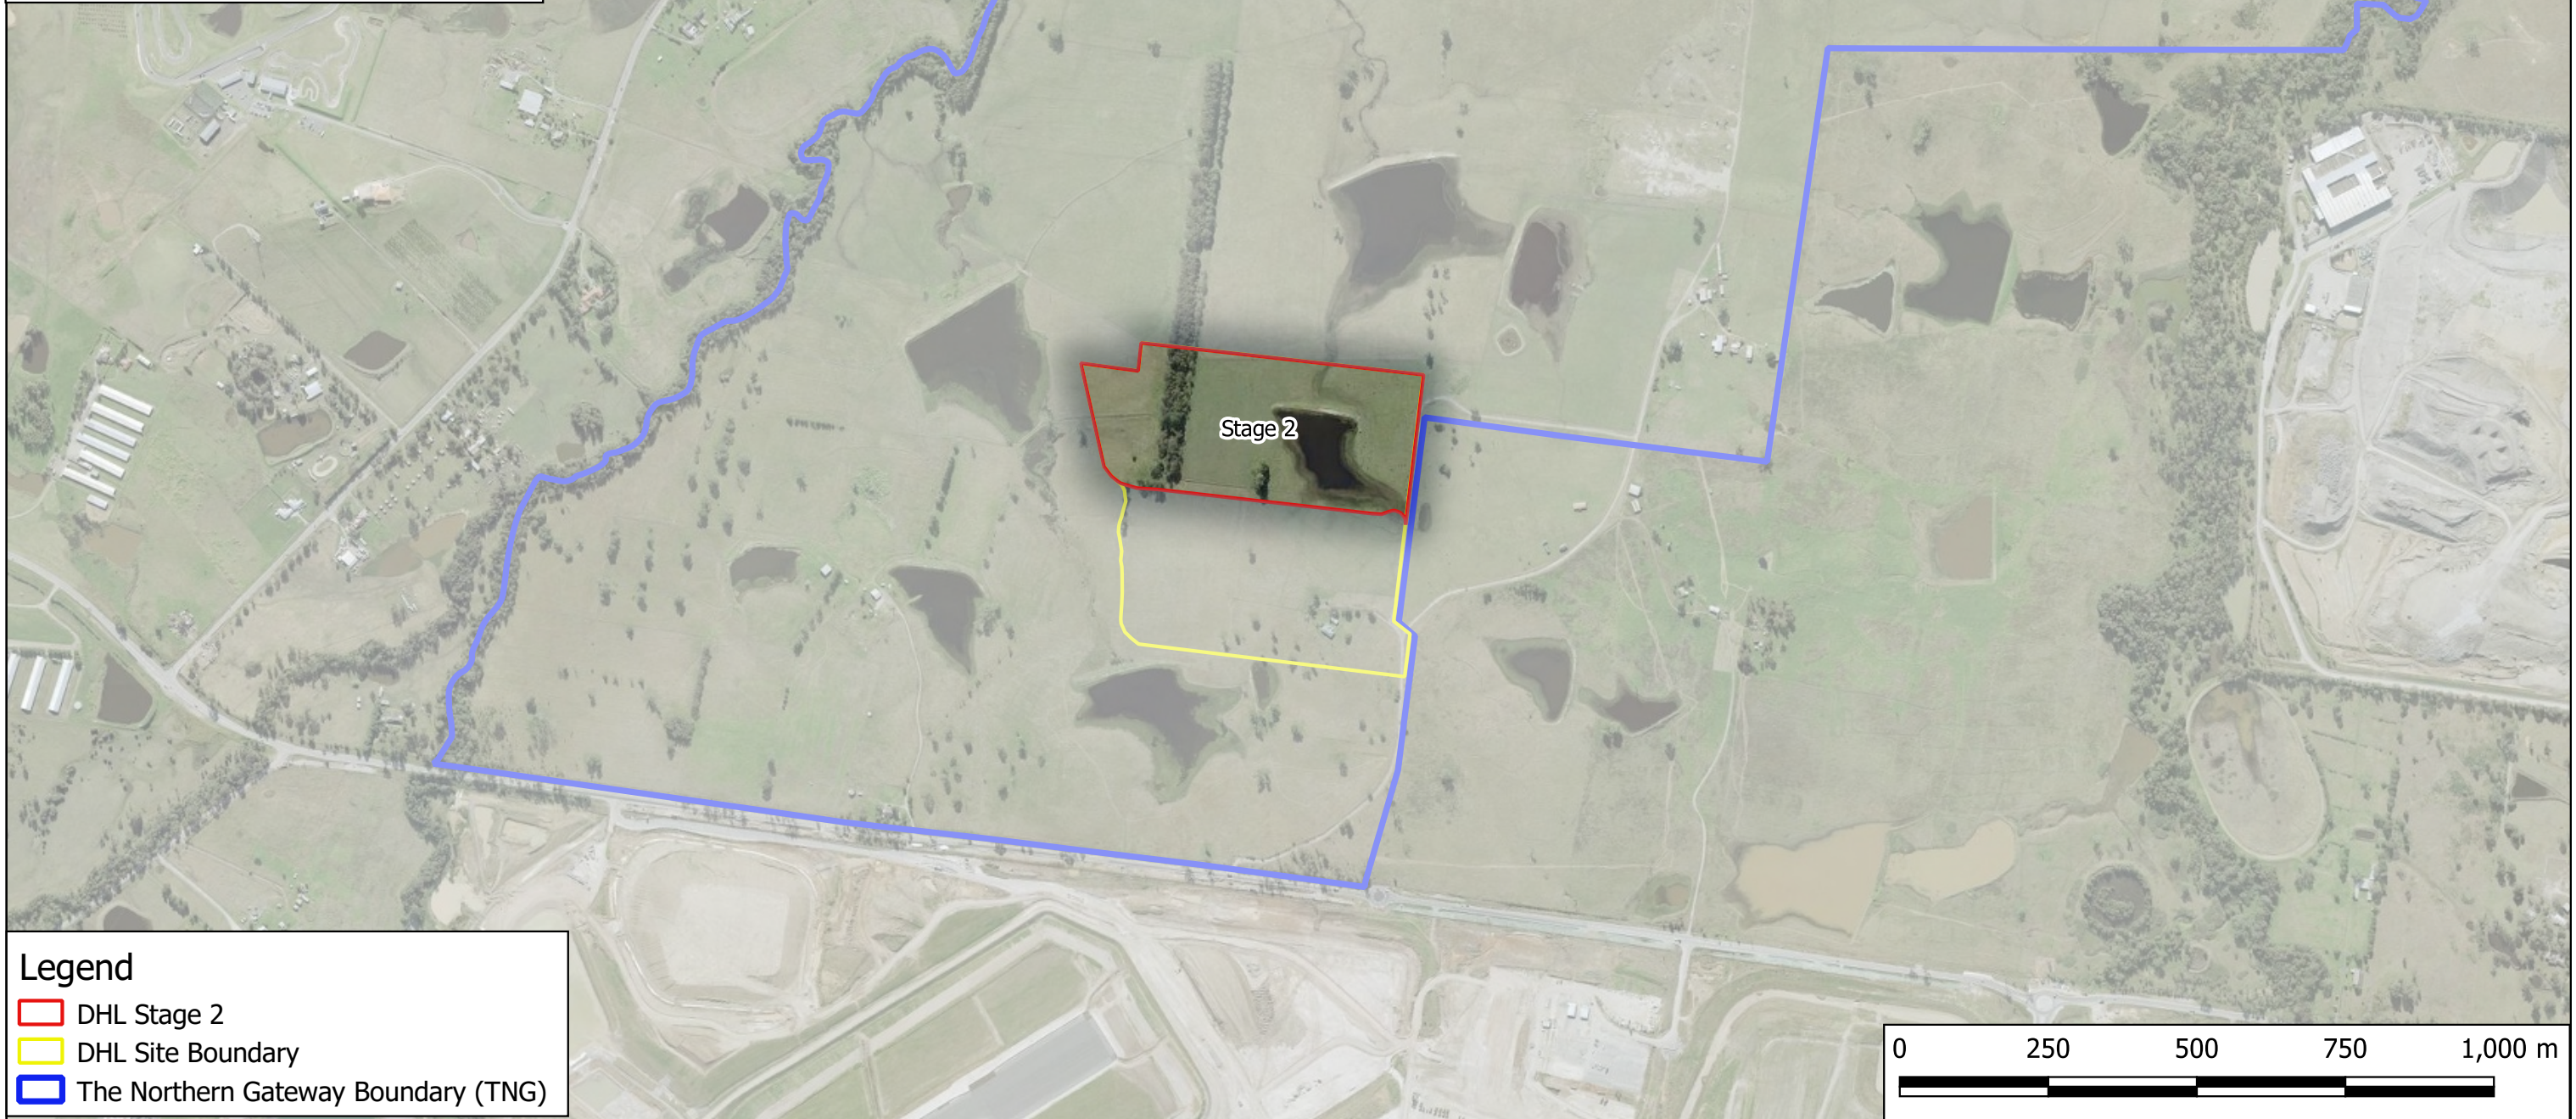
PROJ. #: 86548.20.R.005  
 DRAWING No: 1  
 REVISION: 0

- DHL Stage 2
- DHL Site Boundary
- The Northern Gateway Boundary (TNG)

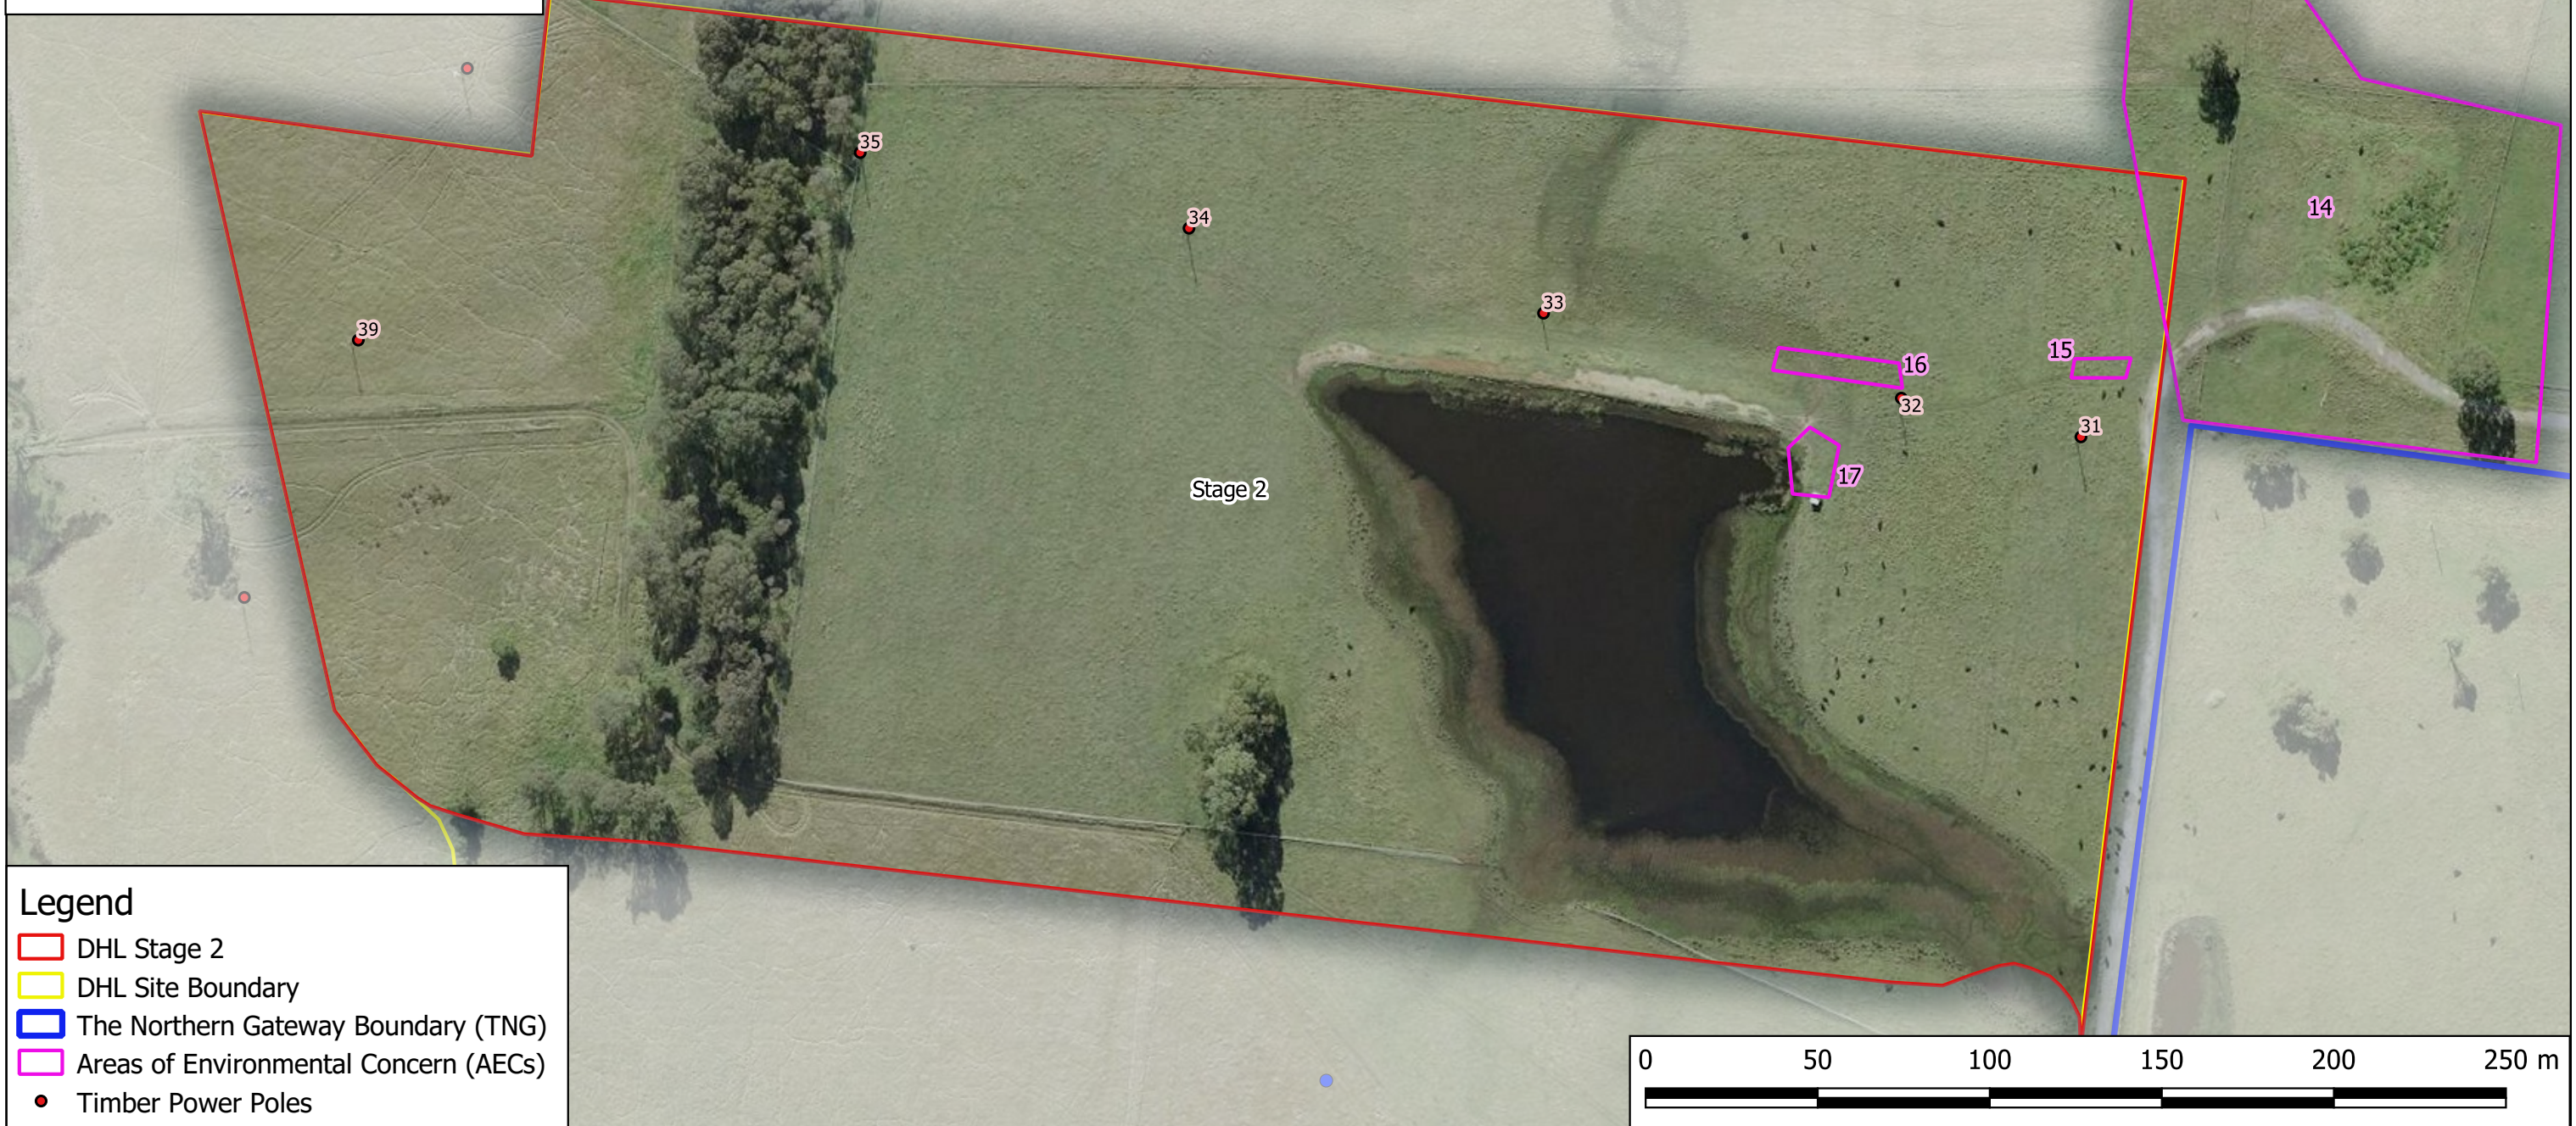
- ▭ DHL Stage 2
- ▭ DHL Site Boundary
- ▭ The Northern Gateway Boundary (TNG)
- ▭ Areas of Environmental Concern (AECs)
- Timber Power Poles

The findings of the previous investigations including a detailed site investigation (DSI)<sup>1</sup> of the subject site (see Section 7) and wider surrounds (referred to as the wider The Northern Gateway – “TNG site” and the wider DHL) has established there is no evidence of widespread or significant contamination across the site, however, localised contamination in some areas of environmental concern (AECs) was observed as requiring further investigation, delineation and/or remediation. These AECs and associated contaminants of potential concern (COPC) requiring further works are summarised in Table 1 (Section 8) and shown in Drawing 2, Appendix A.
