# HASLIN

## Flora and Fauna Management Plan

**Eurobodalla Southern Water Supply Storage Project**

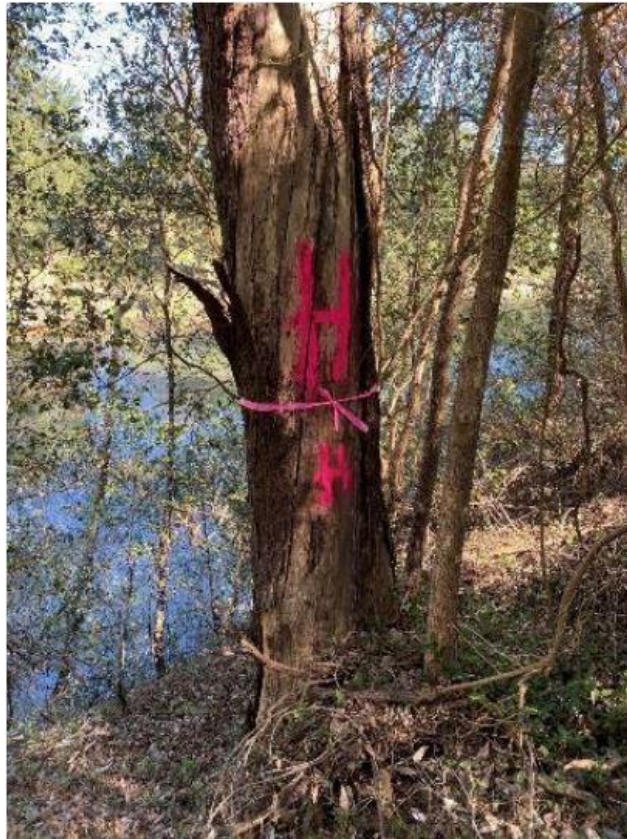
**Figure 6-3** Hollow-bearing tree identification. Hollow-bearing tree were marked with an 'H' and with high-visibility flagging tape.
