Re: CMP Manual and Tank Stream Conservation Management Plans

Below – Tank Stream Tunnel 2002, Sydney Water

June 2003

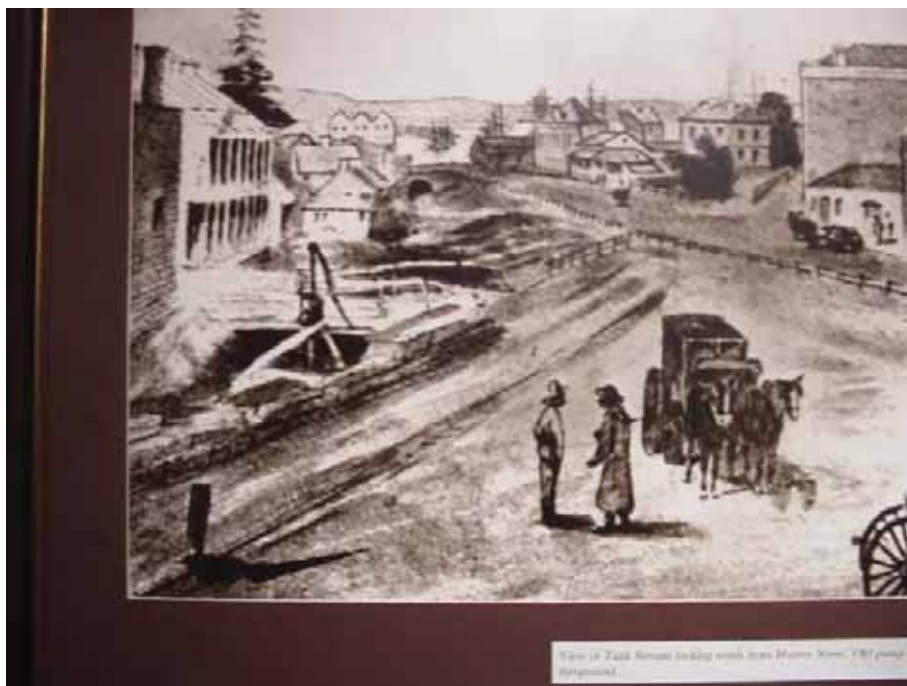
FIGURE 2-3 Unknown Artist – Detail of Illustration showing probable square water tank and pump

Governor Phillip was forced in 1791 to enclose the Tank Stream in a fence to keep stock out. This was as much to prevent trampling and muddying of the water as for hygiene. Ditches were cut alongside the stream, presumably to intercept dirty water that would otherwise pollute the water supply. These measures were *ad hoc* and ultimately ineffective. Tanks to store and hold water were cut into the bedrock near the present location of Australia Square in 1790. There were either three or four tanks, with sources not being definitive. An undated and unsourced drawing, probably c. 1850, is the only known illustration of one of the tanks (Figure 2-3). It shows a rectangular, possibly square, depression to the west of the junction of Pitt and Hunter Street. A large water pump stands on an indistinctly drawn assembly within the boundaries of the tank. The tanks are believed to have been about 5m deep and held 20,000 litres (GML 1996: 9).

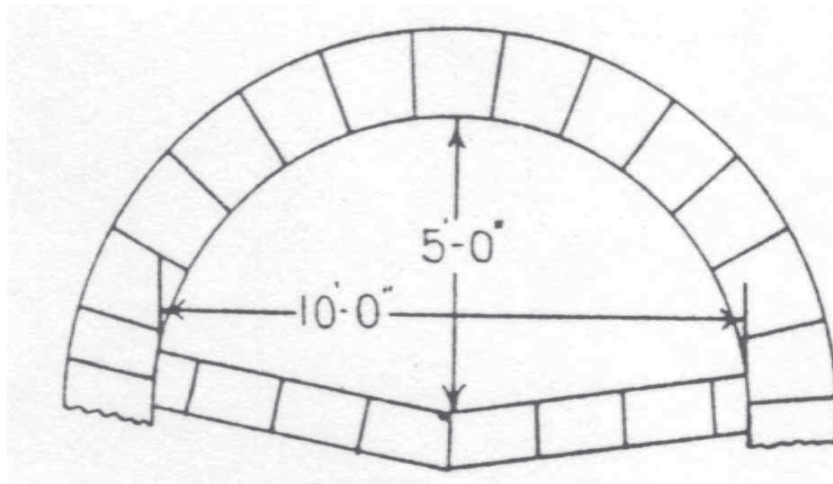
FIGURE 3-5 Profile of the Tank Stream between Access Chambers AC 18-AC 13 and part of the section AC 12-AC 07 from Abercrombie Lane to Bridge Street (McIllwraith 1951).

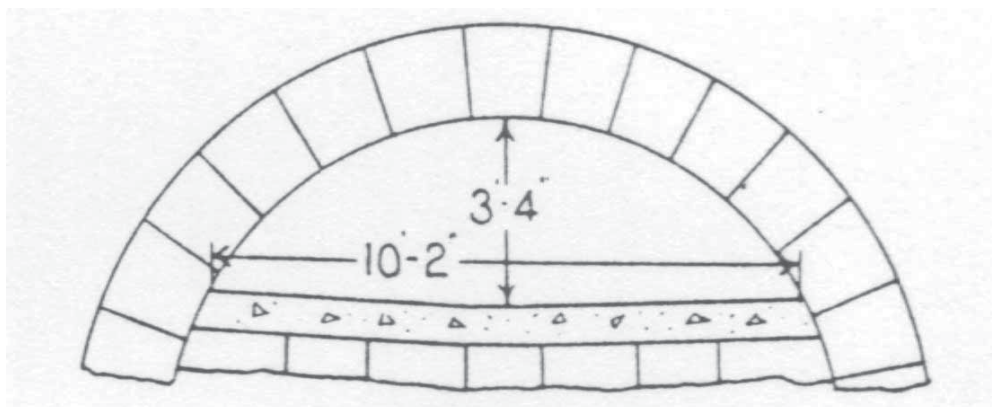
FIGURE 3-7 Profile of the Tank Stream from the Access Chamber AC 02 to the Outlet (McIllwraith 1951).

At AC 02, the channel turns about 45 degrees, and runs about 32m northeast to Sydney Harbour. The profile of this final section is generally similar to that of the previous section, however, it underwent significant modifications as segments were repaired or paved with concrete. The final segment, about 5 metres long, was replaced with a concrete profile. The Tank Stream now discharges into Circular Quay from an opening that is visible during low tides on the west end of the bank of Sydney Cove.
