## 6.4 BUILDING B

### 6.4.1 Proposed Works

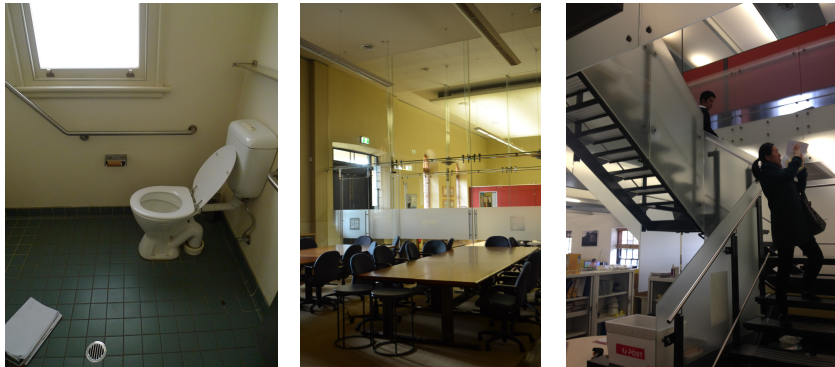
| Demolition | <ul style="list-style-type: none"> <li>• Removal of redundant services from the building (2003).</li> <li>• Removal of ground floor glass screen walls (2003).</li> <li>• Removal of central glass stair (2003) from levels one and two and existing western fire stair (2003).</li> <li>• Removal of later infill panels (2003) and internal partition walls on upper levels.</li> <li>• Existing sanitary fittings and tiles to wet areas (2003).</li> <li>• Existing ceilings where required (2003).</li> <li>• Reinstatement of access in wall connecting to Building C Group at first floor level.</li> <li>• Removal of 2003 joinery elements.</li> </ul> <div data-bbox="453 873 1292 1238"> <p>The first photograph on the left shows a toilet in a small room with green tiled floors and a window. The middle photograph shows a large room with glass screen walls and tables. The third photograph on the right shows a staircase with glass railings and a person walking up.</p> </div> <p>Figures 101,102,103: Sanitary fittings, glass screen walls and the central glass stair (2003) to be removed. Source: Tonkin Zulaikha Greer Architects, 2016.</p> |
