# CONSTRUCTION HERITAGE MANAGEMENT PLAN

Moorebank Precinct East Stage 2 -  
SSD 7628

## Moorebank Intermodal Precinct – Precinct East Stage 2

#### Construction Heritage Management Plan

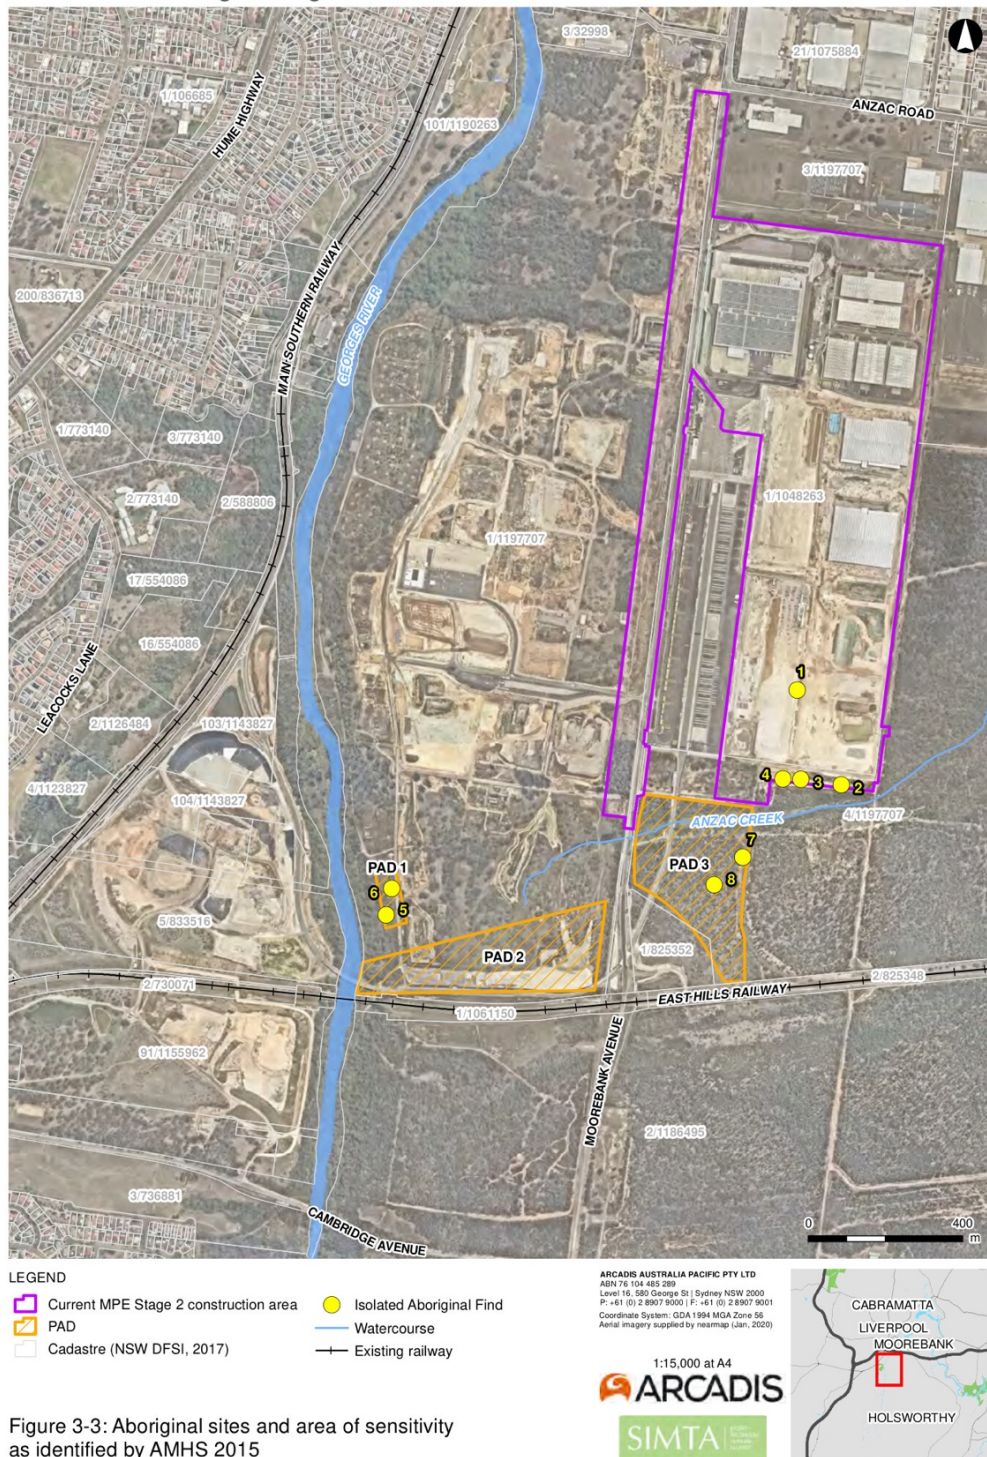
Figure 3-3: Aboriginal sites and area of sensitivity as identified by AMHS 2015

The Development site was subject to additional survey by AHMS in 2012. This survey identified seven isolated Aboriginal objects and three areas of Potential Archaeological Deposit (PAD). Of the identified sites, four isolated objects (Isolated Find #1, 2, 3 and 4) occur within the Development site and none of the PADs are located within the Development site. Descriptions of these sites are provided in Table 3-1. Areas of archaeological sensitivity mapped by AHMS in their 2015 update of the 2012 survey are shown in Figure 3-3.

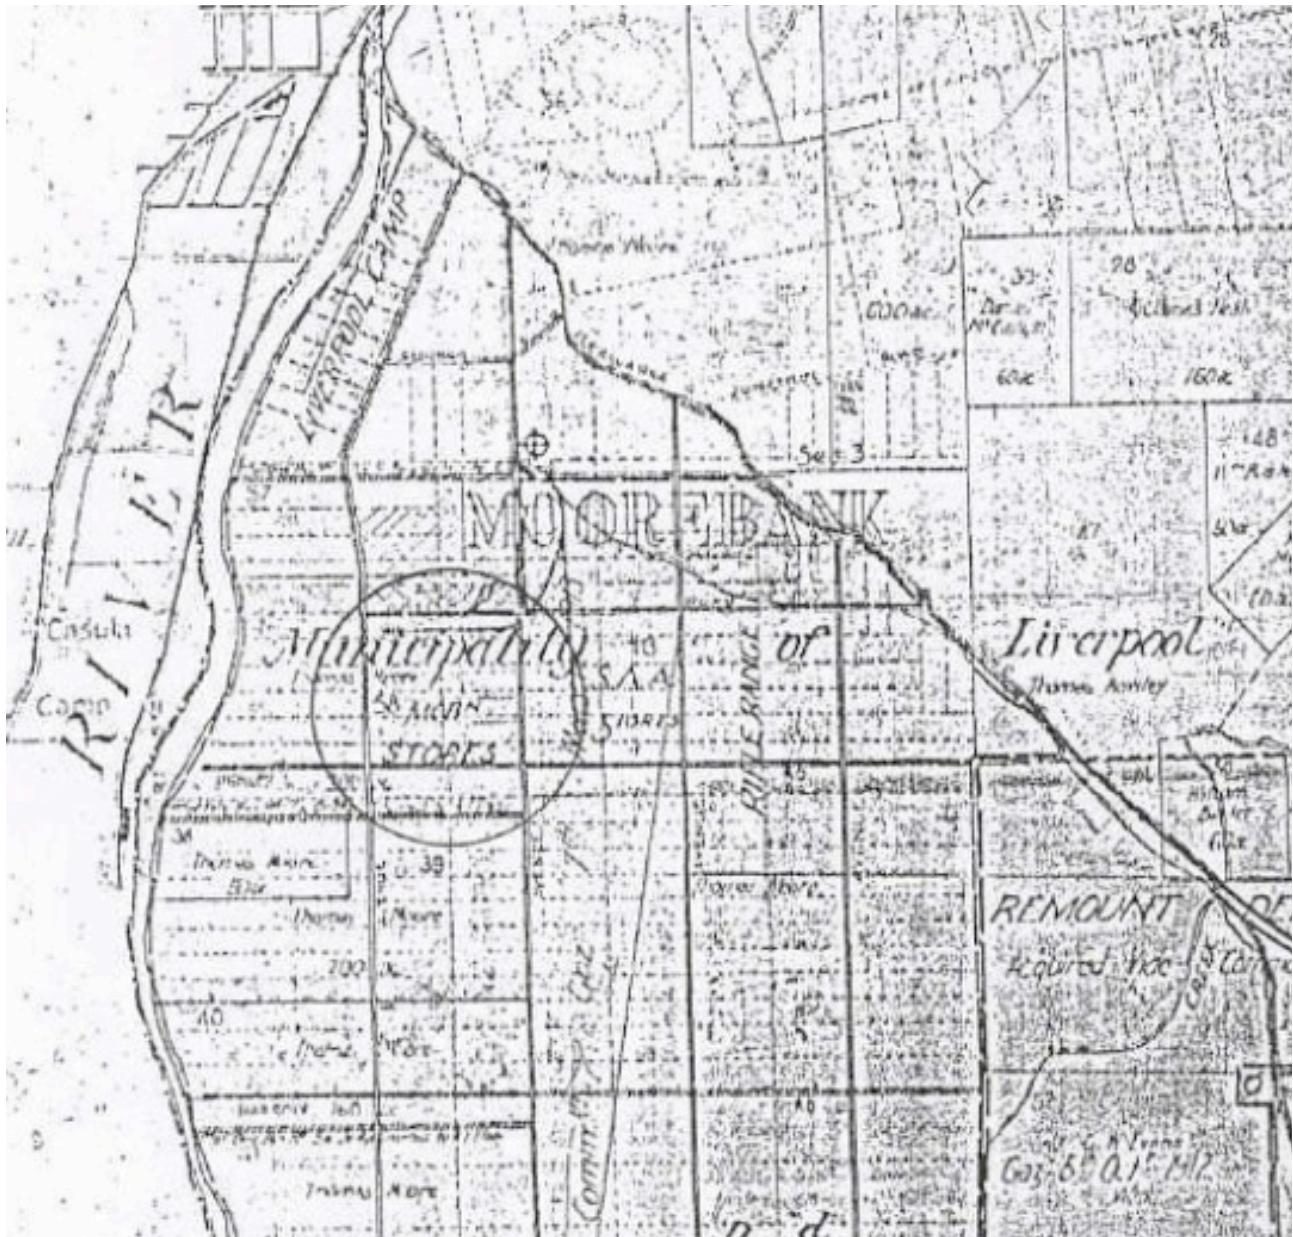
Figure 3-5 Site Layout (Artefact Heritage 2015).

By 1913, the Liverpool camp accommodated 2000 troops in tents and became the main training centre in New South Wales. Plans dating to this period show Liverpool camp located between the Georges River and Moorebank Avenue. To the east of the camp was an area marked 'stores' which included the northern portion of the MPE. To the east of the site was a rifle range. The camp was further developed in the lead up to WWI including the development of huts, kitchens mess buildings etc. (Artefact 2012).

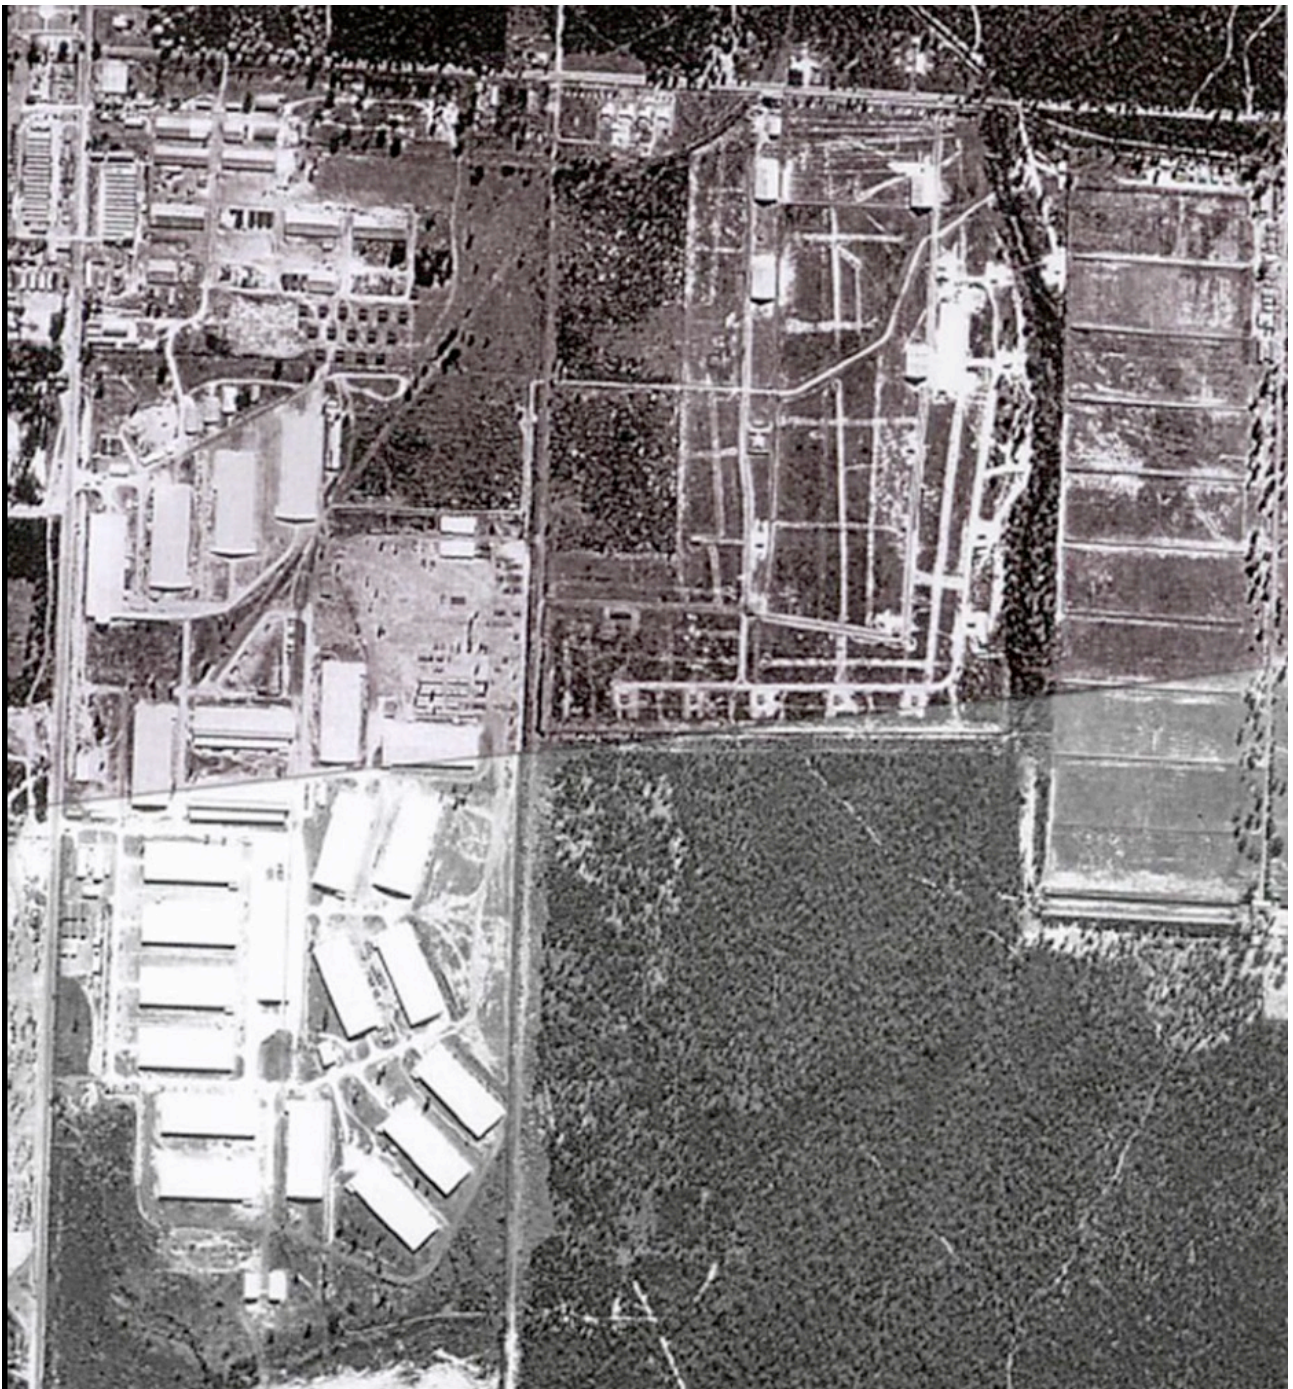
Figure 3-7 Aerial Photograph Showing the Ordnance Depot/DNSDC in 1951 (Brookes & Associates 2002:9)

Aerial photographs indicate that little changed at the site between the late 1940s and early 1990s (Figure 3-7). In the early 1990s the site became the DNSDC as part of a reorganisation of Defence supply services and warehousing arrangements. During the refurbishment of the DNSDC five of the original 20 store buildings (five of which occur within the Development site) were demolished and replaced with larger modern buildings. The remaining WWII store buildings were reclad at this time. Modern steel sheeting replaced the original asbestos walls and new concrete floors were laid. Various WWII structures in the study area were also demolished during this time. Modern ancillary buildings including administrative buildings, workshops and amenities were constructed throughout the complex, twenty of which occur within the Development site (Artefact 2012).
