Long-Term Environmental Management Plan

Moorebank Precinct West (MPW)

Prepared for: Qube Property Management Services Pty Ltd

EP1489.001 v13 1 December 2020

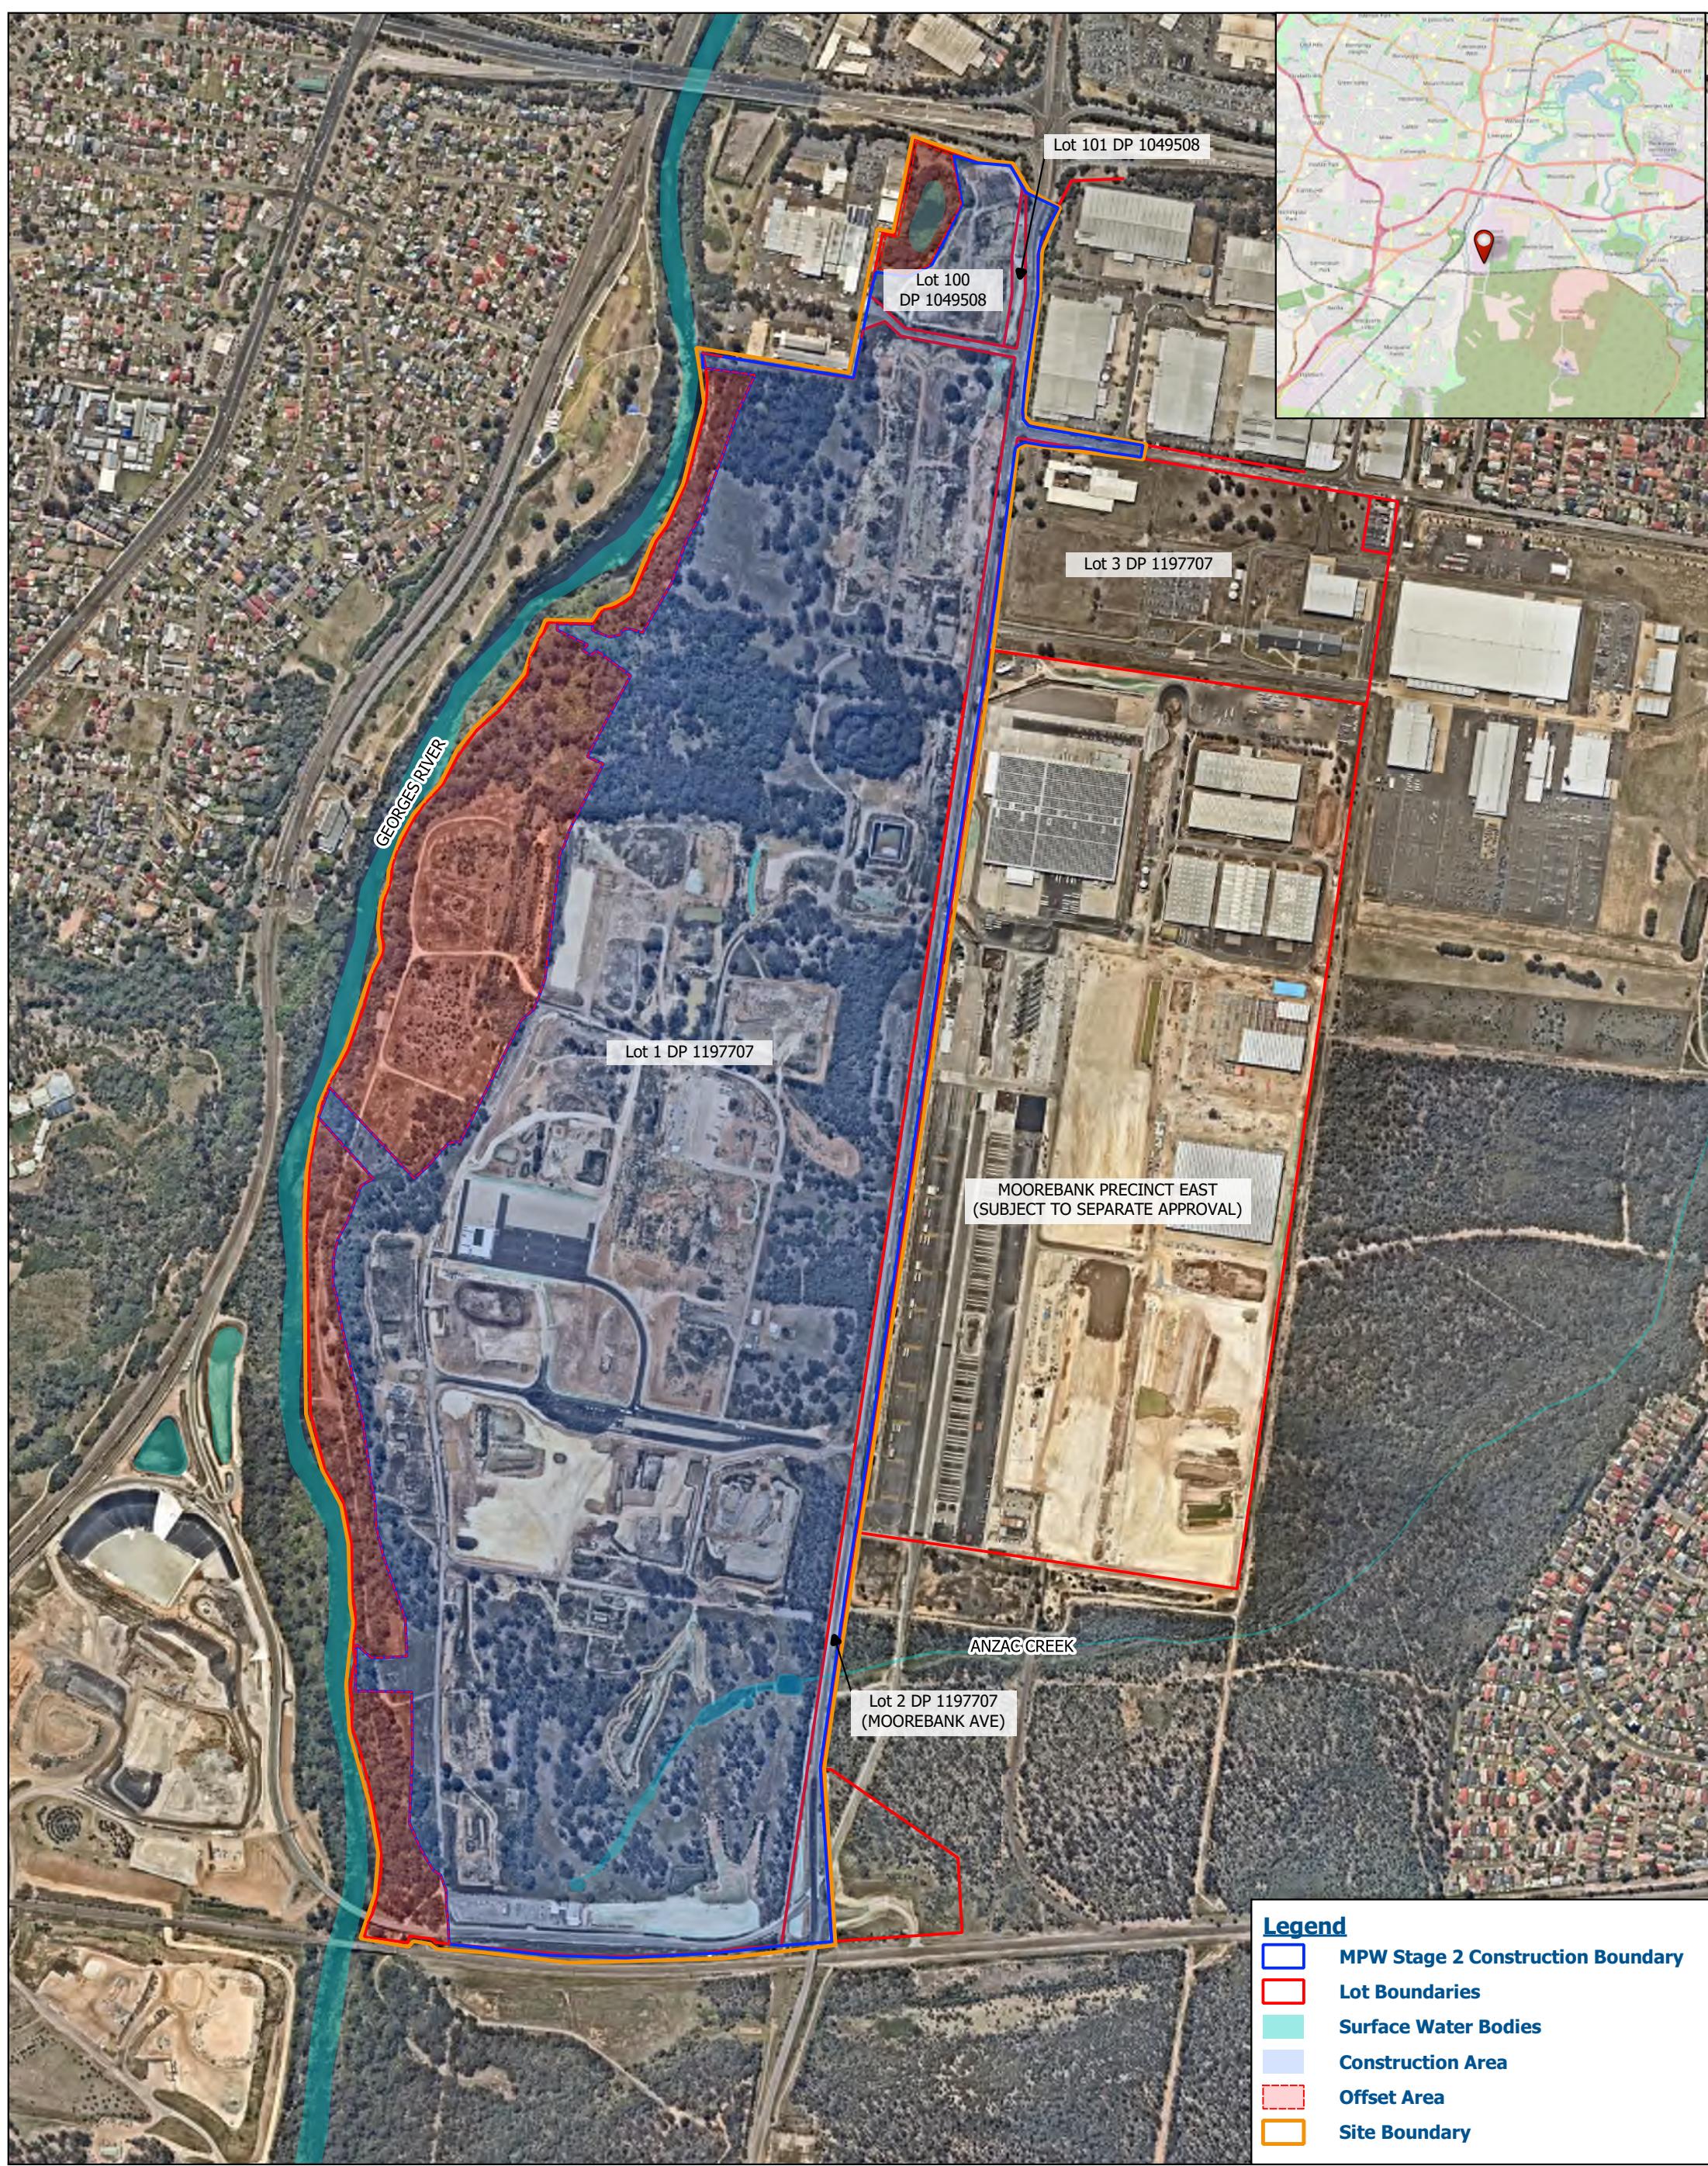
Figure 1 - Site Location

Qube (Qube) Property Management Services Pty Ltd, c/o Tactical Group Pty Ltd (Tactical), engaged EP Risk Management Pty Ltd (EP Risk) to prepare a Long-Term Environmental Management Plan (LTEMP) for the Moorebank Precinct West (MPW) Site located at 400 Moorebank Avenue, Moorebank NSW, 2170 (the Site). The location of the Site is provided as **Figure 1**.

- **Construction Area:** Encompasses the portion of the Site inside the MPW Stage 2 Construction Boundary and includes the proposed onsite stormwater detention basins (ref: **Figure 1**).
- **Offset Area:** Comprises the riparian area adjacent the Georges River which is located outside the MPW Stage 2 Construction Area Boundary in the western portion of the Site (ref: **Figure 1**).

Development of the Site is only proposed along the eastern portion of the Site (Construction Area) within the MPW Stage 2 Construction Boundary (**Figure 1**).

- **Construction Area:** Encompasses the portion of the Site inside the MPW Stage 2 Construction Boundary and includes the proposed onsite stormwater detention basins (ref: **Figure 1**).
- **Offset Area:** Comprises the riparian area adjacent the Georges River which is located outside the MPW Stage 2 Construction Boundary in the western portion of the Site (ref: **Figure 1**).

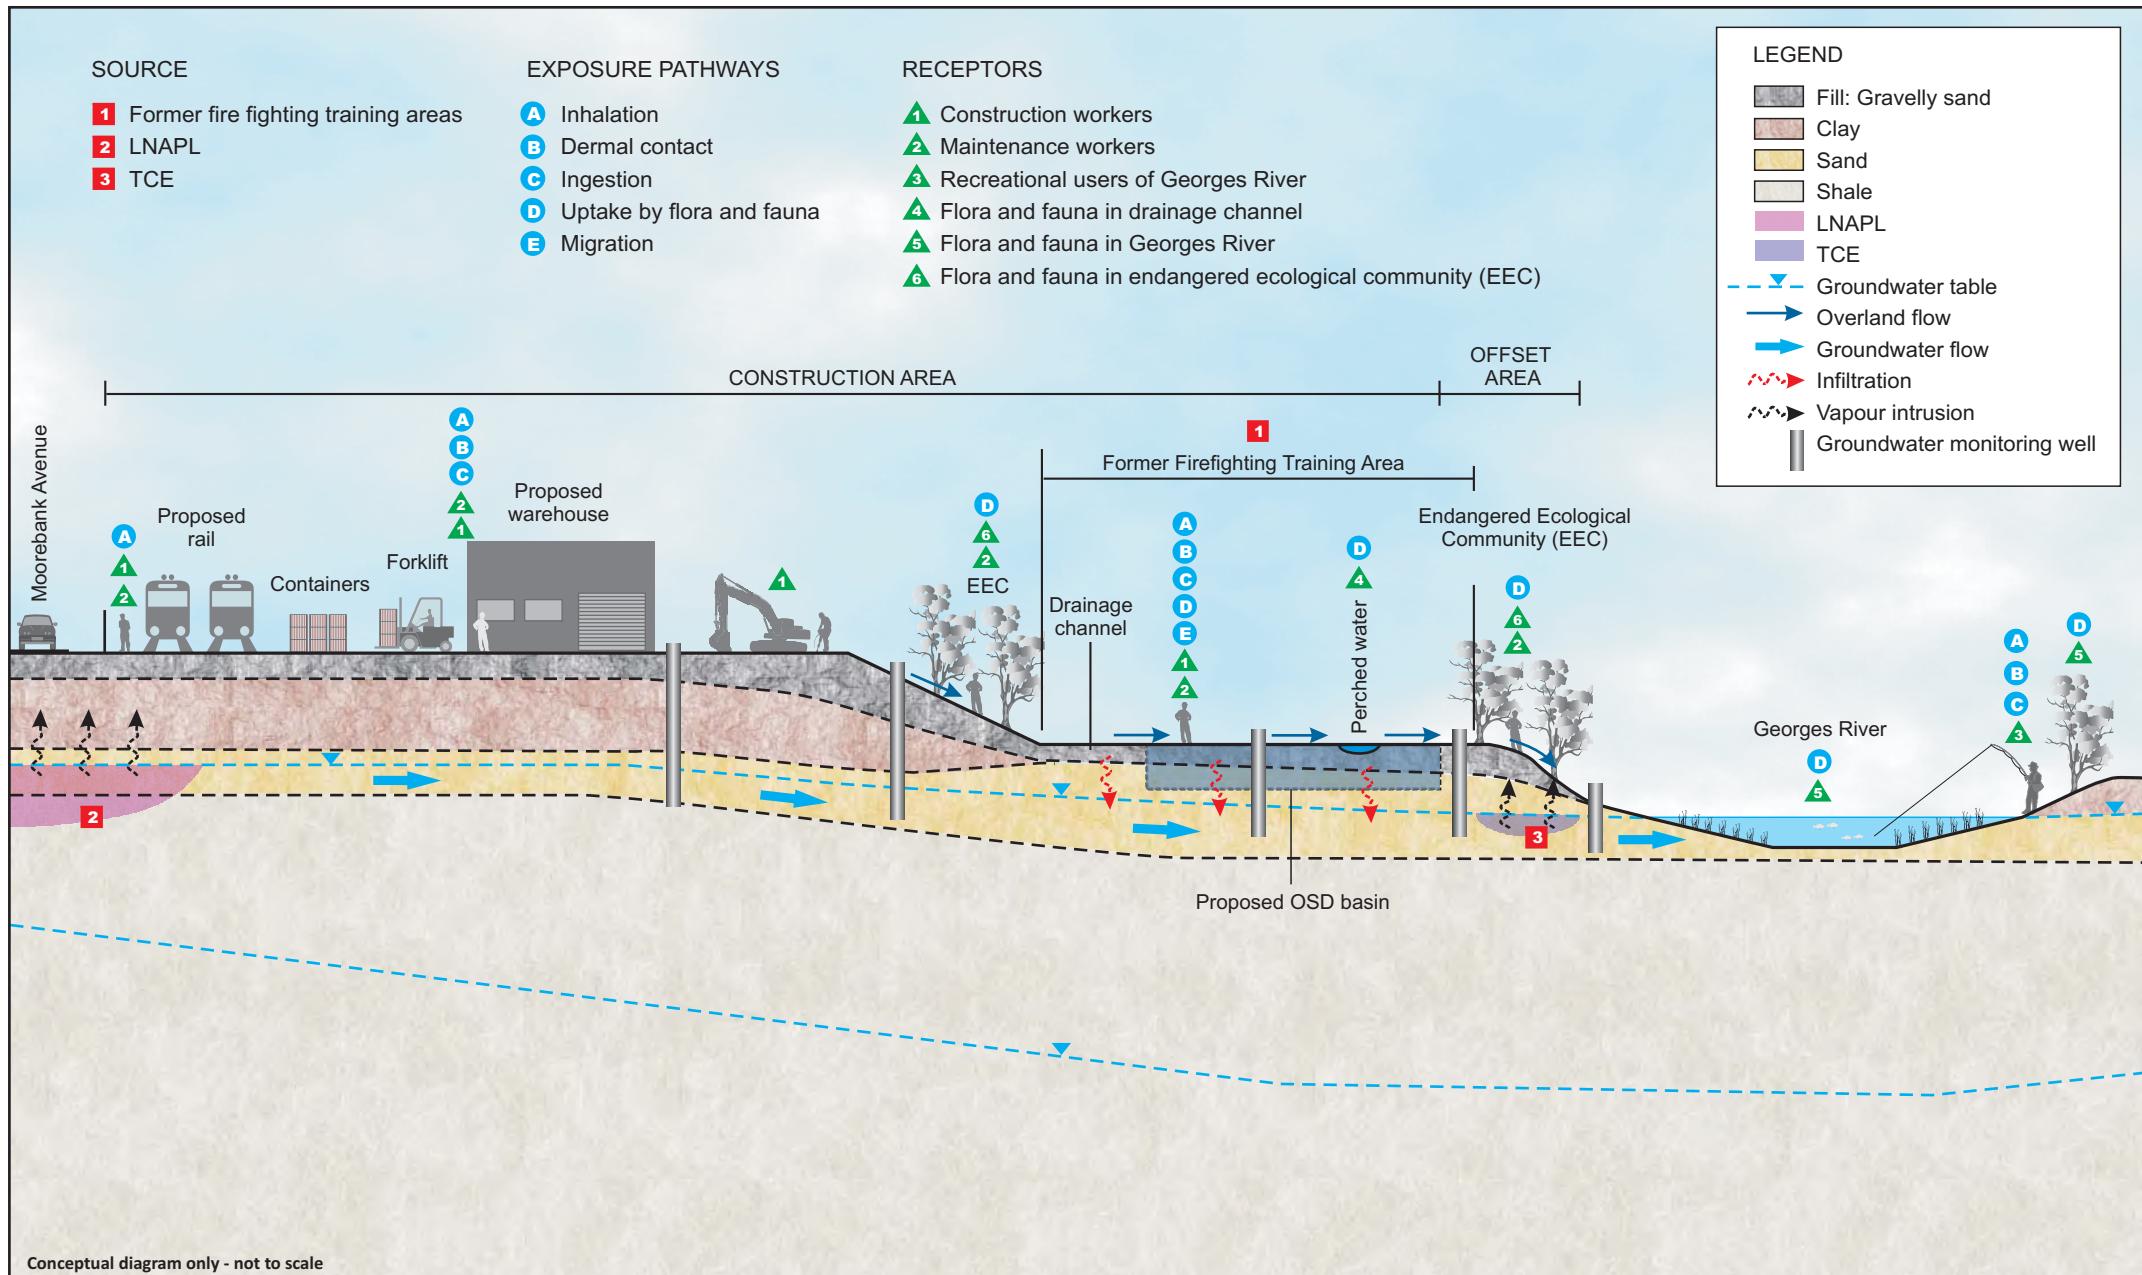
Conceptual diagram only - not to scale

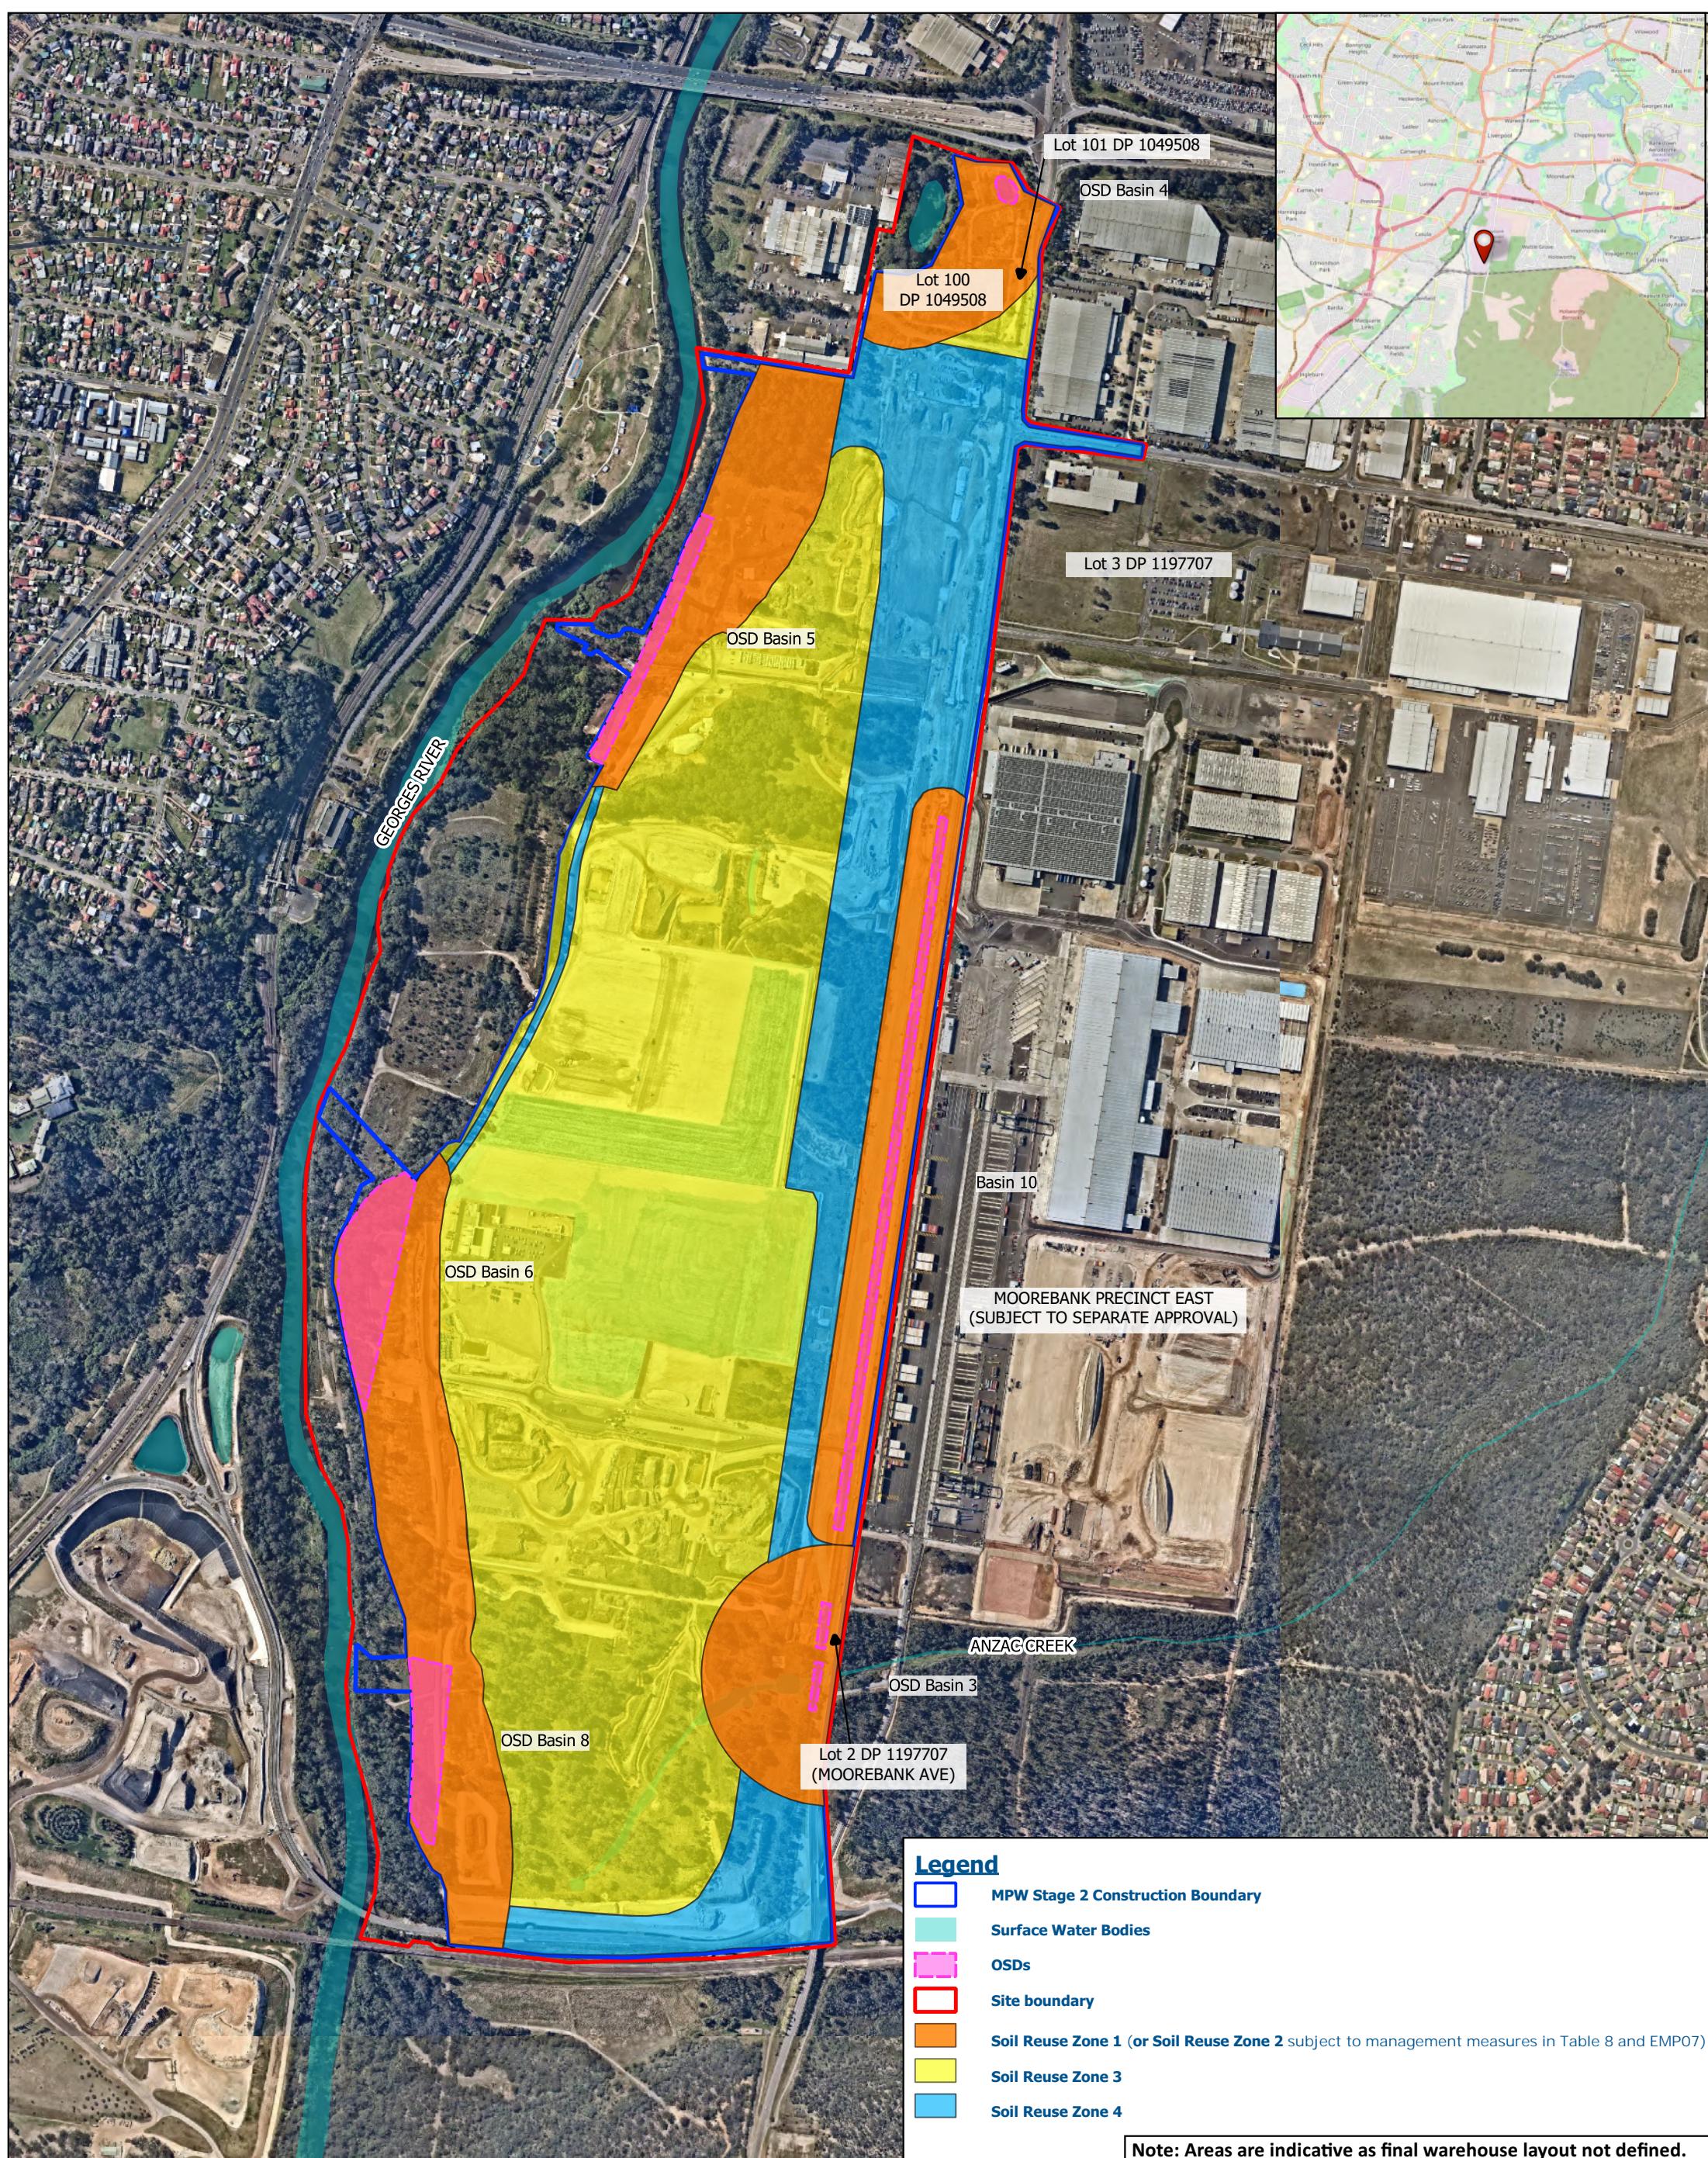
Figure 5 - Soil Reuse Zones

Based upon a review of the setting and development proposed for the Site approximate footprints of the soil reuse zones were developed based upon a 200 m⁴⁶ buffer distance from waterways and a 50 m⁴⁷ buffer distance from stormwater structures. A table presenting differences between seasonal maximum groundwater levels and ground surface levels is provided as **Appendix M**. Shallow groundwater at depths less than 1.0 m are likely to be found within the Offset Area adjacent to the Georges River.

It should be noted that the reuse zones in **Figure 5** have been prepared based upon the Precinct Master Plan ('PMP') provided as **Appendix B**. The PMP at **Appendix B** has been finalised and accepted by MIC and Qube and no further revision to the PMP is contemplated. Should the PMP change then the LTEMP will need to be revised in accordance with **EMP25**.

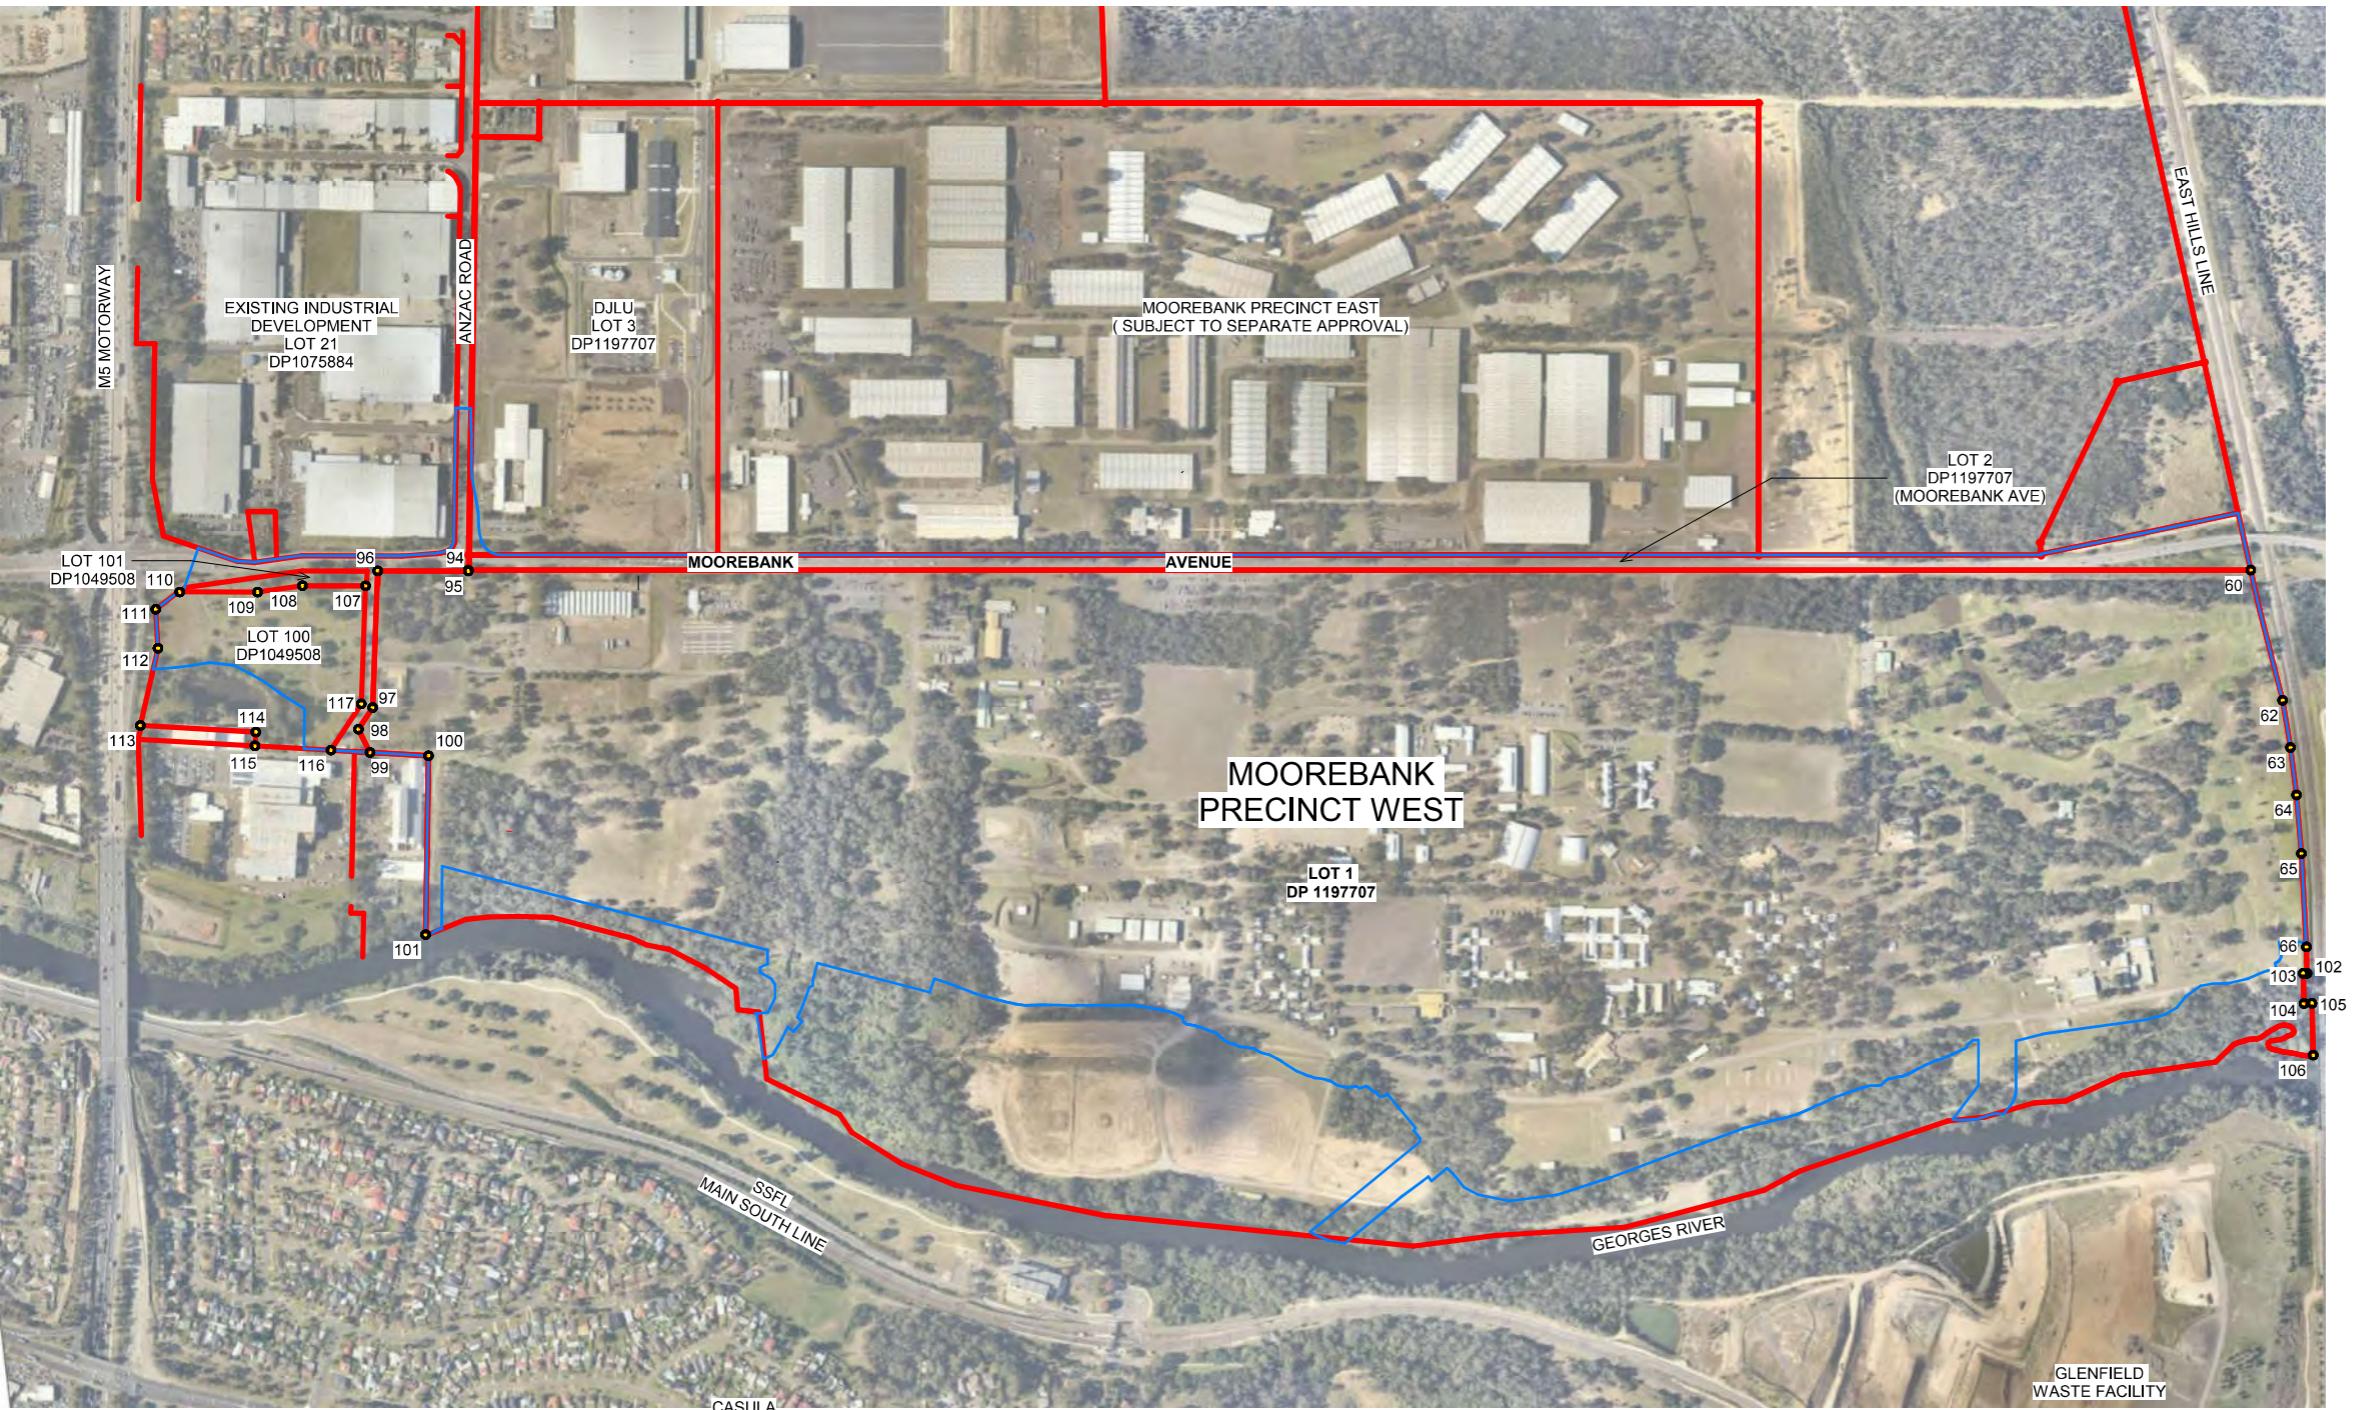
MPW STAGE 2 LOT BOUNDARIES

Site Coordinate Boundaries		
Point	E	N
60	307 860.568	6 239 766.887
62	307 683.718	6 239 746.852
63	307 620.255	6 239 744.471
64	307 556.748	6 239 744.491
65	307 478.726	6 239 747.812
66	308 007.151	6 240 914.68
94	308 160.388	6 242 114.54
95	308 159.102	6 242 114.727
96	308 174.57	6 242 234.079
97	307 995.439	6 242 263.613
98	307 969.255	6 242 285.993
99	307 936.892	6 242 274.555
100	307 922.712	6 242 198.119
101	307 687.634	6 242 231.948
102	307 320.056	6 239 760.576
103	307 320.569	6 239 765.549
104	307 280.775	6 239 769.657
105	307 279.687	6 239 759.113
106	307 211.251	6 239 766.176
107	308 156.894	6 242 252.429
108	308 167.667	6 242 335.549
109	308 166.834	6 242 395.719
110	308 180.535	6 242 499.513
111	308 161.49	6 242 532.768
112	308 109.722	6 242 536.338
113	308 010.949	6 242 572.571
114	307 982.921	6 242 421.672
115	307 964.938	6 242 425.012
116	307 946.349	6 242 325.592
117	308 002.084	6 242 277.954

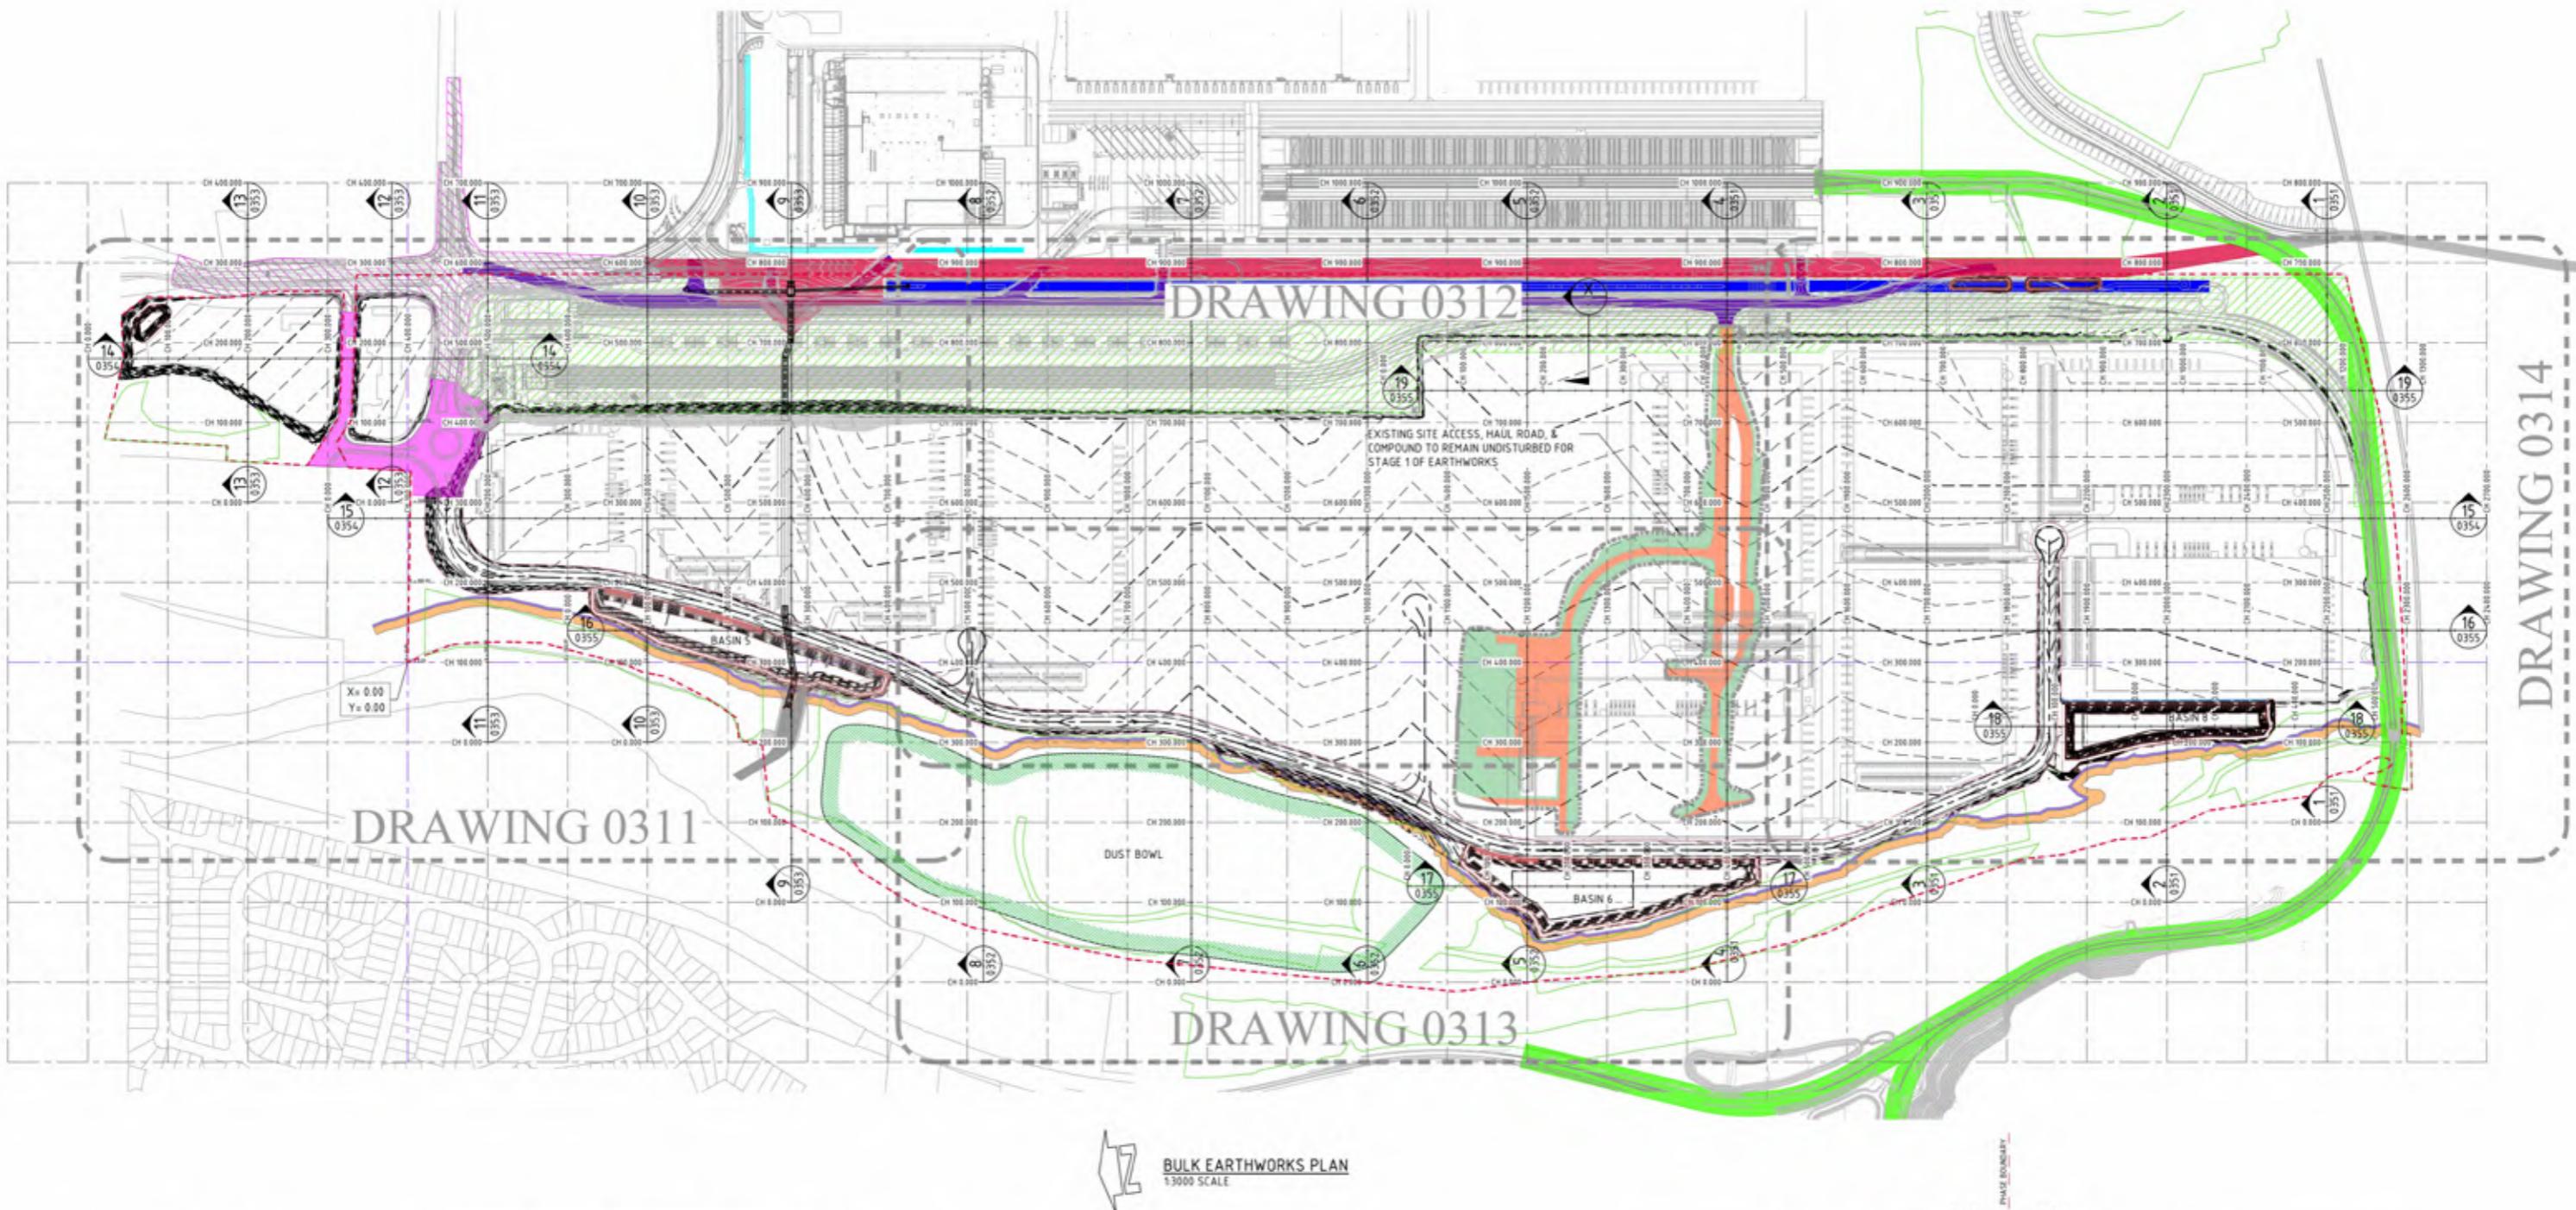
EARTHWORKS PLAN
SCALE

<u>BULK EARTHWORKS VOLUMES</u>	
VOLUMES SHOWN BELOW ARE BASED ON THE COMPARISON BETWEEN THE DETAILED EARTHWORKS LEVELS AND EXISTING SITE LEVELS AS SHOWN ON THE CARONI SITE SURVEY REF 1889461001 DATED 01/05/2019	
TOPSOIL (APPROXIMATE)	= ~ 300,000m ³
CUT MATERIAL	= ~ 291,500m ³
FILL MATERIAL	= ~ 1514,300m ³
SITE WON FILL FROM DUST BOWL	= ~ 300,000m ³
DETAILED EXCAVATION FROM FUTURE WAREHOUSING AT 1,500m ³ /Ha (9.47Ha of WAREHOUSING)	= ~ 150,000m ³
BALANCE	= ~ 1,072,800m ³ (IE IMPORT)
<u>NOTE:</u>	
EARTHWORK VOLUMES ARE APPROXIMATE ONLY. NO ALLOWANCE HAS BEEN MADE FOR DELETERIOUS MATERIAL, EXISTING SLAB REMOVAL, EROSION AND SEDIMENT CONTROL OR BULKING OR COMPACTION OF FILED SOILS. CONTRACTOR TO ALLOW FOR THESE ITEMS AS REQUIRED.

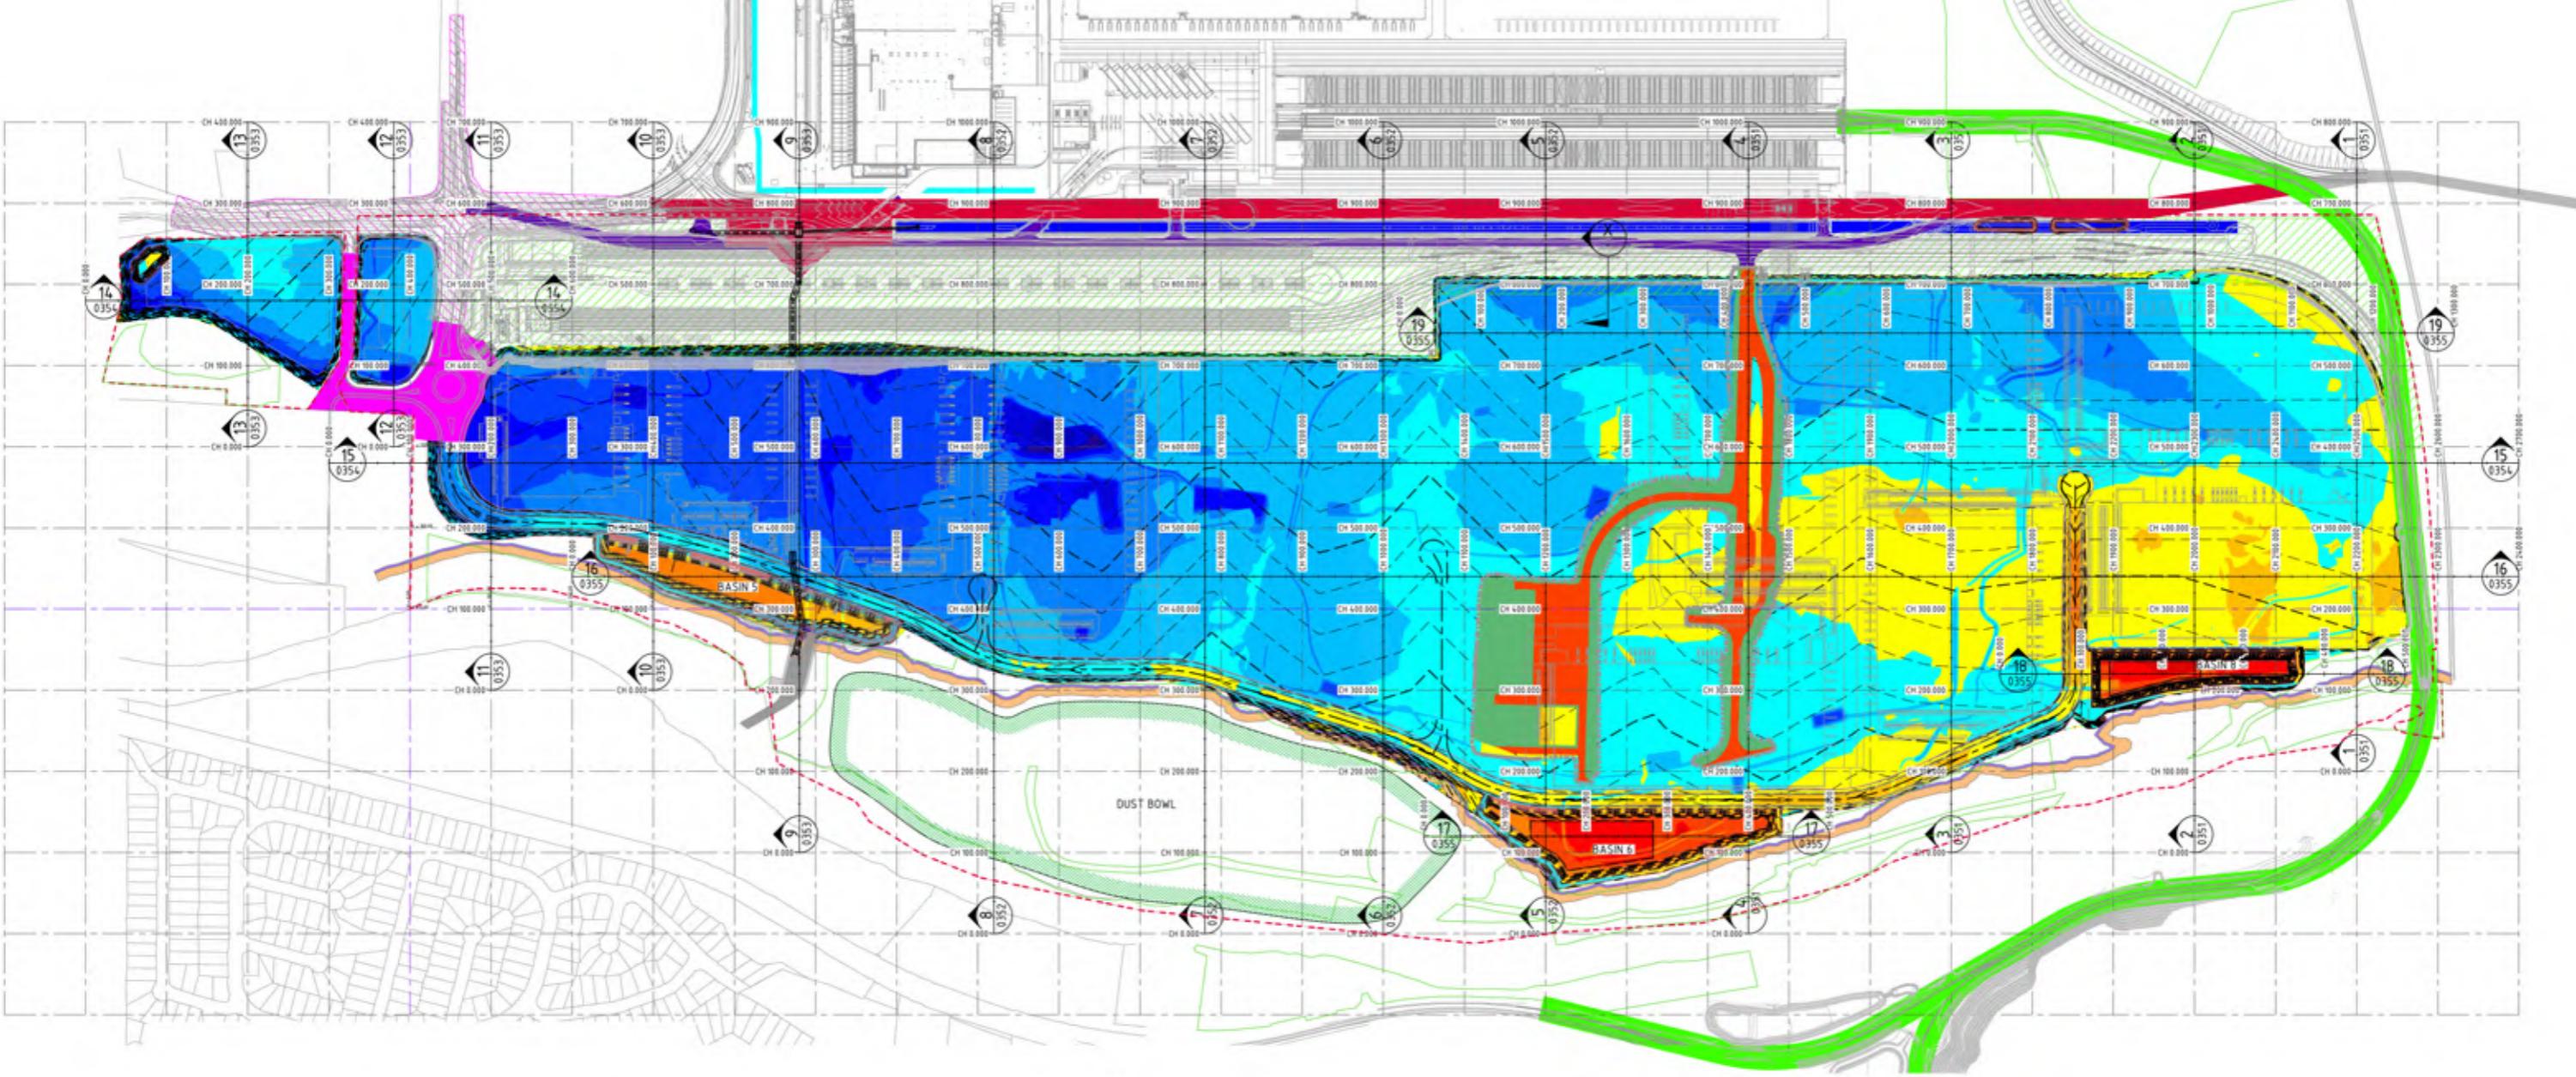
CUT/FILL PLAN
1:3000 SCALE @A1

DEPTH RANGE				
No.	FROM DEPTH	TO DEPTH	COLOUR	
1	-7.000	-6.000	Red	0m
2	-6.000	-5.000	Red	3m
3	-5.000	-4.000	Red	16.6m
4	-4.000	-3.000	Orange	12.2m
5	-3.000	-2.000	Orange	25.5m
6	-2.000	-1.000	Yellow	46.8m
7	-1.000	0.000	Yellow	75.8m
8	0.000	1.000	Cyan	76.576m
9	1.000	2.000	Cyan	21.182m
10	2.000	3.000	Cyan	21.182m
11	3.000	4.000	Blue	80.378m
12	4.000	5.000	Blue	188.4m
13	5.000	6.000	Blue	658.9m
14	6.000	7.000	Blue	118m
15	7.000	8.000	Blue	101m

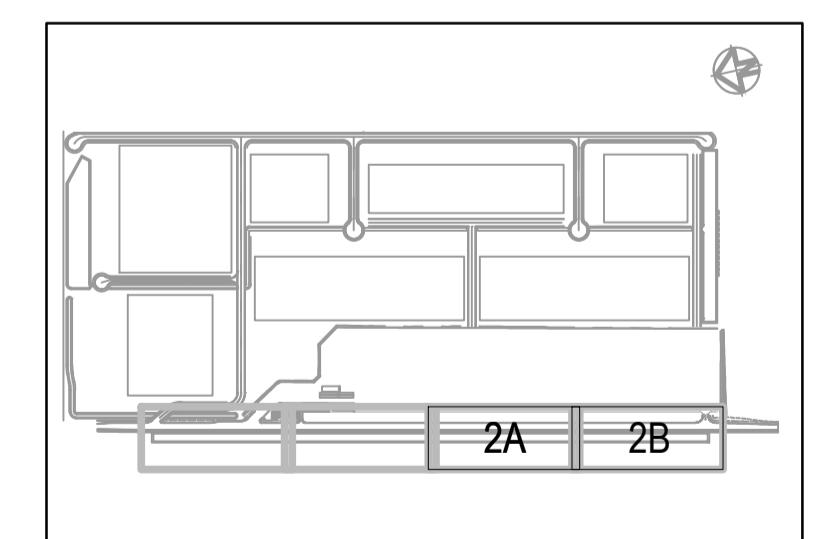
TYPICAL EARTHWORKS SECTION

1. HATCHING SHOWN REPRESENTS DEPTH RANGE BETWEEN THE EXISTING SURFACE WITH 150 mm STRIP AND THE BULK EARTHWORKS SURFACE.
2. NO ALLOWANCE HAS BEEN MADE FOR;
 - BULKING OR COMPACTION FACTORS
 - TRENCHING FOR UTILITIES (INC. STORMWATER, WATER, SEWER, ELECTRICAL AND COMMUNICATIONS)
3. DESIGN MATERIAL THICKNESS HAS BEEN ASSUMED AS:
 - TOPSOIL DEPTH 150mm
 - RAINGARDEN DEPTH 1000mm
 - CONCRETE RAMP FORMATION 300mm
4. IT IS ASSUMED NO OVER EXCAVATION IS REQUIRED FOR PLACEMENT OF IMPORTED FILL
5. CONTOURS SHOWN REPRESENT THE BULK EARTHWORKS LEVELS.
