Long-Term Environmental Management Plan

Moorebank Precinct West (MPW)

Prepared for: Qube Property Management Services Pty Ltd

EP1489.001 v13 1 December 2020

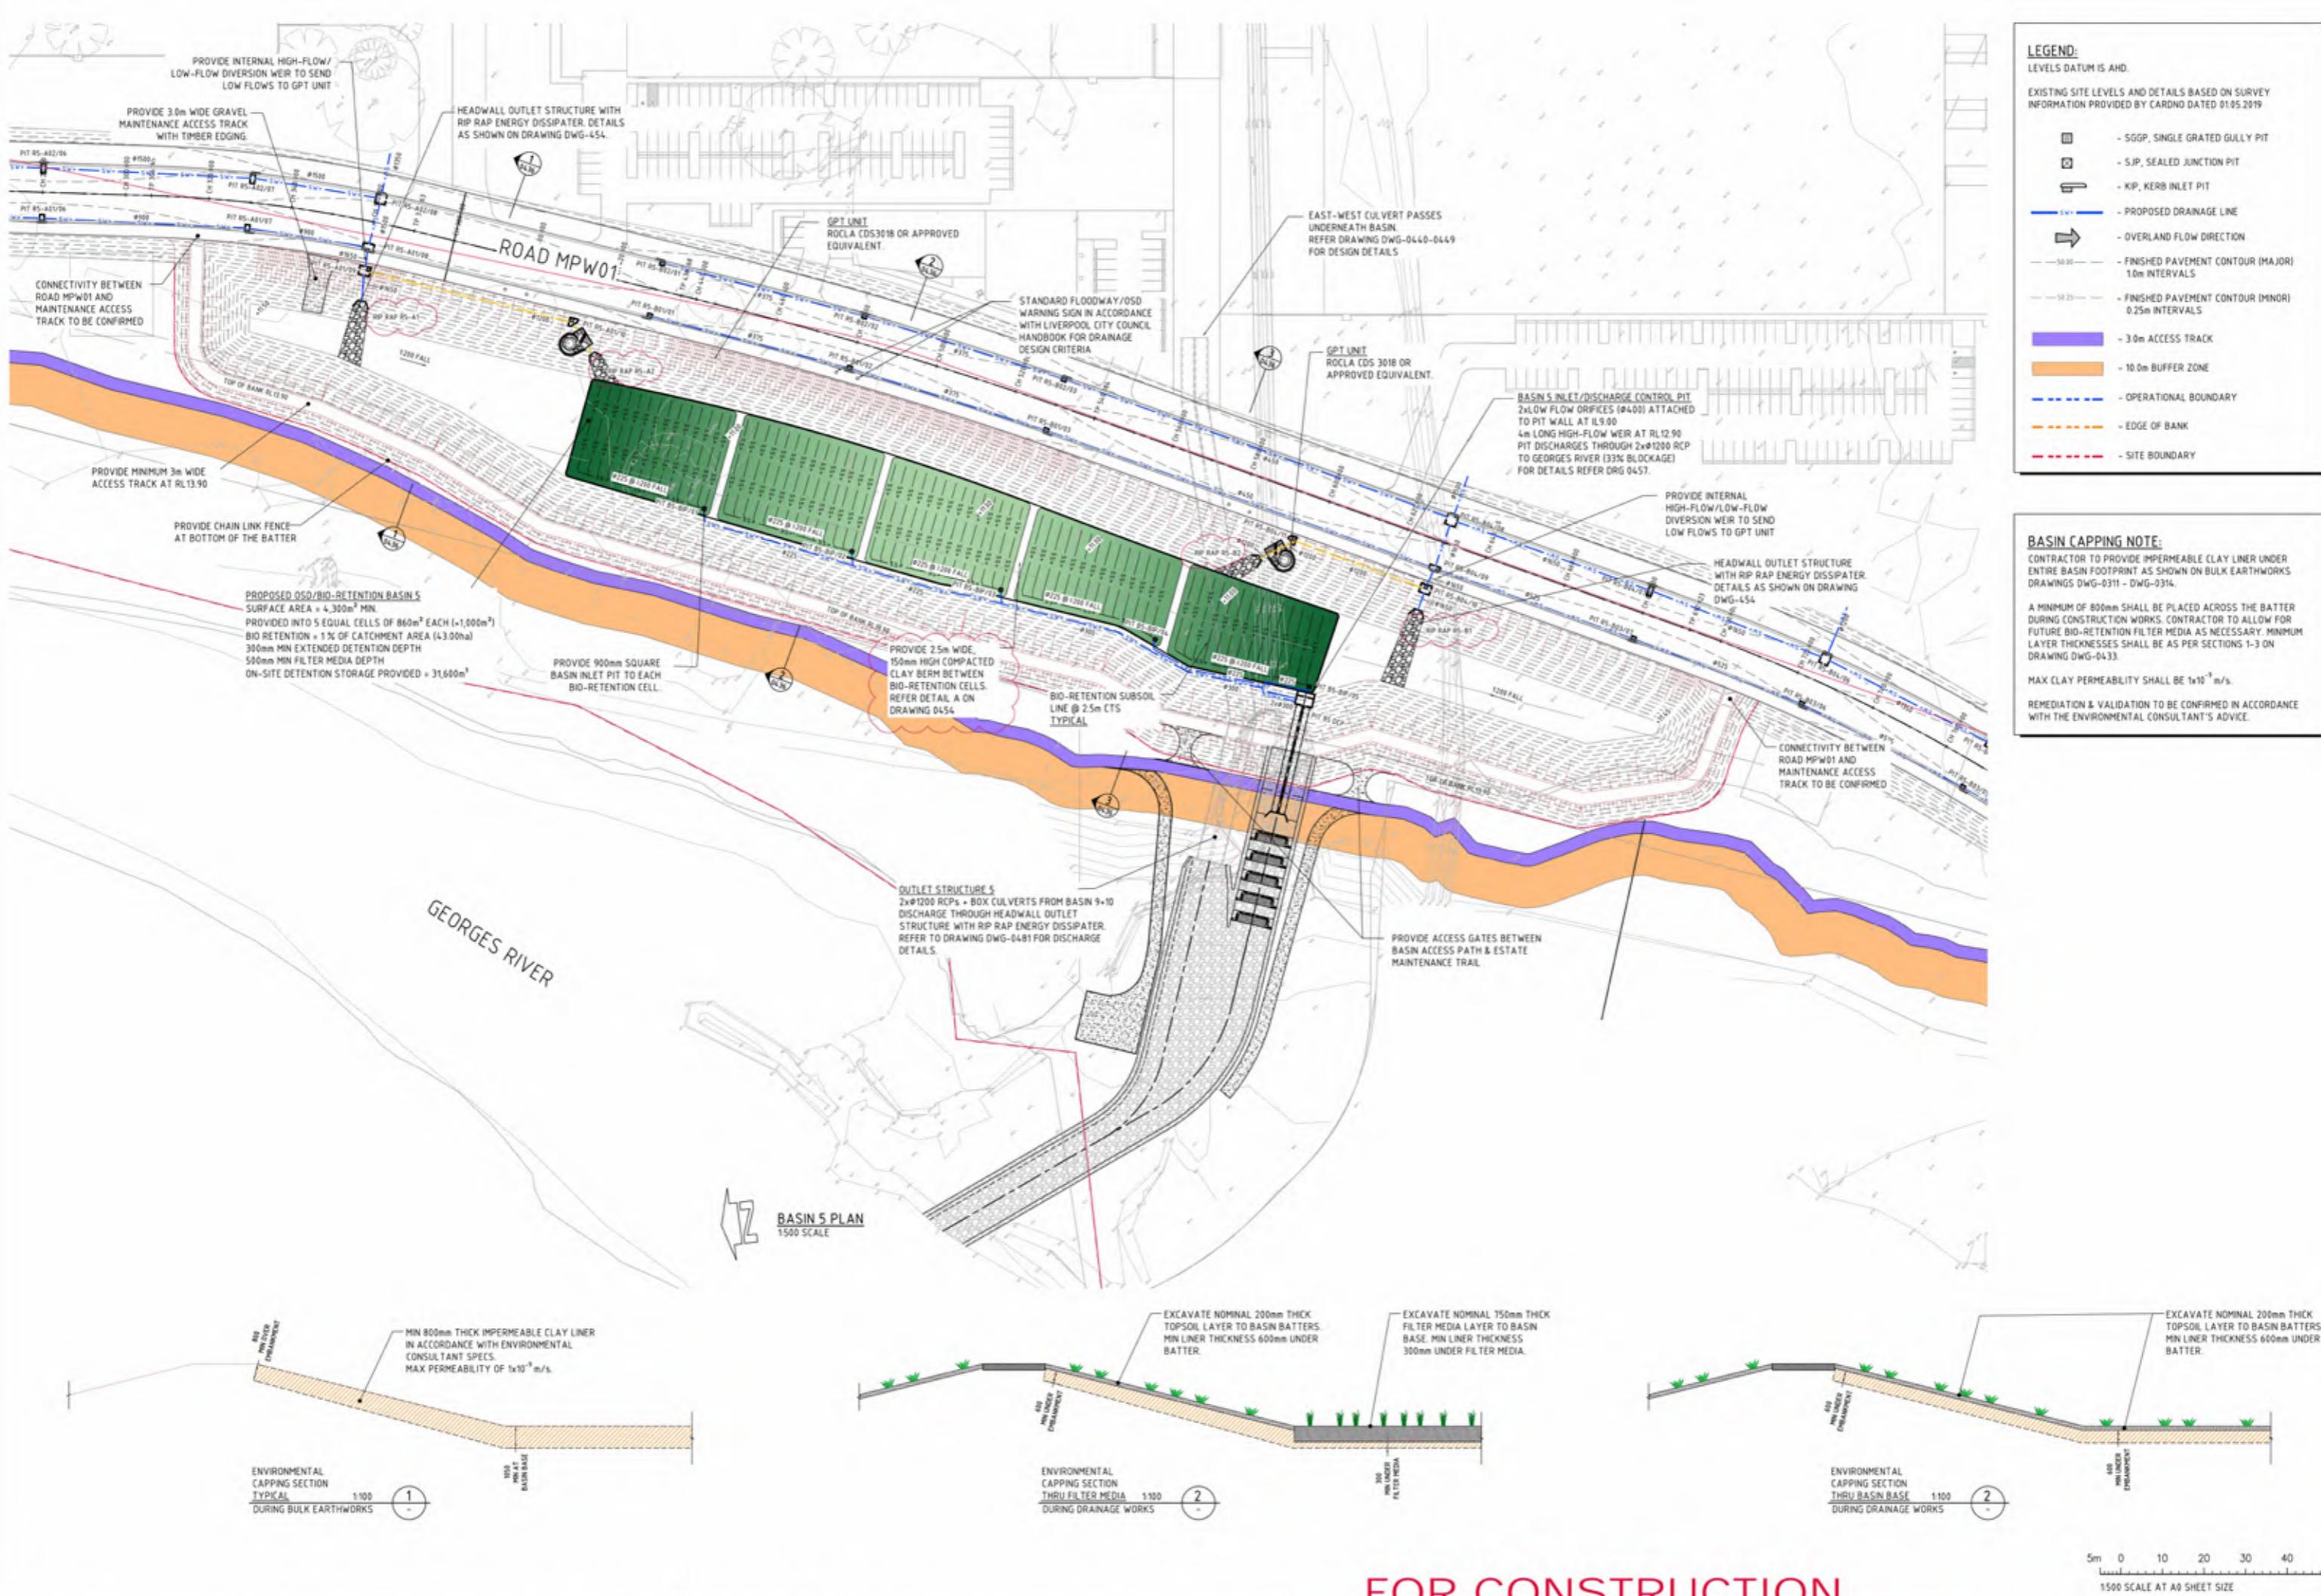
DRAWING TITLE
BASIN 5 PLAN
DRAWING NO.
LPWPW-COS-CV-DWG-0433

- OSD 10 – 12.50 m AHD³³ (depth of excavation to be approximately 3.4 m above the groundwater level)³⁴.
- Installation of clay liners at OSD 5, OSD 6 and OSD 8 in accordance with the construction drawings provided as **Appendix B**. The clay liner to consist of clean clay capping liner; 600 mm minimum thickness through embankments and basin floors; and 300 mm thickness under bio-retention basins with a maximum permeability of 1×10^{-9} m/s³⁵ to minimise infiltration to groundwater from these structures. The construction of the clay liners has been designed to mitigate any preferential pathways of stormwater to groundwater and limit leaching from PFAS impacted soil remaining insitu beneath these structures.

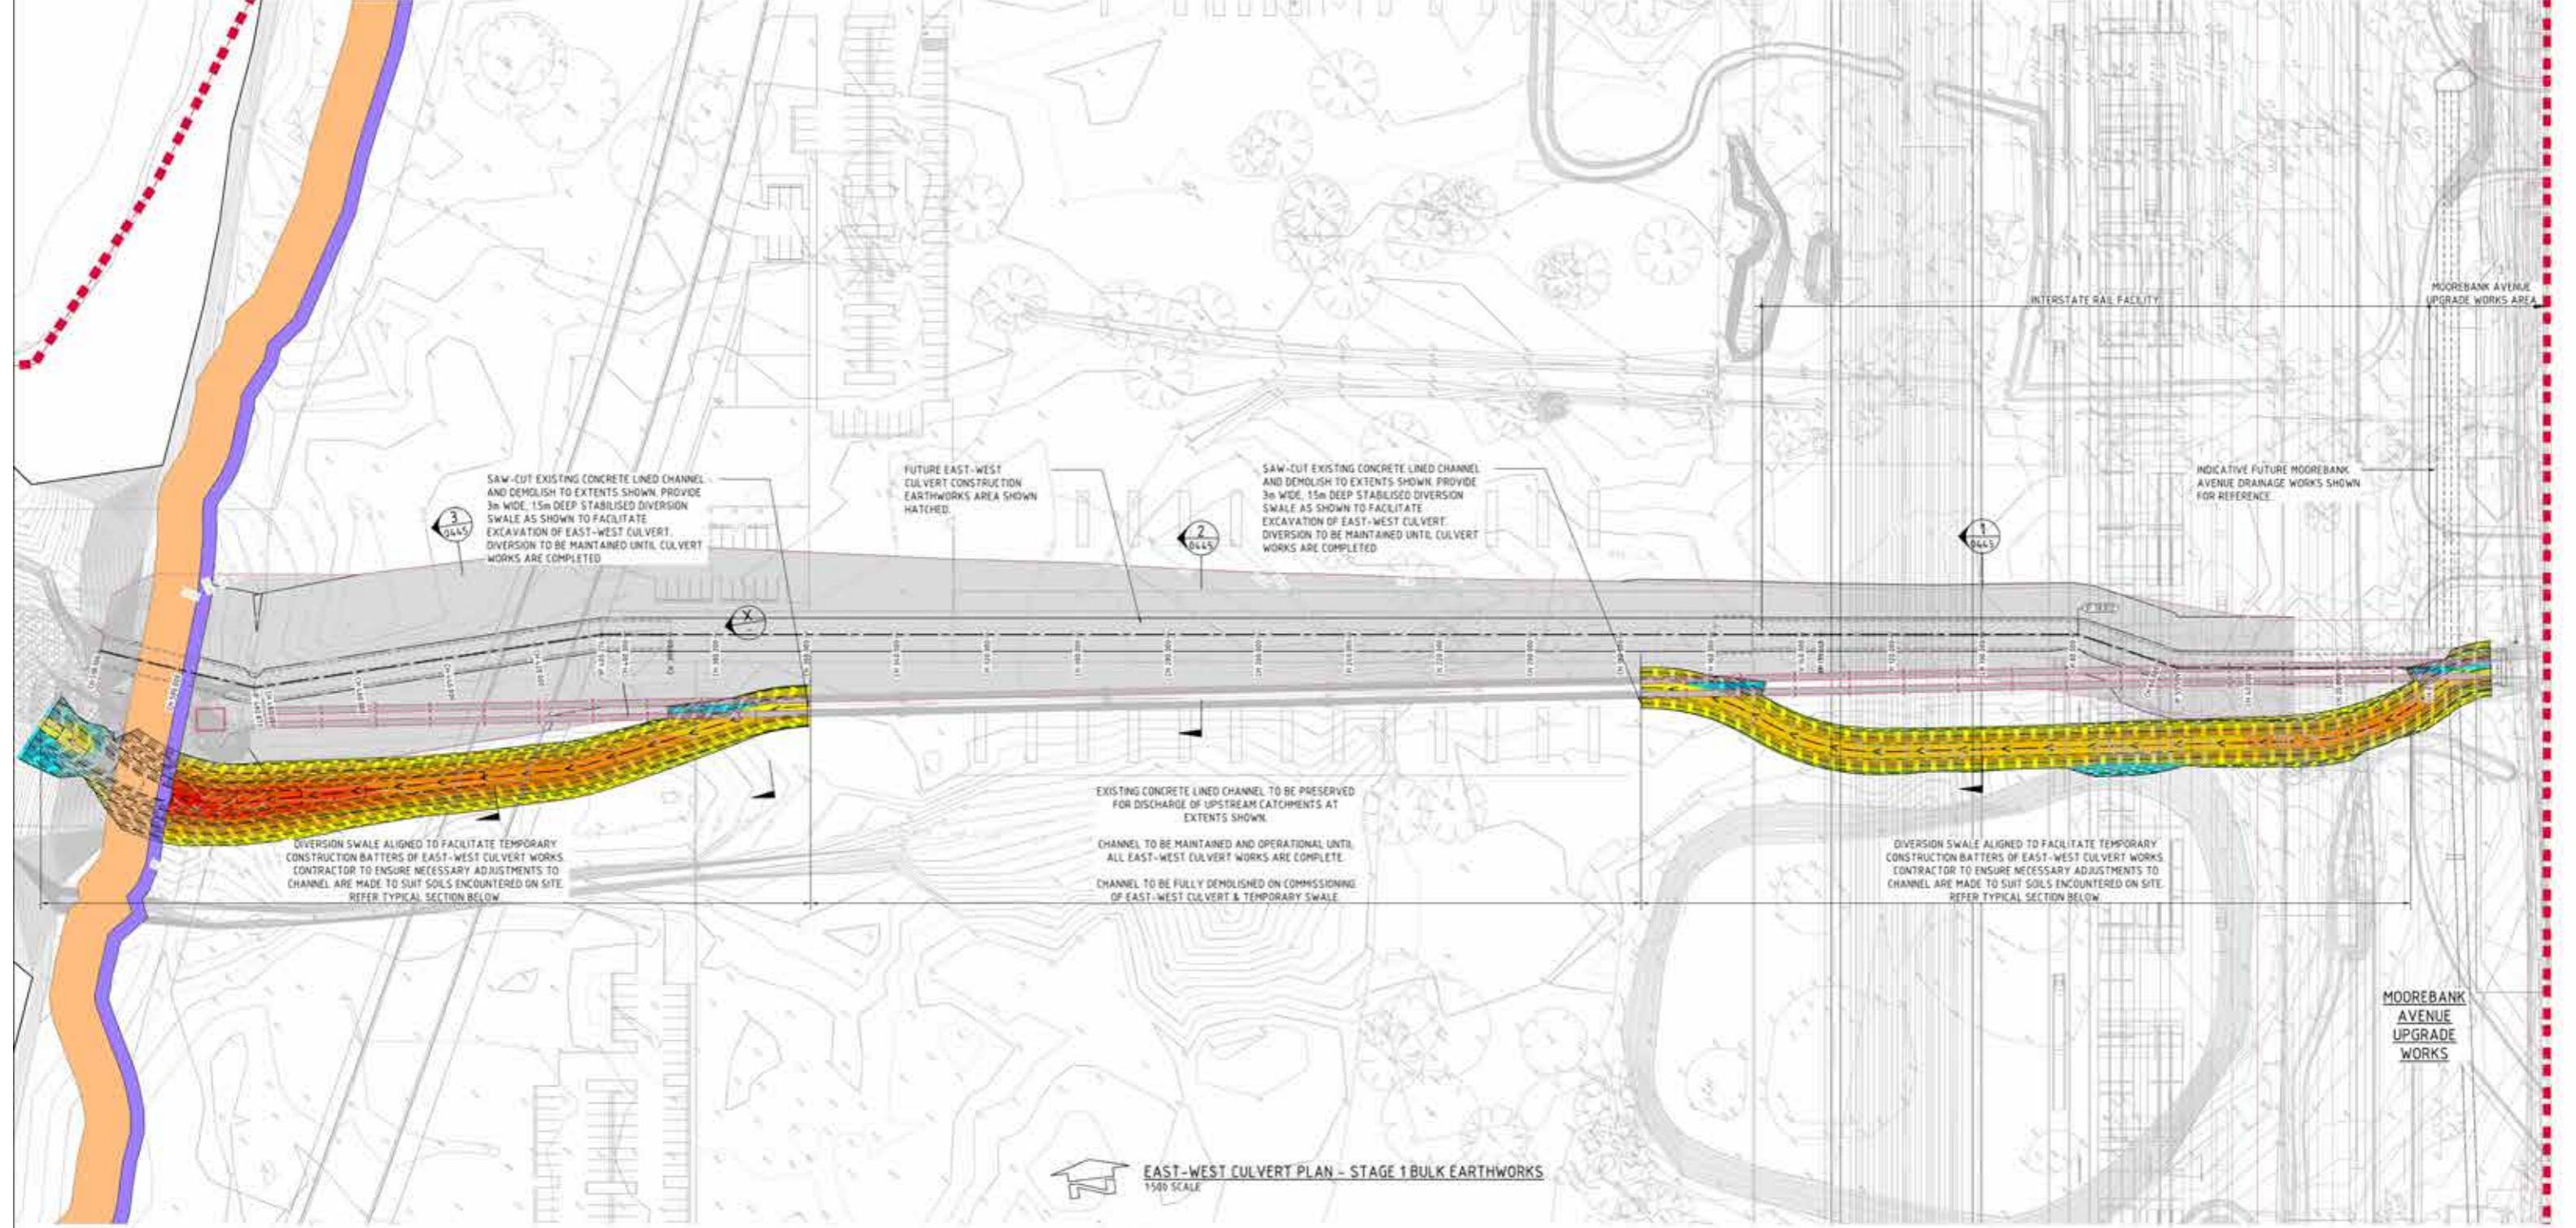
CUT TO EXISTING LEVEL $\approx 6,200 \text{ m}^3$
FILL TO EXISTING LEVEL $\approx 200 \text{ m}^3$

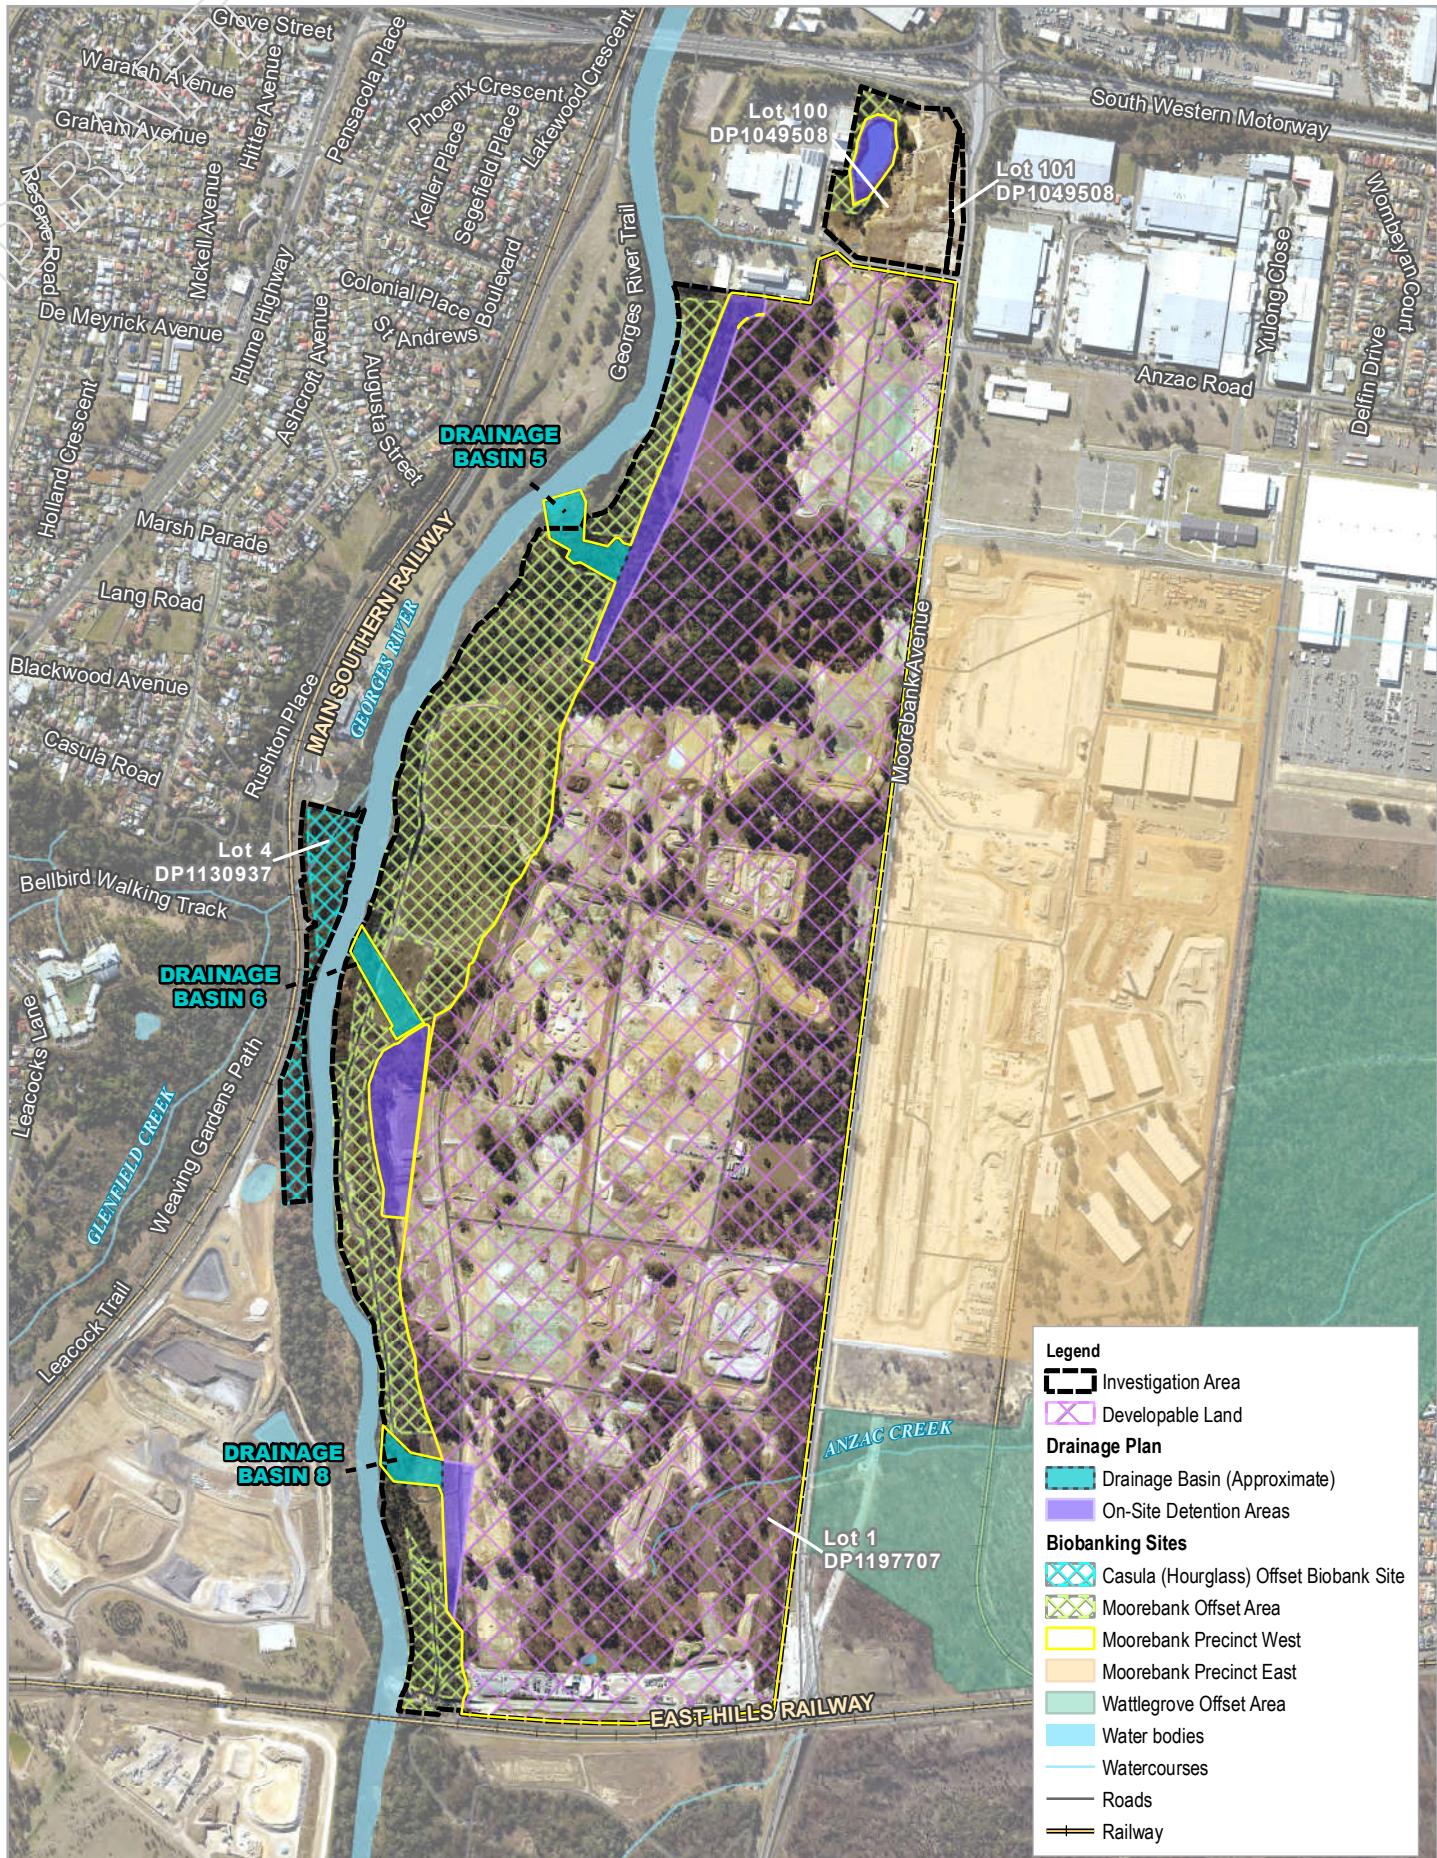
FIGURE 2

Site Layout - Proposed Development

The locations of the Biobanking Areas within the Offset Area are presented in **Figure 2** and the Master Plan for the Proposed Development is provided as **Appendix B**. Notably the construction area includes land provision for the construction of OSD outlet channels from the main construction area to the Georges River. These portions of the construction footprint are not included within the identified Offset Area.

The historical drainage system has been replaced by temporary sediment control swales and dams during Stage 1 Works. The temporary sediment control swales and dams are to be replaced by the proposed OSDs shown on **Figure 2** (OSD 5, OSD6 and OSD 8). In addition, another OSD (OSD 10) is proposed to be constructed along Moorebank Avenue to the east of the Site. The OSDs are to be constructed with an impermeable base to limit infiltration of stormwater within these areas. Construction of the OSDs will involve shallow excavation that is not anticipated to intercept the groundwater table based upon the design levels.

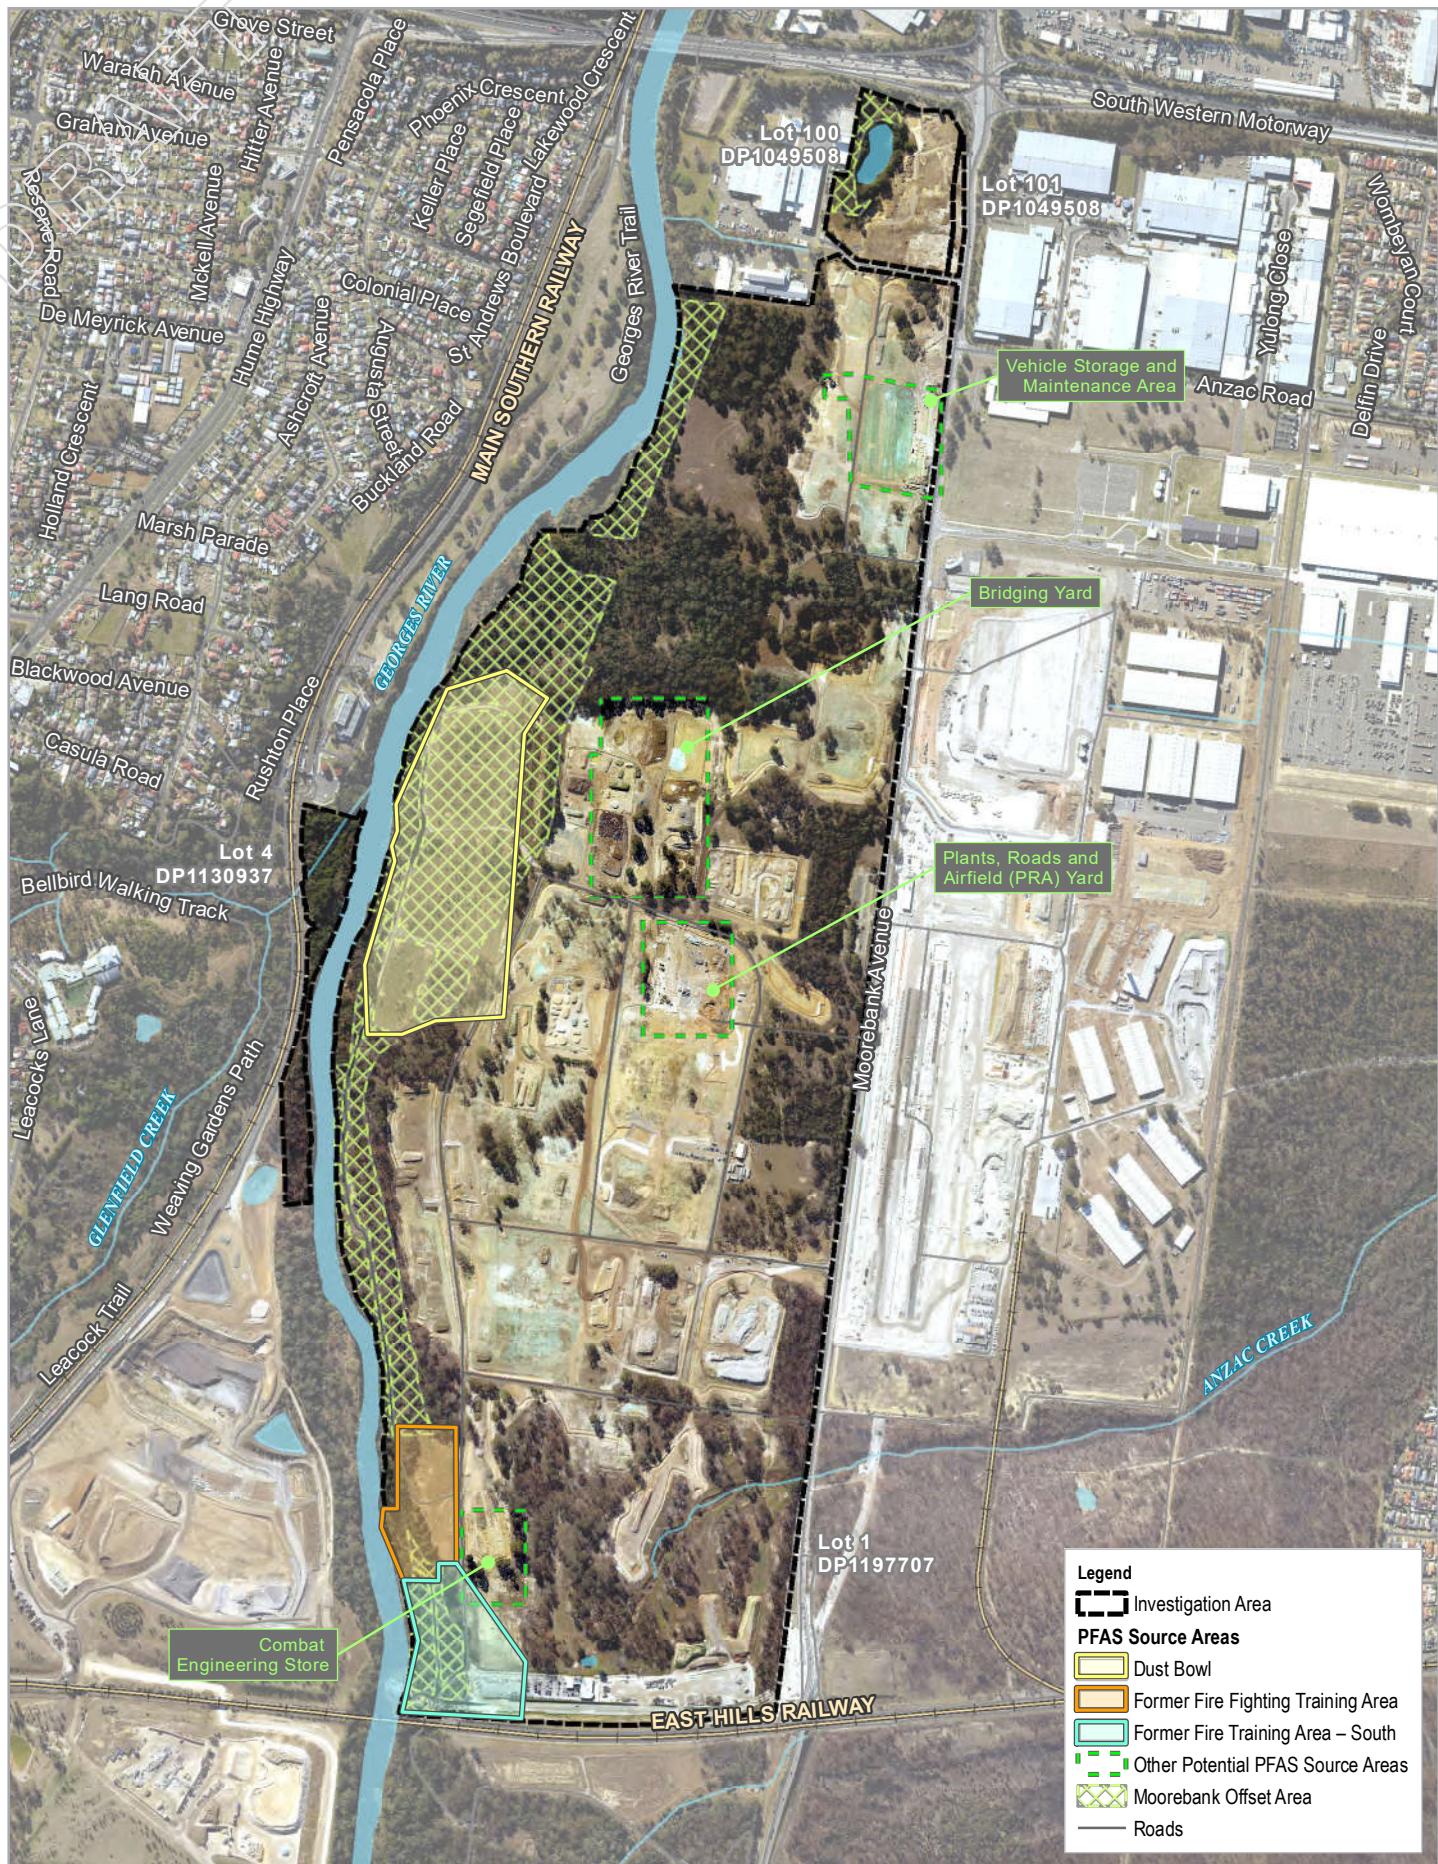
FIGURE 3

PFAS Source Areas

The two PFAS source areas were located in the Offset Area, known as the Dust Bowl and the FFTA. The location of the Dust Bowl and FFTA is provided as **Figure 2** in the '**Figures**' section of this report.

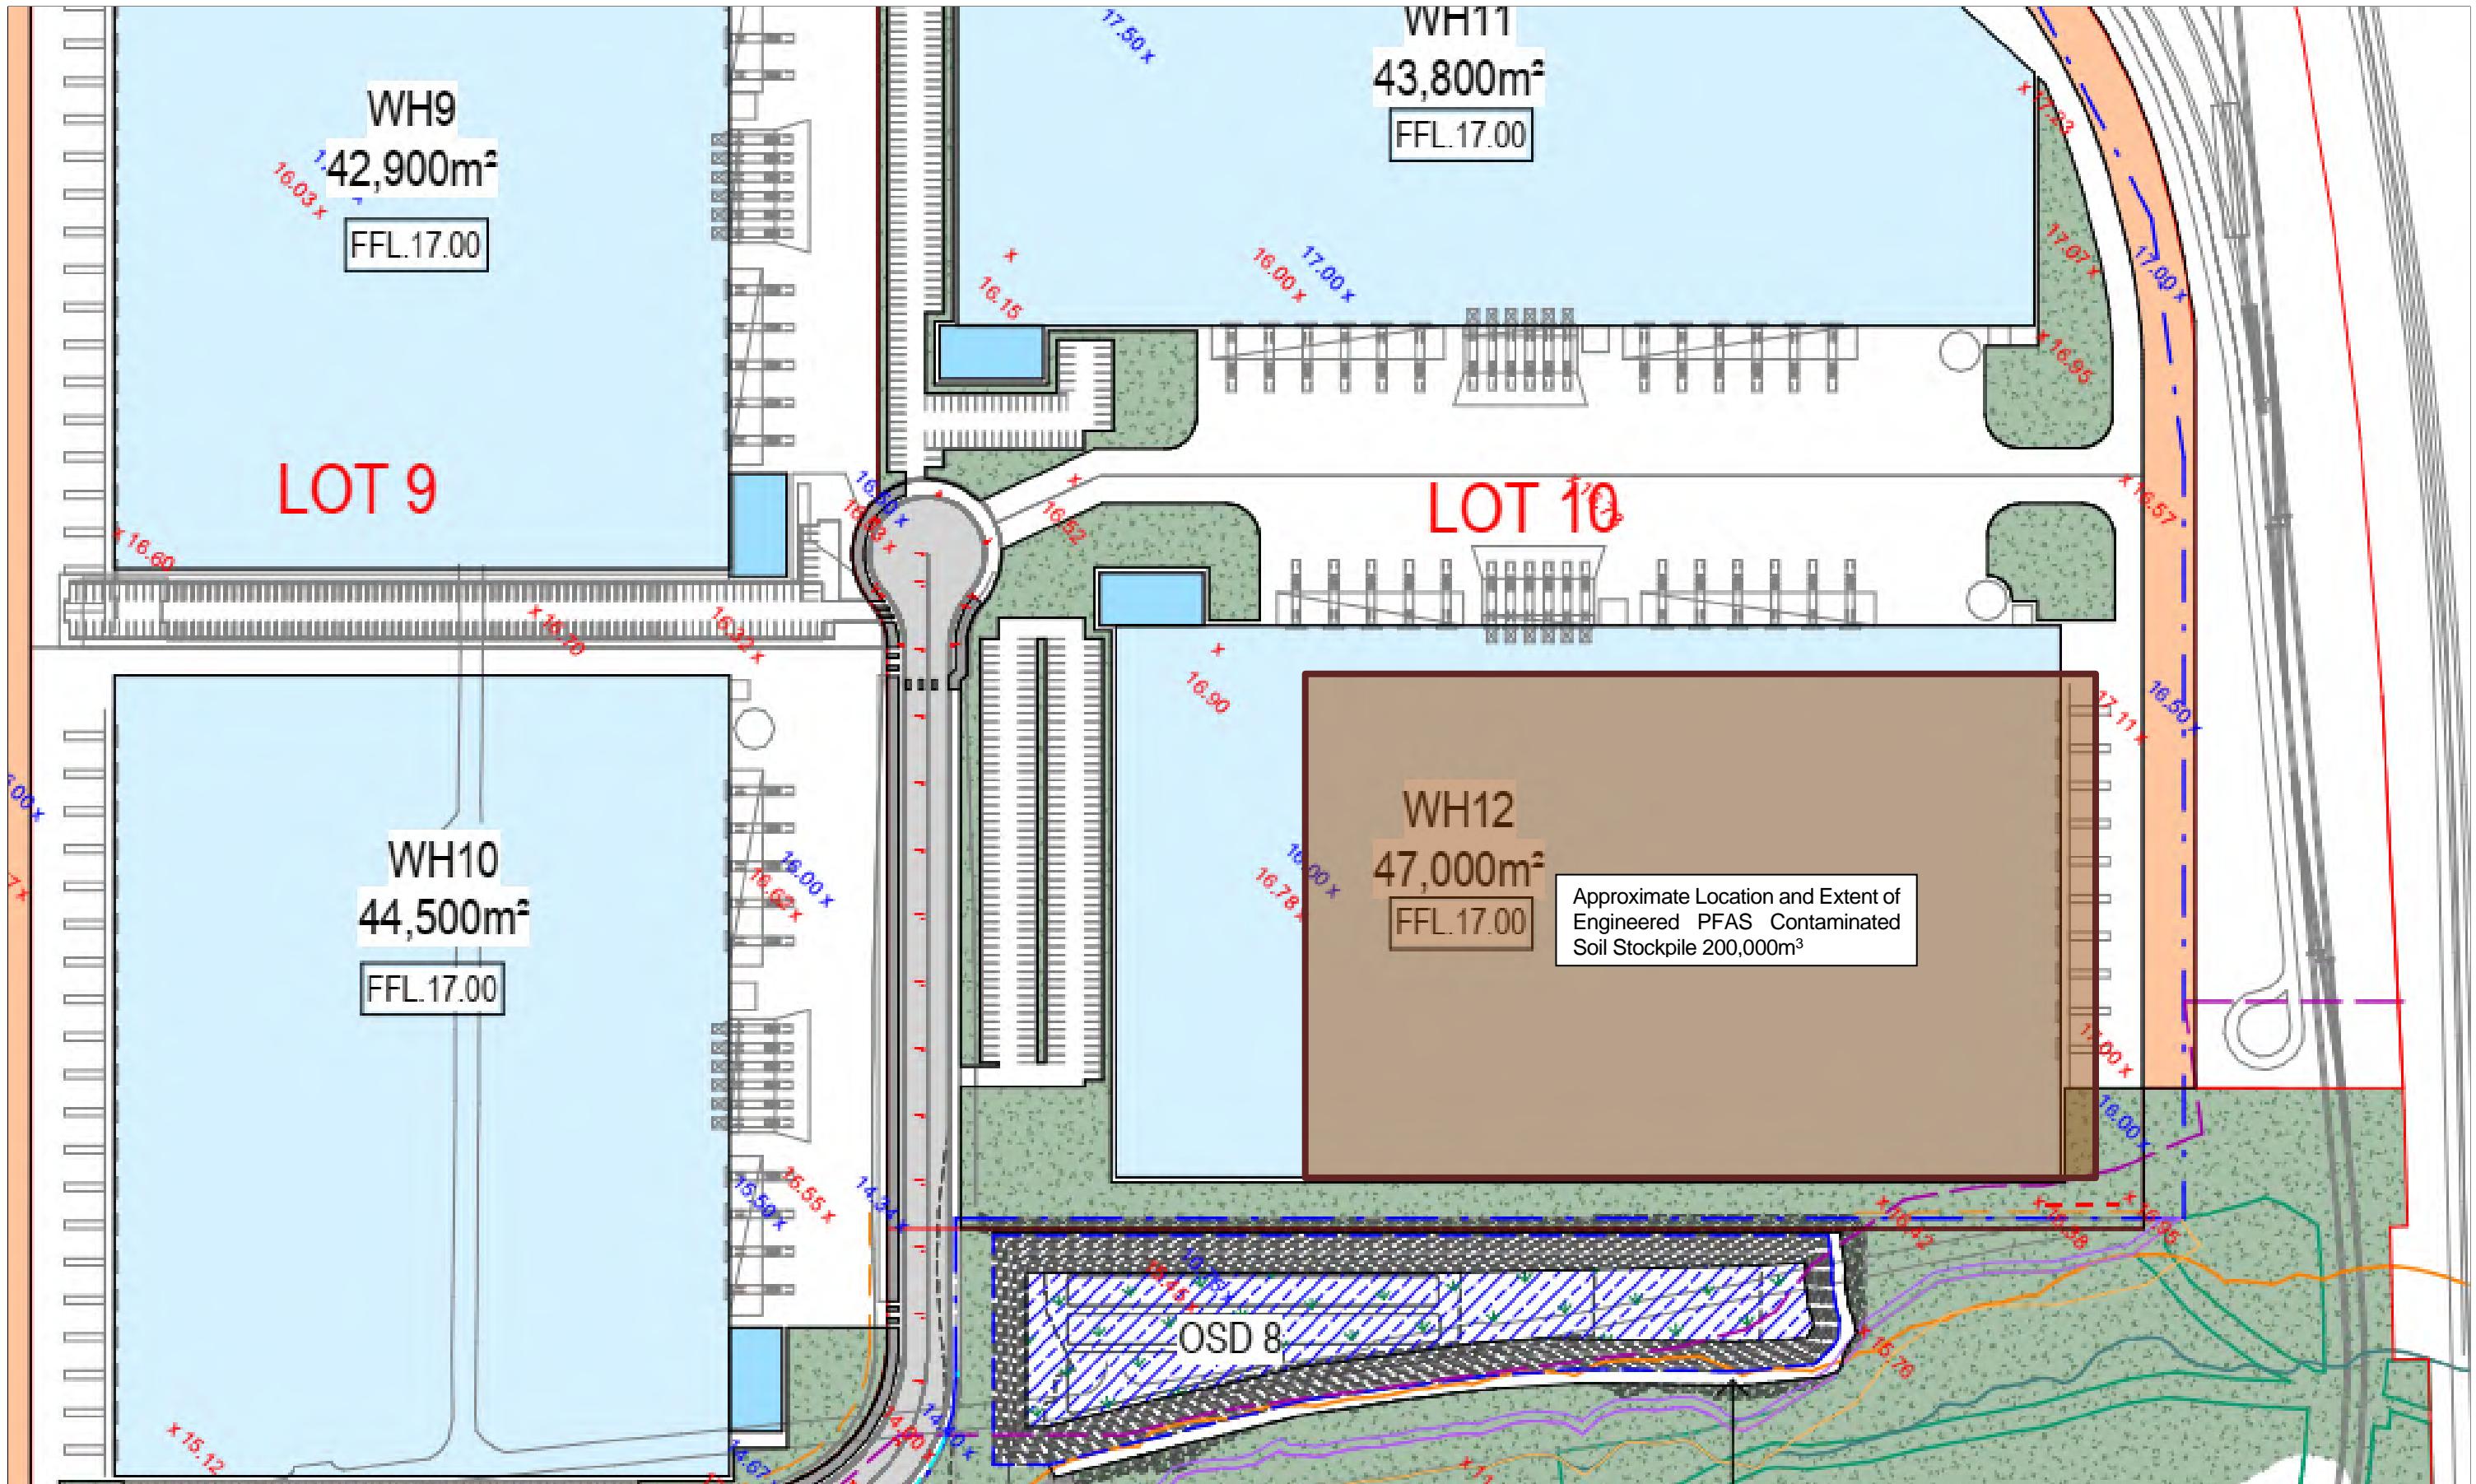
Figure H1 – Engineered Stockpile Concept Plan
–Medium Term - Layout – Plan View

It should be noted that the design requirements for medium term storage include an engineered containment facility with effective stormwater controls and are the same as the design requirements for storage over the long-term (>5 years).

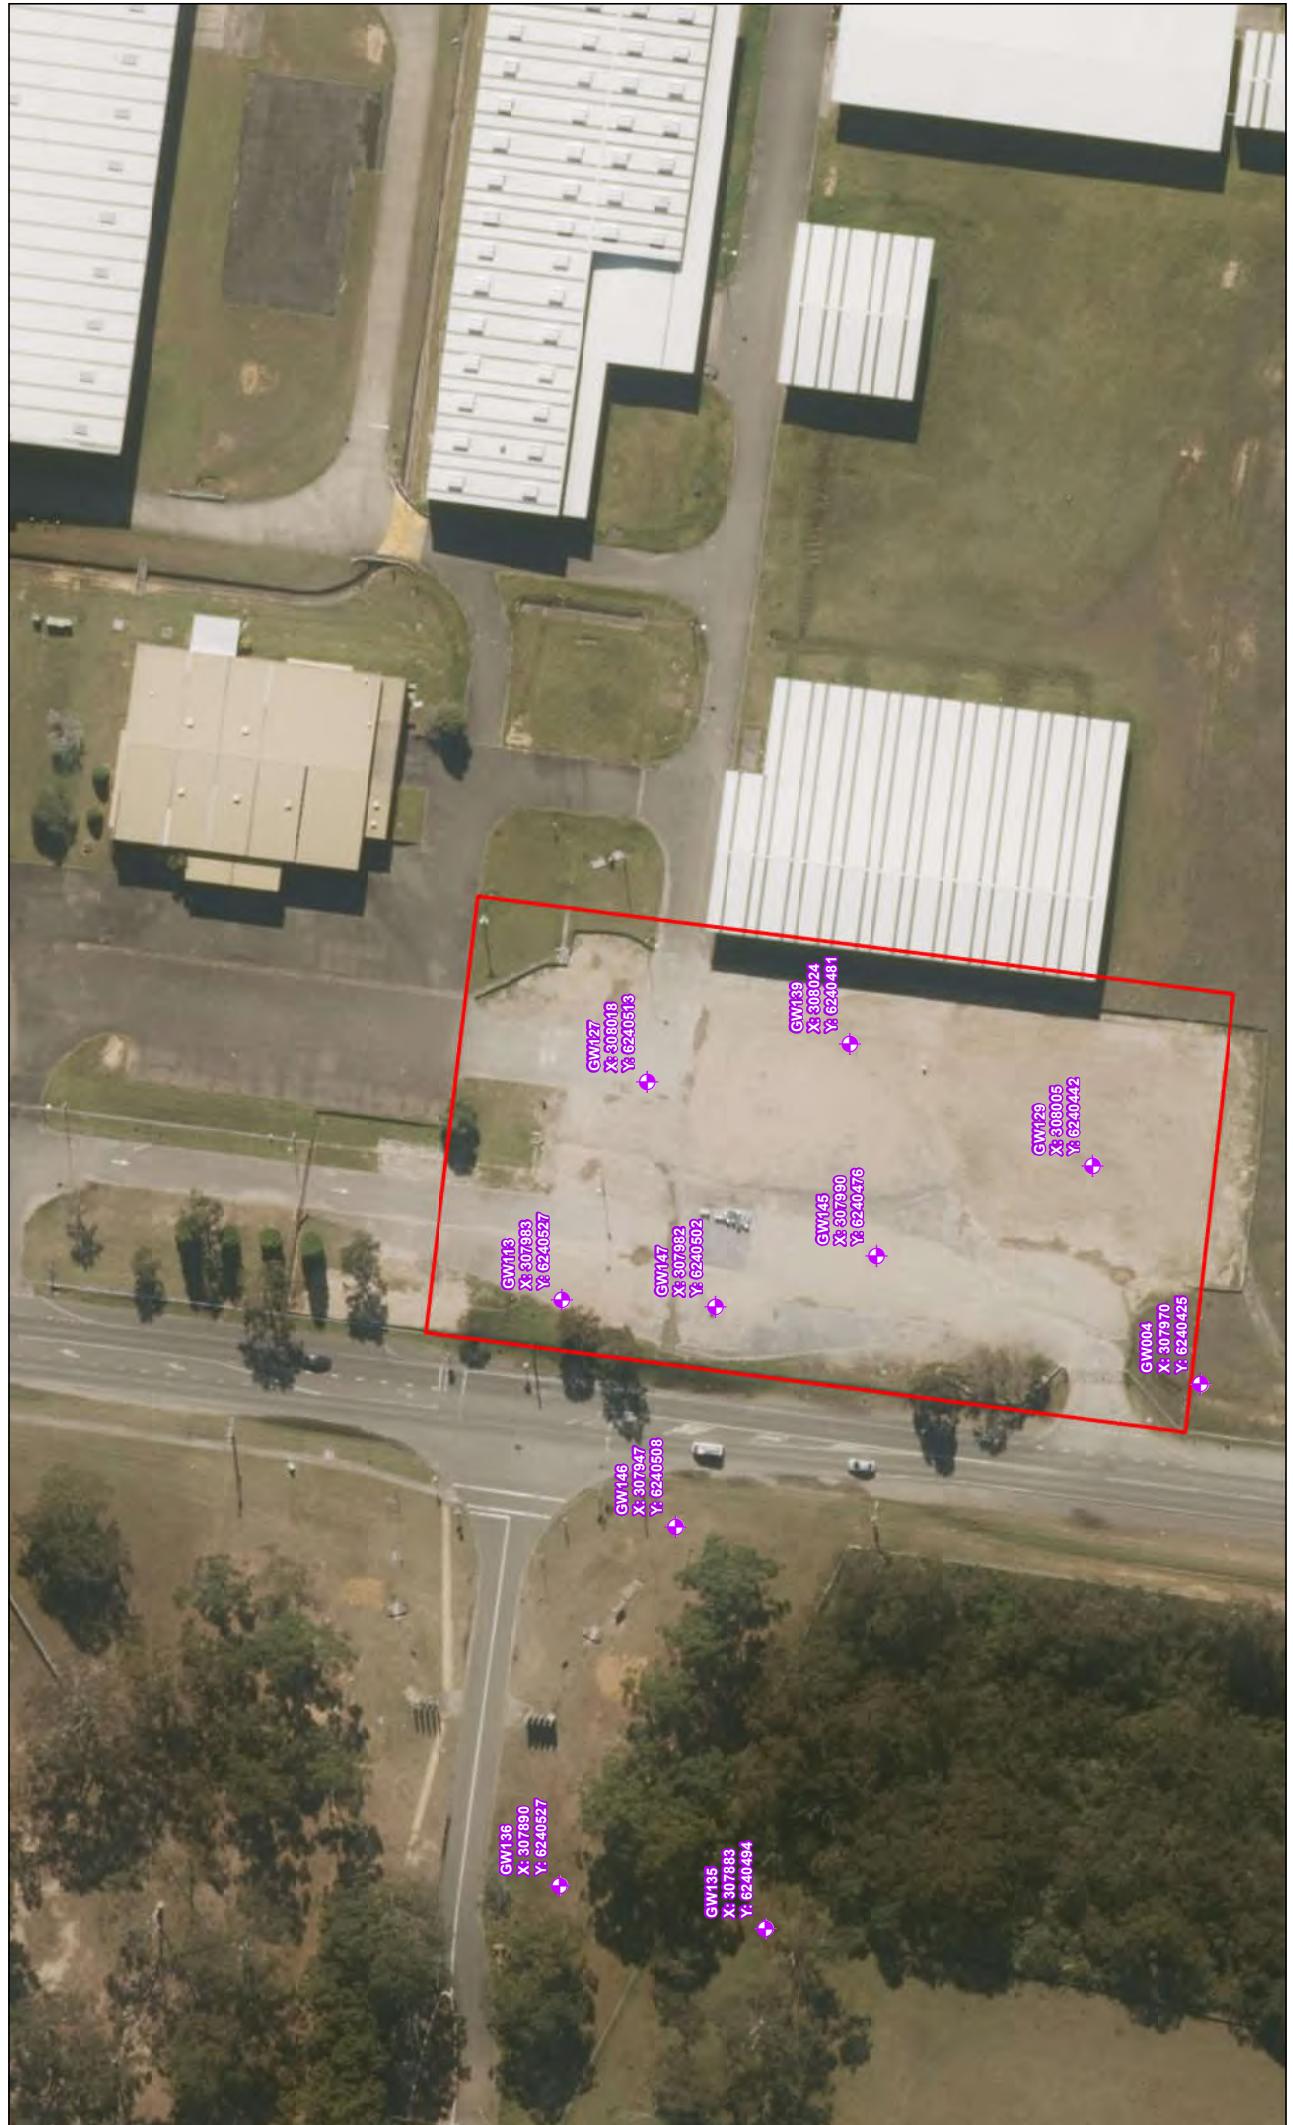
AEC -2 PROPOSED GROUNDWATER MONITORING LOCATIONS

Department of Defence
 DNSDC Refuelling Area Remediation
 Environmental Management Plan
 Proposed groundwater monitoring
 locations

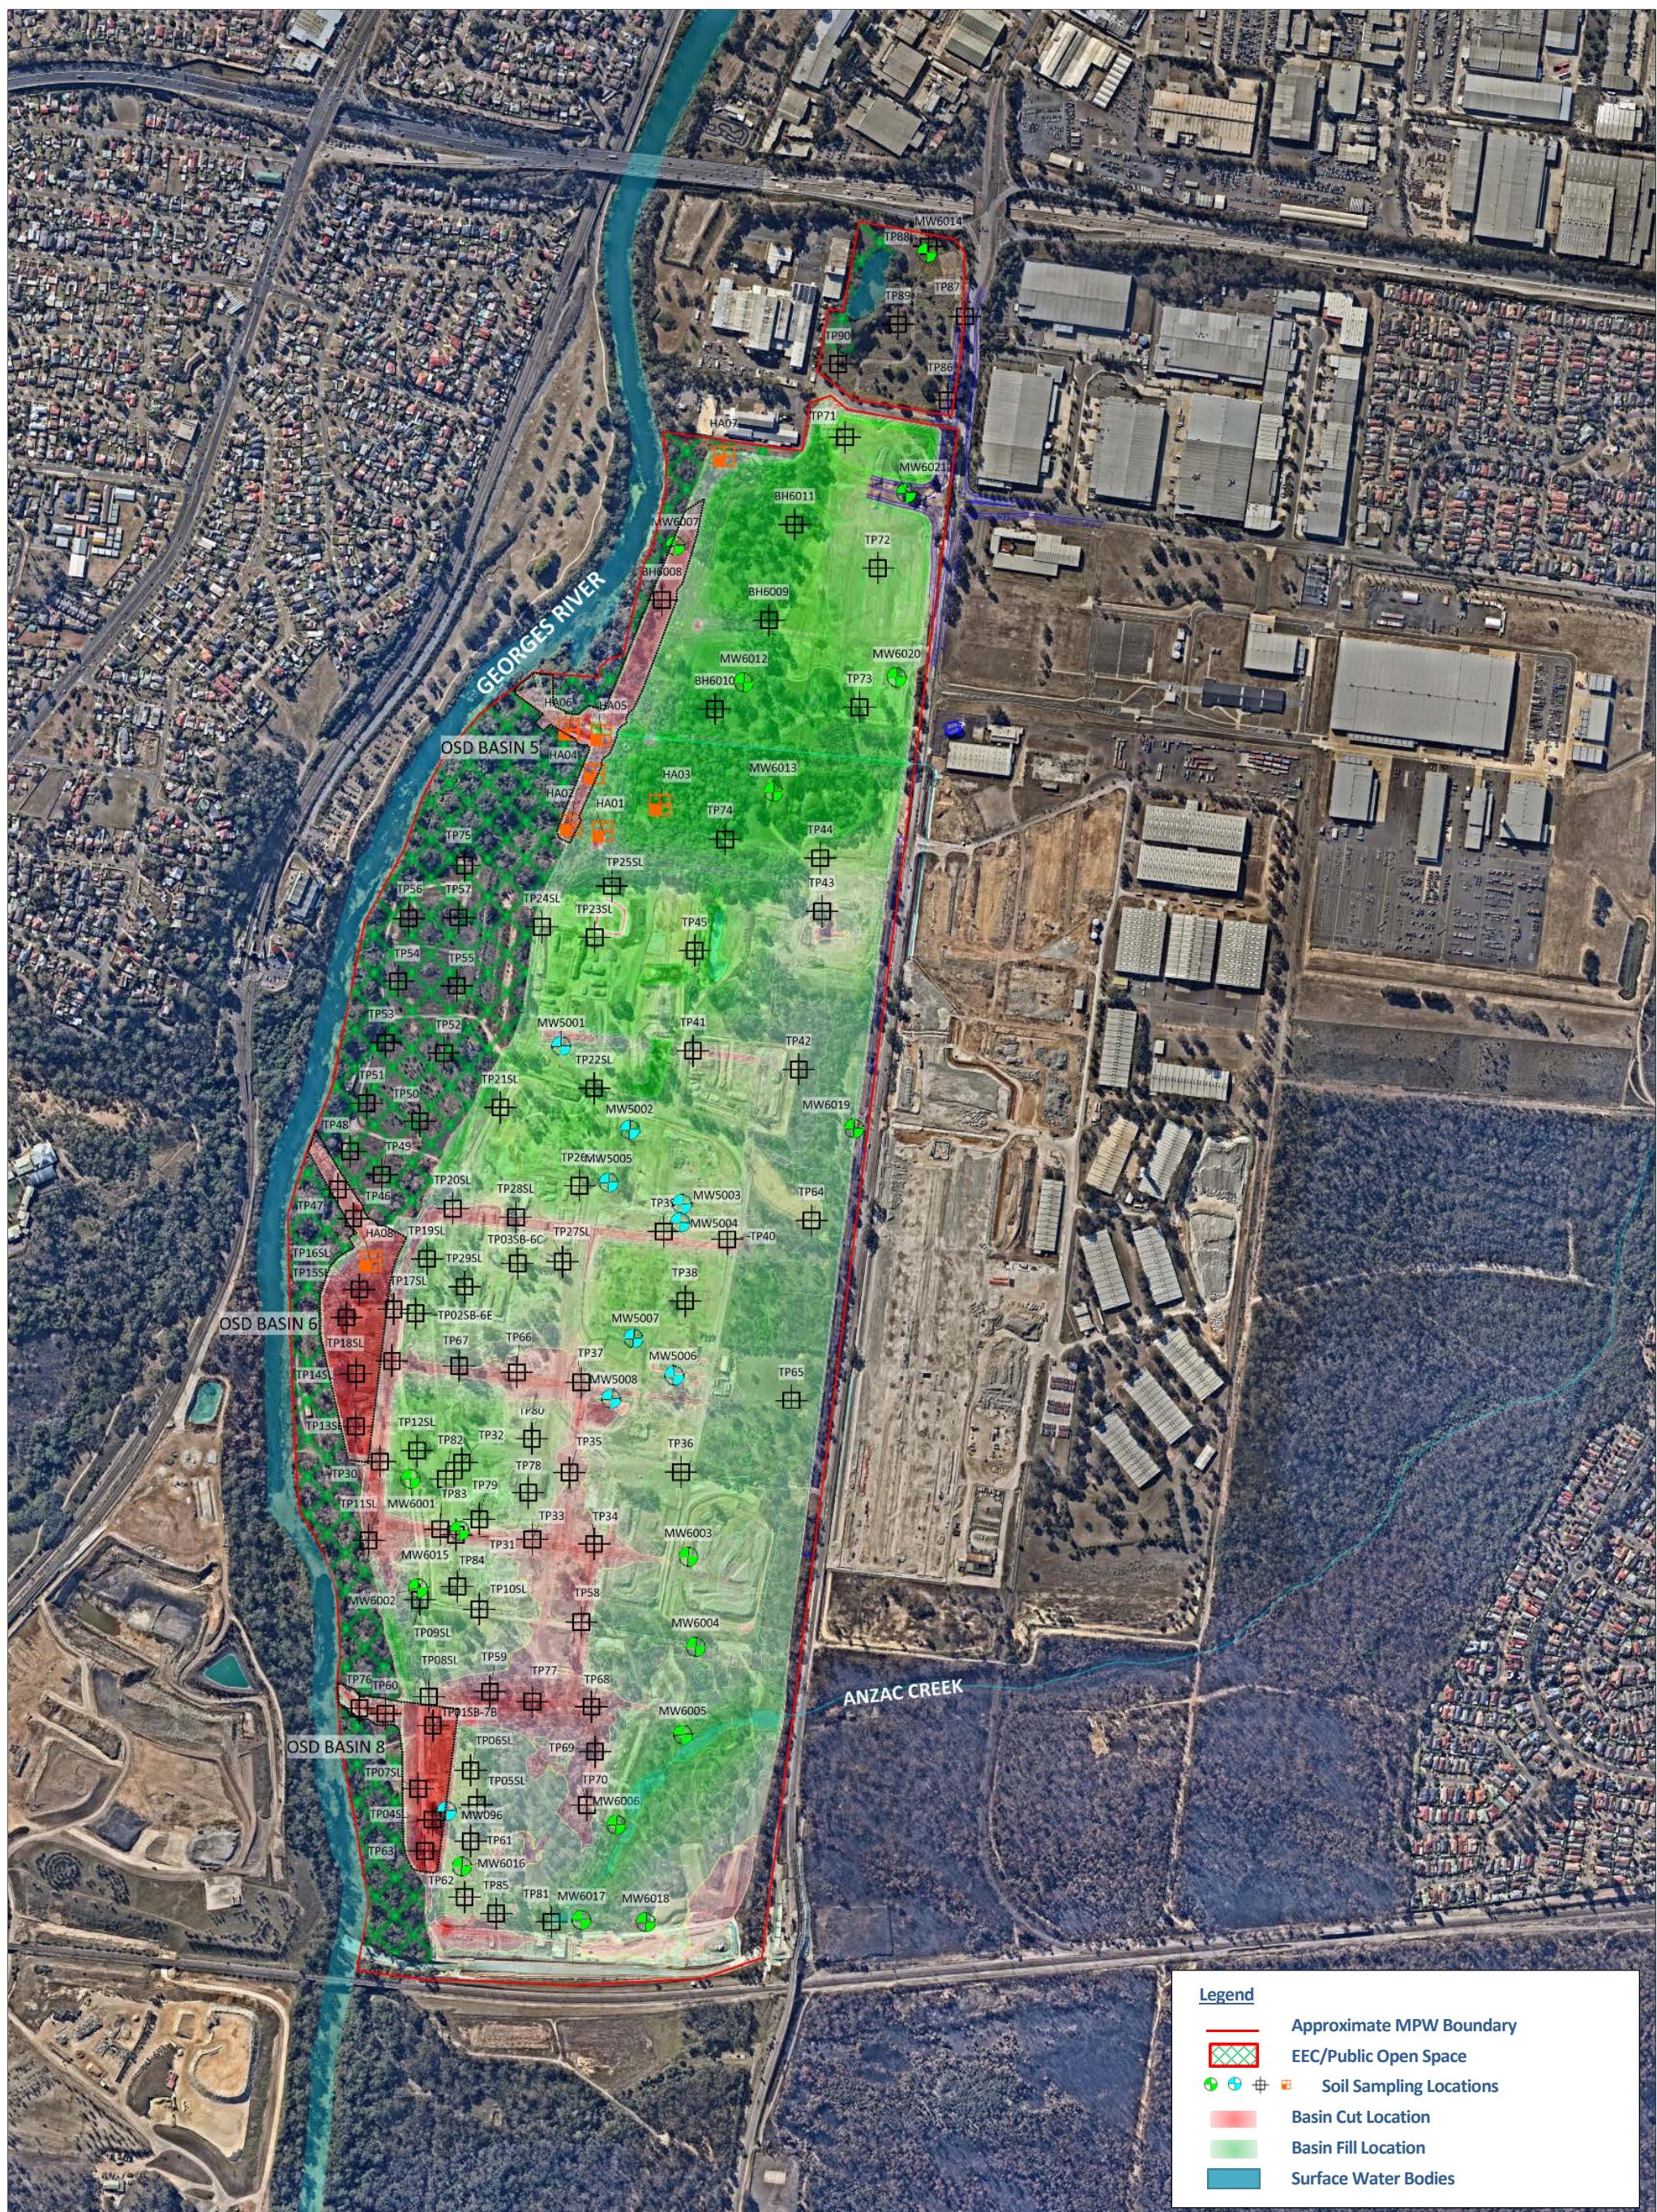
Figure 4 – Soil Sampling Locations

Soil - Exceedance of PFAS NEMP Indirect Ecological Criteria (all uses)

Leachate - Exceedance of ADWG HBGVs
