Long-Term Environmental Management Plan

Moorebank Precinct West (MPW)

Prepared for: Qube Property Management Services Pty Ltd

EP1489.001 v13 1 December 2020

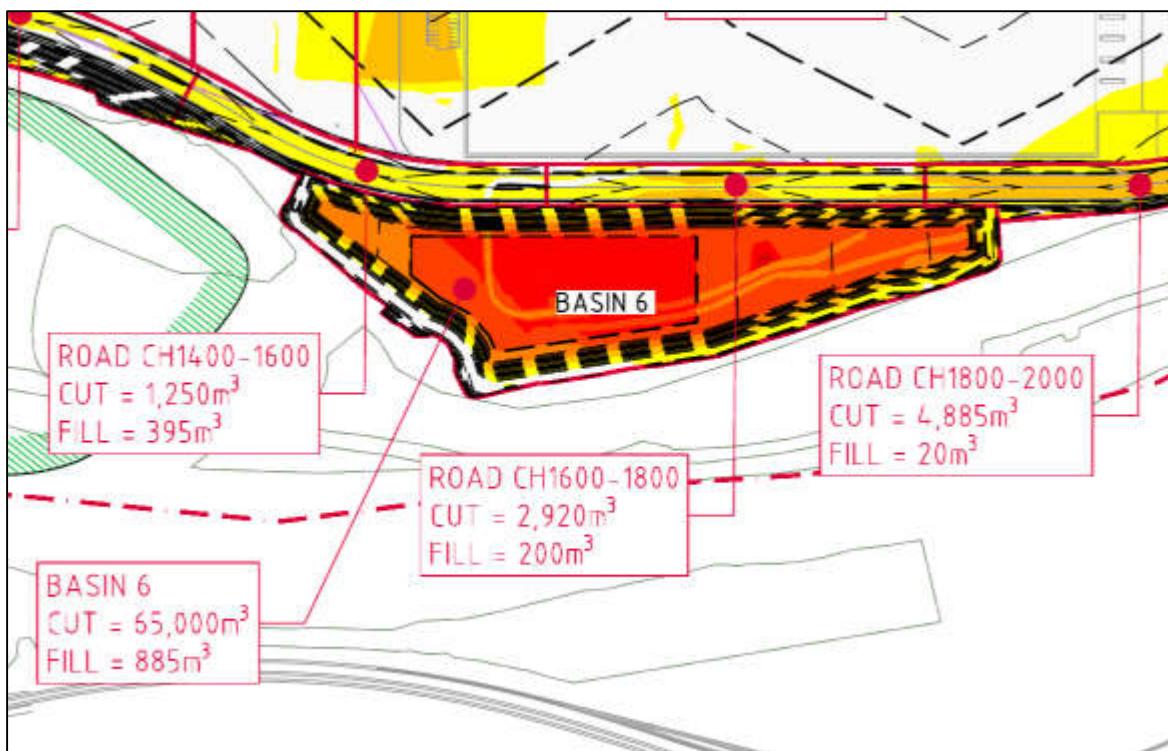
Figure K1 – Cut and Fill Plan for OSD 6

The proposed cut and fill estimates for OSD 6 and OSD 8 are presented in **Figure K1** and **Figure K2**, respectively.

The estimate of fill to be won from the excavation of OSD 6 and OSD 6 is presented in **Table K1**.
