Vegetation Management Plan

Pymble Ladies College – Secondary Innovation Precinct, Pymble NSW

Report prepared by Narla Environmental Pty Ltd

May 2025

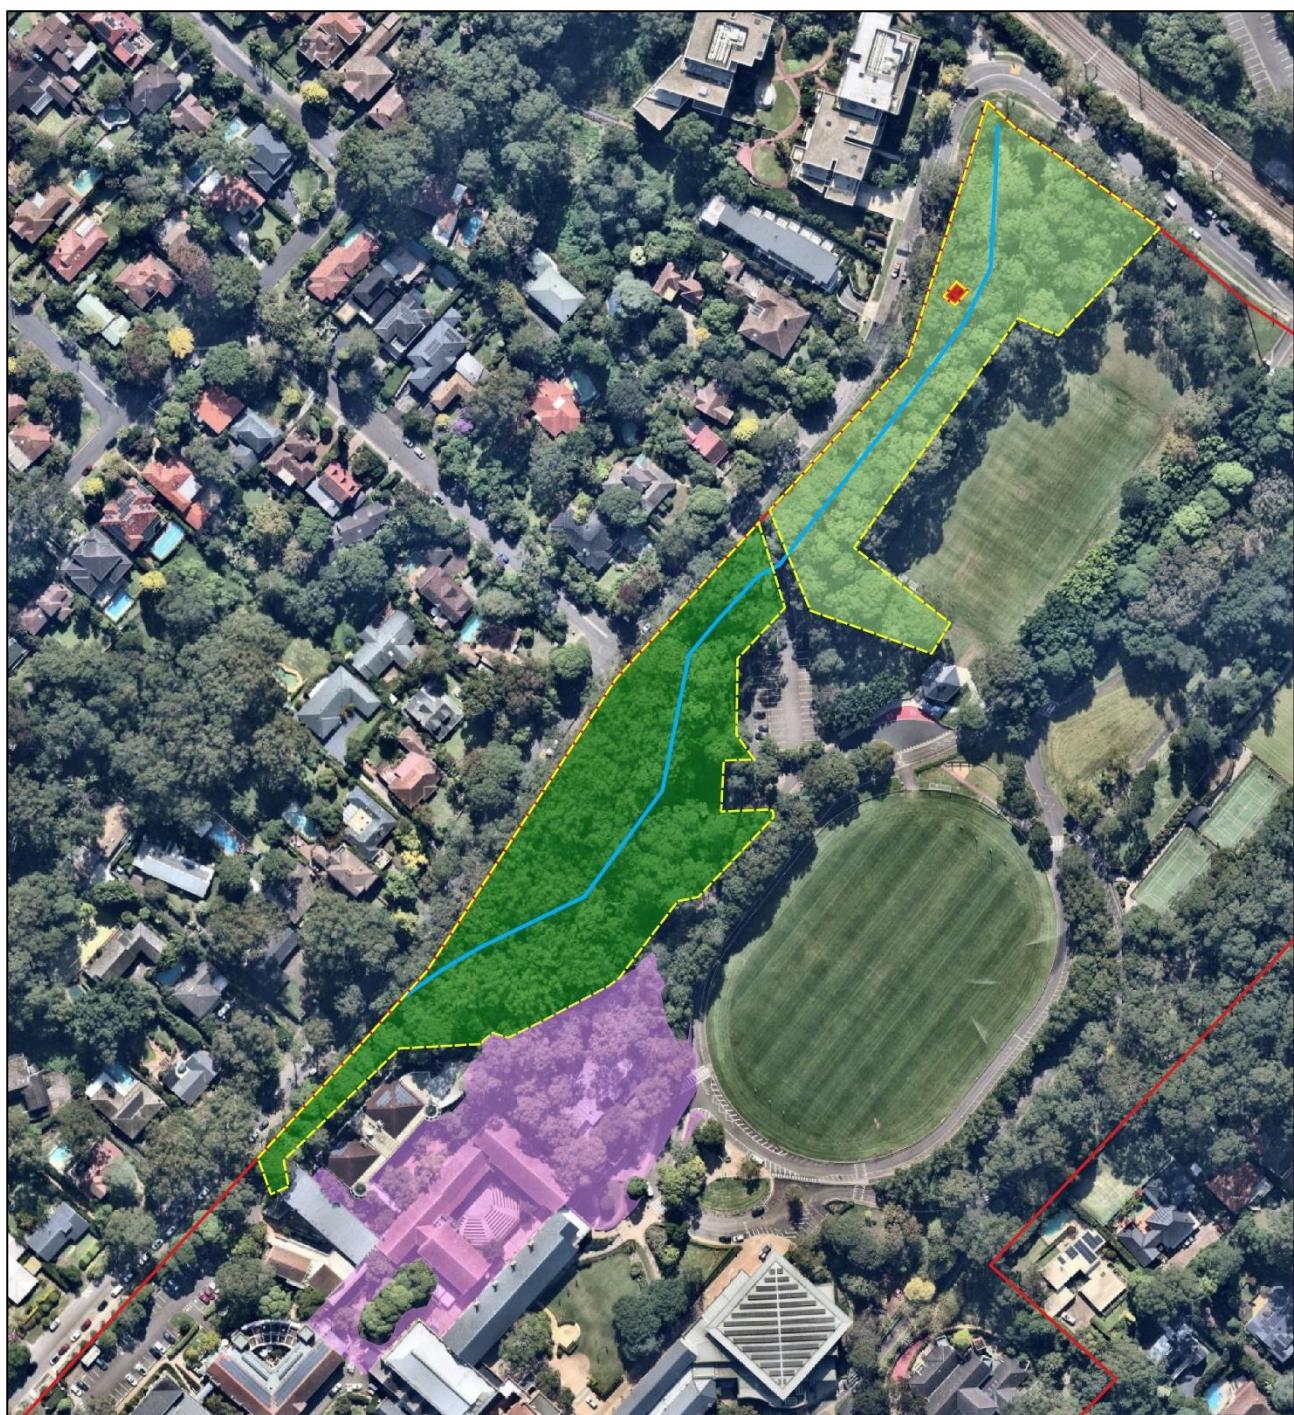
Figure 1. Management Zones within the Subject Site.

Management Zones Within the Subject Site

- Subject Site
- Subject Property
- SP2 Infrastructure Zoned Land
- Secondary Innovation Precinct
- Unnamed Watercourse

- Management Zone 1: Upper Riparian Management
- Management Zone 2: Lower Riparian Management

The VMP encompasses 1.84ha of the Subject Property. This designated area is henceforth referred to as the 'Subject Site.' This defined area has been allocated two (2) management zones, Management Zone 1 and 2, covering approximately 1.80 hectares (**Figure 1**).

The Subject Site has been assigned two (2) management zones to guide the management of vegetation (Figure 1):

- Management Zone 1: Upper Riparian Management; and
- Management Zone 2: Lower Riparian Management

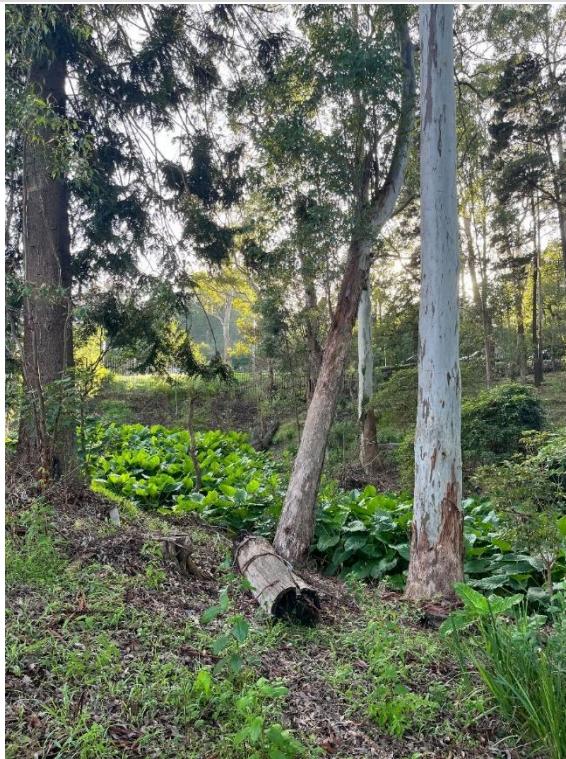
Table 1. Description, objectives, and management requirements for Management Zone 1: Upper Riparian Management
Management Zone 1: Upper Riparian Management
Approximate Area = 0.75ha

Description

The upper riparian zone comprises a mix of native and exotic species, with exotic species found predominantly within the creek line. The canopy was largely native, including *Eucalyptus saligna* (Blue Gum), *Syncarpia glomulifera* (Turpentine Tree), *Eucalyptus pilularis* (Blackbutt), *Eucalyptus piperita* (Peppermint) and *Brachychiton acerifolius* (Illawarra Flame Tree). Locally occurring *Araucaria bidwillii* (Bunya Pine) and exotic species (*Cinnamomum camphora* (Camphor Laurel) were also present within this layer. The mid-storey included *Acacia parramattensis* (Parramatta Wattle), *Breynia oblongifolia* (Coffee Bush), *Homolanthus populifolius* (Bleeding Heart), *Indigofera australis* (Indigo), *Pittosporum undulatum* (Sweet Pittosporum) and various *Cyathea* spp. (Tree Ferns) are prevalent. Exotic species within this layer included *Ligustrum lucidum* (Broad-leaf Privet). Native groundcover species included *Adiantum aethiopicum* (Maidenhair Fern), *Dichondra repens* (Kidney Weed), *Doodia aspera* (Fern), *Echinopogon ovatus* (Hedgehog Grass), *Lomandra longifolia* (Spiny-headed Mat-rush), *Oplismenus aemulus* (Australian Basket-grass), *Pteridium esculentum* (Bracken Fern), *Solanum prinophyllum* (Forest Nightshade). Highly invasive species such as *Alocasia* spp. (Elephant Ears), *Hedera helix* (English Ivy), *Ipomea purpurea* (Morning Glory), *Tradescantia fluminensis* (Trad) and *Ehrharta erecta* (Panic Veldtgrass) are present in large amounts. Priority weed *Asparagus aethiopicus* (Ground Asparagus) was present within this zone.

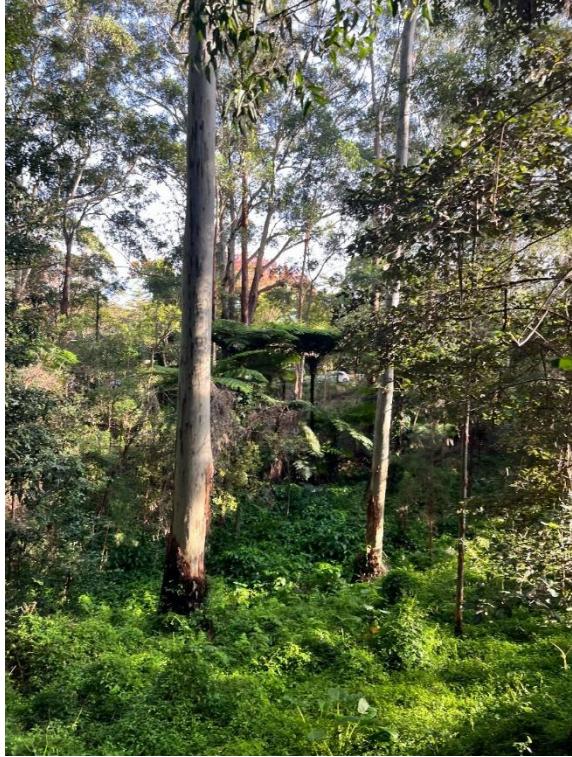
Table 2. Description, Objectives, and Management Actions Required for Management Zone 2: Lower Riparian Management.

Management Zone 2: Lower Riparian Management Approximate Area = 1.06ha

Description	<p>The lower riparian zone had considerably more exotic species present than the upper riparian area. The canopy was largely native, including <i>Eucalyptus saligna</i> (Blue Gum), <i>Syncarpia glomulifera</i> (Turpentine Tree), <i>Eucalyptus pilularis</i> (Blackbutt), <i>Eucalyptus piperita</i> (Peppermint), <i>Acacia decurrens</i> (Black Wattle) and <i>Brachychiton acerifolius</i> (Illawarra Flame Tree). The exotic species <i>Cinnamomum camphora</i> (Camphor Laurel) was present within this layer. The mid-storey included <i>Acacia parramattensis</i> (Parramatta Wattle), <i>Breynia oblongifolia</i> (Coffee Bush), <i>Elaeocarpus reticulatus</i> (Blueberry Ash), <i>Homolanthus populifolius</i> (Bleeding Heart), <i>Indigofera australis</i> (Indigo), <i>Ozothamnus diosmifolius</i> (Rice Flower), <i>Pittosporum undulatum</i> (Sweet Pittosporum), <i>Santalum obtusifolium</i> (Sandalwood), <i>Solanum aviculare</i> (New Zealand Apple) and various <i>Cyathea</i> spp. (Tree Ferns) are prevalent. Exotic species within this layer included <i>Ligustrum lucidum</i> (Broad-leaf Privet), <i>Ligustrum sinense</i> (Small-leaf Privet). Native groundcover species included <i>Adiantum aethiopicum</i> (Maidenhair Fern), <i>Dichondra repens</i> (Kidney Weed), <i>Doodia aspera</i> (Fern), <i>Echinopogon ovatus</i> (Hedgehog Grass), <i>Lomandra longifolia</i> (Spiny-headed Mat-rush), <i>Nephrolepsis cordifolia</i> (Fishbone Fern), <i>Oplismenus aemulus</i> (Australian Basket-grass), <i>Pteridium esculentum</i> (Bracken Fern), <i>Solanum prinophyllum</i> (Forest Nightshade). Highly invasive species such as <i>Alocasia</i> spp. (Elephant Ears), <i>Hedera helix</i> (English Ivy), <i>Ipomea purpurea</i> (Morning Glory), <i>Tradescantia fluminensis</i> (Trad) and <i>Ehrharta erecta</i> (Panic Veldtgrass) are present in large amounts. Priority weeds <i>Asparagus aethiopicus</i> (Ground Asparagus) and <i>Hedychium gardnerianum</i> (Ginger Lily) were present within this zone.</p>
