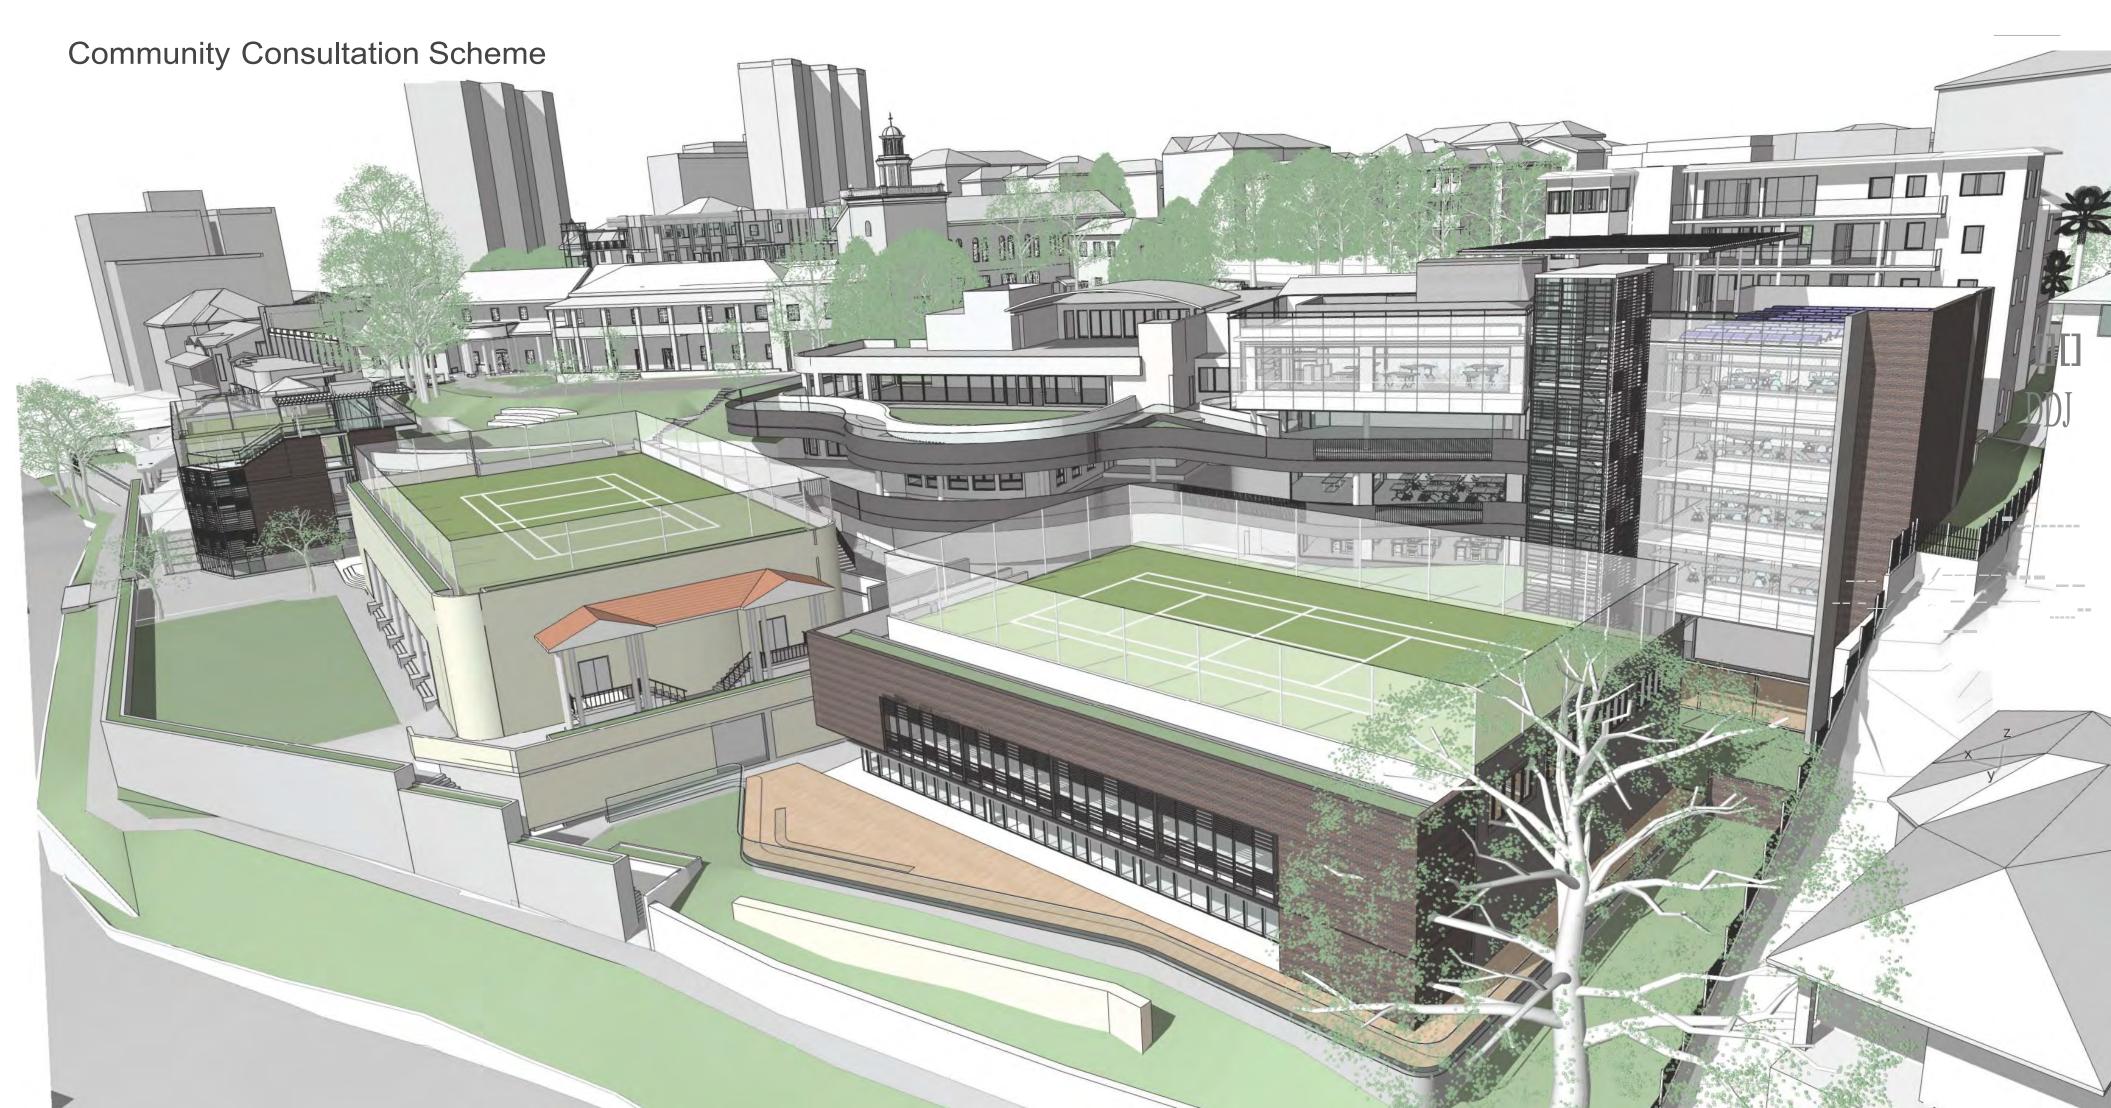
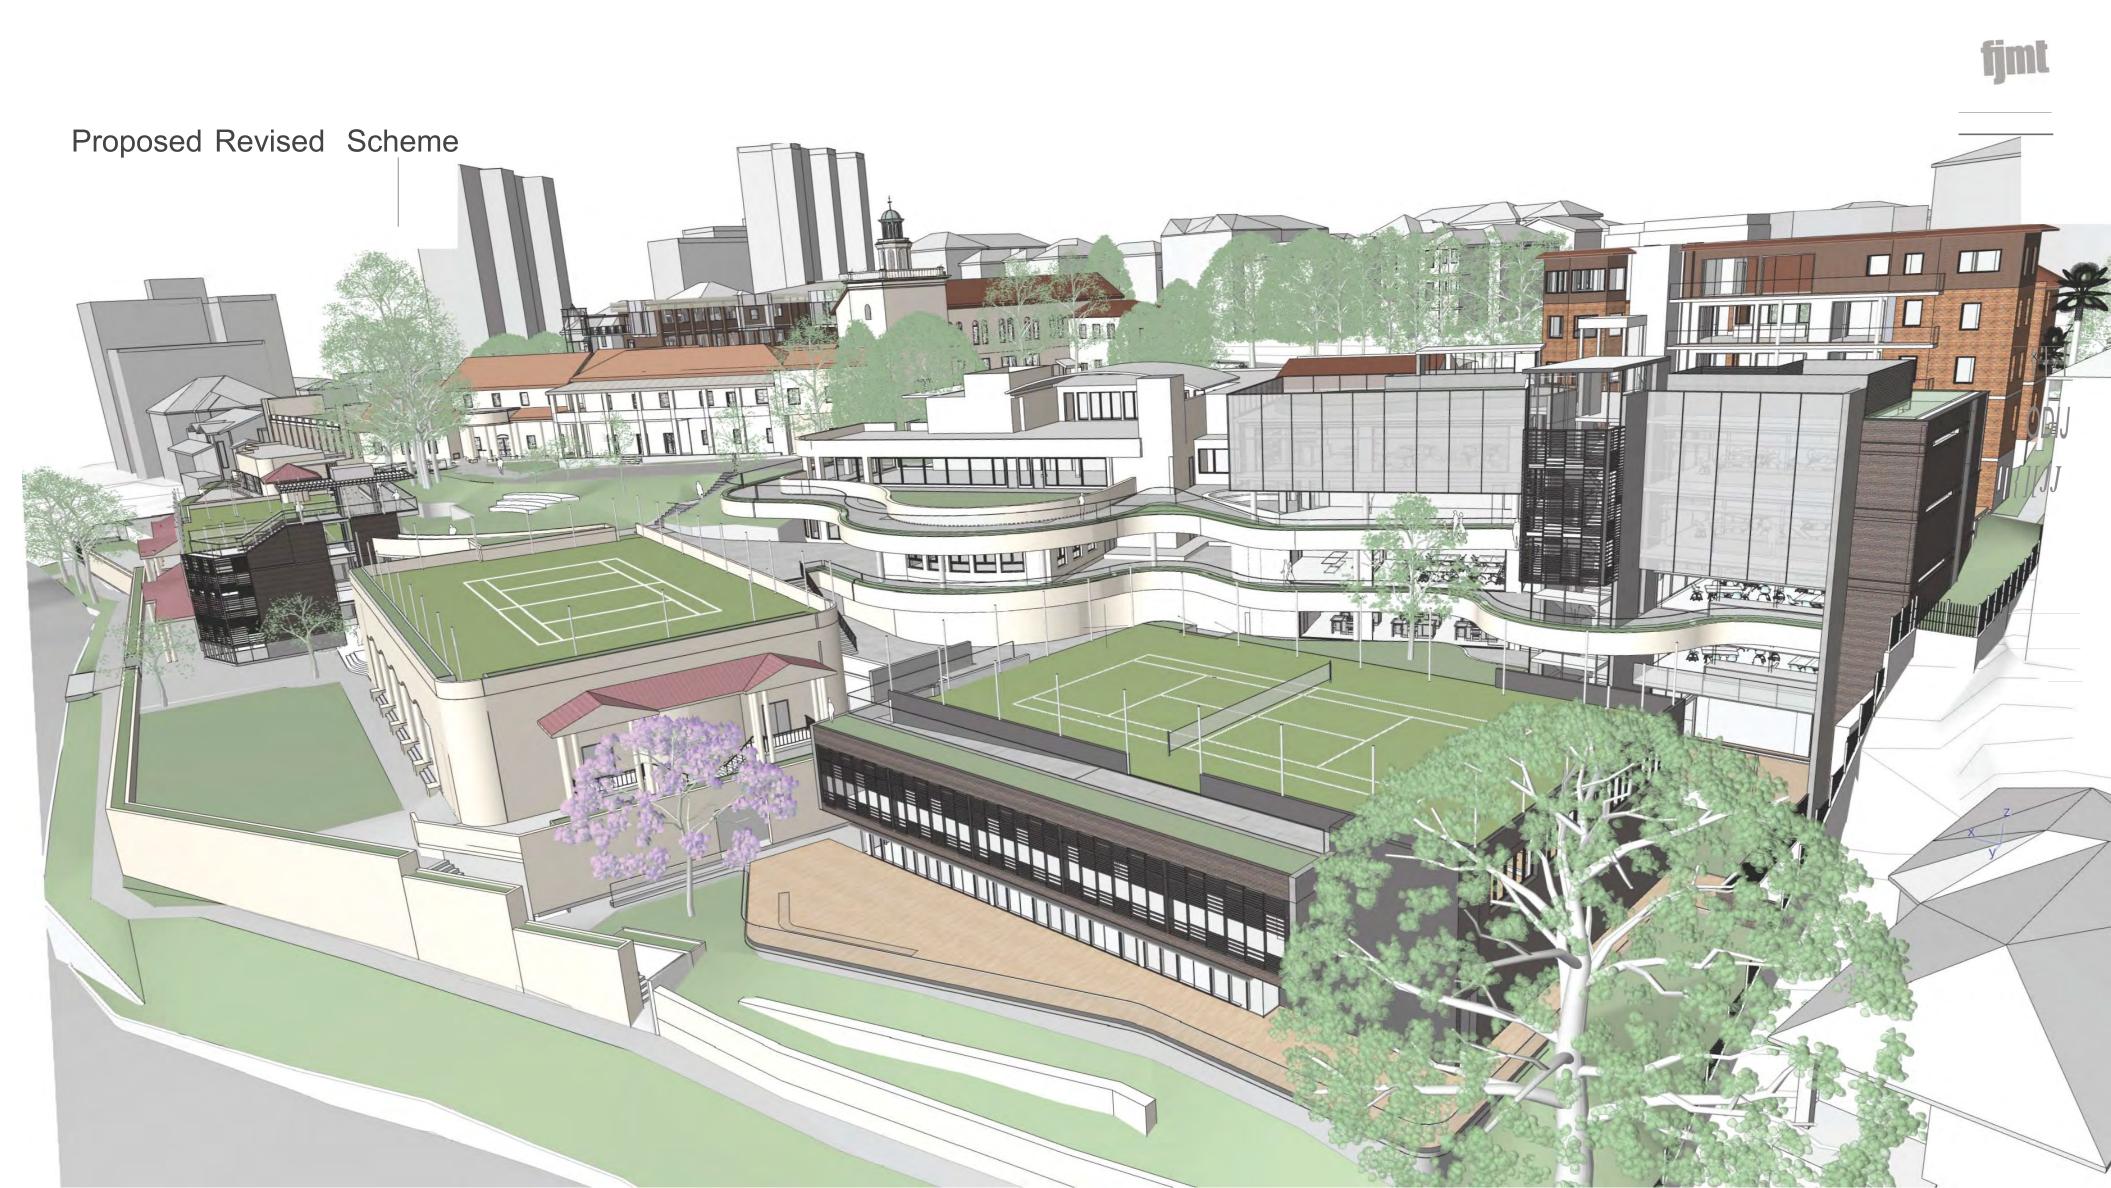
- 2 Increased Roof Garden
- Western boundary facade articulation; Introduced high level windows and brick detailing
- 4 Relocated Mechanical Plant Acoustically treated
- 5 Building setback to improve access to light and air 22 Elamang
- 6 Louvred roof removed
- **7** Glazed Lift
- Reduced bulk and scale of connector form

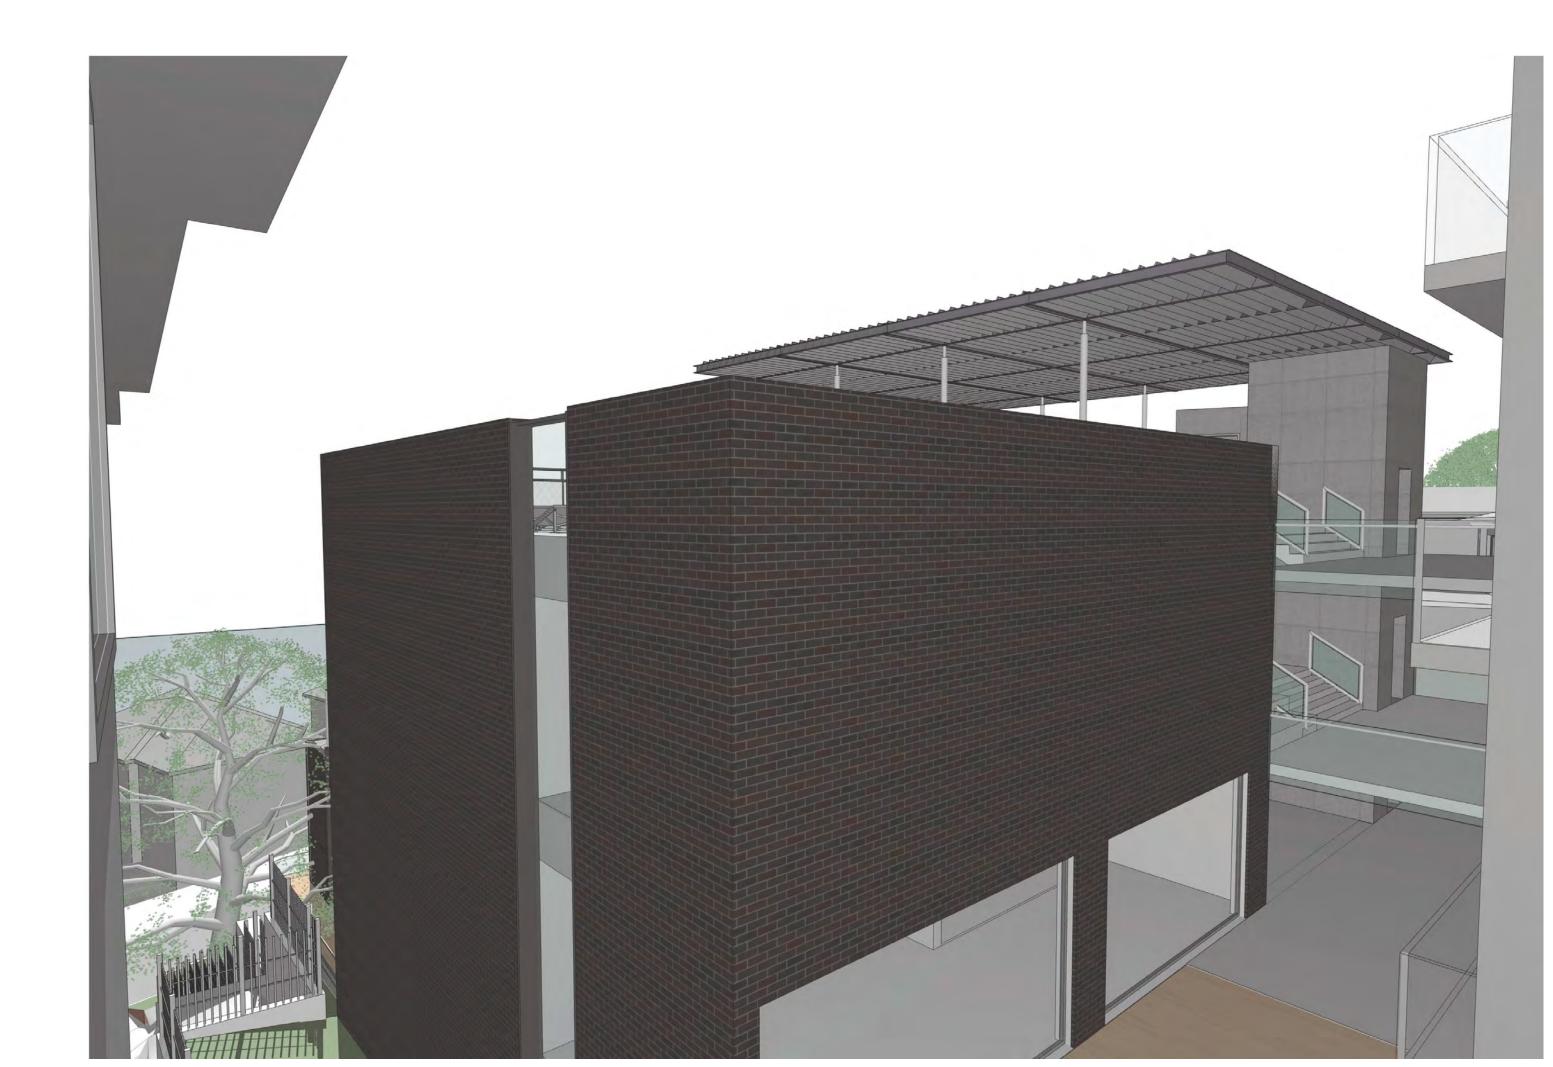
- Parapet reduced in height Integrated planter creating a landscape buffer to 111 Carabella St
- **2** Glazed lift
- Introduced high level windows and slot windows
- 4 Privacy screen
- 5 Brick detailing
