Costin Roe were engaged by Prime Constructions to carry out a pre-construction dilapidation survey of the roads and kerbs bounding and within the development site, southern and eastern retaining walls in accordance with Appendix A-E.

The purpose of this report is to record the condition of all public infrastructure and assets, prior to the construction works at Lot K SFKC – 200 Adlington Road, Kemps Creek.

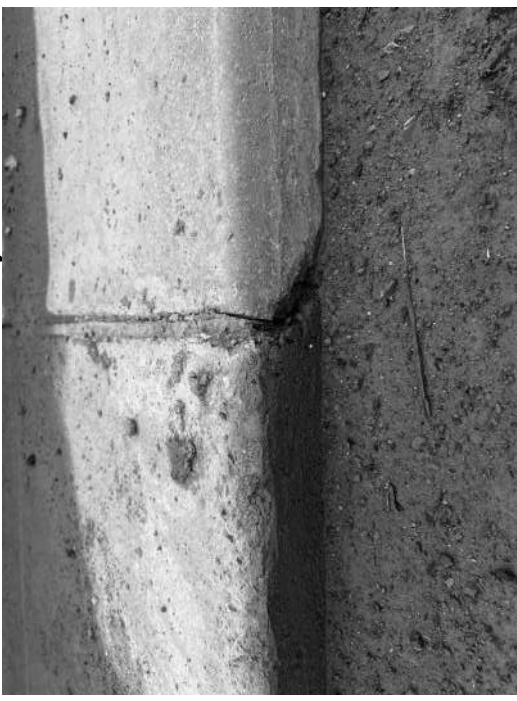
Photo 51 (Chainage 10-20m)

| 1.2.6 | General view of damage to the kerb | <b>51-52</b> |

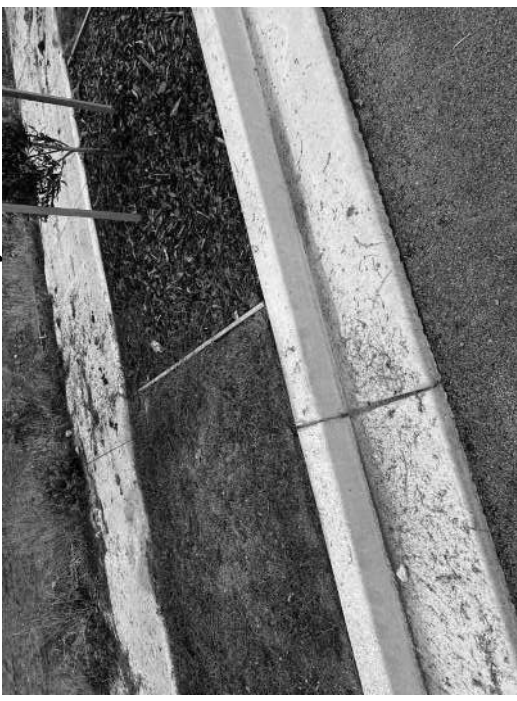
Photo 283 (Chainage 80-90m)

| 1.9.2 | Damage to the kerb and kerb joint observed. Cracking was measured to be approximately 1.0mm | <b>283-285</b> |
