**REPORT TO**  
**T&P CHIMES DEVELOPMENT PTY LTD**

**ON**  
**REMEDIATION ACTION PLAN**

**FOR**  
**PROPOSED MIXED-USE DEVELOPMENT**

**AT**  
**45-53 MACLEAY STREET, POTTS POINT, NSW**

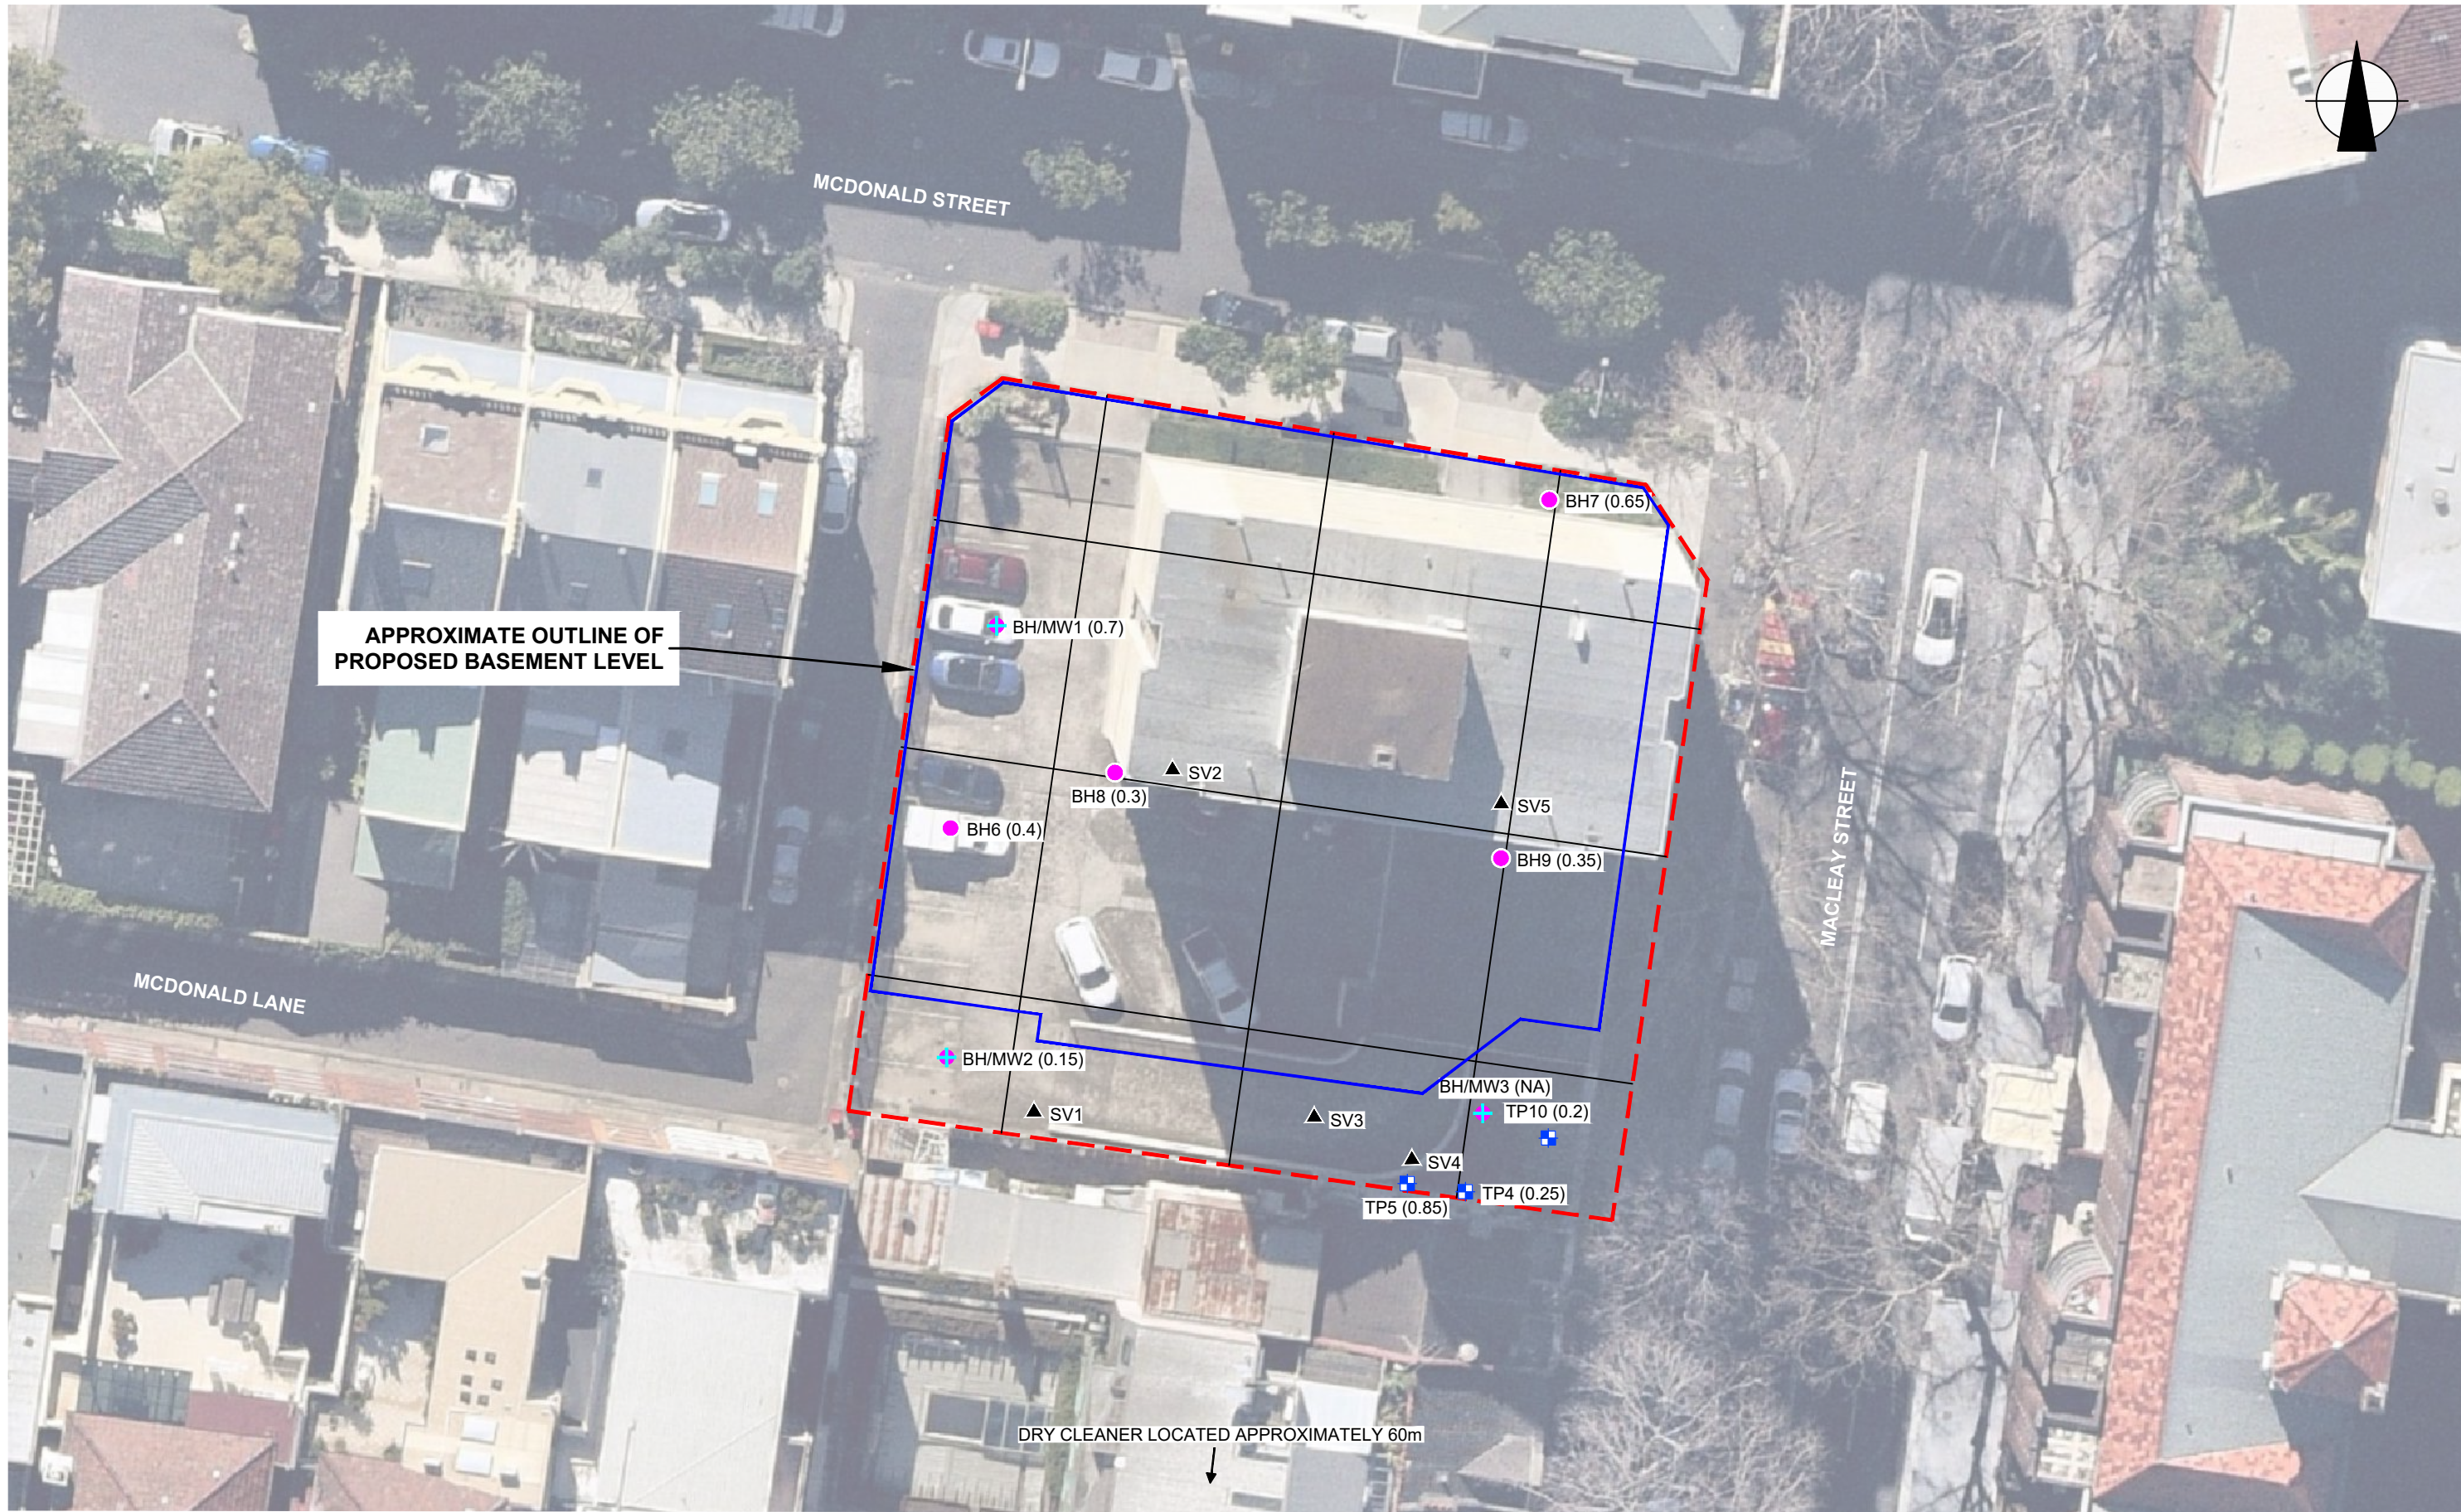
- APPROXIMATE SITE BOUNDARY
- BH(Fill Depth) BOREHOLE LOCATION, NUMBER AND DEPTH OF FILL (m)
- TP(Fill Depth) TEST PIT LOCATION, NUMBER AND DEPTH OF FILL (m)
- ▲ SV1 SOIL VAPOUR PIN LOCATION AND NUMBER

The DSI included a review of existing project information, a site inspection, soil sampling from nine locations including seven boreholes and two test pits, soil vapour sampling from five sub-slab vapour pins and groundwater sampling from three monitoring wells. The DSI sampling locations are shown on Figure 2. The following potential contamination sources were identified at the site: fill material; use of pesticides; hazardous building materials from existing or former structures; and off-site dry cleaners with the closest one located approximately 60m to the south of the site.
