Mirvac Projects Pty Ltd  
Australian Technology Park Remedial Action Plan  
2 Locomotive Street, Eveleigh, NSW

15 June 2016  
51142/104280 (Revision 0)  
JBS&G Australia Pty Ltd

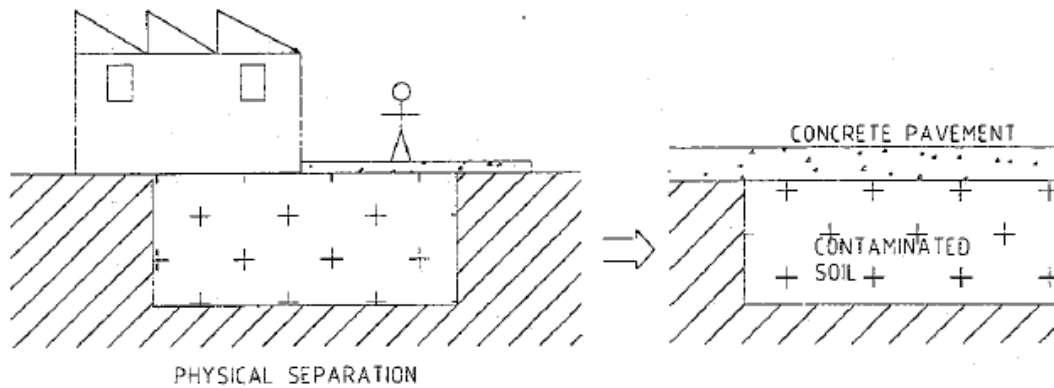
- Permanent concrete floor slab or asphalt surfaced pavement. The pavement outside of the building footprint shall be underlain by a marker layer; or
- A thickness of soil that is unlikely to be penetrated by future users of the site. A minimum soil cover thickness of 0.5m is nominated as underlain by a layer of 'marker layer' in areas of exposed site soil (i.e. landscaped beds).

As shown schematically below:

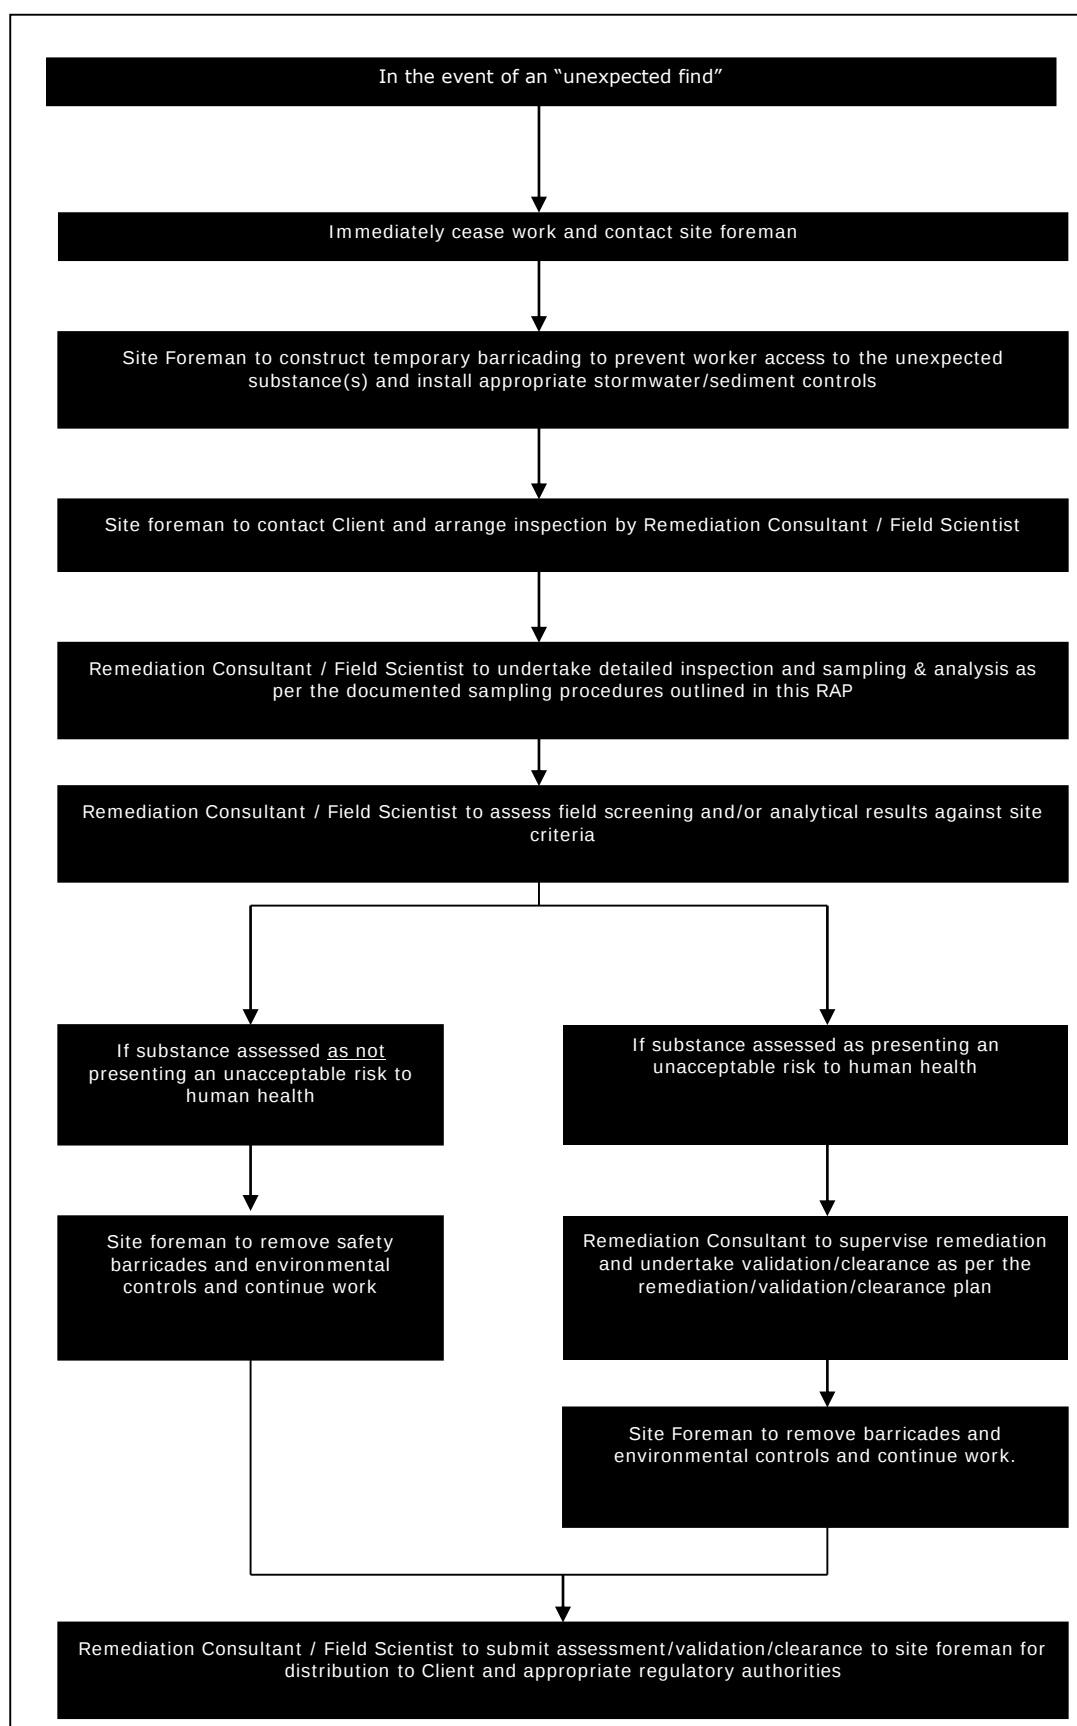
Figure 9.1 - Unexpected Finds Protocol

Following removal of hardstands across the site, an inspection of the site’s surface for the presence of visible ACM in accordance with NEPC (2013) or other visual or olfactory indicators of contamination should be undertaken.

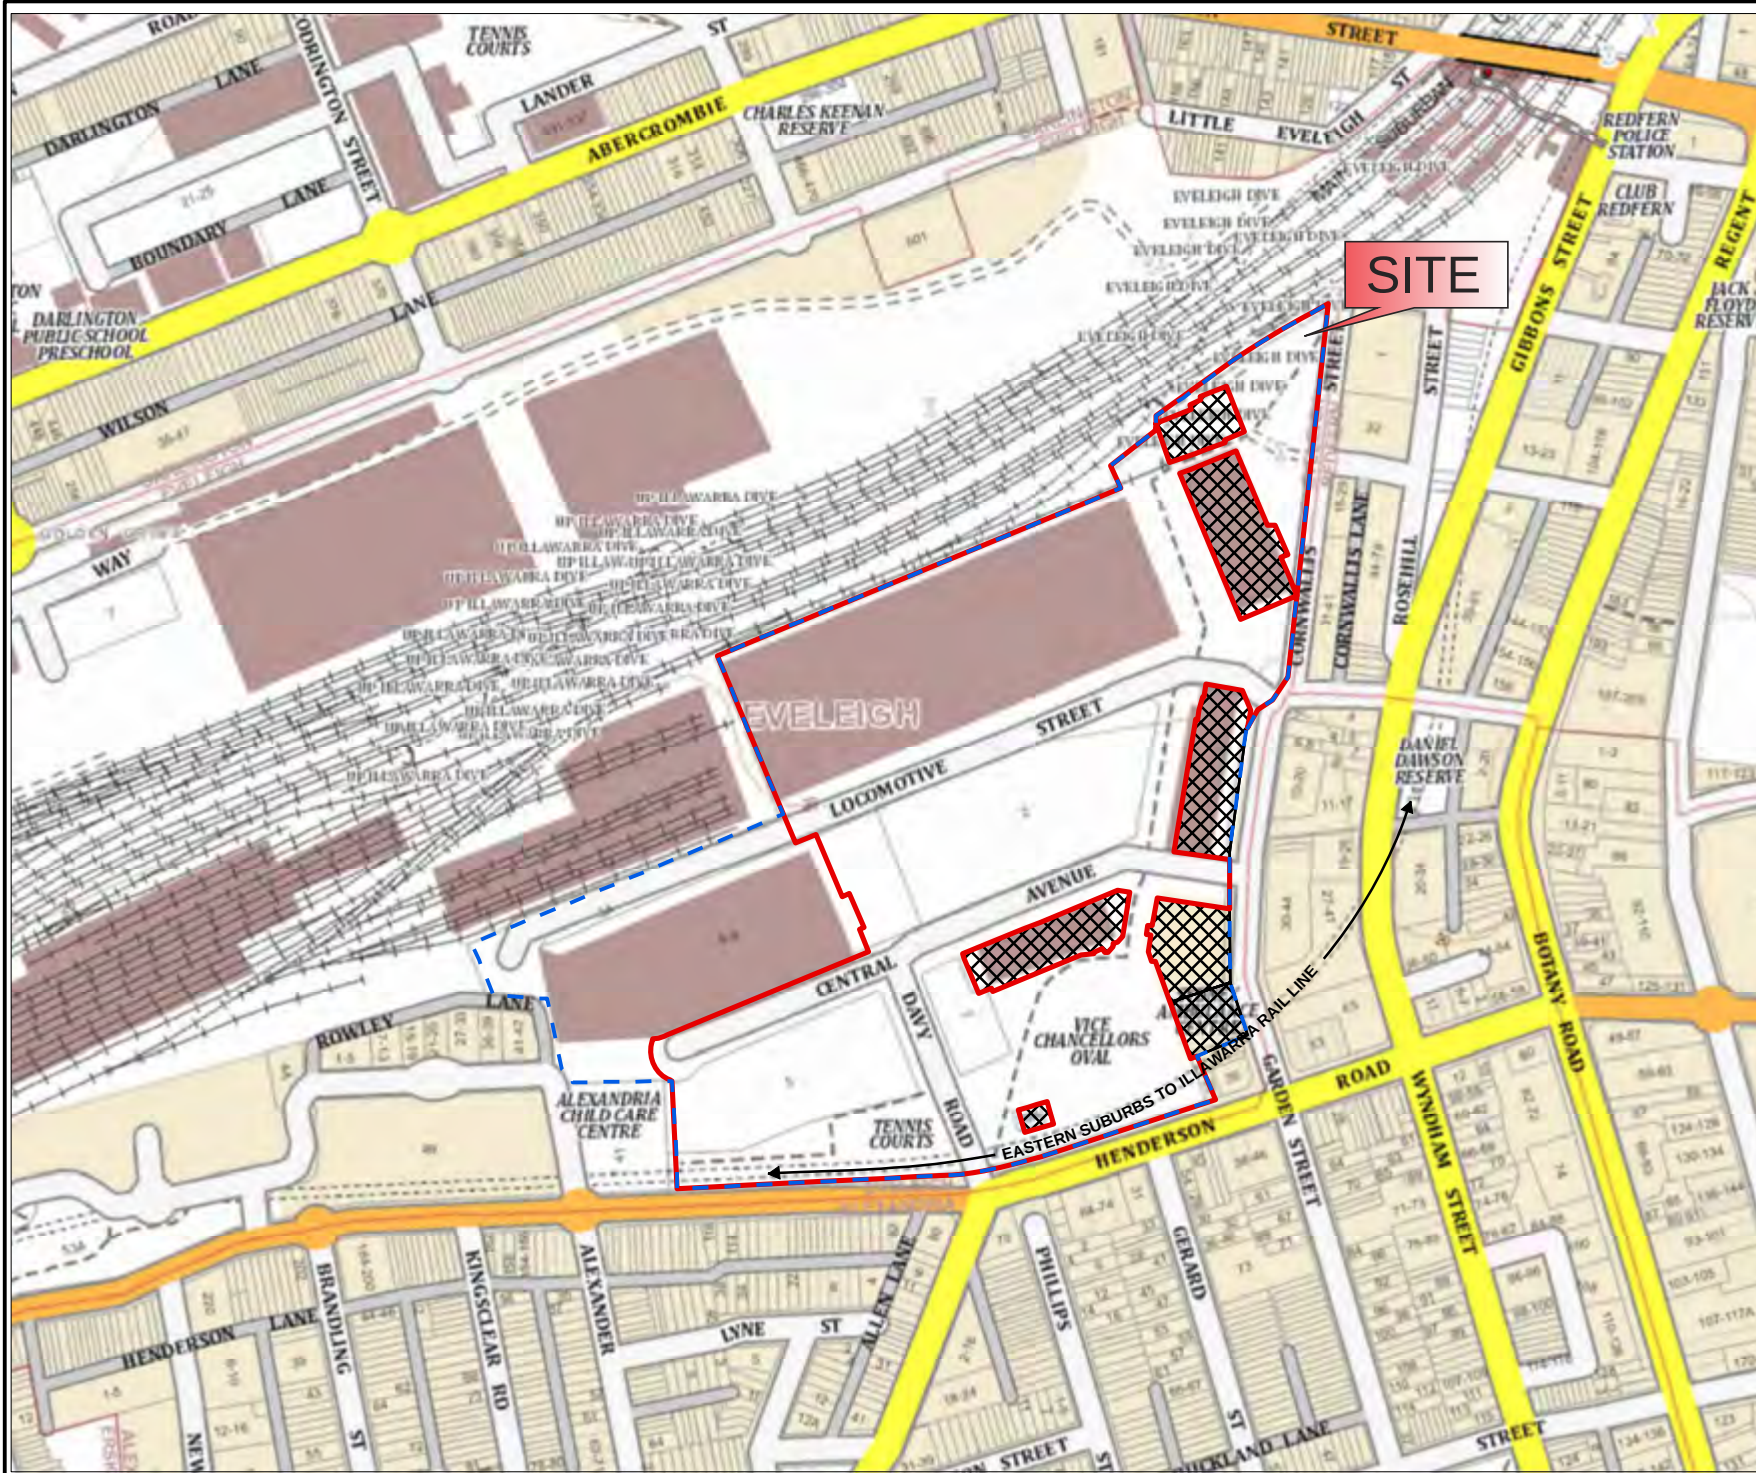
**FIGURE 1:**

**SITE LOCATION**

The ATP precinct, for which the site is part, comprises a 13.2 hectare (ha) parcel of land and is occupied by a number of modern high rise buildings, heritage industrial buildings, private roads and public domains, as shown in **Figures 1** and **2**. The Mirvac site, herein referred to as 'the site' is legally identified as Lots 8, 9, 12 in Deposited Plan (DP) 1136859, Lot 4000 in DP 1194309, Part Lot 4007 in DP 1194309 and Part Lot 10 in DP 1136859 (**Figure 3**) and occupies an area of 11.6 ha. The site includes the Locomotive Workshop, public roads/domains (road reserves and pedestrian easements, recreational facilities and the eastern most extent of Lot 10 DP 1136859) and Developable Lots (Lots 8, 9 and 12). Lots 4001 to 4006 including the International Business Centre, National Innovation Centre, Traffic Management Centre (formally the RTA Building), Ambulance Service Building and Biomedical Building footprints) and Lot 501 DP 1033739 (rail easement) fall outside the site boundaries, as shown on **Figure 2**. It is noted Lots 4000 to 4007 were previously identified as Lot 13 in DP1136859.

The location of the site is shown in **Figure 1**, current layout is shown in **Figure 2**. Site details are summarised in **Table 3.1**.

- South – The site is bound to the south by Henderson Road, across which are mixed land uses comprising residential and commercial allotments. A child care facility (Alexandria Childcare Centre) bounds the site to the south west. The Eastern Suburbs/Illawarra Train Line Tunnel runs parallel to Henderson Road along the southern site boundary (**Figure 1**); and

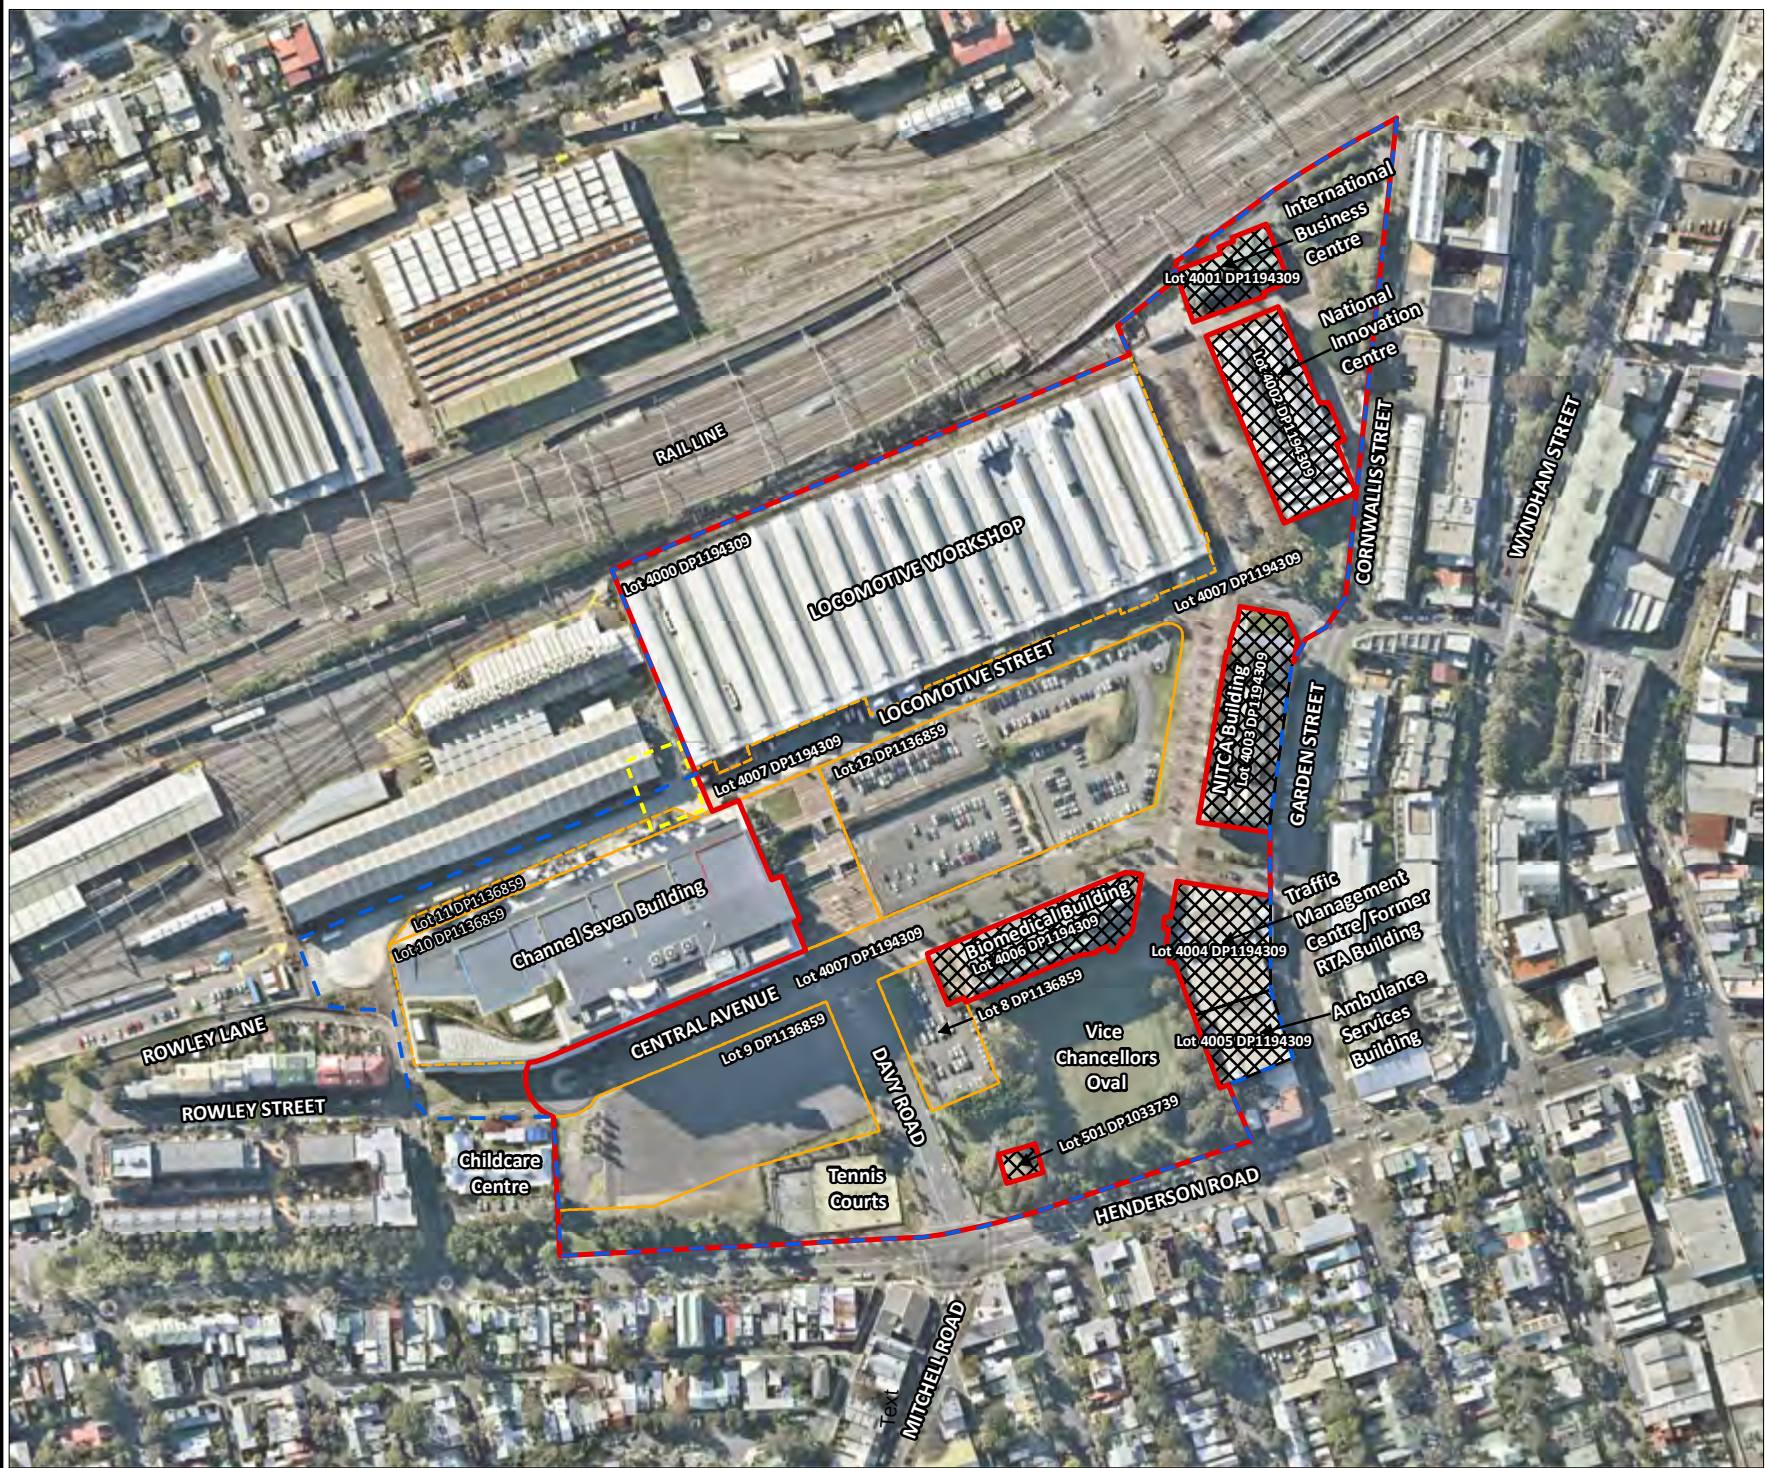
**FIGURE 2:**

**SITE LAYOUT**

The ATP site layout is shown in **Figure 2**.

- The lateral extent of the works relevant to this RAP as presented in **Figure 2** and **Table 3.1**;
- The vertical extent of the works is defined as the depths required to implement appropriate capping, as schematically shown in **Figures 9A to 9D**.

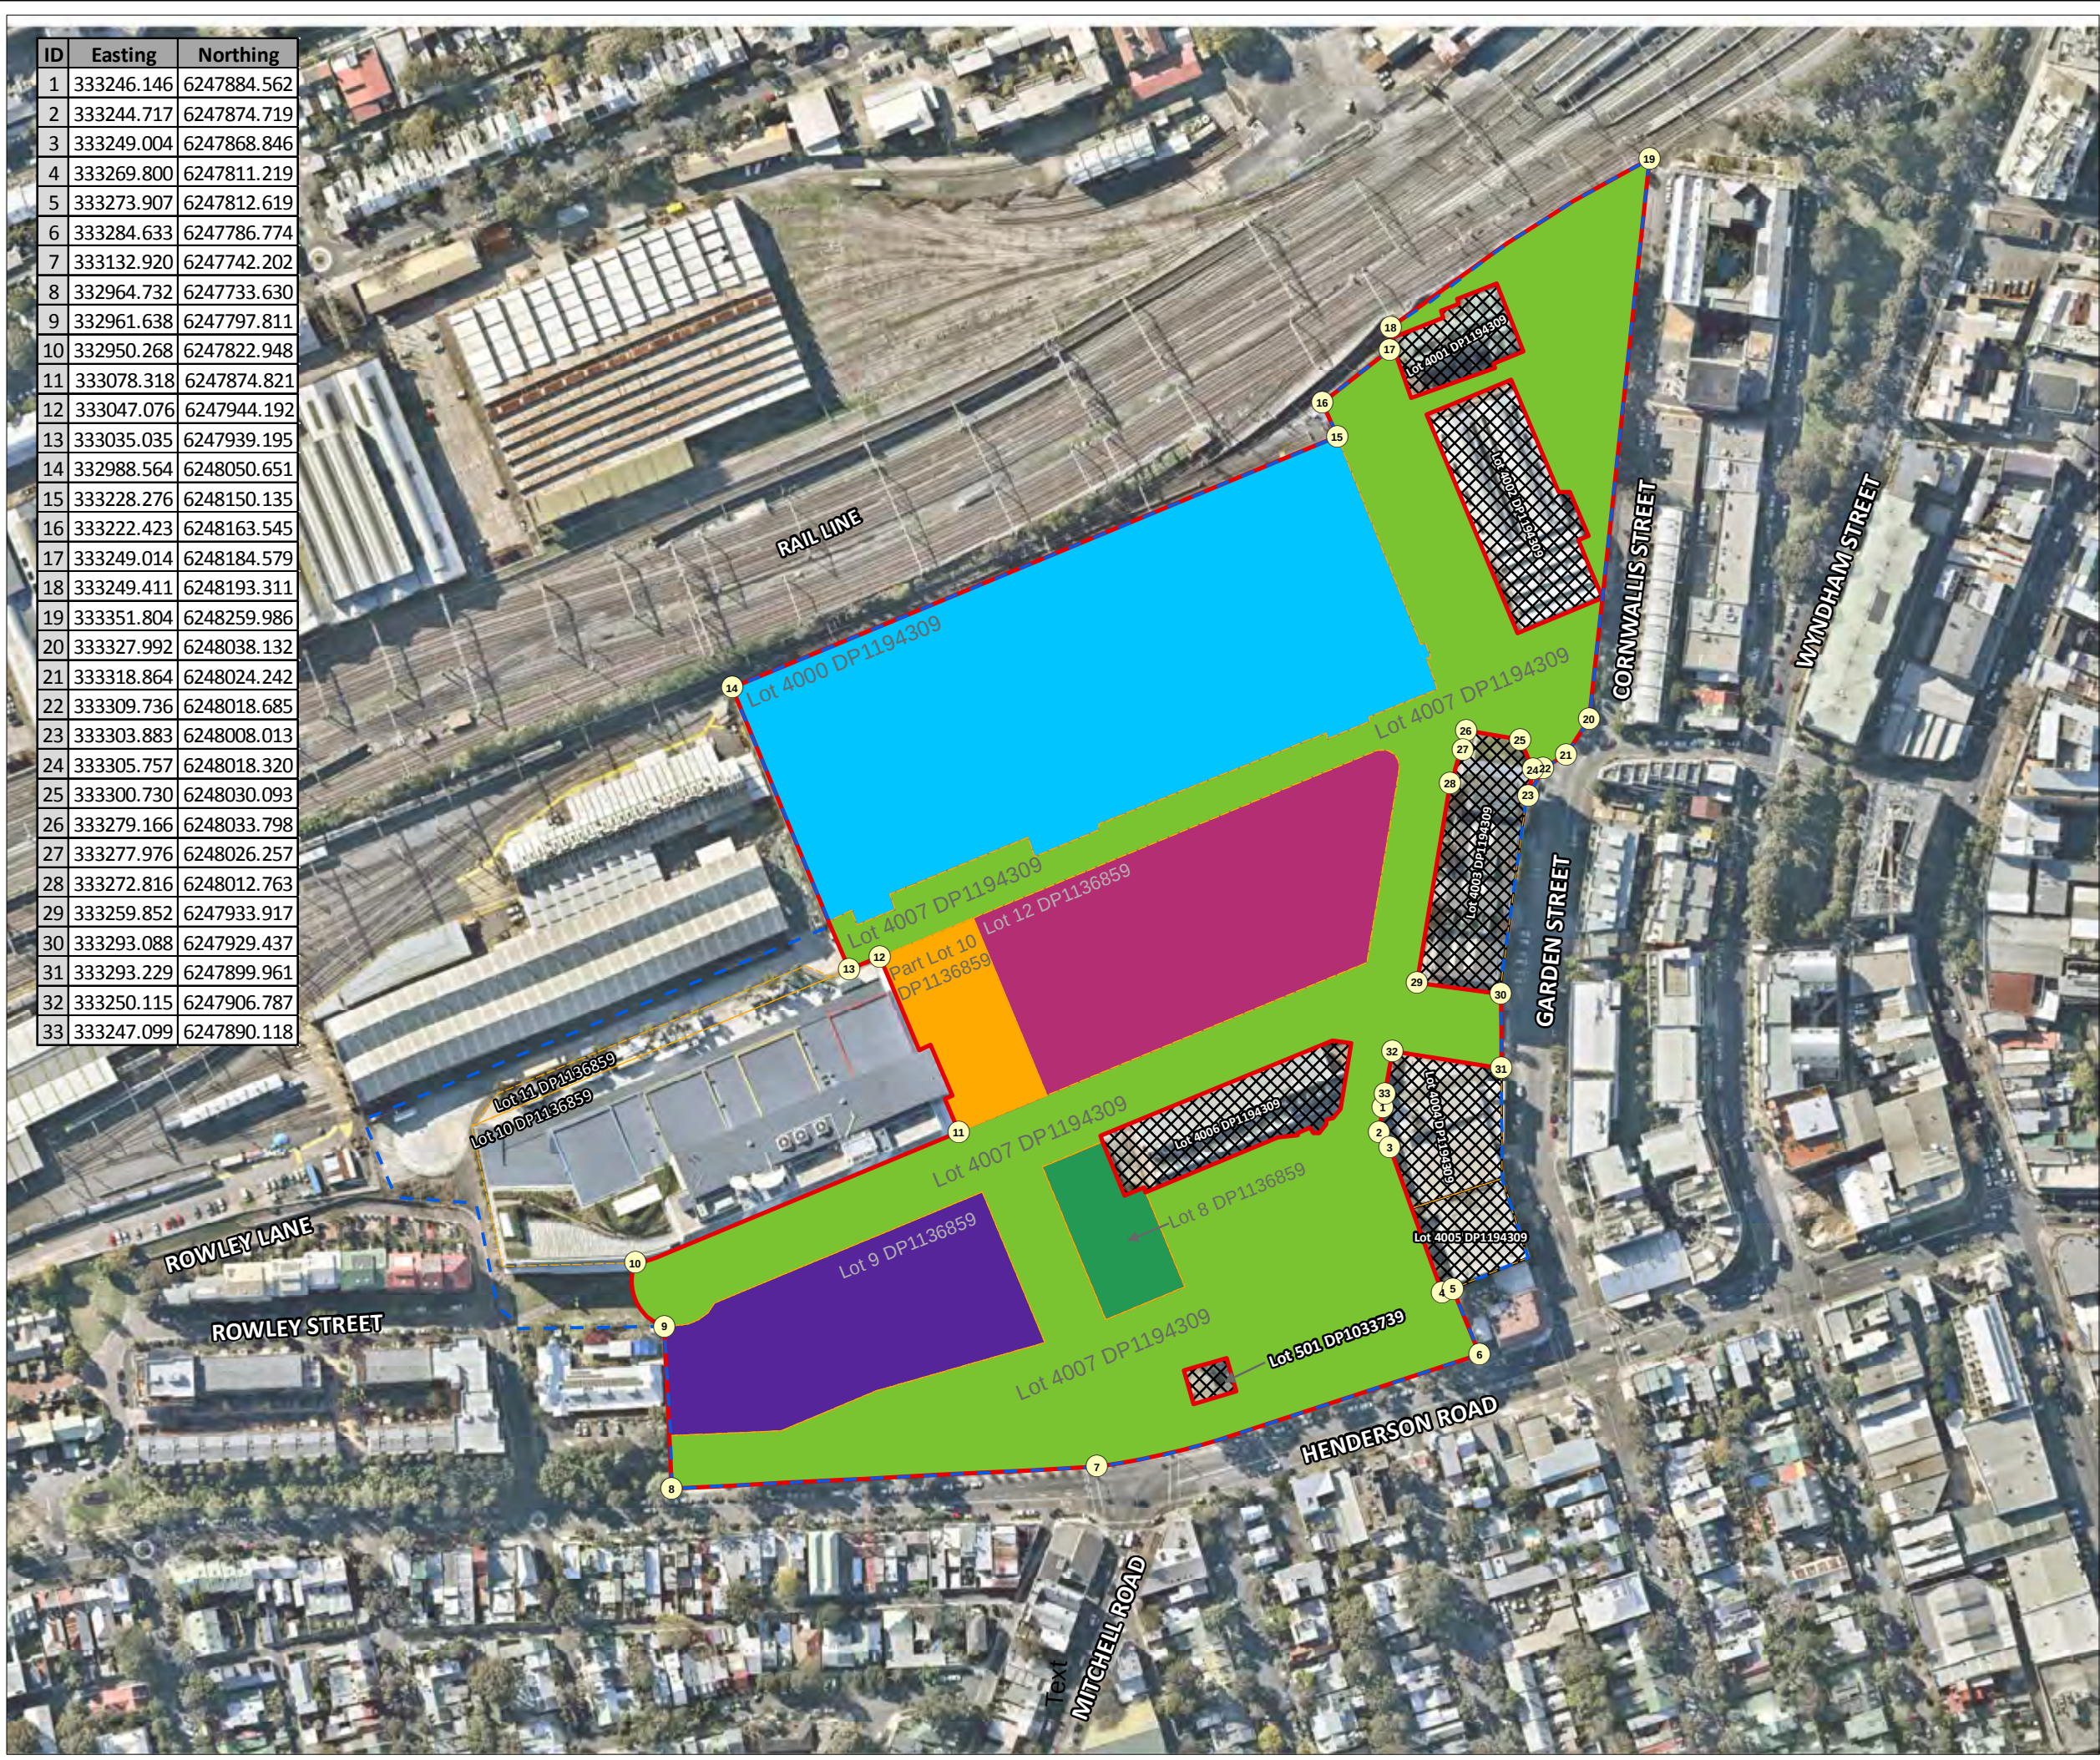
**FIGURE 4:**

**DEPTH OF FILL**

Previous investigations, as discussed in **Section 5**, identified fill materials across the entire site with minor exceptions, ranging from a skeletal fill soil profile to 7.6 m in depth (**Figure 4**). In general, the vertical extent of fill is reported to be greatest within the northern site extent, adjacent the Locomotive Workshop. Fill materials are considered result from a combination of site activity (waste products) and importation of fill materials to establish site levels.

As part of its development, the site was extensively filled and built up with a range of hard fill material including sand, clay, railway ballast, construction and demolition and other waste materials (see **Figure 4** for inferred fill depth). Fill materials were reported resultant from site derived waste and materials importation.

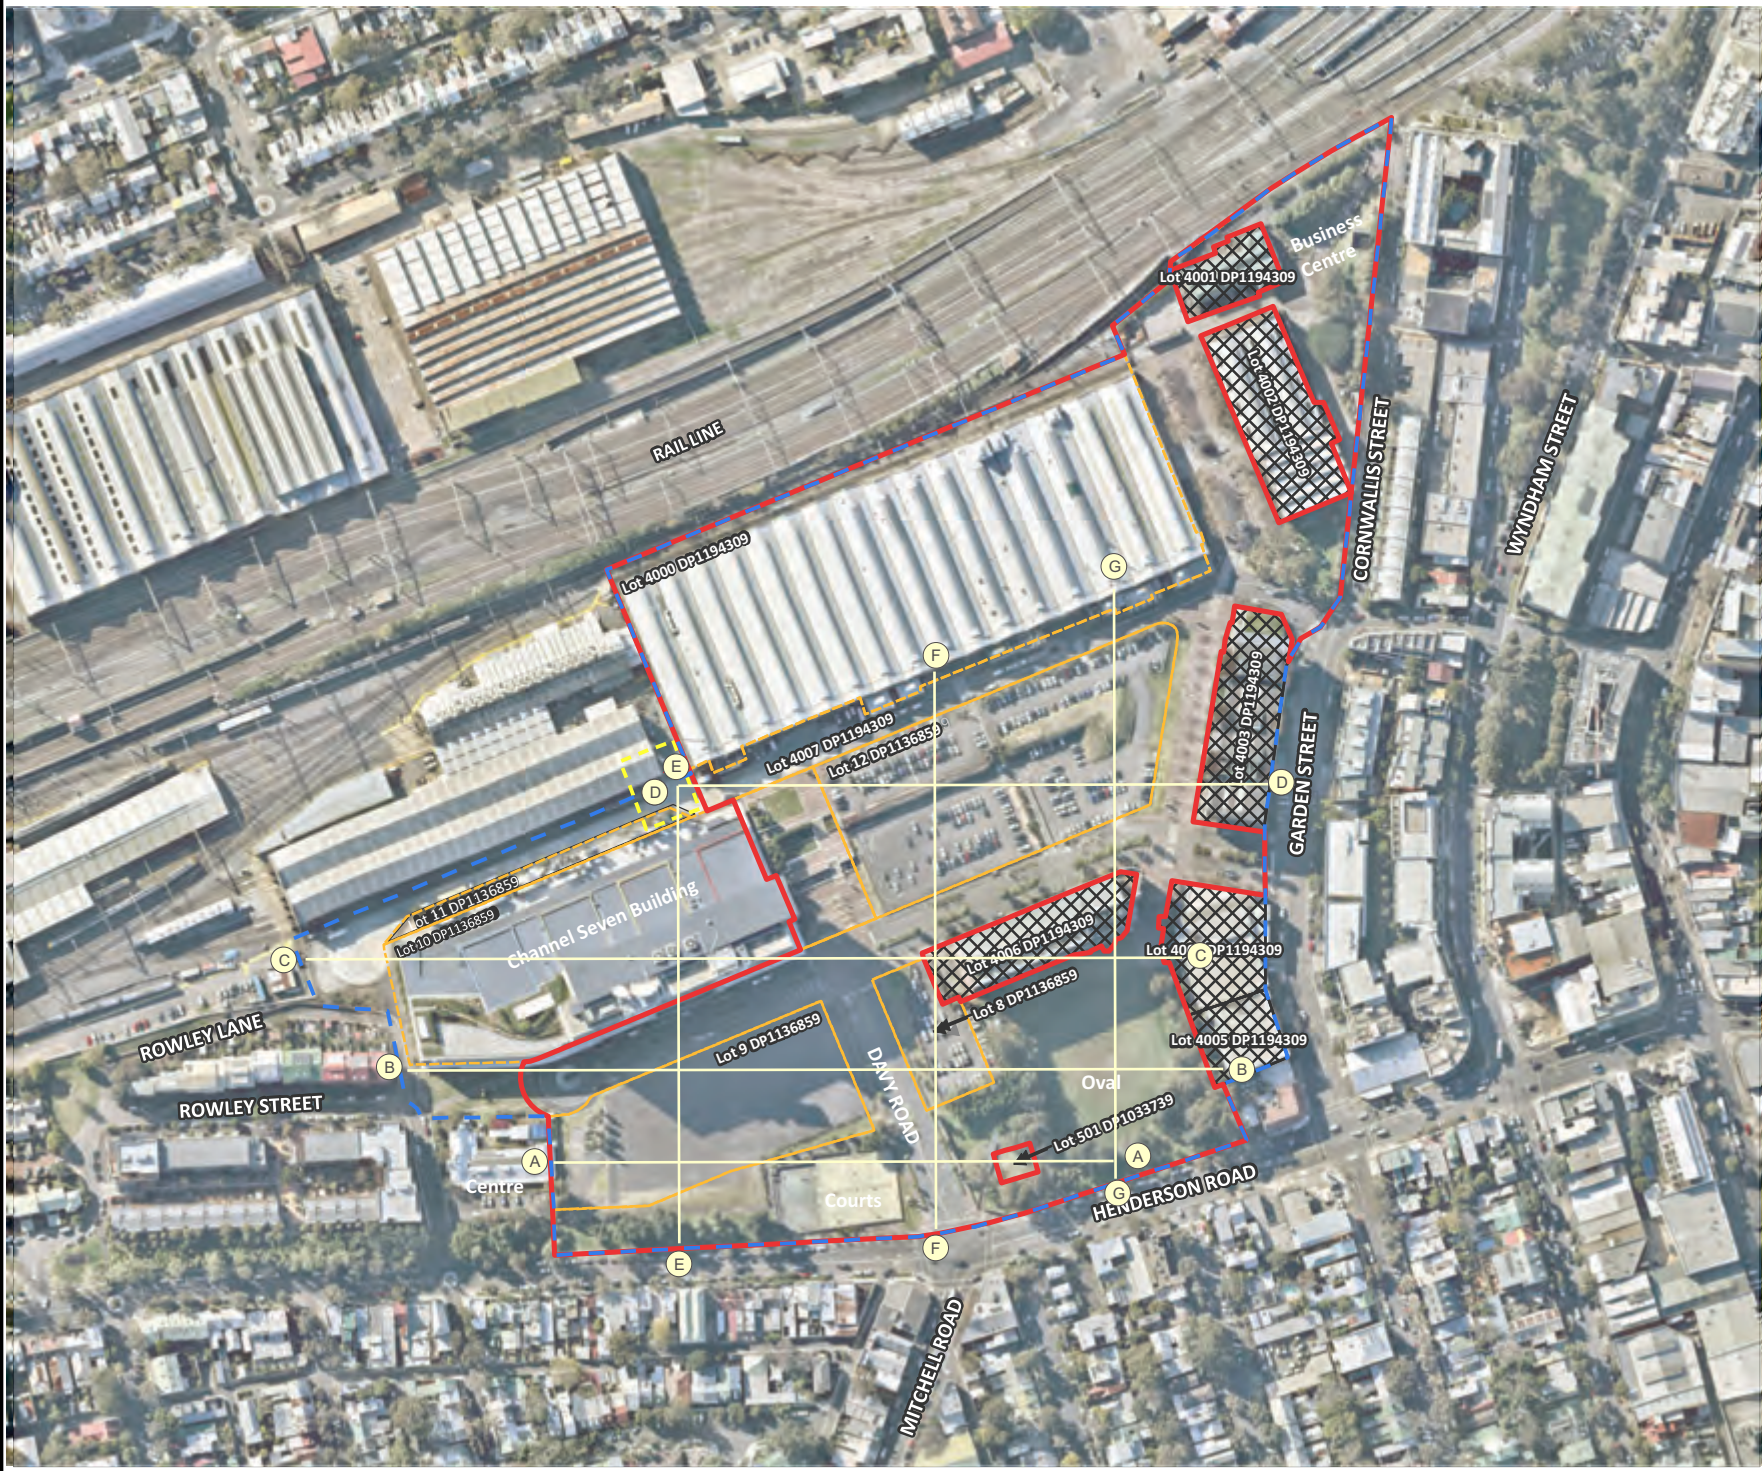
**FIGURE 6:**

**HISTORICAL SITE LAYOUT**

The primary potentially contaminating activities at the ATP site was considered to be its previous use as part of the Eveleigh Railway Workshops. Workshops included a paint shop, potash shed, wheel press, welder shop, copper shop, Oliver shop, tin smiths and pattern shop among others. The Locomotive Workshop was partitioned to accommodate a blacksmiths, fitter shop, machine shop, fabrication shop etc. Other significant buildings included the Engine Shop, foundry and Alexandria Goods Shed (**Figure 6**).

Archaeological reports presented in previous reports indicated that an underground storage tank (UST) may have been located between the Locomotive Workshop and the large erecting shop (**Figure 6**). The contents of the potential UST were unknown. In addition, it was reported solvent like substances were stored in a UST(s), along with a waste oil separator in the north eastern site extent (location unknown). Light non-aqueous phase liquid (LNAPL) hydrocarbons and elevated dissolved hydrocarbons have historically been reported at sample location MW3 within Area 2 (**Figure 7D**) and within Lot 10 DP 1136859 (beneath the Channel 7 building, outside the site boundary).

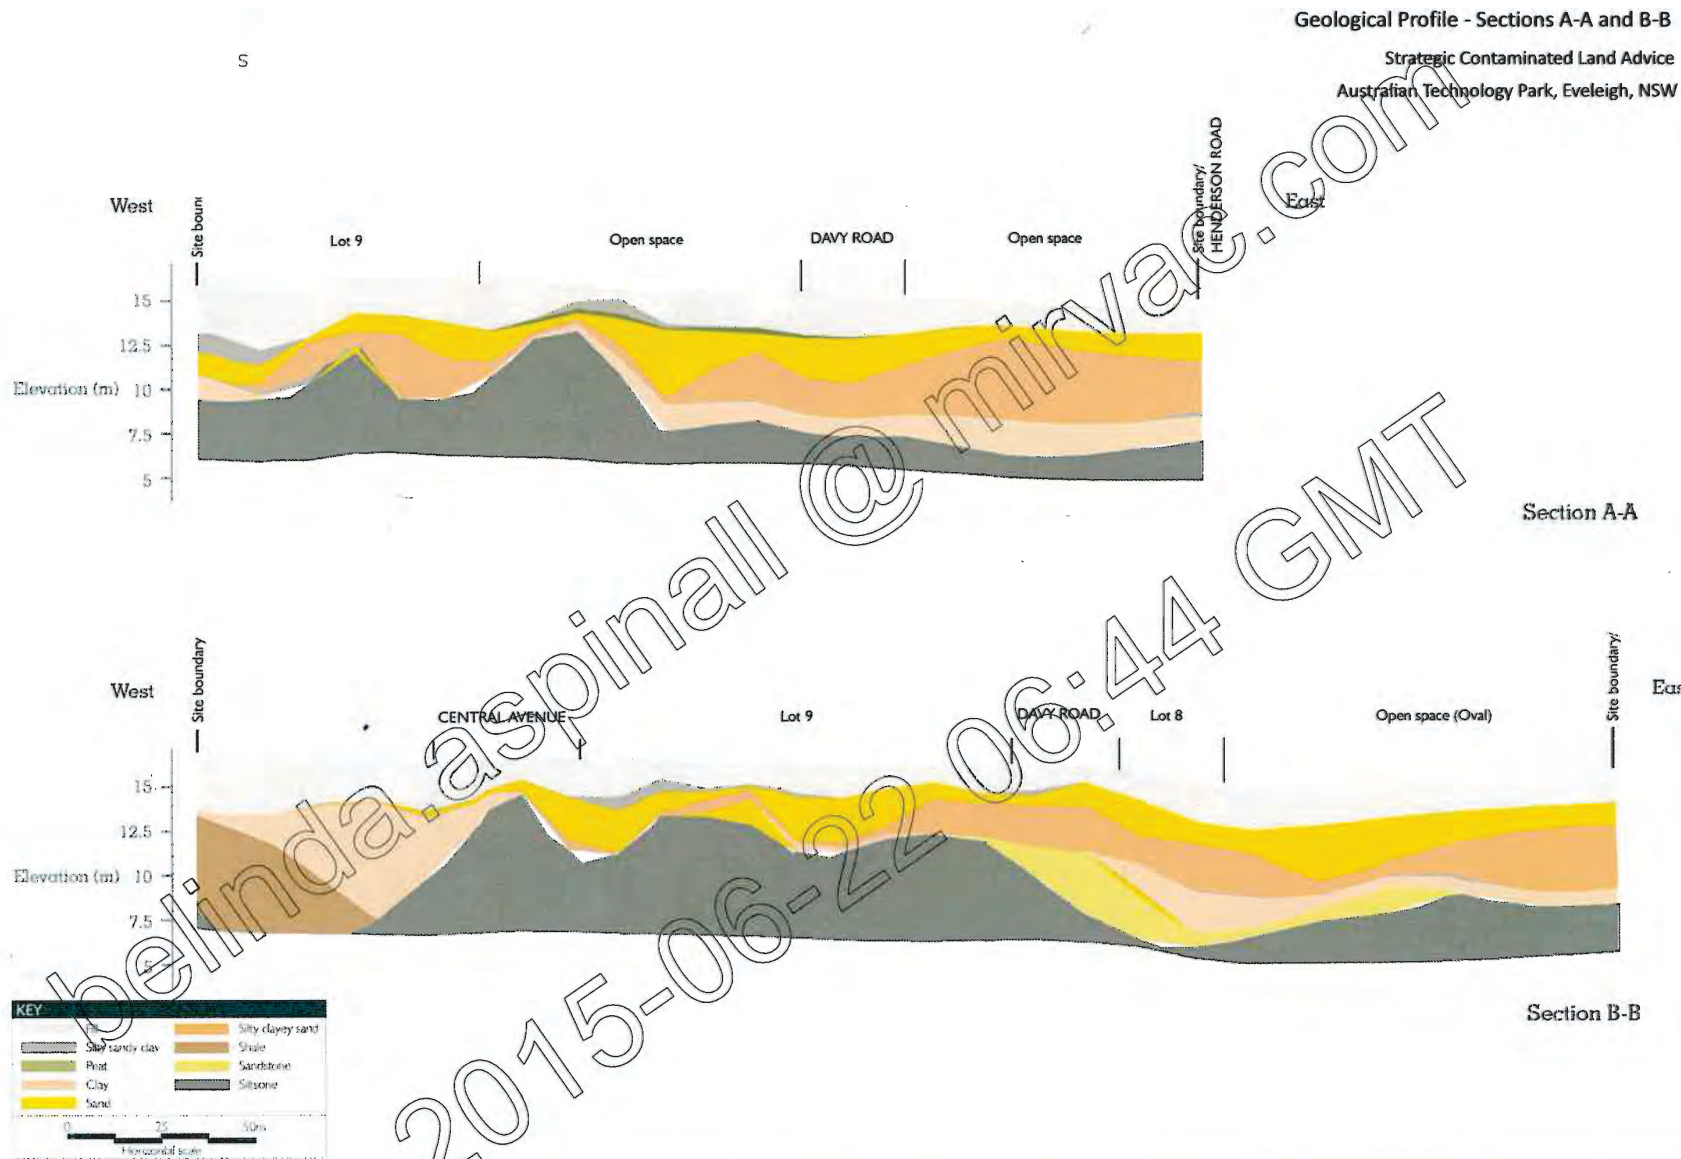
**FIGURE 5a:**

**SECTIONS A-A and B-B**

Silty clay soils, with small isolated clayey sand/sand lens and in turn shale/sandstone bedrock were encountered underlying fill materials. Detailed schematic cross section of the identified subsurface conditions are provided as **Figure 5** and **Figures 5A to 5D**. Lot 12 is noted to be underlain by fill and in turn clay and shale bedrock.

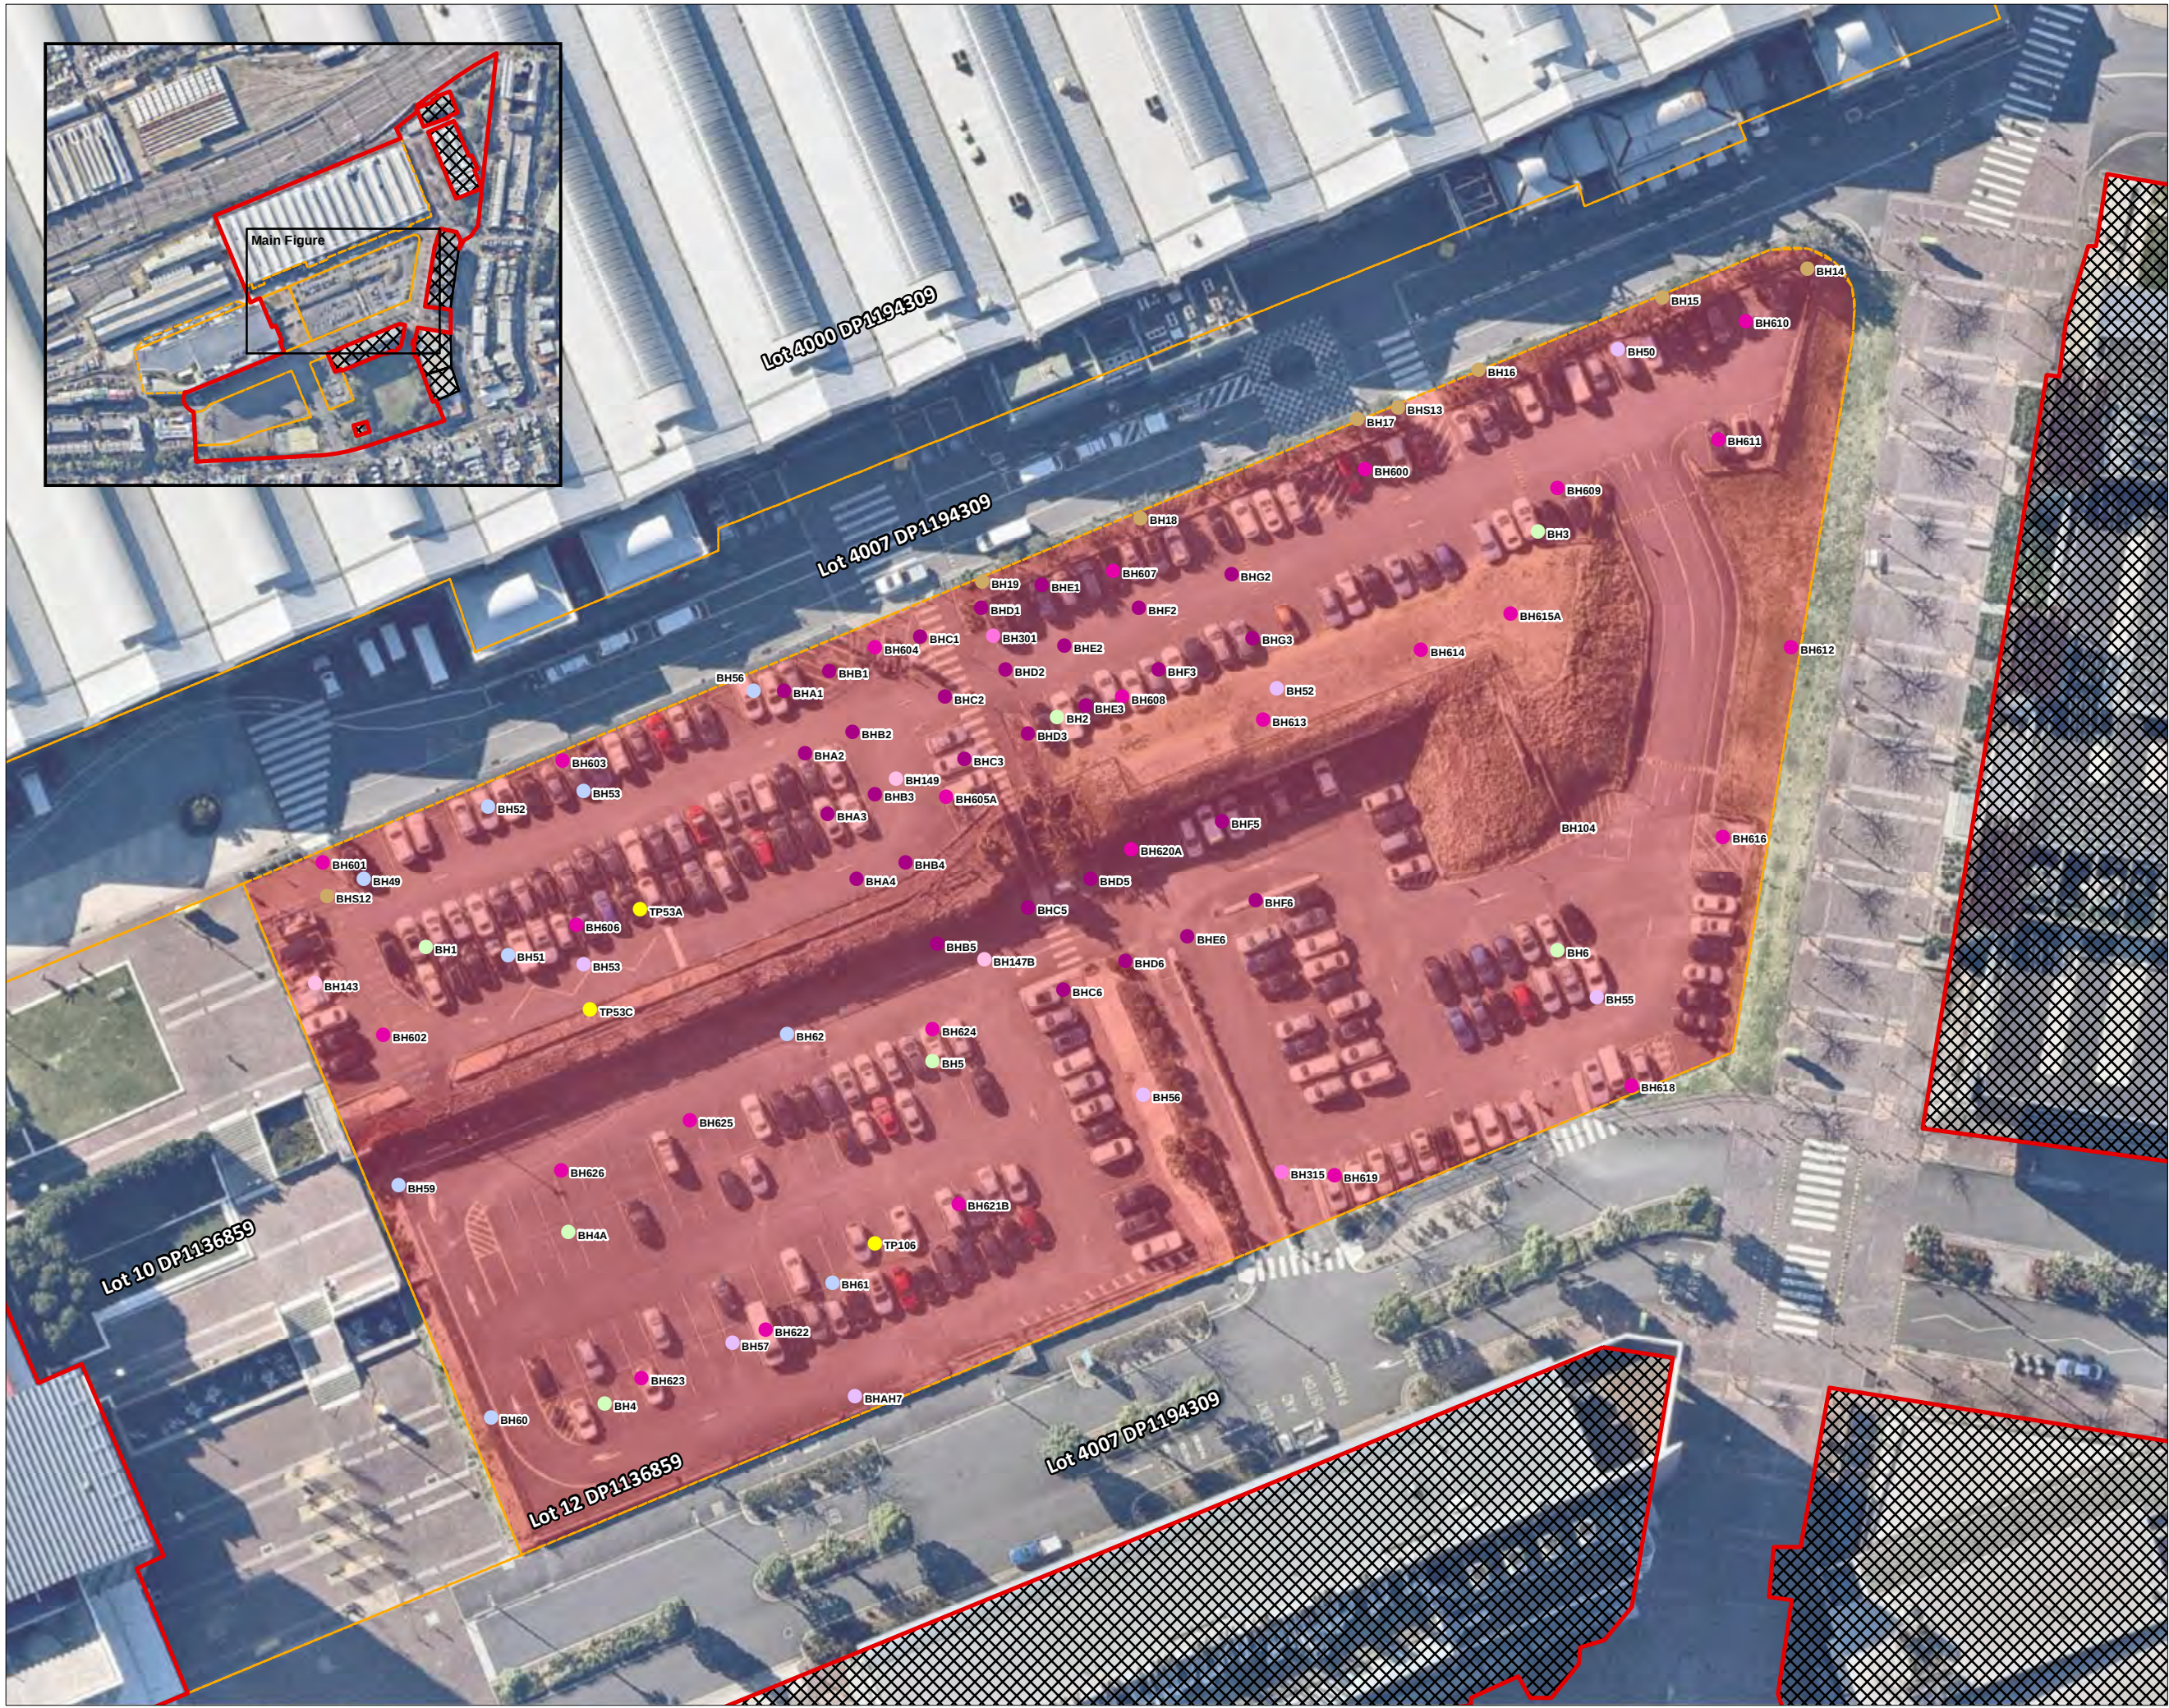
**FIGURE 7B:**

**HISTORIC SOIL SAMPLE  
LOCATIONS LOT 12**
