Mirvac Projects Pty Ltd  
Australian Technology Park Remedial Action Plan  
2 Locomotive Street, Eveleigh, NSW

15 June 2016  
51142/104280 (Revision 0)  
JBS&G Australia Pty Ltd

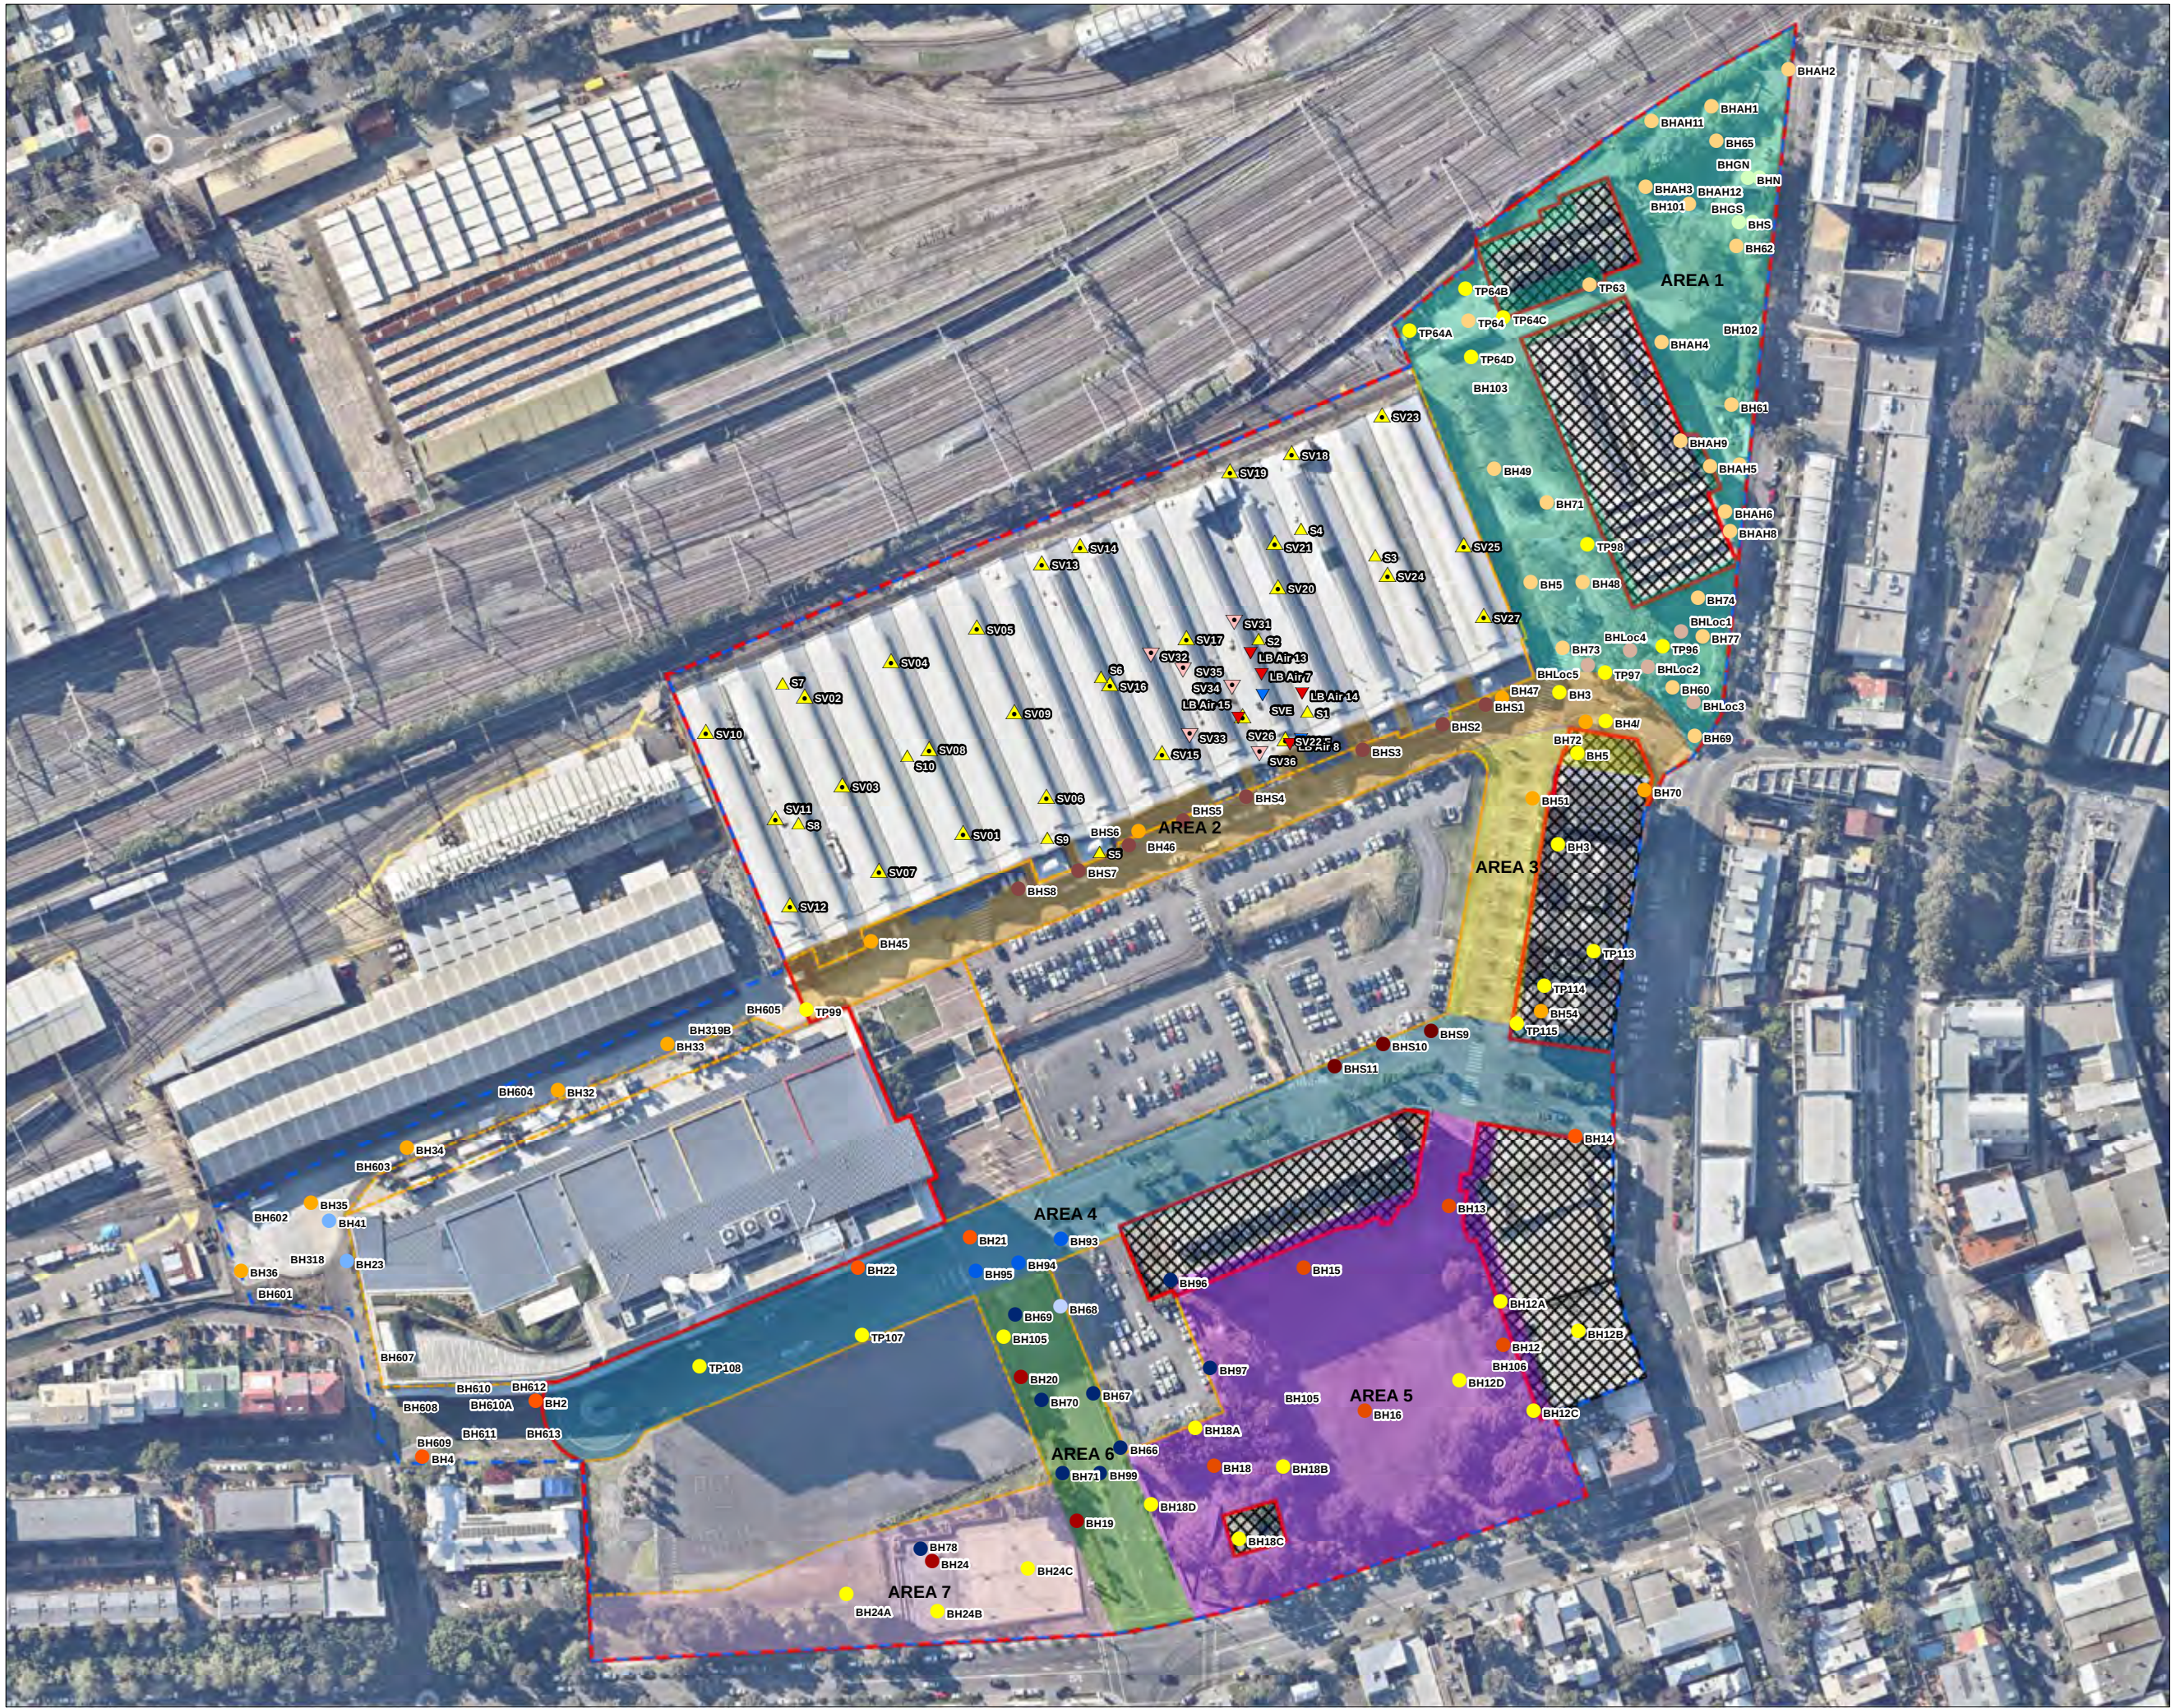
**FIGURE 7C:**

**HISTORIC SOIL/SOIL VAPOUR  
SAMPLE LOCATIONS  
LOTS 4000 AND 4007**

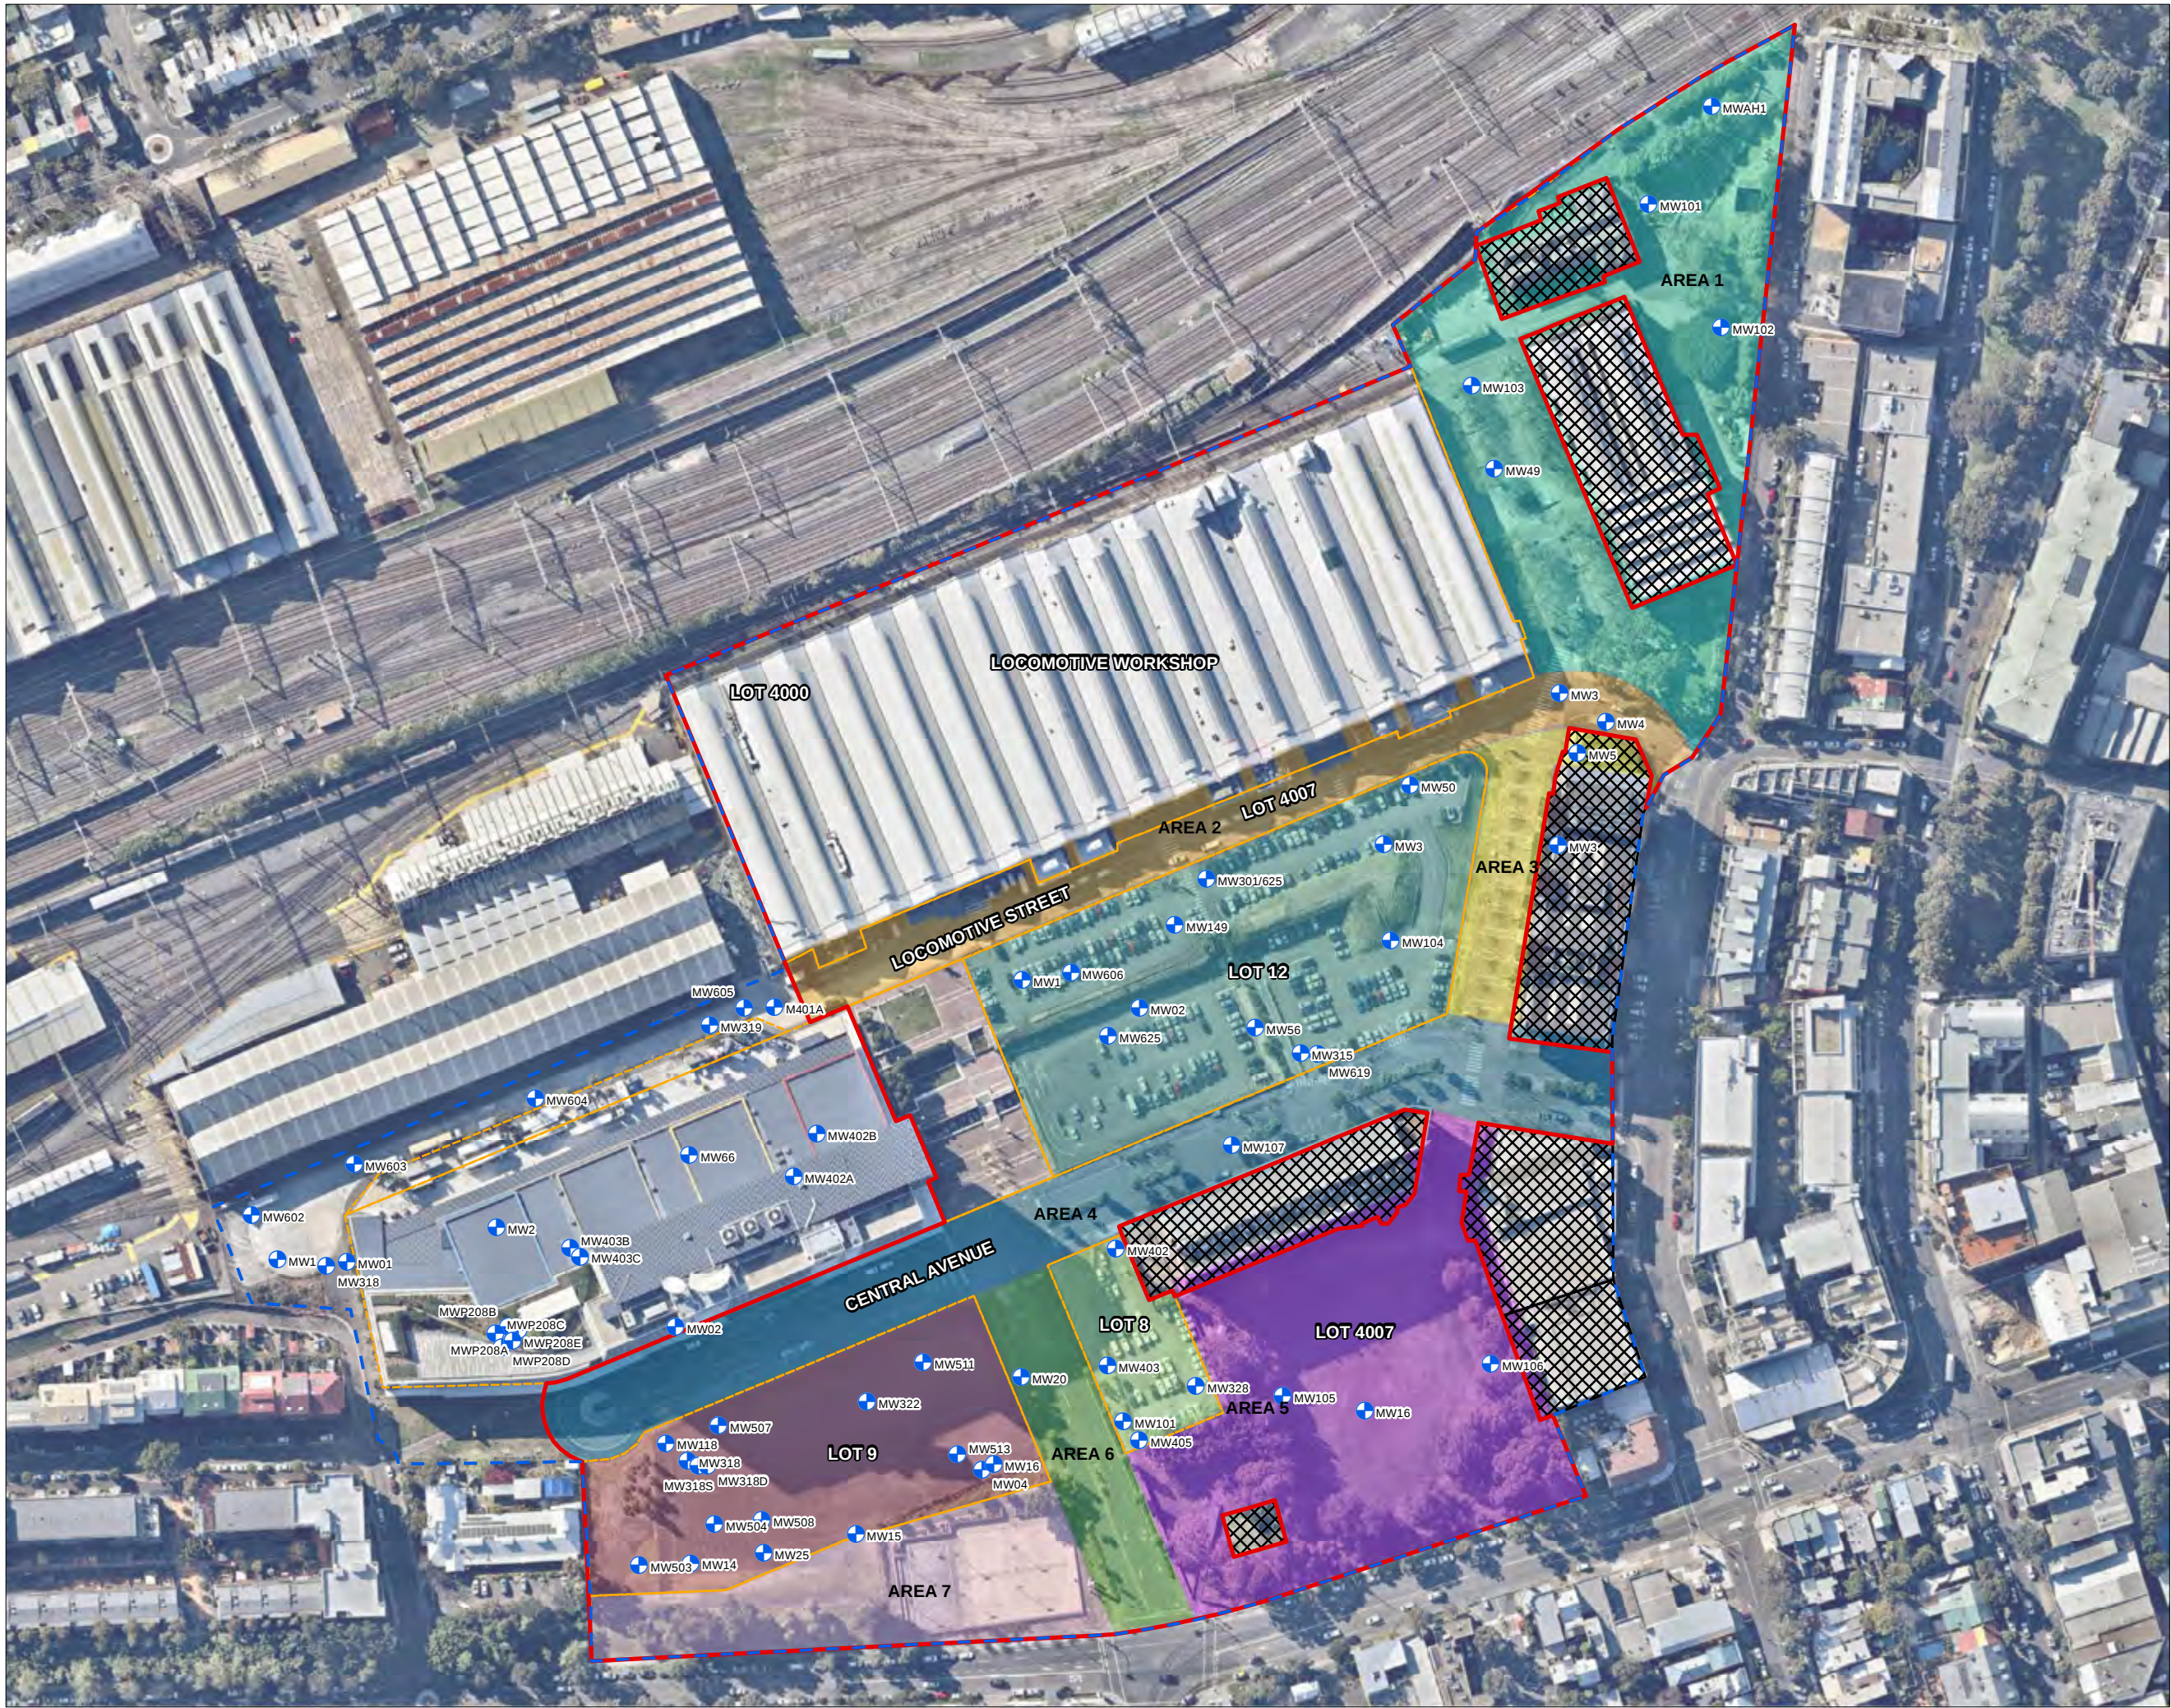
FIGURE 7D:

**HISTORIC GROUNDWATER  
MONITORING WELL  
LOCATIONS**

Archaeological reports presented in previous reports indicated that an underground storage tank (UST) may have been located between the Locomotive Workshop and the large erecting shop (**Figure 6**). The contents of the potential UST were unknown. In addition, it was reported solvent like substances were stored in a UST(s), along with a waste oil separator in the north eastern site extent (location unknown). Light non-aqueous phase liquid (LNAPL) hydrocarbons and elevated dissolved hydrocarbons have historically been reported at sample location MW3 within Area 2 (**Figure 7D**) and within Lot 10 DP 1136859 (beneath the Channel 7 building, outside the site boundary).

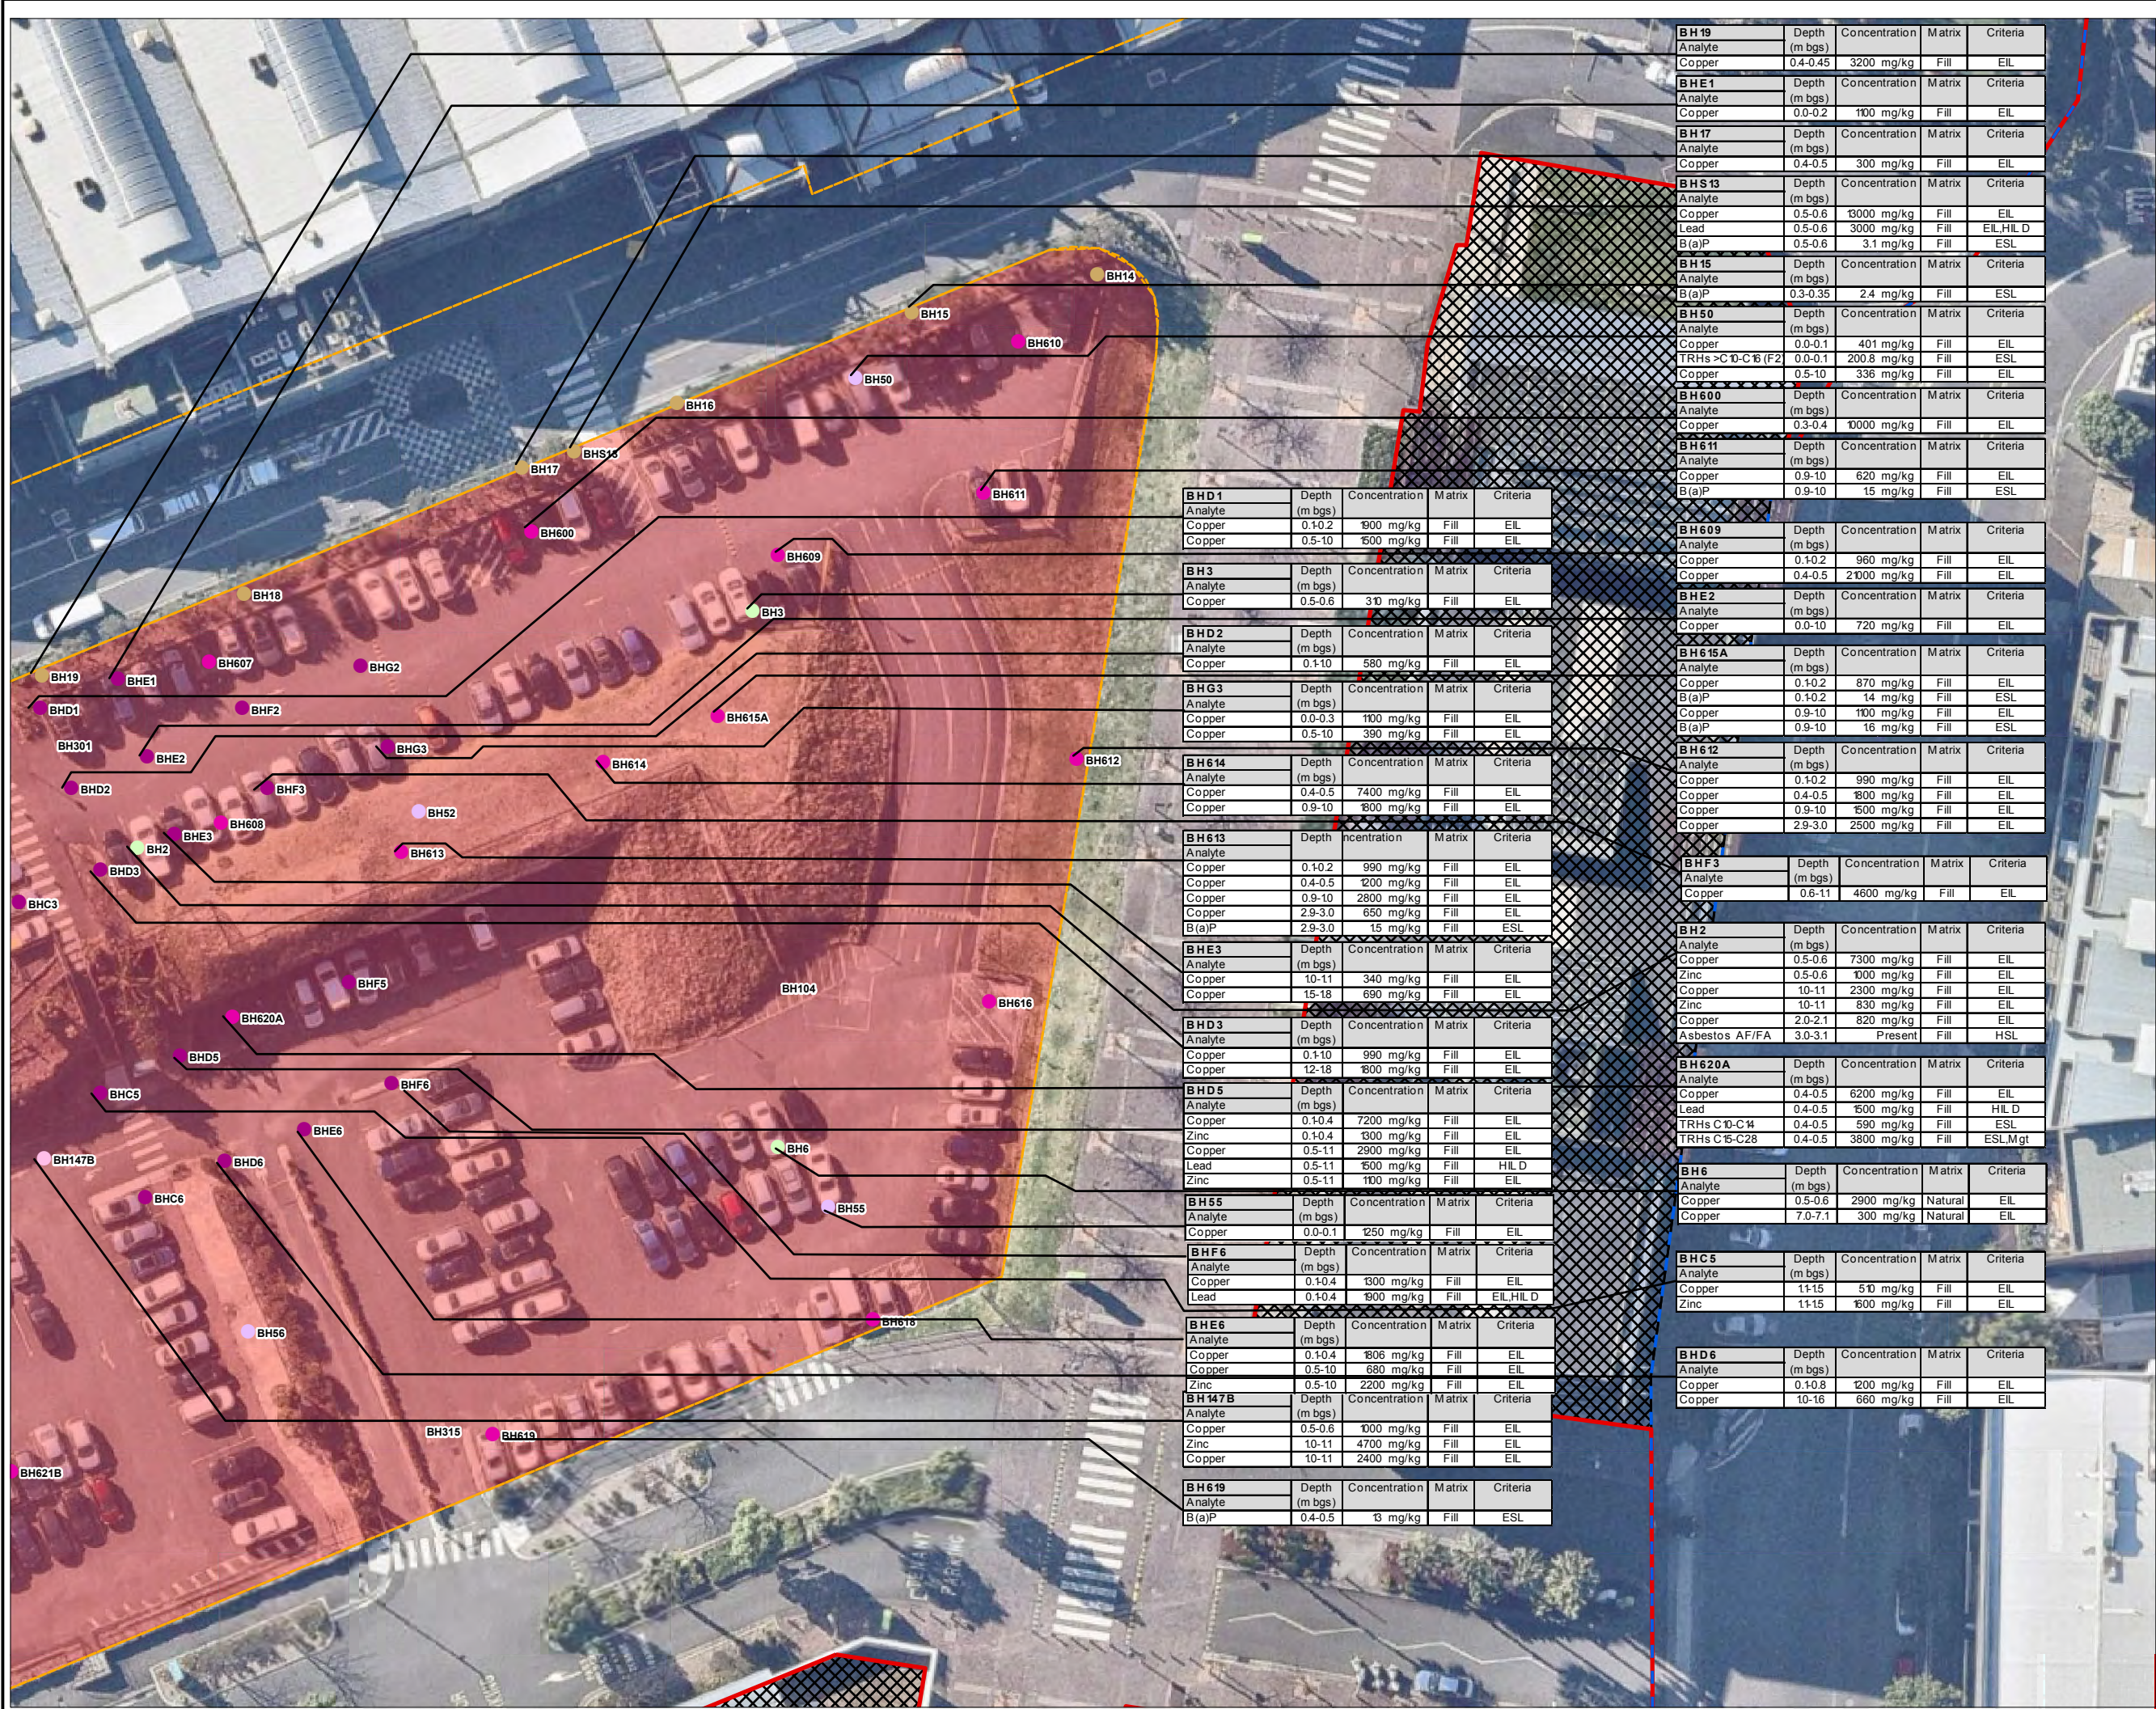
**FIGURE 8B EAST:**

**HISTORIC EXCEEDANCES  
IN SOIL AND REMEDIAL EXTENT  
- LOT 12 EAST**

A summary of existing analytical data is provided in **Appendix D**. Depth of fill and cross sections of site's lithology are depicted in **Figure 4** and **Figure 5** and **Figures 5A to 5D**, respectively to assist with the interpretation of site conditions. Soil sample exceedance with respect to land used criteria presented NEPC (2013) are shown on **Figures 8A, 8B-East, 8B-West, 8C and 8D**.

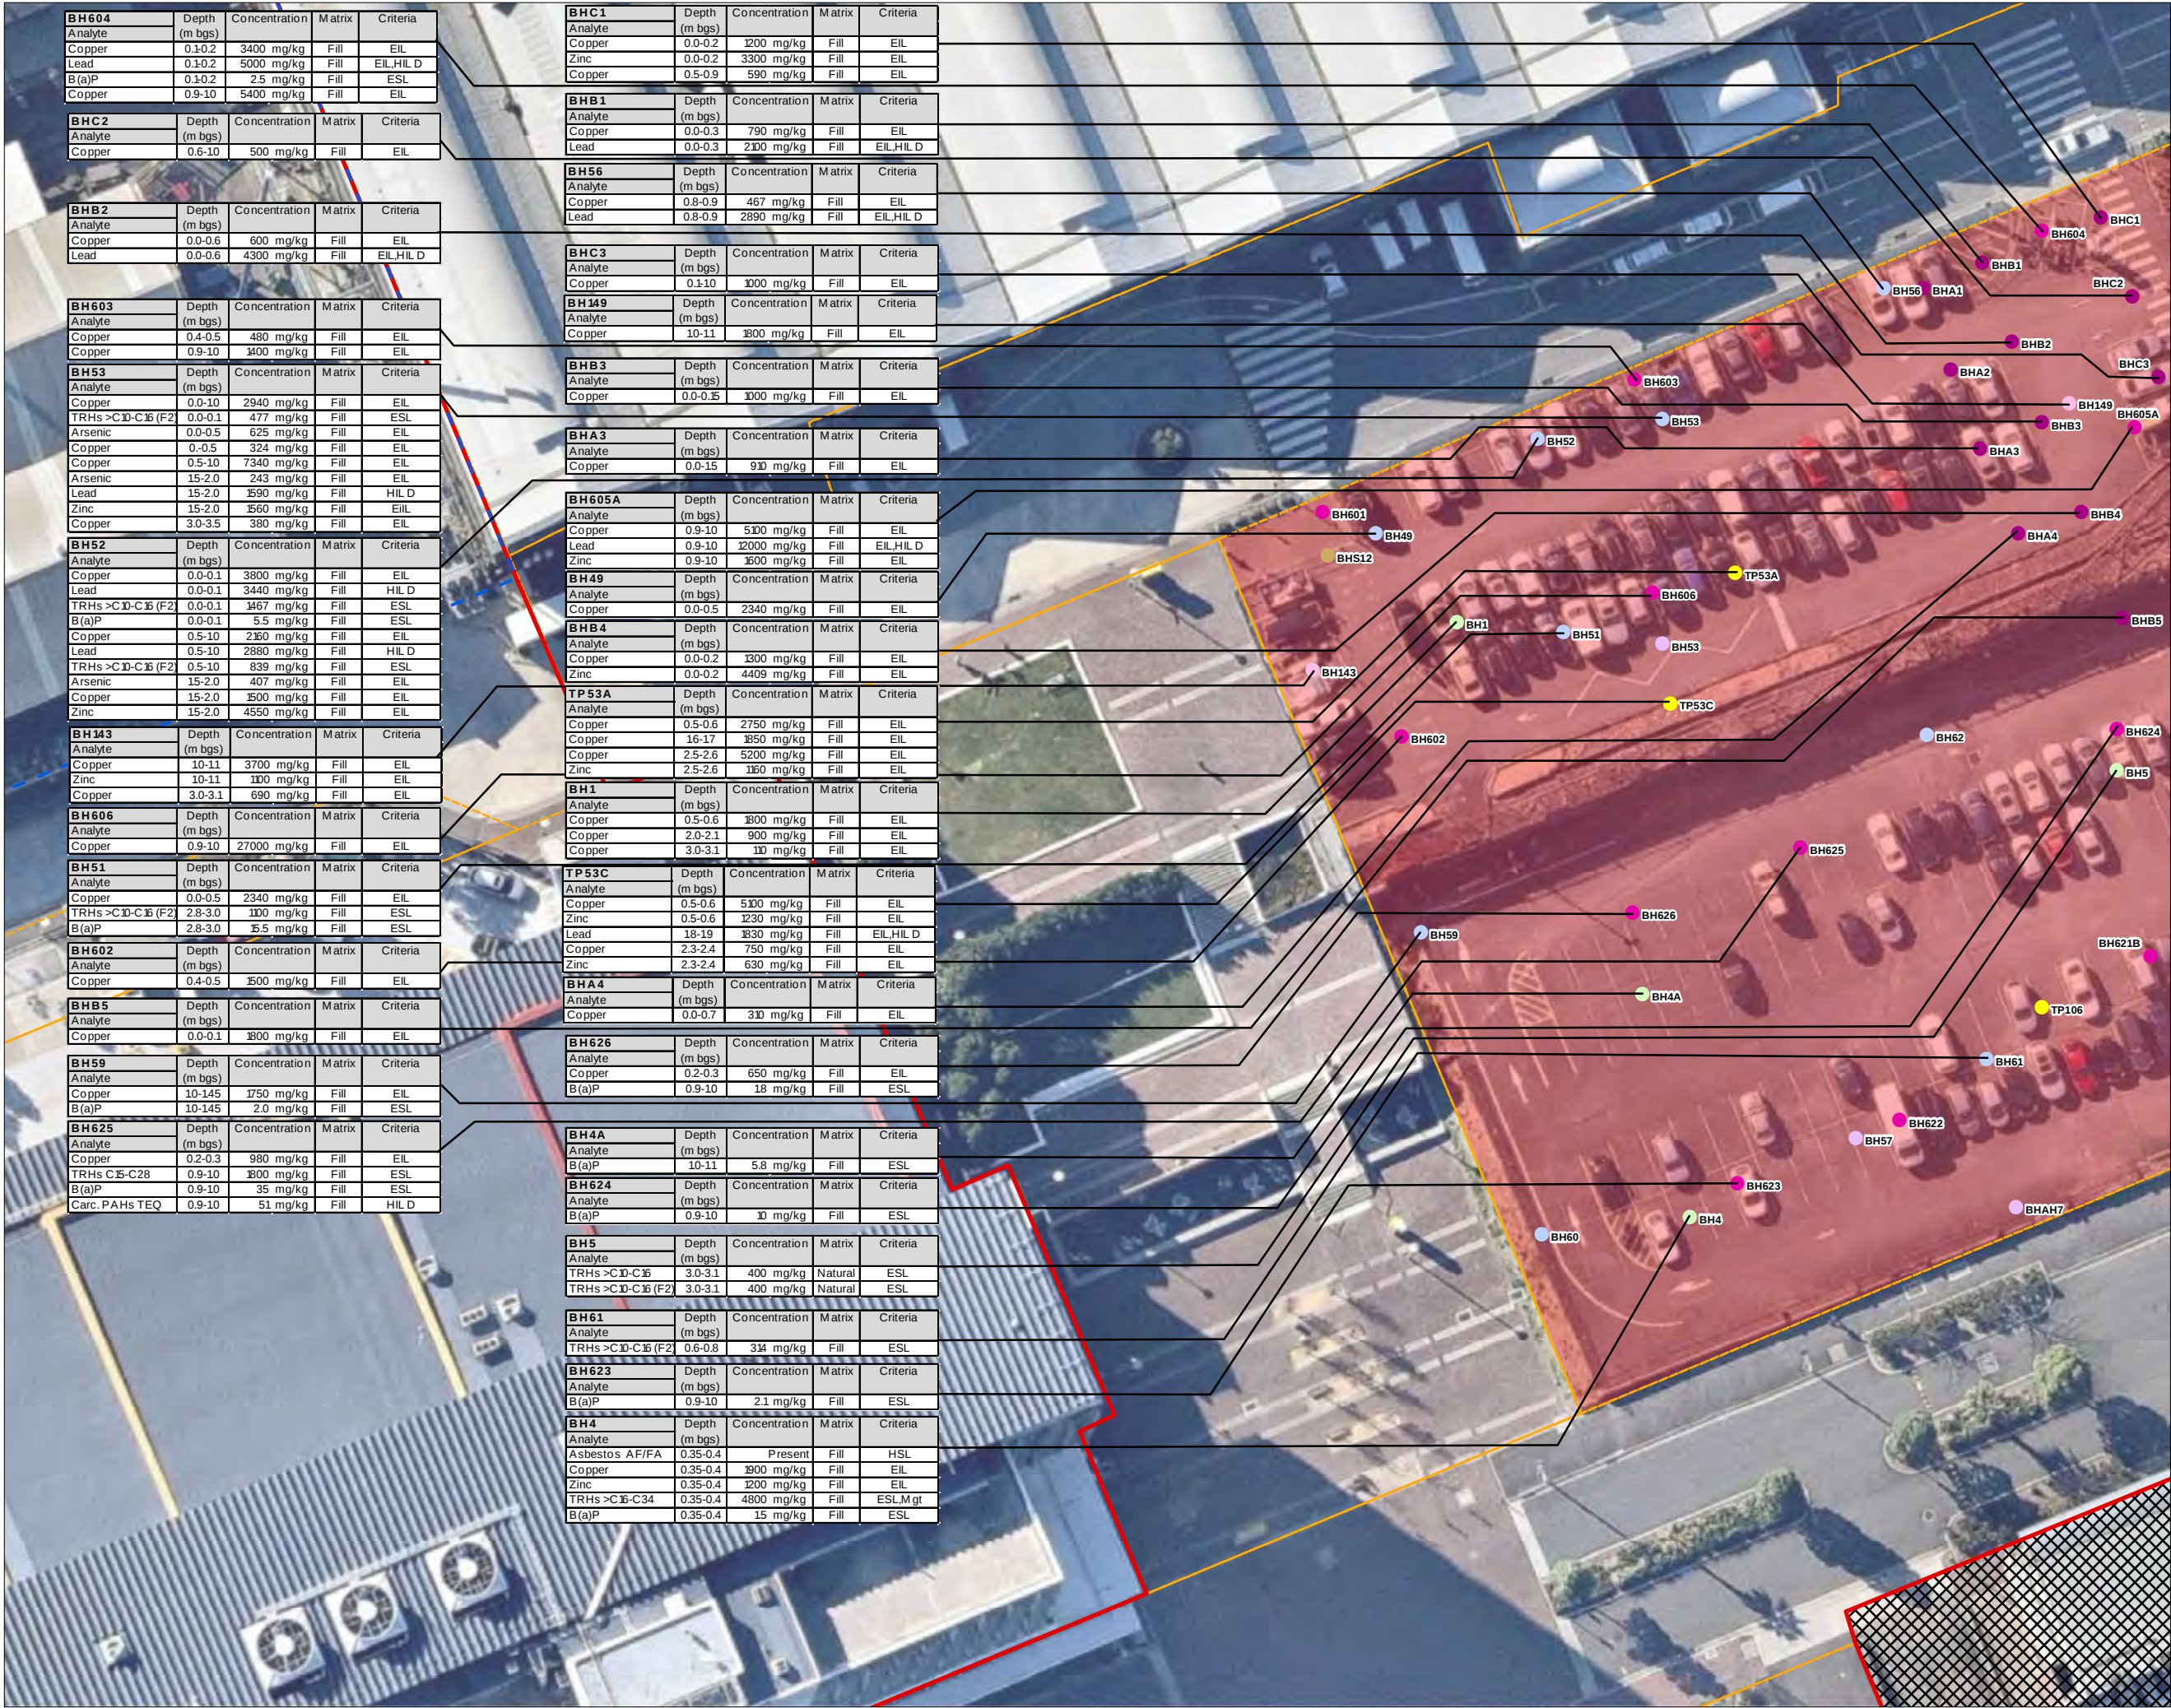
**FIGURE 8B WEST:**

**HISTORIC EXCEEDANCES  
IN SOIL AND REMEDIAL EXTENT  
- LOT 12 WEST**

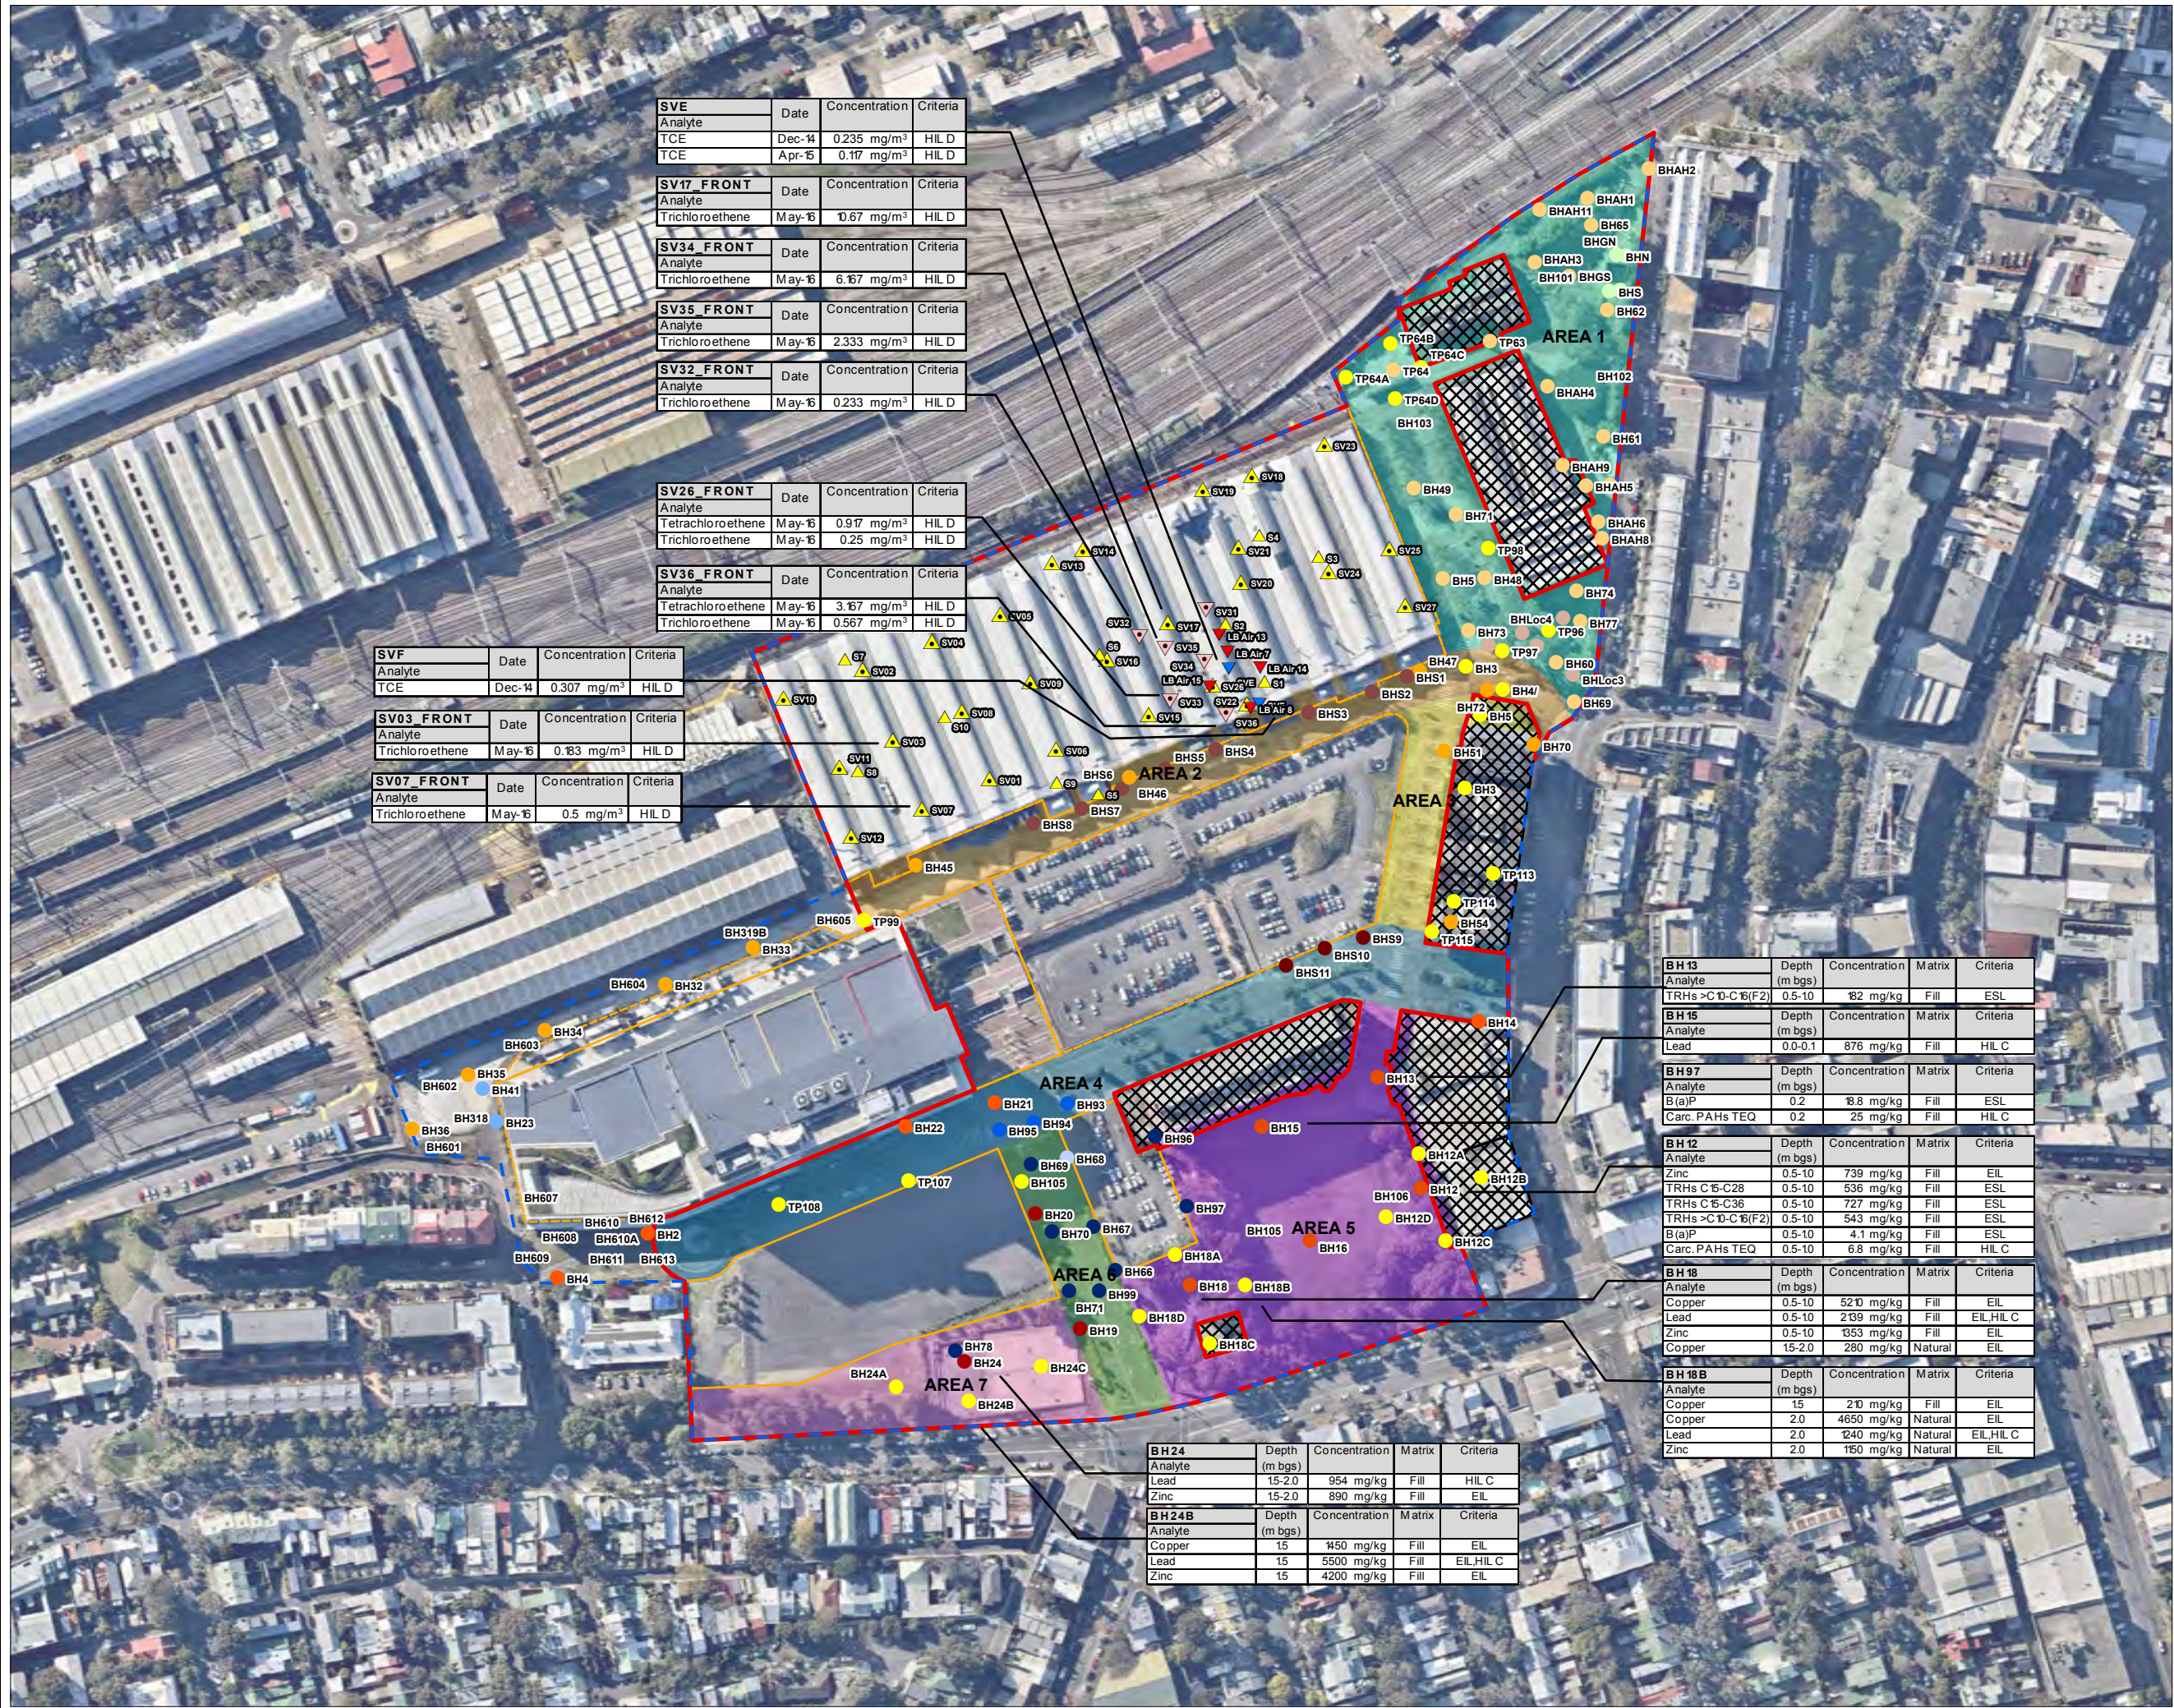
**FIGURE 8C:**

**HISTORIC EXCEEDANCES  
IN SOIL/SOIL VAPOUR -  
LOTS 4000 AND 4007,  
AREA 5 AND AREA 7  
(RECREATIONAL)**

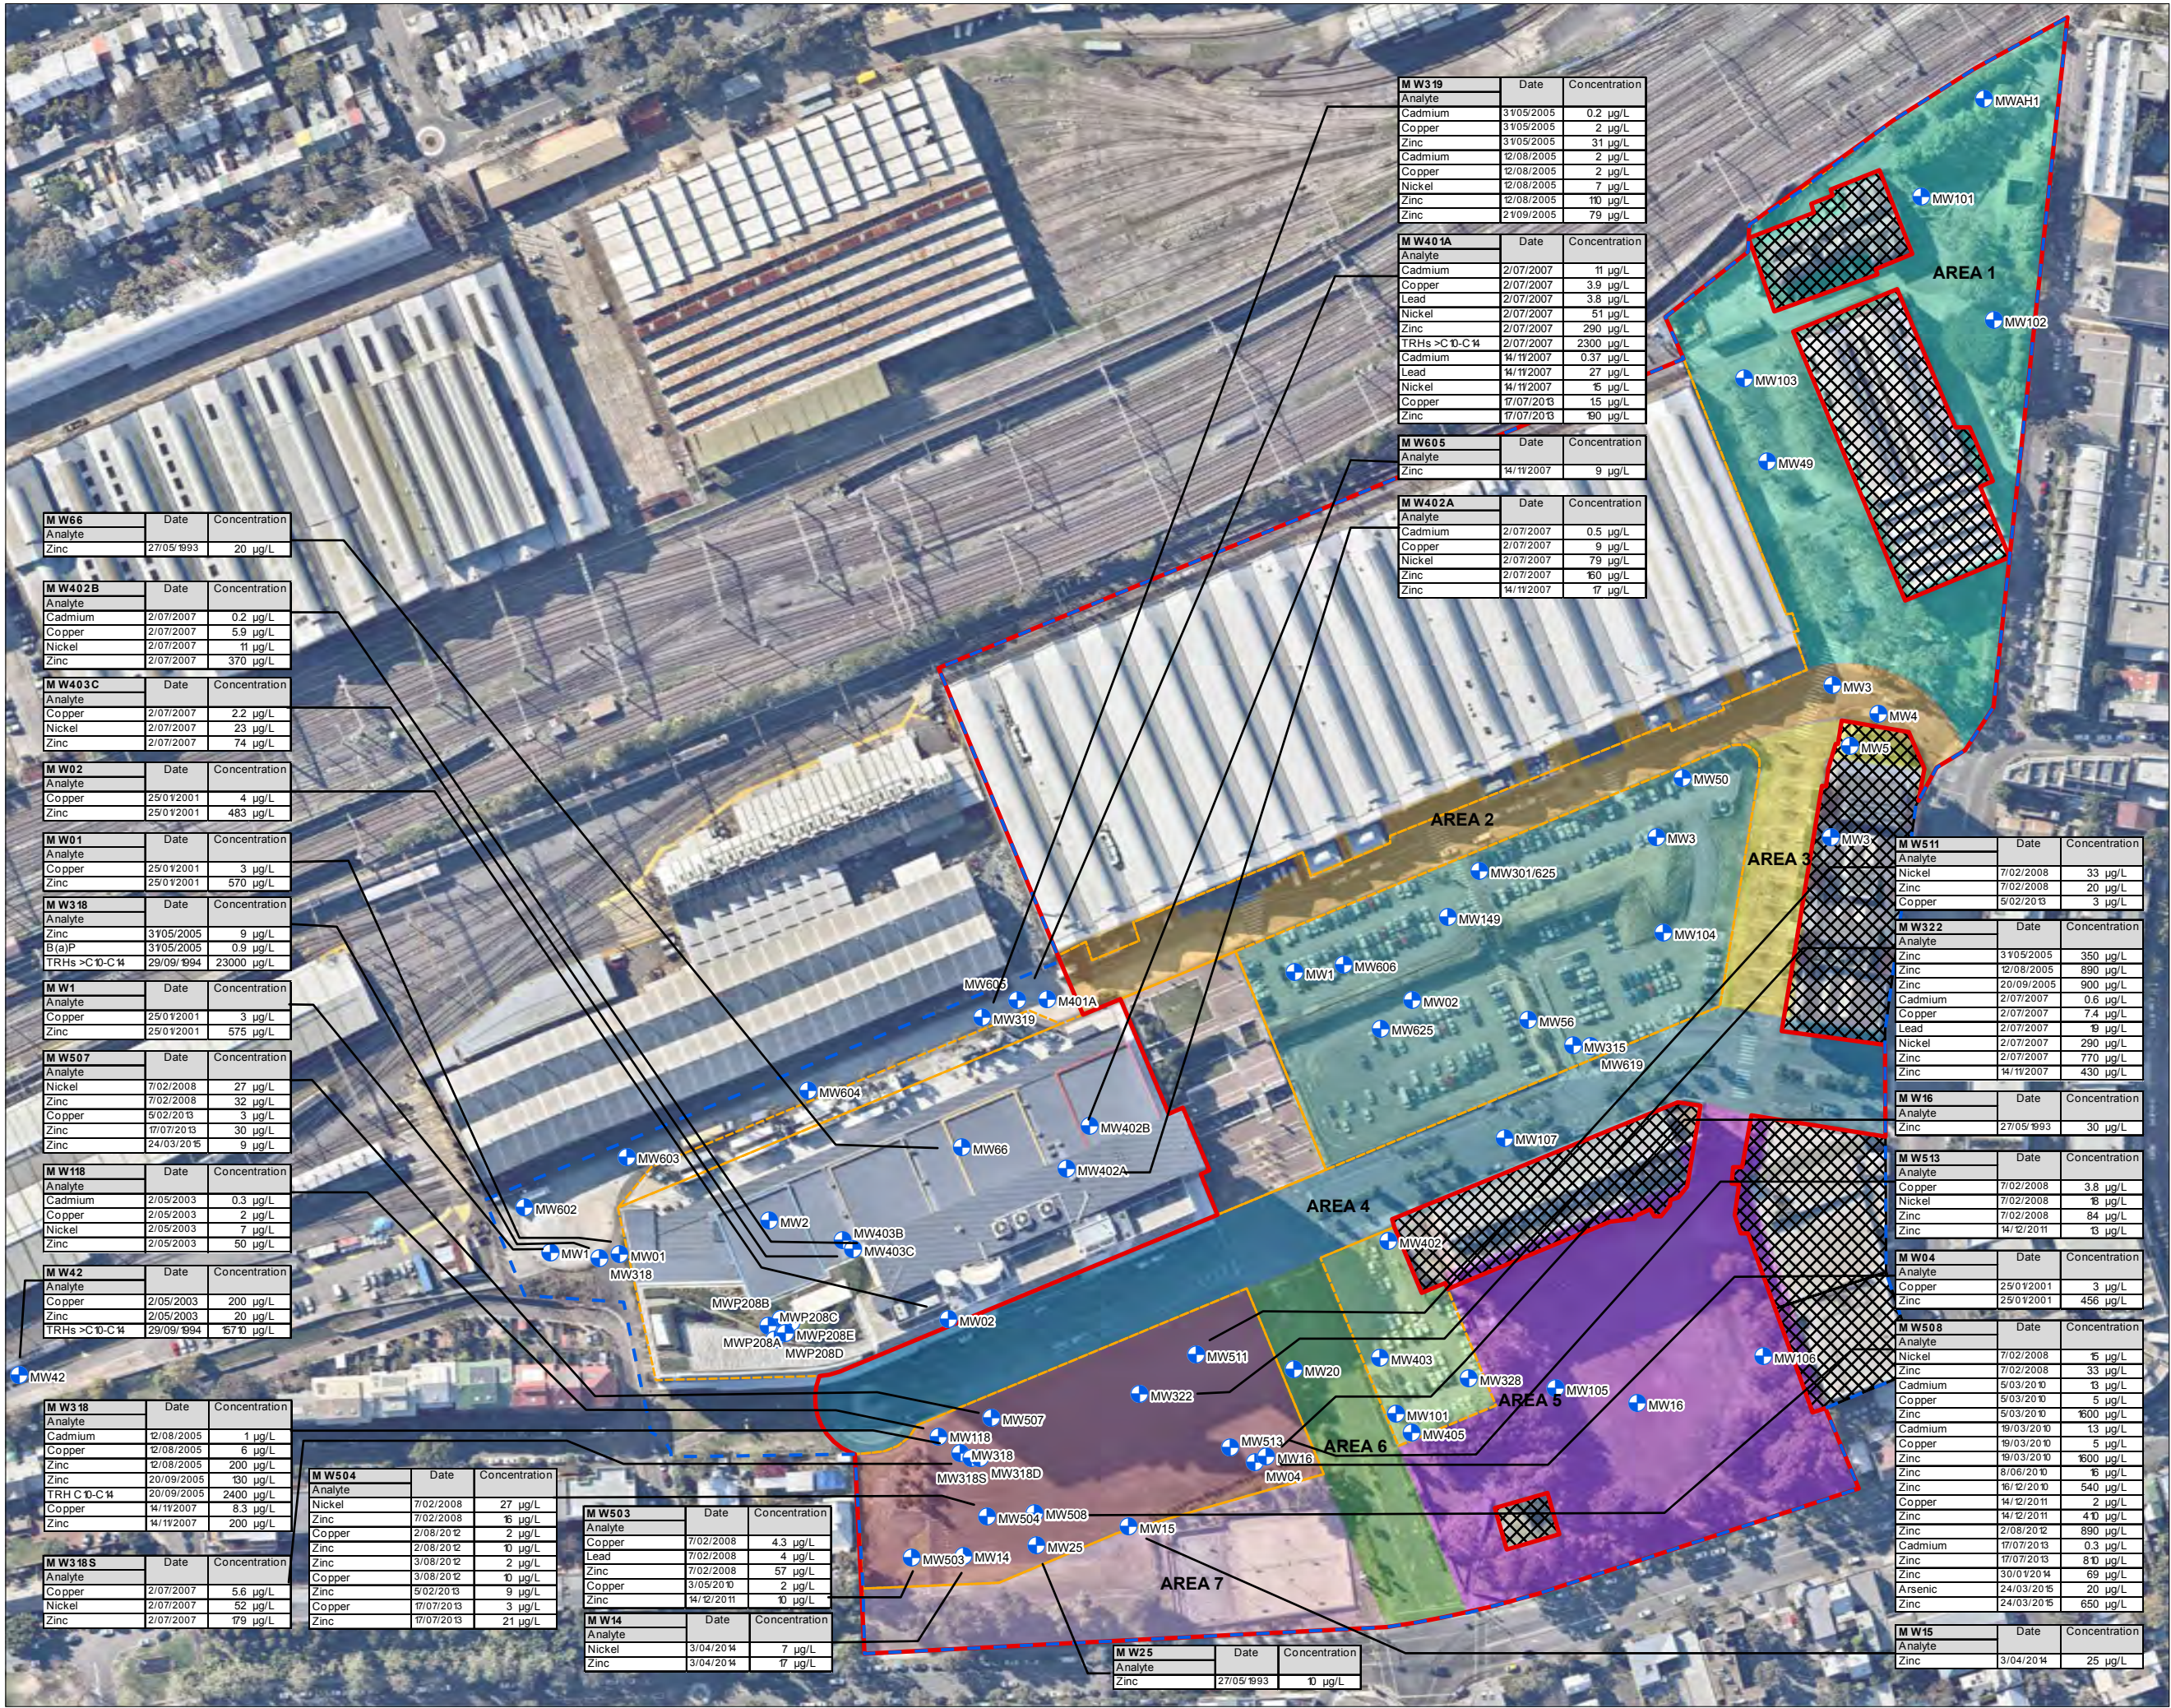
FIGURE 8E WEST:

**HISTORIC EXCEEDANCES  
IN GROUNDWATER**
