Mirvac Projects Pty Ltd  
Australian Technology Park Remedial Action Plan  
2 Locomotive Street, Eveleigh, NSW

15 June 2016  
51142/104280 (Revision 0)  
JBS&G Australia Pty Ltd

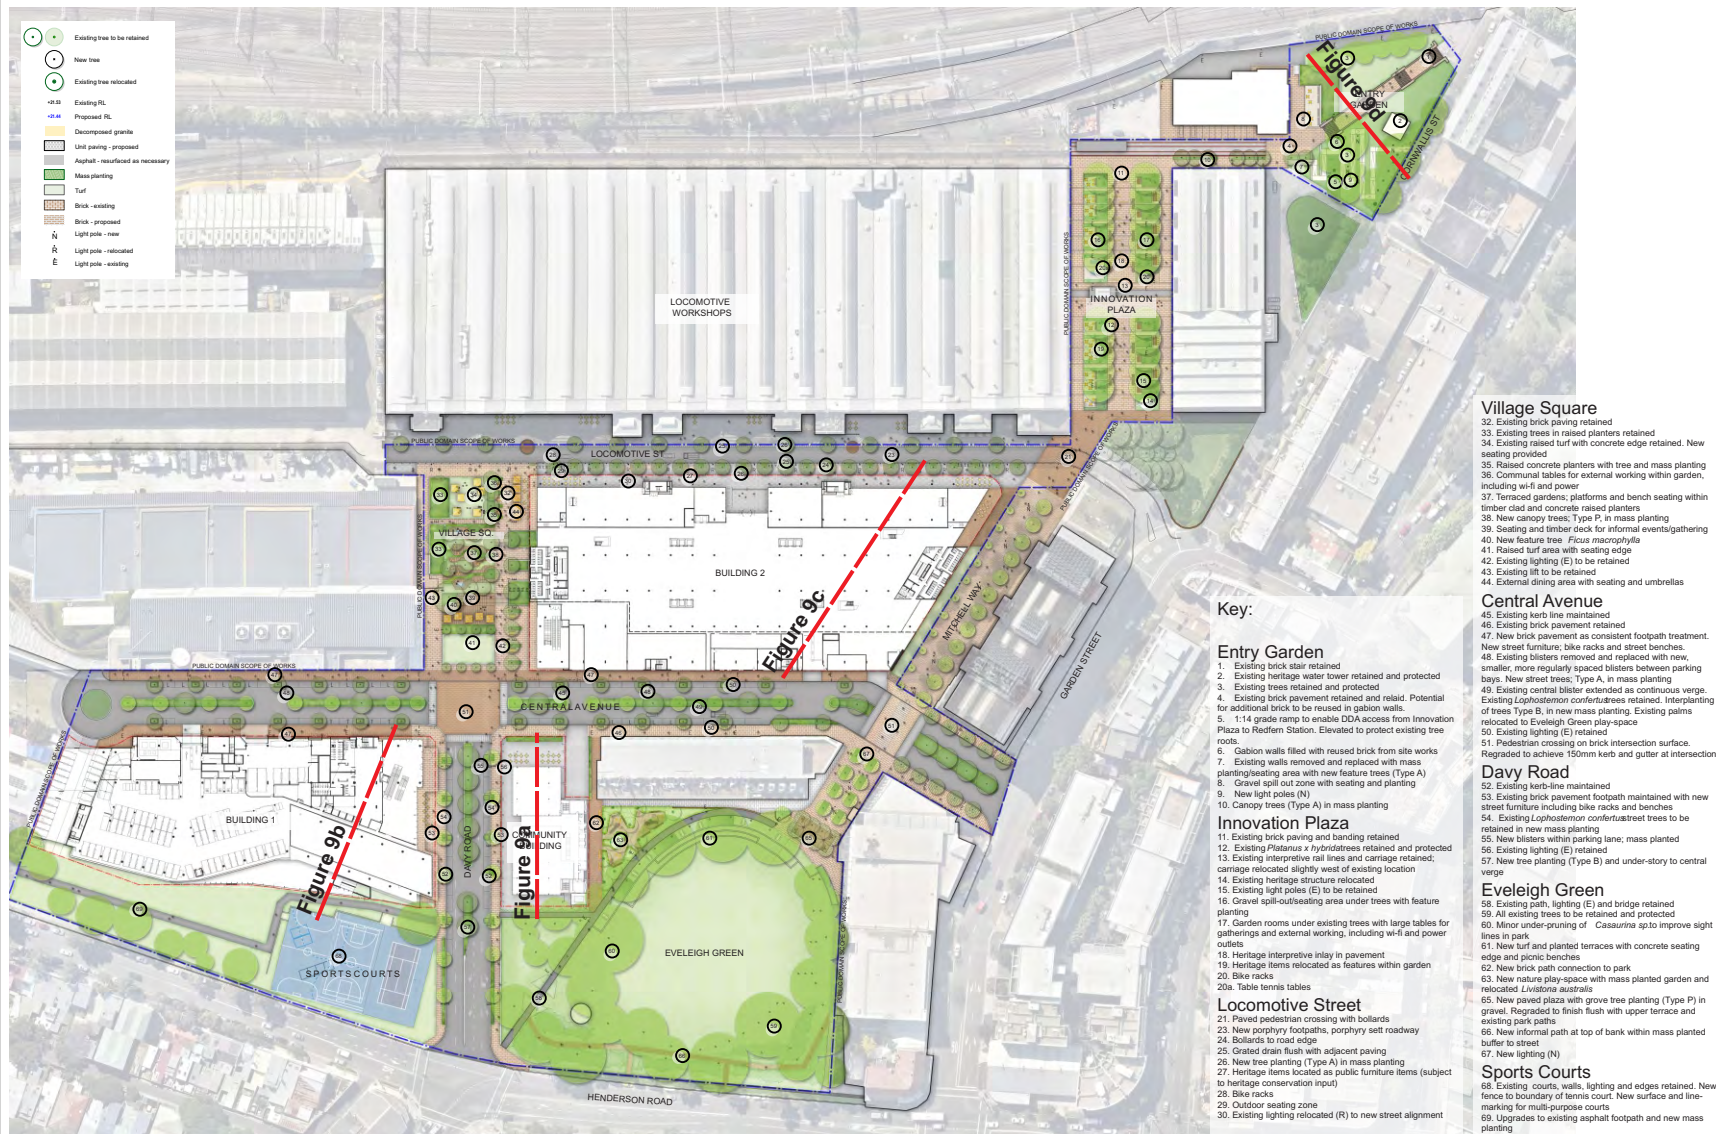
**FIGURE 9d:**

**SCHEMATIC REPRESENTATION  
OF CAPPING ARRANGEMENTS  
- LOT 4007 DP1194309 - AREA 1  
PUBLIC DOMAIN**

- The lateral extent of the works relevant to this RAP as presented in **Figure 2** and **Table 3.1**;
- The vertical extent of the works is defined as the depths required to implement appropriate capping, as schematically shown in **Figures 9A to 9D**.

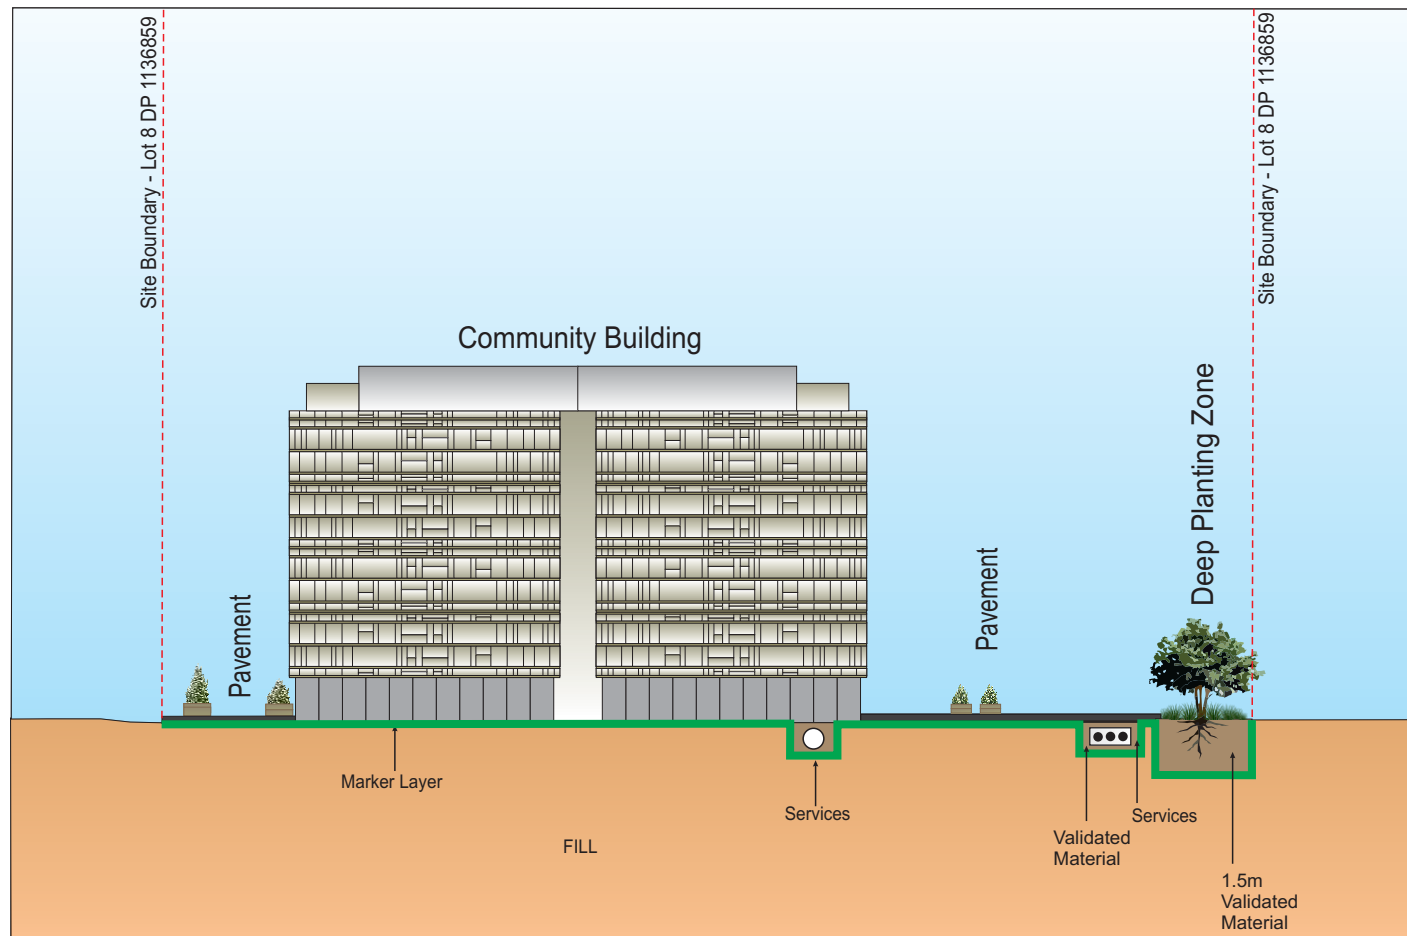
**FIGURE 9a:**

**SCHEMATIC REPRESENTATION  
OF CAPPING ARRANGEMENTS  
- LOT 8 DP1136859**

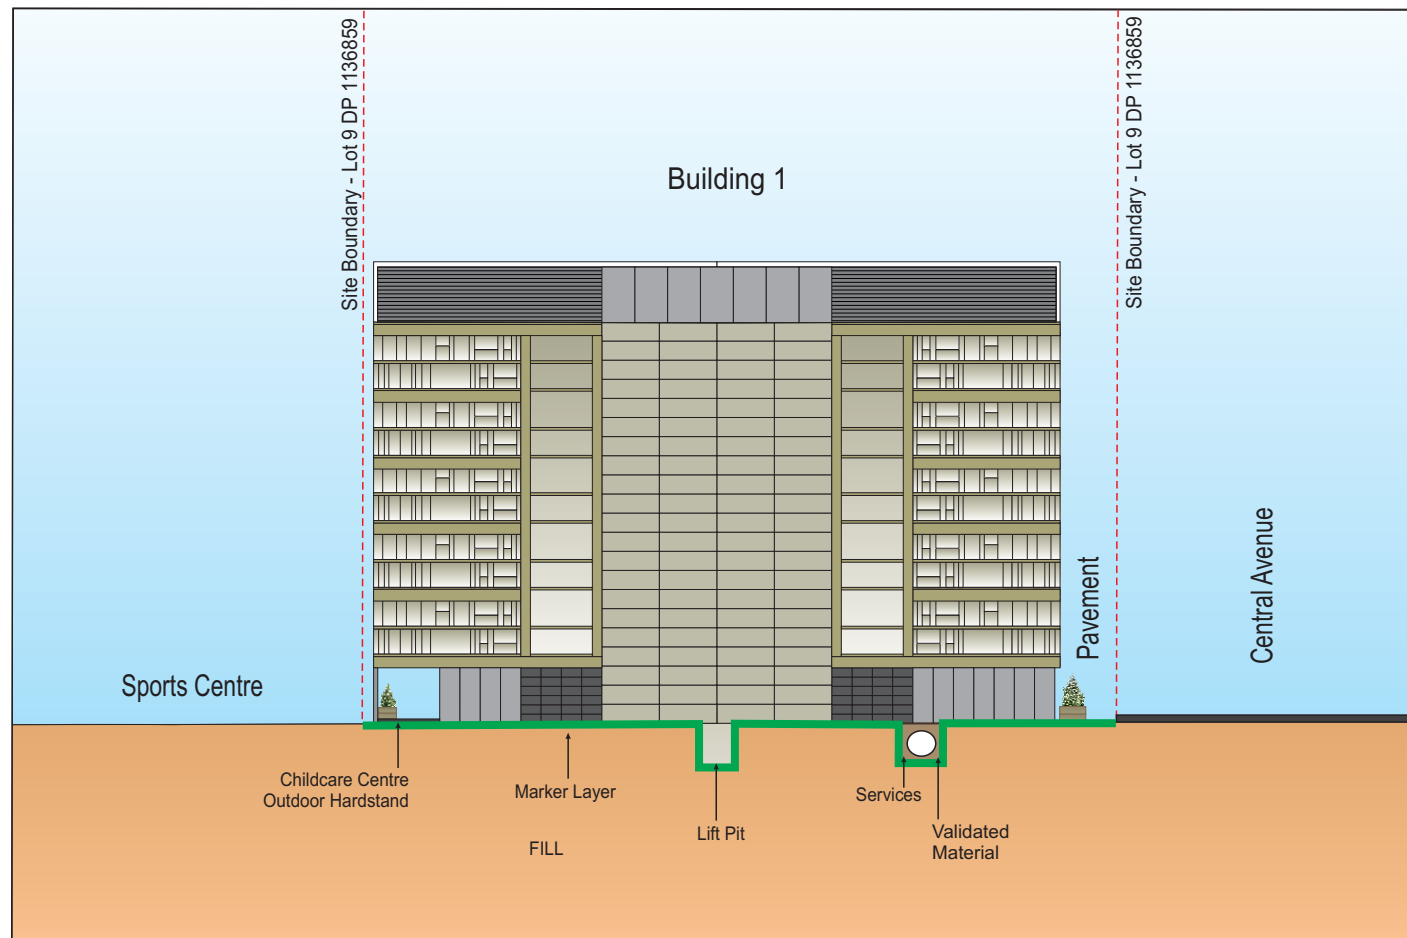
**FIGURE 9b:**

**SCHEMATIC REPRESENTATION  
OF CAPPING ARRANGEMENTS  
- LOT 9 DP1136859**

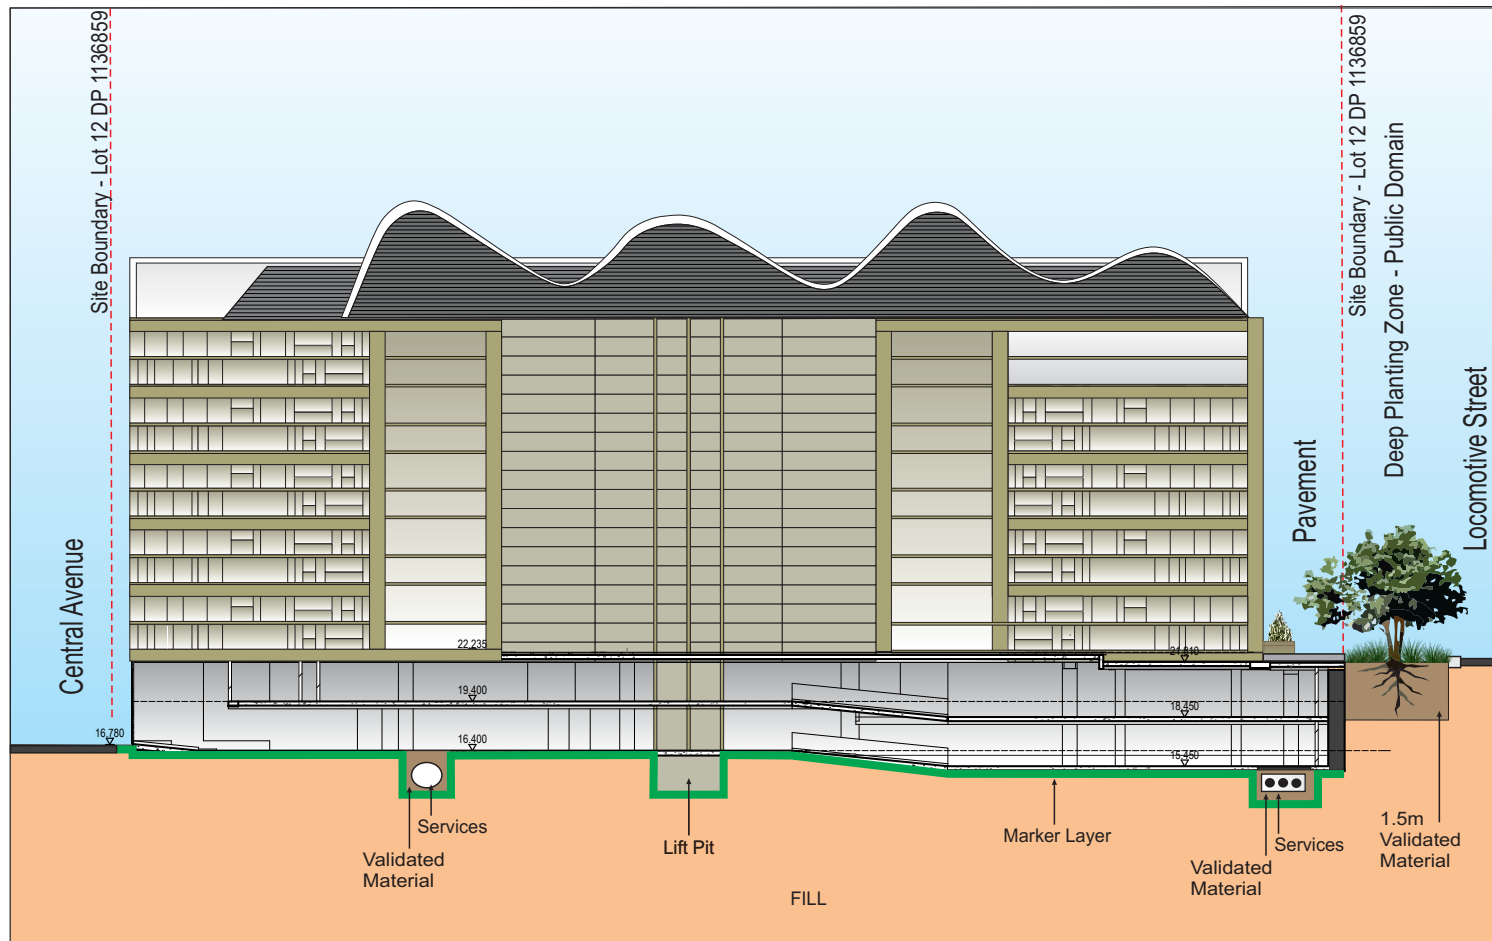
**FIGURE 9c:**

**SCHEMATIC REPRESENTATION  
OF CAPPING ARRANGEMENTS  
- LOT 12 DP1136859**

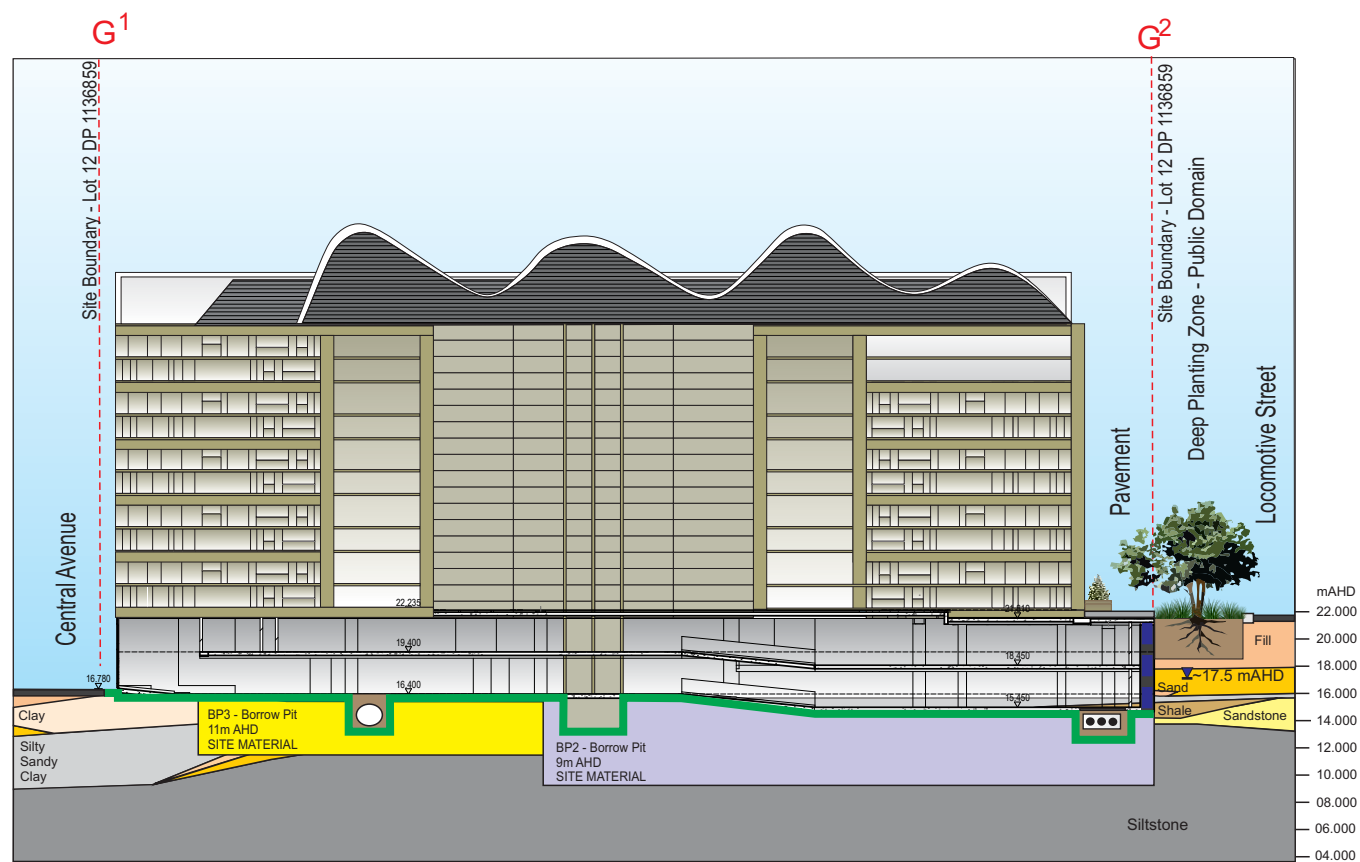
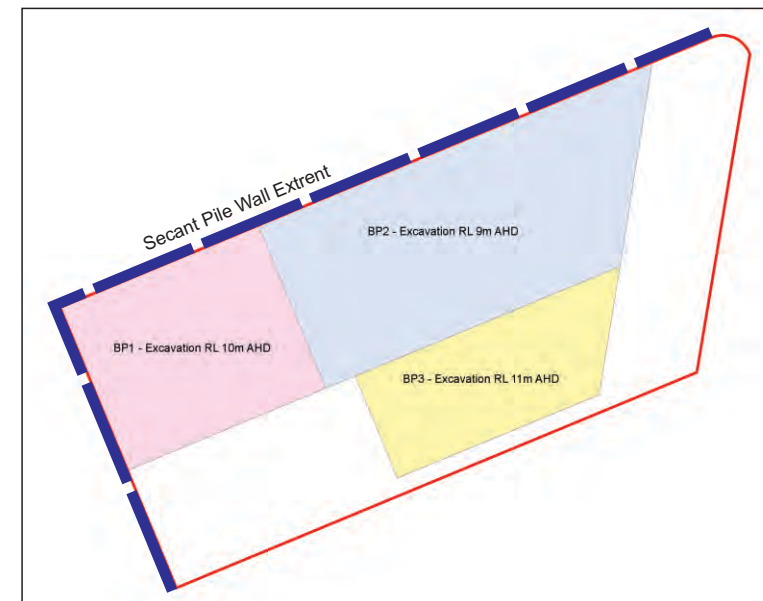
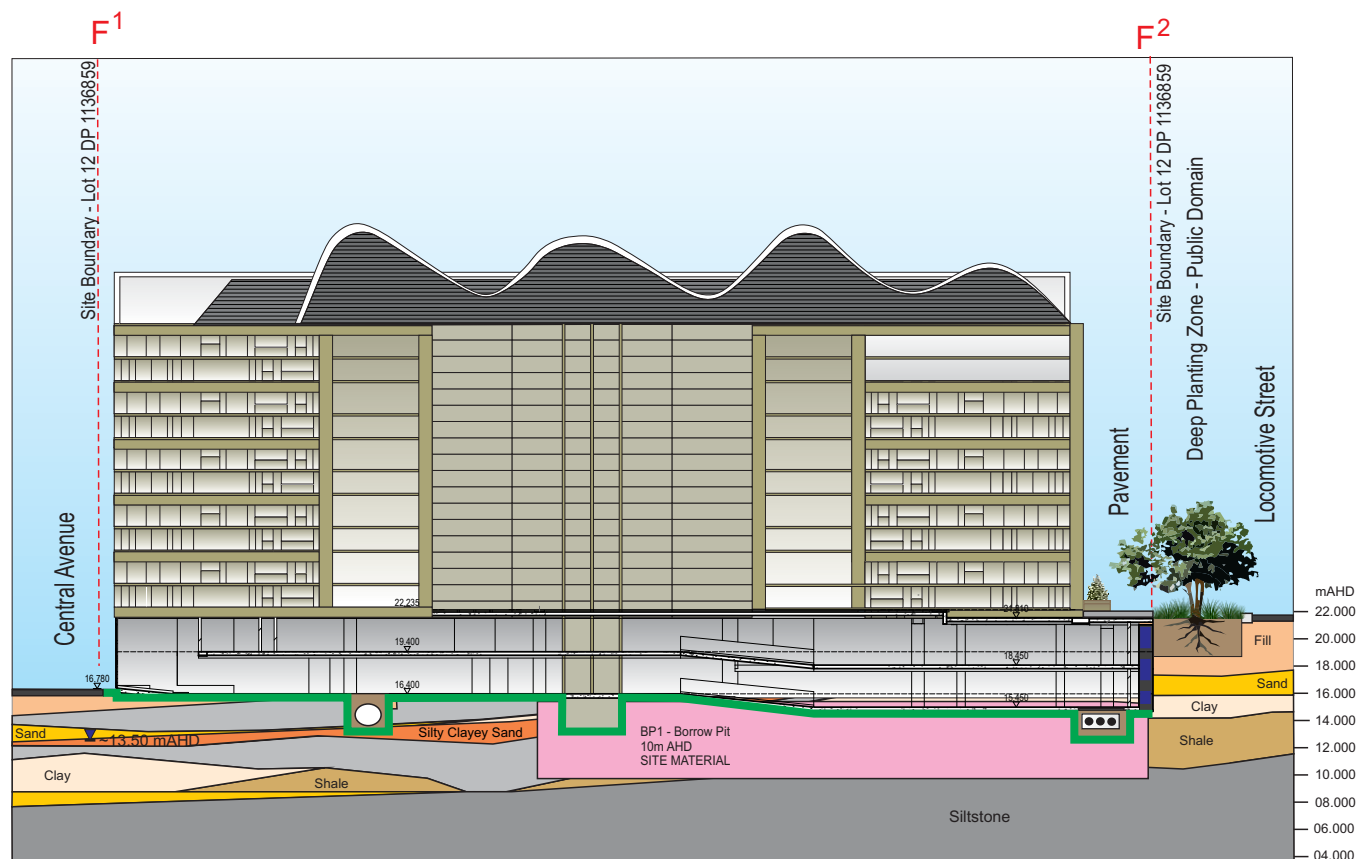
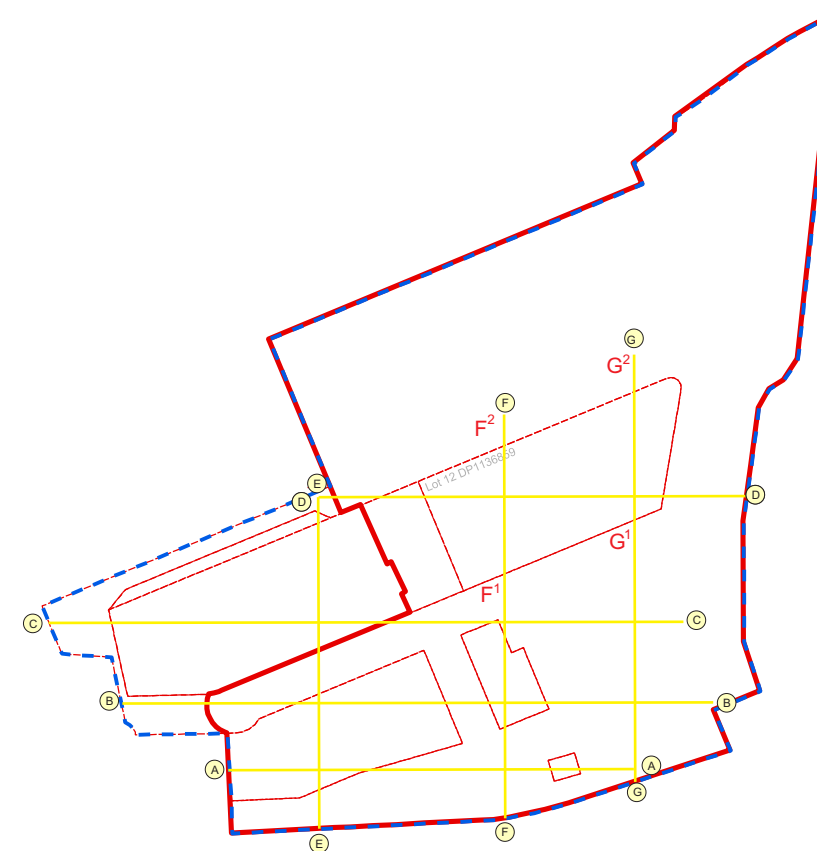
**FIGURE 10:**

- Legend:**
- Approximate Site Boundary
  - Borrow Pit Locations**
    - BP1 - Excavation RL 10m AHD
    - BP2 - Excavation RL 9m AHD
    - BP3 - Excavation RL 11m AHD
  - Site Material
  - Lithology**
    - Silty Sandy Clay
    - Clay
    - Sand
    - Silty Clayey Sand
    - Shale
    - Sandstone
    - Siltstone
  - Secant Pile Wall

With regards to the borrow pit/retention of fill materials beneath the future Lot 12 commercial building, to minimise waste generation and help achieve a green star rating, Mirvac propose to excavate fill materials, natural soils and bedrock to depths ranging to approximately 9 AHD m to 11 m AHD. The proposed excavation location/layout is shown on **Figure 10**. Additional design details are summarised in **Table 7.2** below.

| Borrow pit footprint | The borrow pit is proposed to be excavated beneath the future Lot 12 commercial building offset by approximately 26 m from the eastern Lot 12 boundary, 5 m from the southern Lot 12 boundary and approximately 40 m from the south western Lot 12 boundary. The borrow pit abuts the northern and western Lot 12 boundary. A secant pile wall (or similar) is proposed along the northern and western Lot 12 boundaries, retaining fill materials from neighbouring allotments. Potential remains for the secant pile wall (or similar) to be extended along the north eastern Lot 12 boundary, however, these details have yet to be confirmed/finalised. The borrow pit layout is shown on <b>Figure 10</b> . The secant pile wall (or similar) will help reduce groundwater migration |
| Borrow pit elevation (base) | Mirvac propose to excavate fill materials, natural soils and bedrock to depths ranging to approximately 9 AHD m to 11 m AHD, as shown on <b>Figure 10</b> |

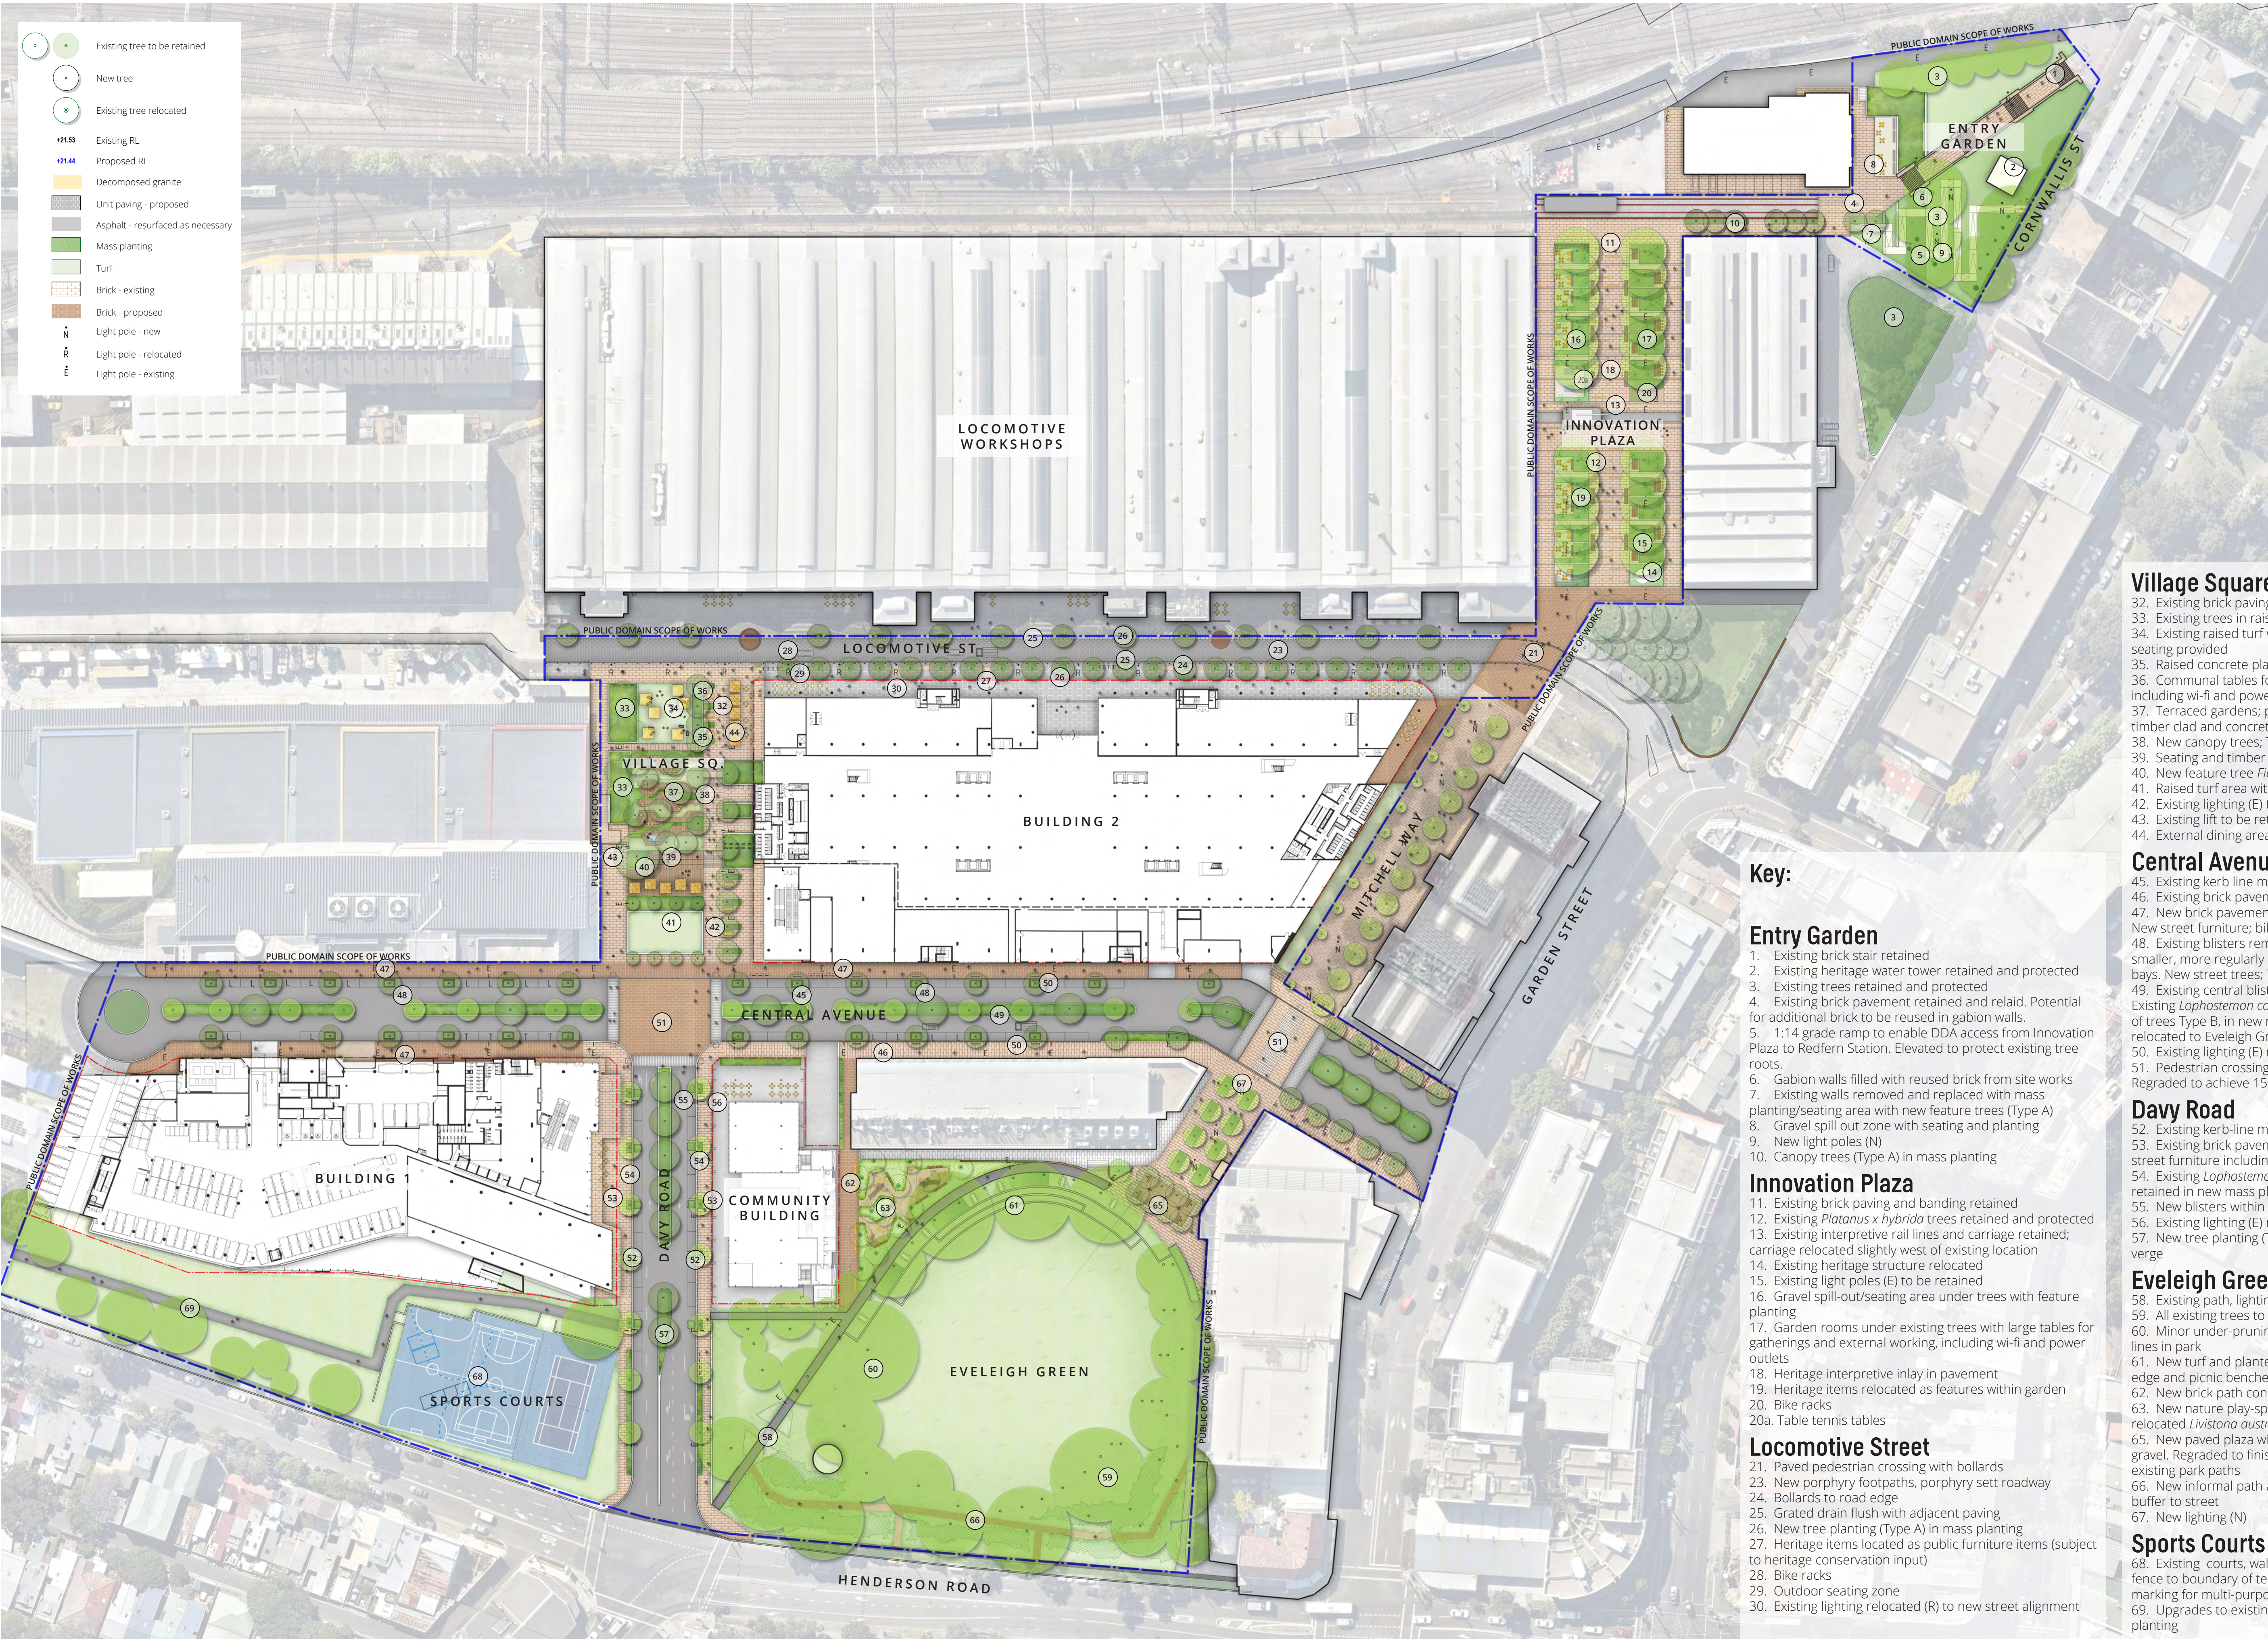
- 32. Existing brick paving retained
- 33. Existing trees in raised planters retained
- 34. Existing raised turf with concrete edge retained. New seating provided
- 35. Raised concrete planters with tree and mass planting
- 36. Communal tables for external working within garden, including wi-fi and power
- 37. Terraced gardens; platforms and bench seating within timber clad and concrete raised planters
- 38. New canopy trees; Type P, in mass planting
- 39. Seating and timber deck for informal events/gathering
- 40. New feature tree *Ficus macrophylla*
- 41. Raised turf area with seating edge
- 42. Existing lighting (E) to be retained
- 43. Existing lift to be retained
- 44. External dining area with seating and umbrellas

- 21. Paved pedestrian crossing with bollards
- 23. New porphyry footpaths, porphyry sett roadway
- 24. Bollards to road edge
- 25. Grated drain flush with adjacent paving
- 26. New tree planting (Type A) in mass planting
- 27. Heritage items located as public furniture items (subject to heritage conservation input)
- 28. Bike racks
- 29. Outdoor seating zone
- 30. Existing lighting relocated (R) to new street alignment

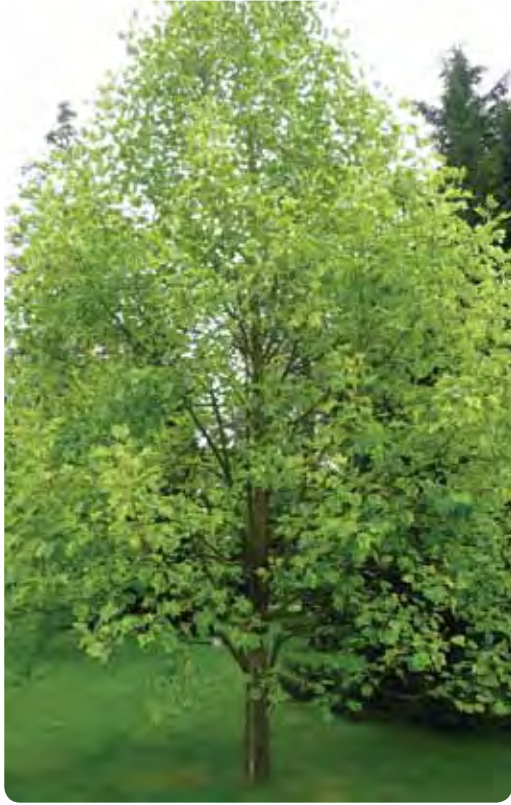
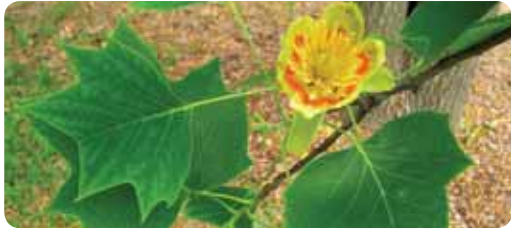
LIRIODENDRON TULIPIFERA - TULIP TREE

Scale: 20m x 5m  
Form: pyramidal crown when young, becoming oval in shape with time.  
Native: No  
Evergreen: No  
CoS MP: Y

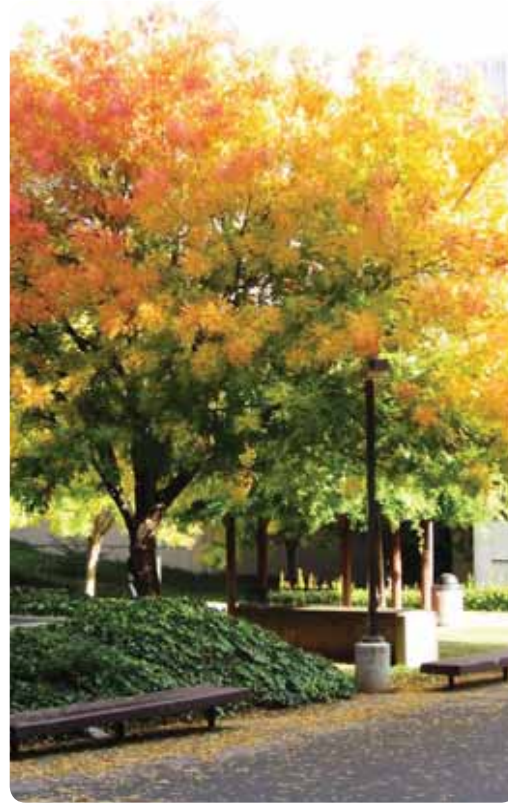
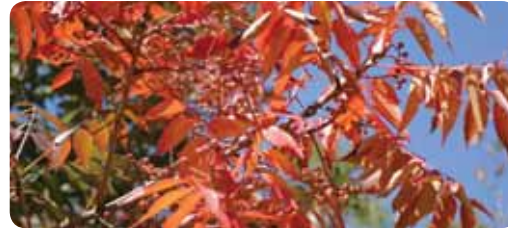
PISTACIA CHINENSIS - CHINESE PISTACHIO

Scale: 8m x 6m  
Form: Rounded habit.  
Native: No  
Evergreen: No  
CoS MP: Y

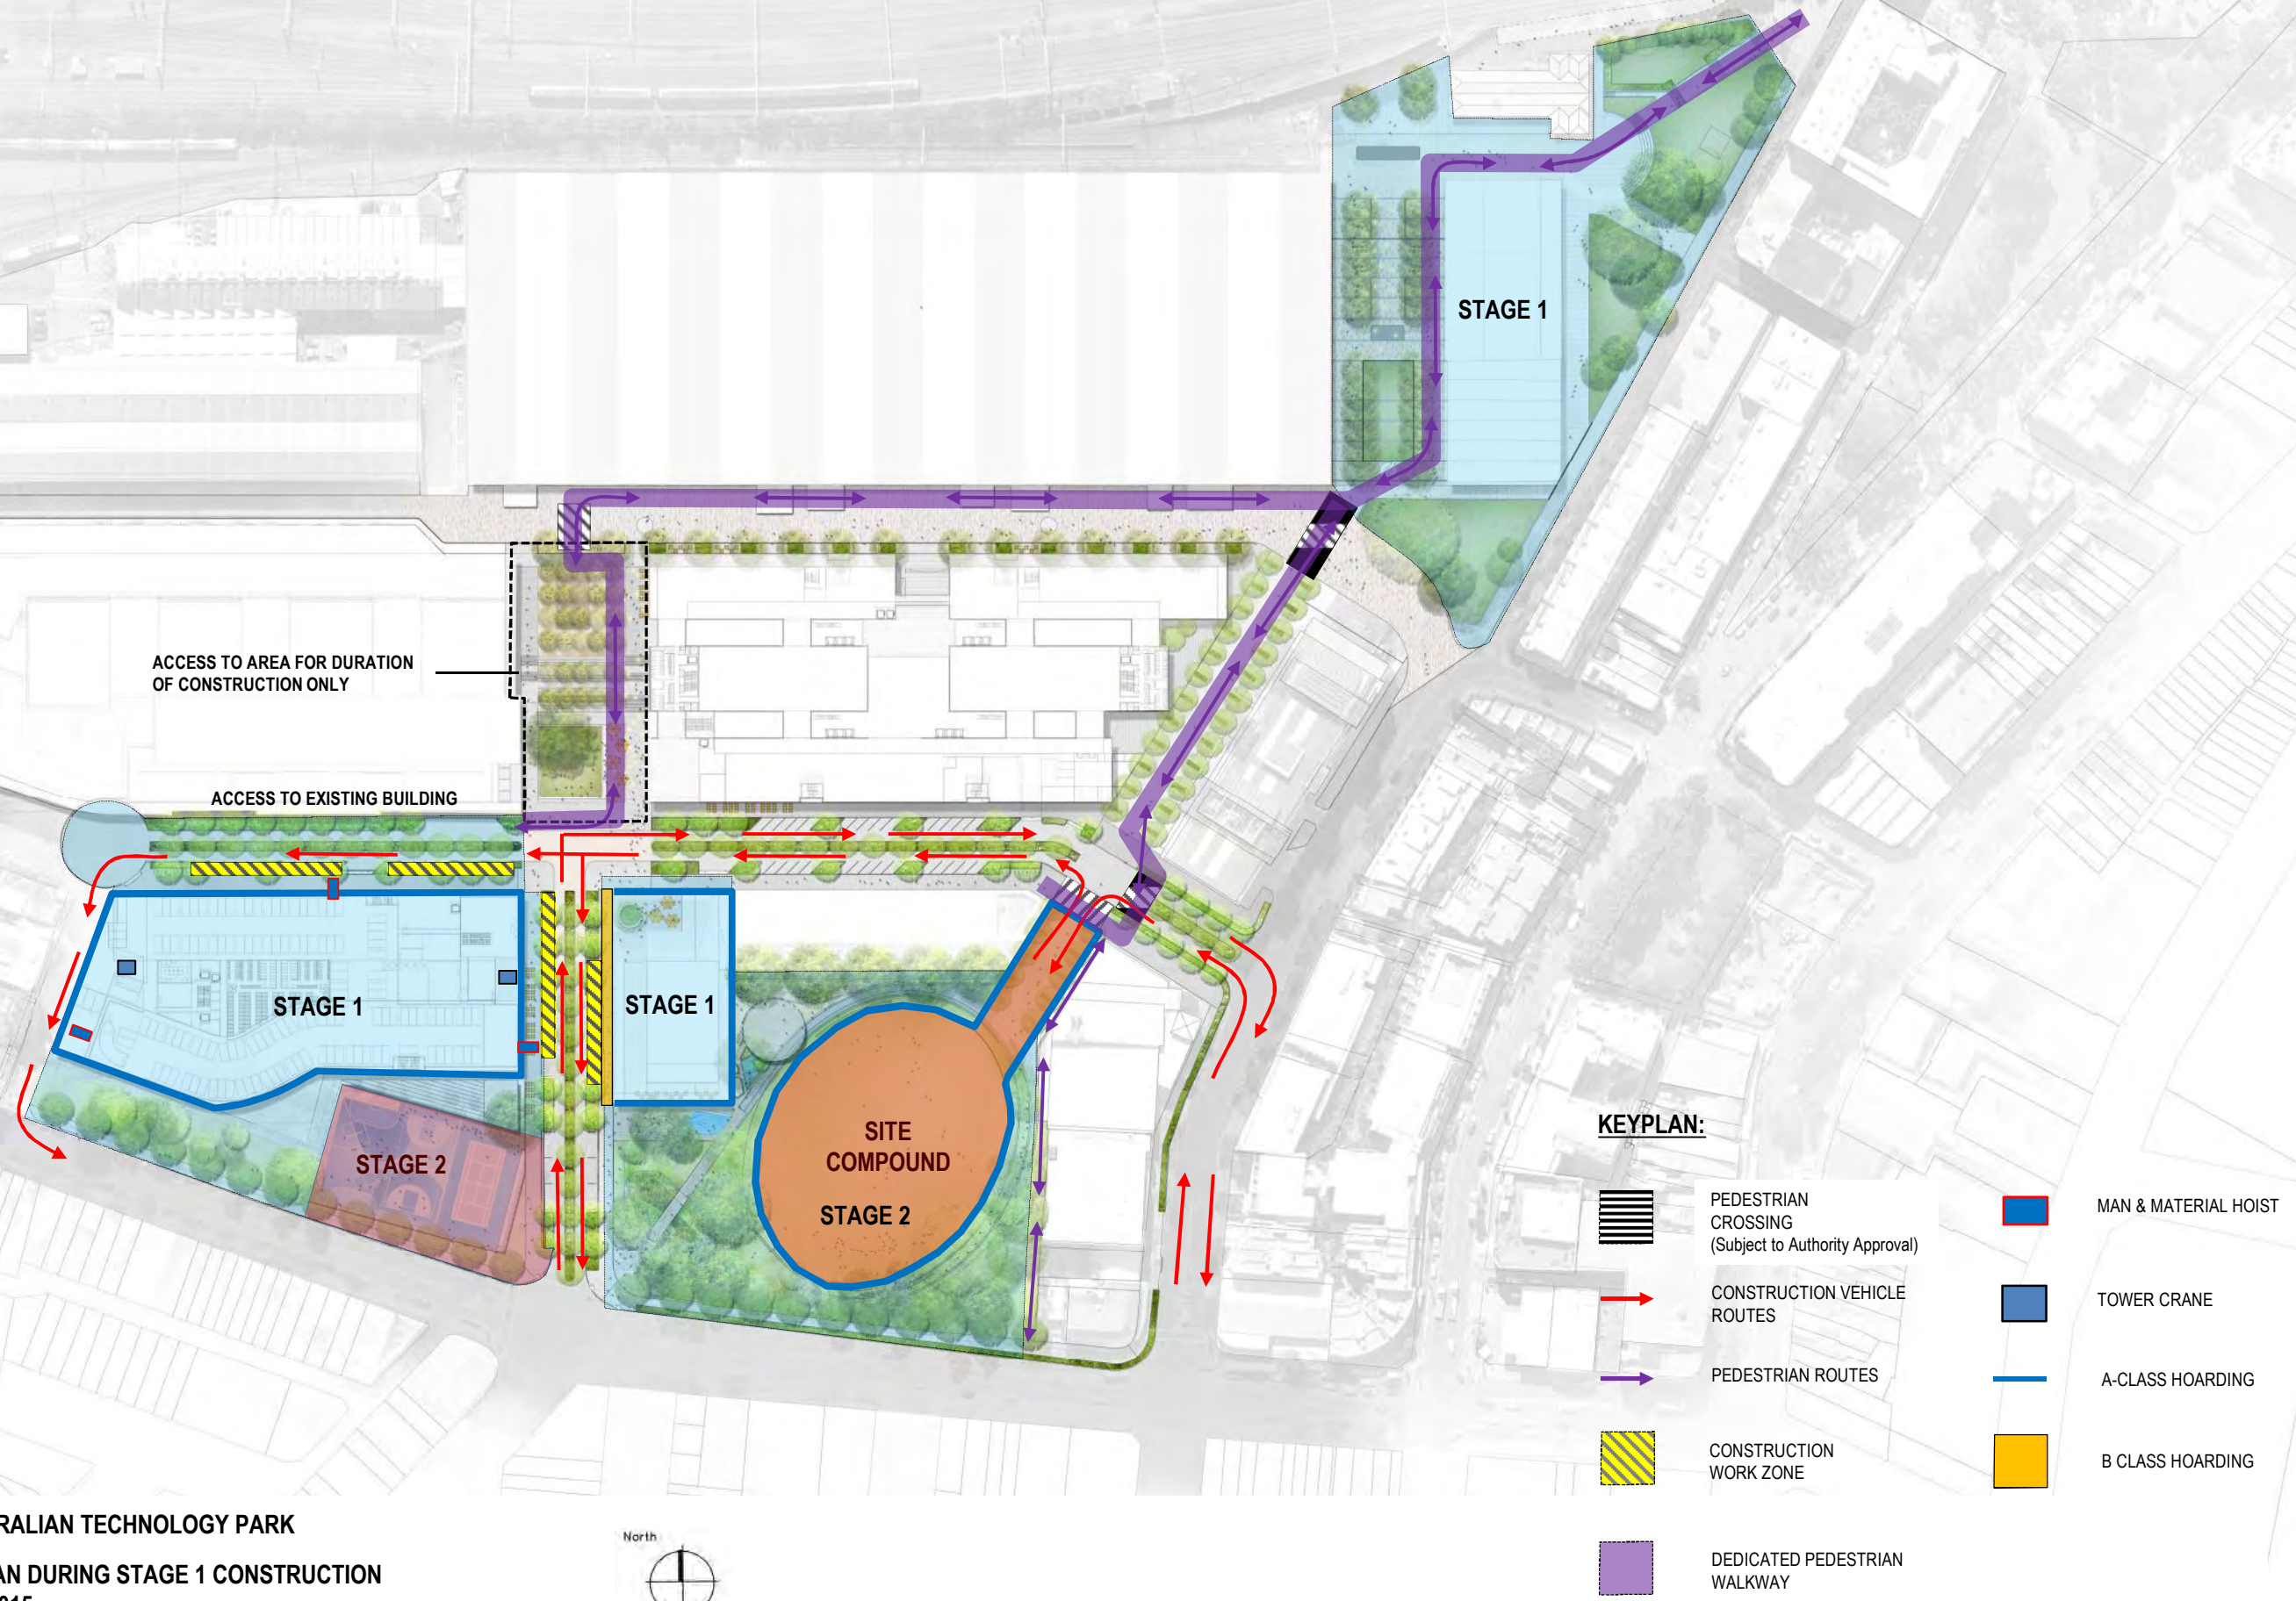
Title: **SITE PLAN DURING STAGE 1 CONSTRUCTION**  
REV 1 30.07.2015

**NOTE:** THE LOCATION OF CONSTRUCTION PLANT, EQUIPMENT, WORK ZONES AND ACCESS ROUTES ARE SUBJECT TO FINAL PLANNING BY MIRVAC

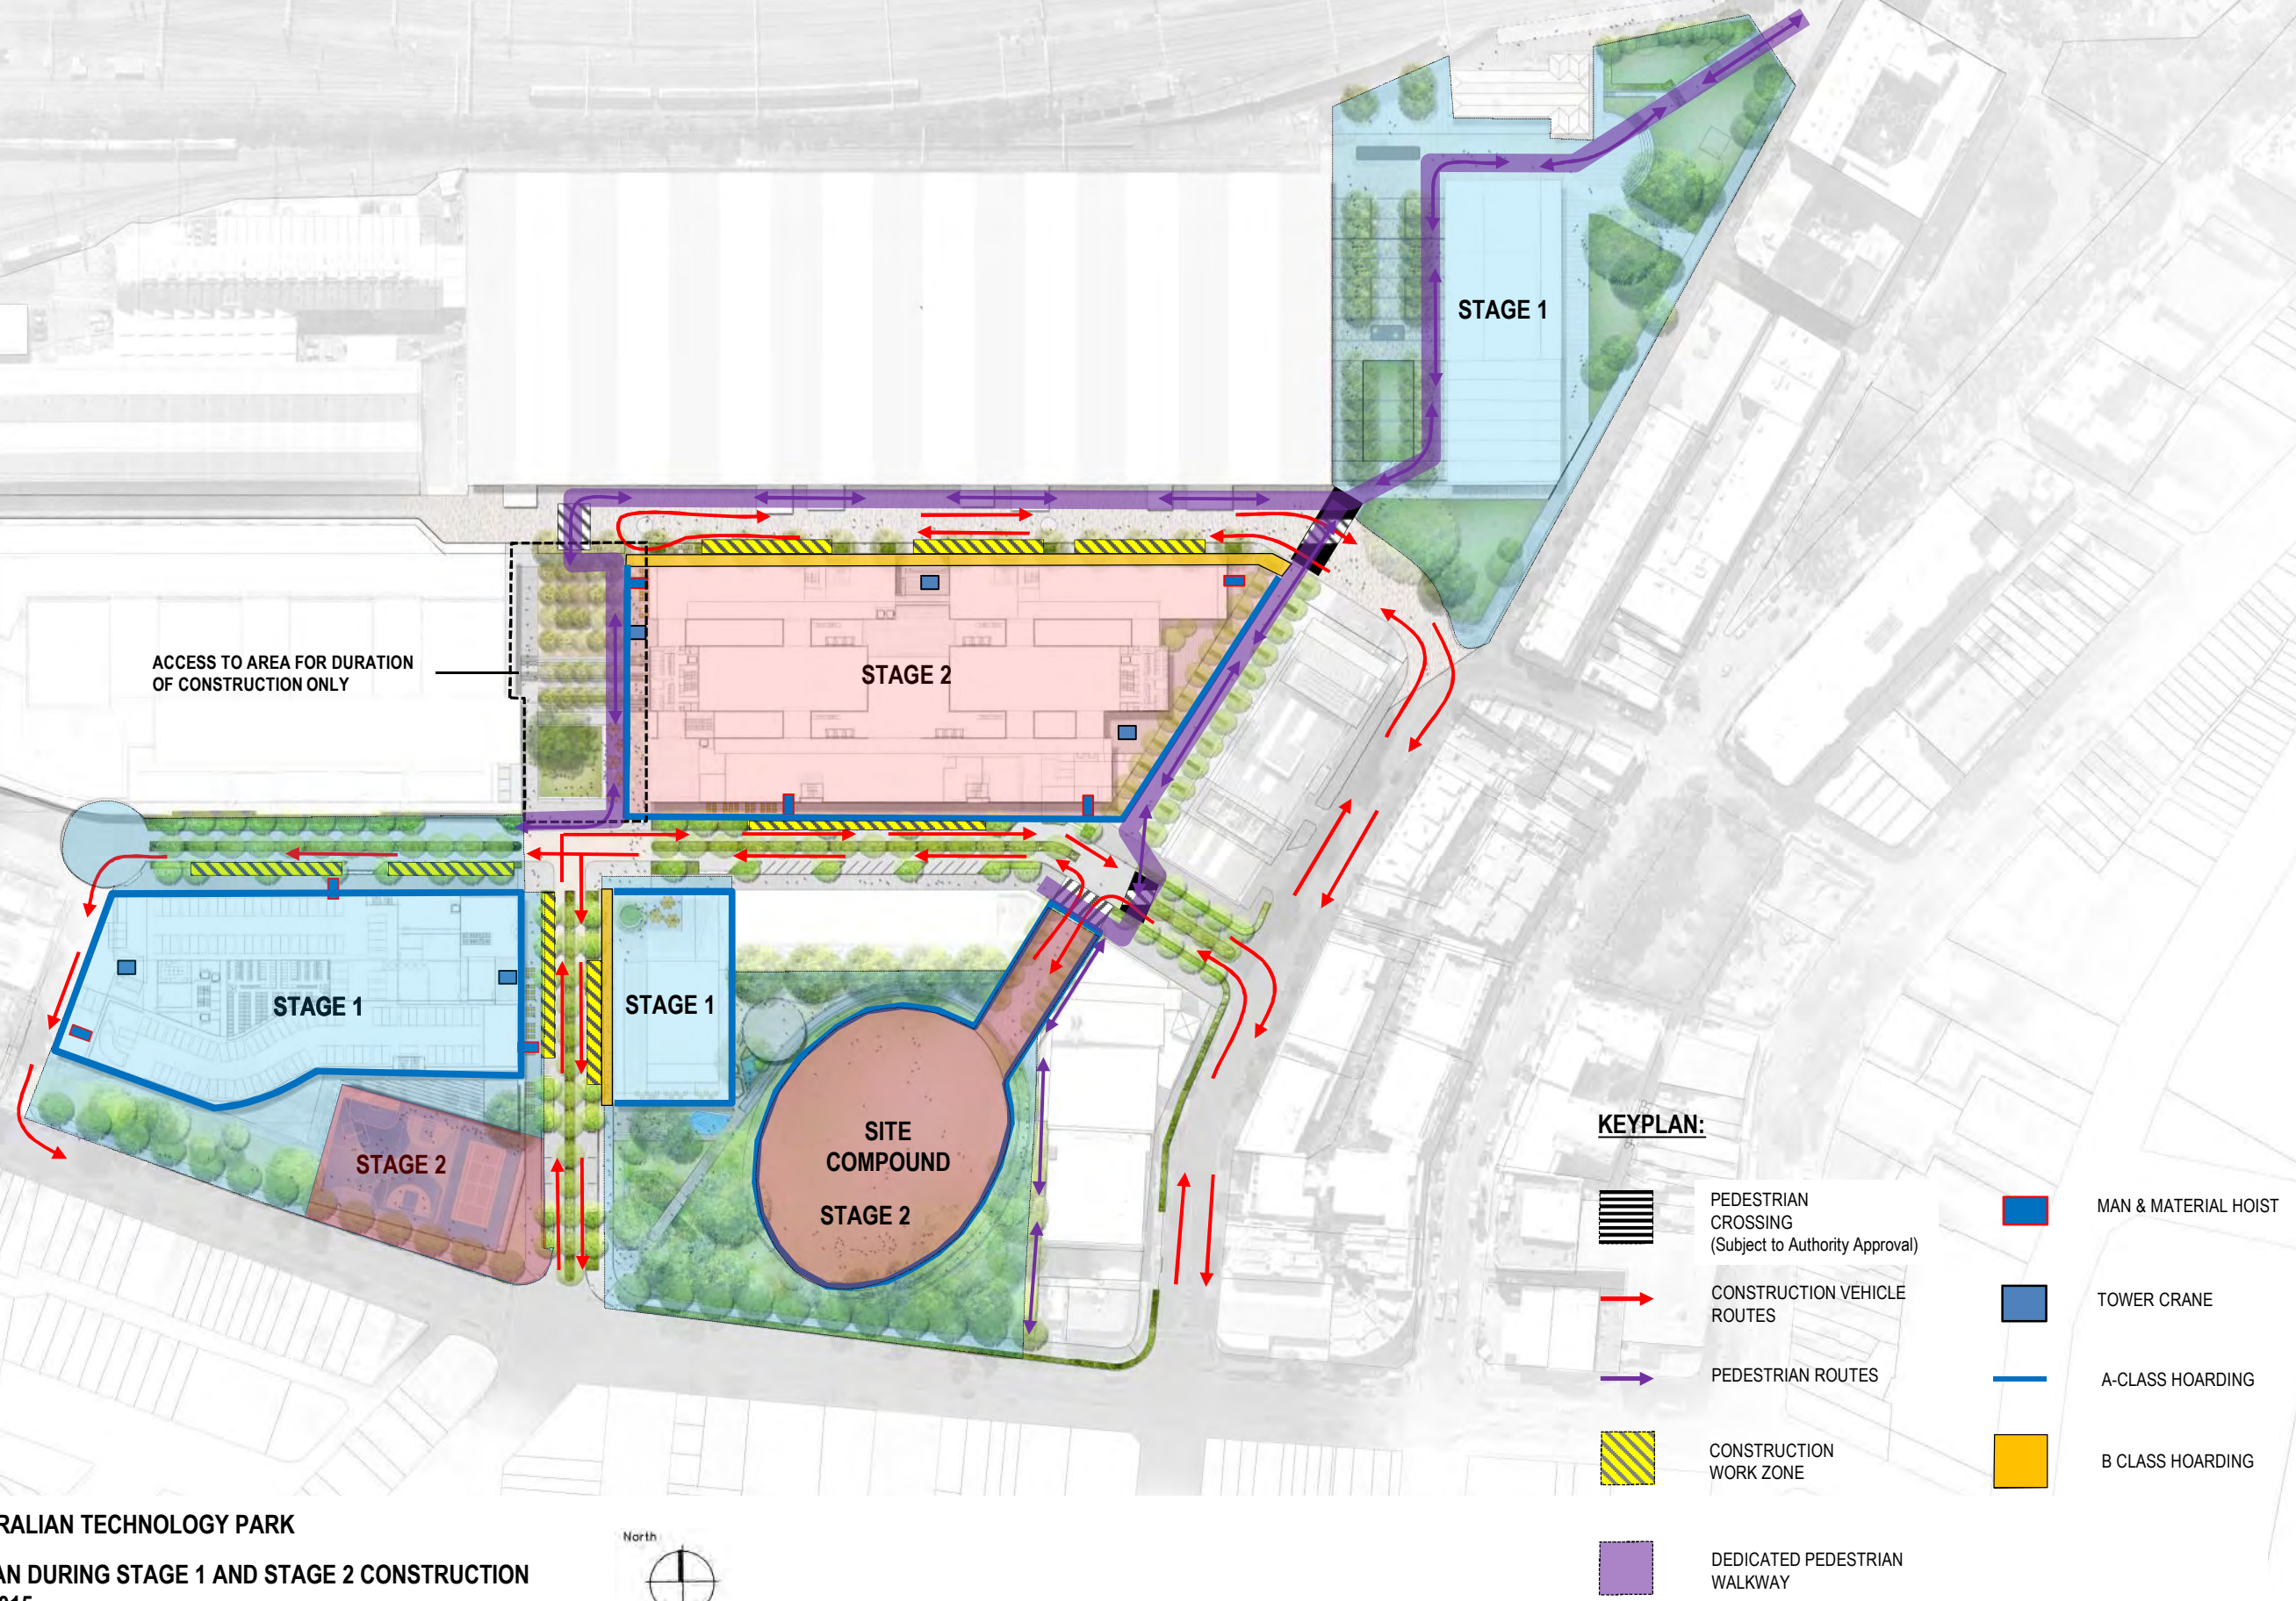
Title: **SITE PLAN DURING STAGE 1 AND STAGE 2 CONSTRUCTION**  
REV 1 30.07.2015

**NOTE:** THE LOCATION OF CONSTRUCTION PLANT, EQUIPMENT, WORK ZONES AND ACCESS ROUTES ARE SUBJECT TO FINAL PLANNING BY MIRVAC
