Mirvac Projects Pty Ltd  
Australian Technology Park Remedial Action Plan  
2 Locomotive Street, Eveleigh, NSW

15 June 2016  
51142/104280 (Revision 0)  
JBS&G Australia Pty Ltd

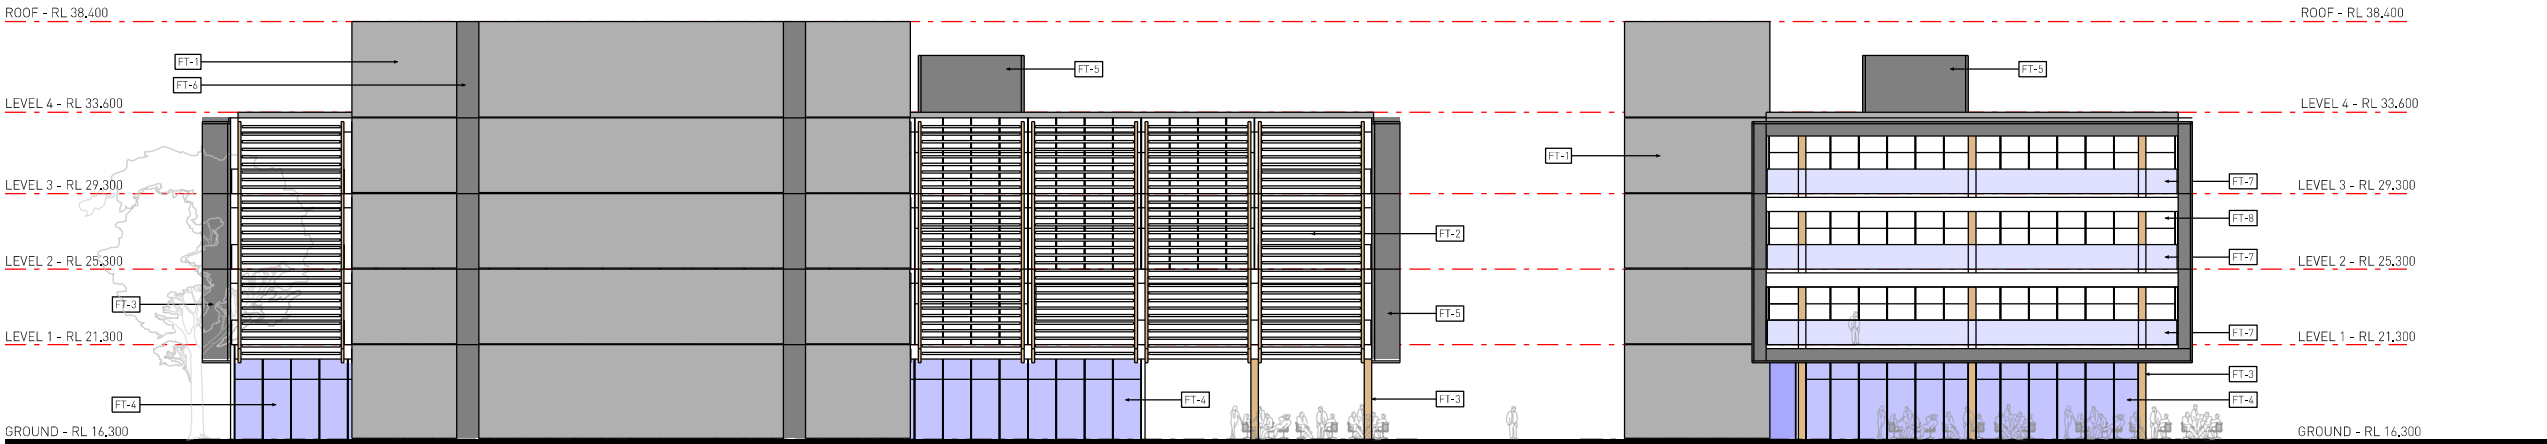
EAST ELEVATION

NORTH ELEVATION

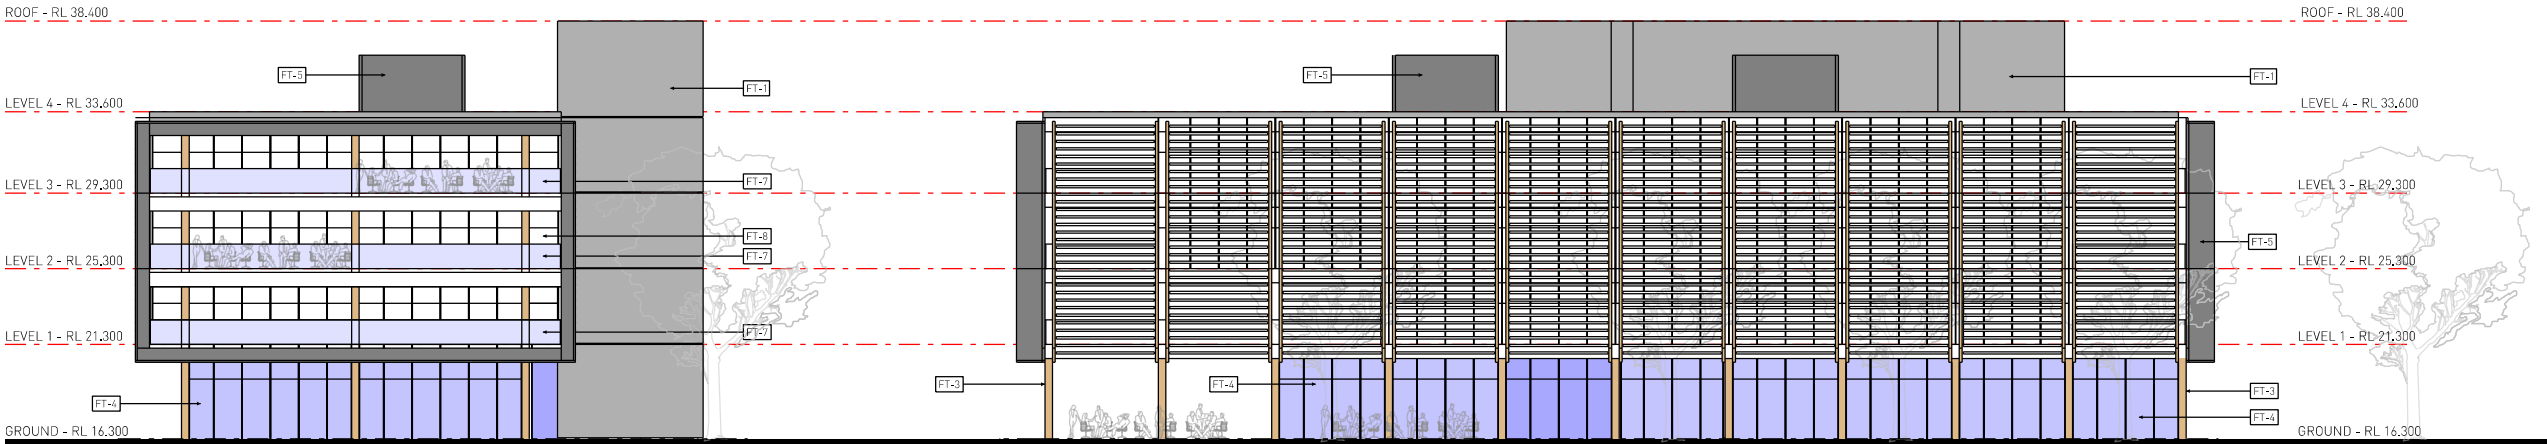
SOUTH ELEVATION

WEST ELEVATION
