Glebe Island Concrete Batch Plant

Statement of Heritage Impact

Client: Hanson

21-March-2018

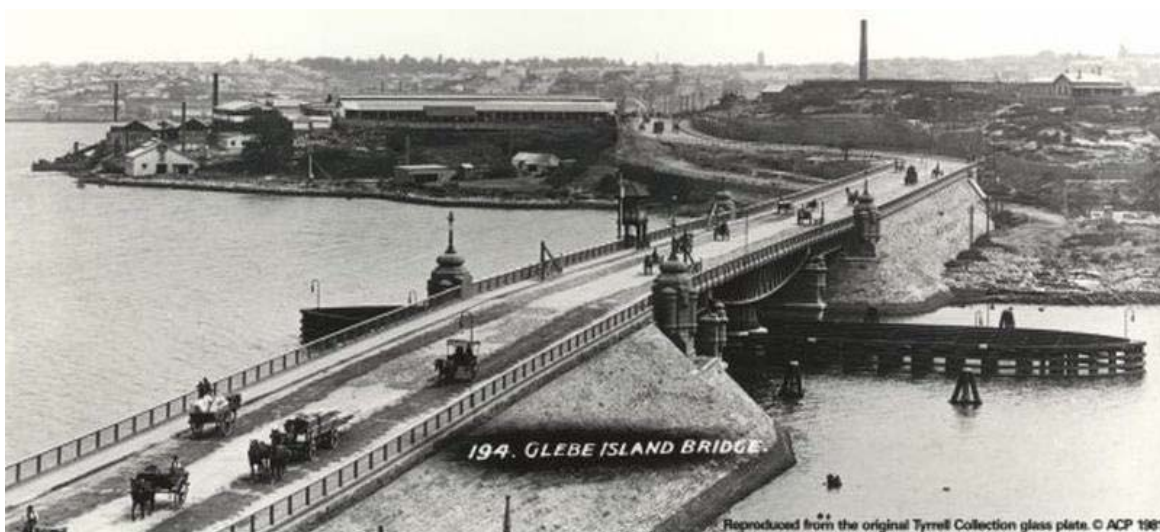
Figure 7 “Glebe Island Bridge c.1910). Note: The pile remains of the first Glebe Island Bridge can be seen cut off near the water level on both sides of the timber fenders associated with the current Glebe Island Bridge. (Source Tyrrell Collection held online at the National Library)

Construction of the trussed swing spans at each site was by simple cantilevering out from the steel pivot ring. Where timber trusses were used for the approaches of the Pyrmont Bridge, the Glebe Island Bridge used two steel deck trusses, then stone-faced embankments to reach each shore. The use of steel trusses for the approach spans had been part of Allan's original design for the Pyrmont Bridge but the Parliamentary Standing Committee on Public Works directed that this material be replaced with timber, presumably as a cost-cutting measure. When Glebe Island Bridge was built, Allan's original specification was reinstated (perhaps owing to the use of built-up embankments and shorter approach spans, providing a more economical outcome) (NSW Heritage Division, 2013) (Figure 7).

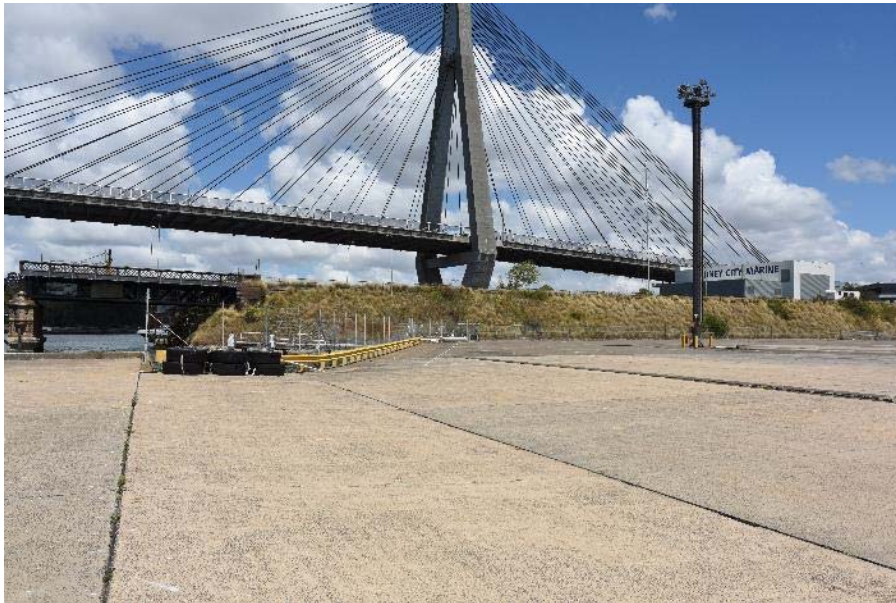
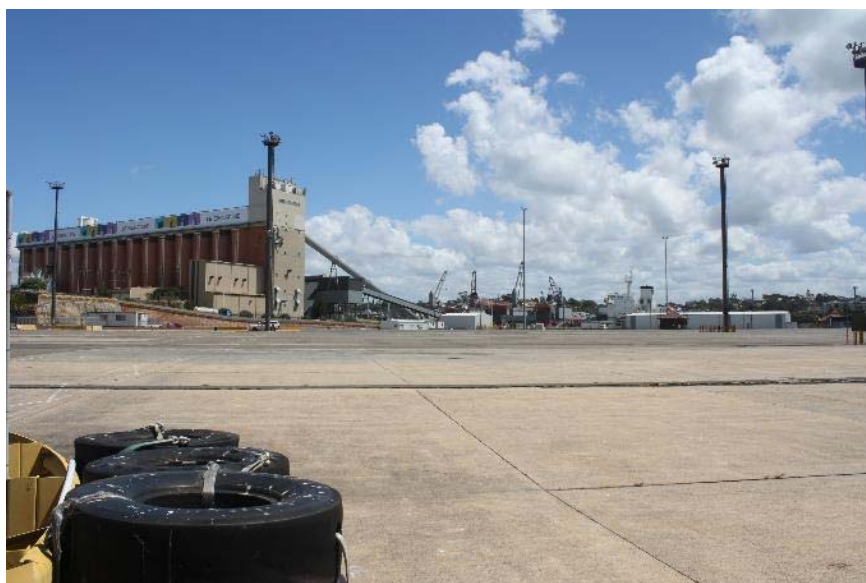
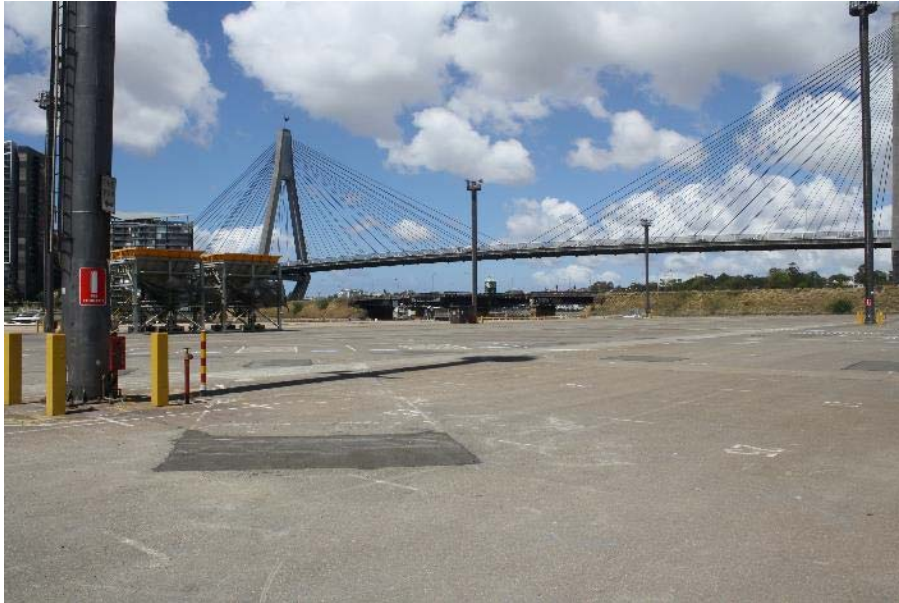
Figure 9 View of the Site on Glebe Island looking towards the western approach of the Glebe Island Bridge. (View to the southwest)

Figure 10 View of Glebe Island Site (View to West)

Figure 11 View of Glebe Island Site (View to southwest)

The Site consists of an asphalt and concrete hard stand associated with the former grain silos loading area and later car export wharves. The area is generally level and void of any structures, other than lighting towers and other associated electrical substation units (Figure 9, Figure 10 and Figure 11)

Of particular note along the boundaries of the Site are the Glebe Island Bridge approach to the south and wharves to the east. The southern boundary of the Site is bound by a cyclone fence that separates the wharf and hardstand area with the sandstone embankment associated with the approach of the Glebe Island Bridge. The stone faced embankment is covered in swamp foxtail grass and other low lying vegetation where the stone abutment face has separated or failed.

The eastern boundary of the Site is formed by the existing wharf frontages. The south eastern corner of the boundary consists of a rock armour. Further along the southern boundary are the existing wharves. These consist of a concrete apron with rubber fenders along the front face, mooring bollards along the top (Figure 12). The deck of the wharf section consists of a concrete surface. The surface of the wharf area has buckled along the top of the rows of longitudinal piles that support it below. At the point where the wharf connects back into where the land reclamation area is, the wharf area has subsided along the joint exposing the asphalt road surface.

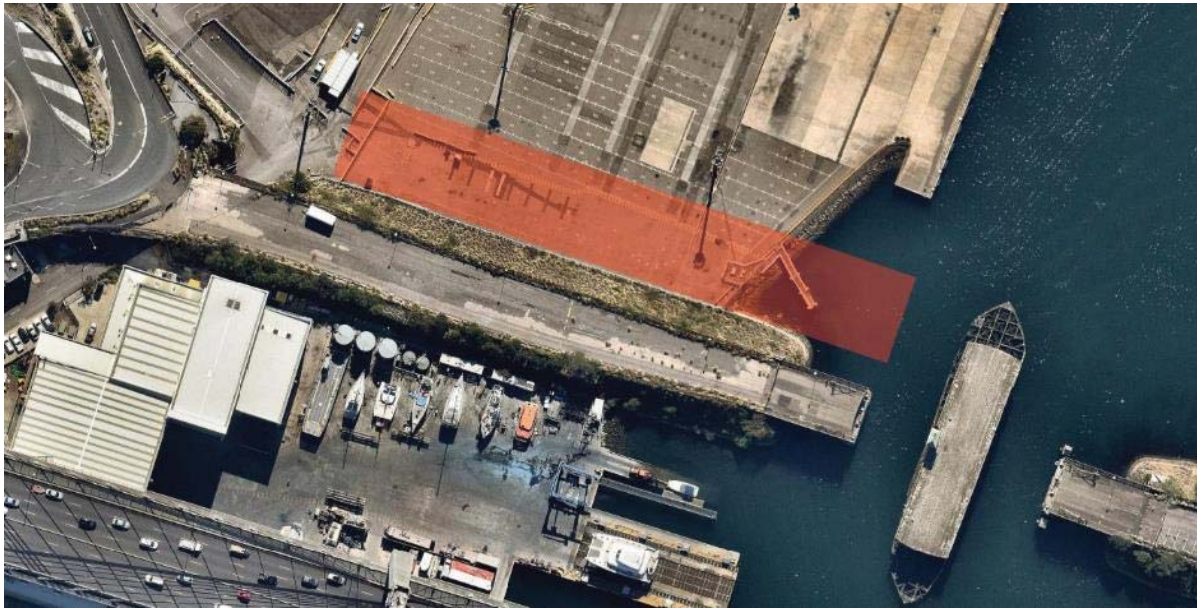
Figure 15 Area of identified archaeological potential (shown in red) associated with the alignment of the first Glebe Island Bridge

The location of the first Glebe Island Bridge was located on the northern side of the existing Glebe Island Bridge. The bridge was a lower pile and timber decked bridge located immediately to the north of the approach embankments of the present Glebe Island Bridge and located within the Site. The original bridge was constructed out of Blackbutt timber piles. The approach to the bridge on the western side appears to have included an earthen embankment with potential stone abutments. It is common practice when former wharves and bridges are demolished, that piles and other remains associated with the former structures would be built over. After the construction of the current Glebe Island Bridge, the former bridge was removed to allow for safe navigation through the new swing bridge into Black Wattle Bay. There is no information relating to the specific removal of those piles, either within in water or on land. An early photograph from 1920s when the Glebe Island Bridge had been constructed shows the remains of some of the piles from the former bridge still present in the water (Figure 7). It is therefore considered likely that evidence of the Bridge remains *in situ*. Any excavation below the current hardstand adjacent to the Glebe Island Bridge would have the potential to expose archaeological remains associated with the first Glebe Island Bridge (Figure 15).

The reclamation works that took place from 1917 onwards for the construction of the grain storage development and ultimately, the construction of the grain silos, extended the land available to the east of the former Glebe Island foreshore. There is low potential for archaeological remains associated with the reclamation works to be present below the current hardstands on the Site behind the line of current wharves. The archaeological potential would be limited to fill material only and is not expected to have any archaeological research value.

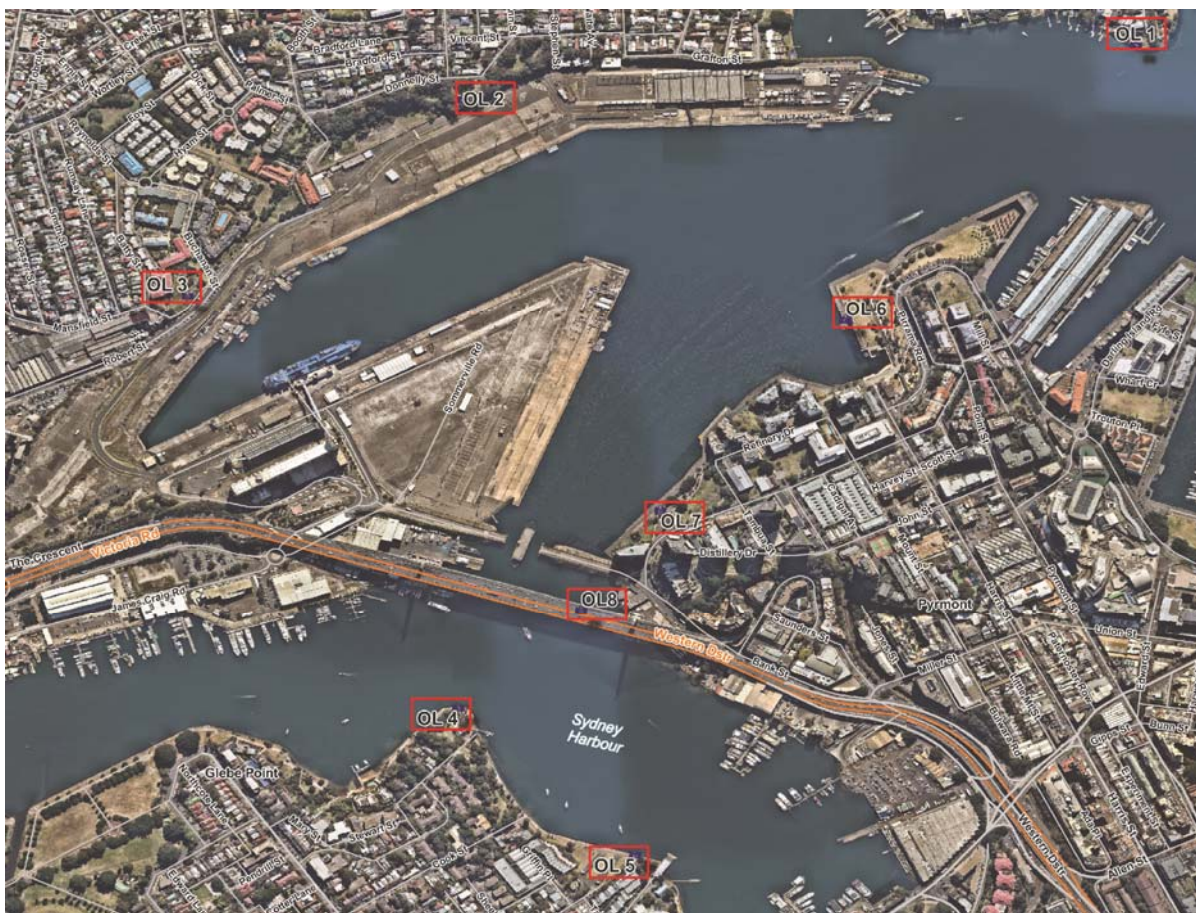
Figure 17 Glebe Island Concrete Batching Plant Observer Locations. OL1: Peacock Point; OL2: Birrung Park, OL3 Mansfield Street; OL4 Glebe Foreshore Walk; OL5 Glebe Foreshore Walk; OL6 Pirrama Park; Waterfront Park; OL8 ANZAC Bridge

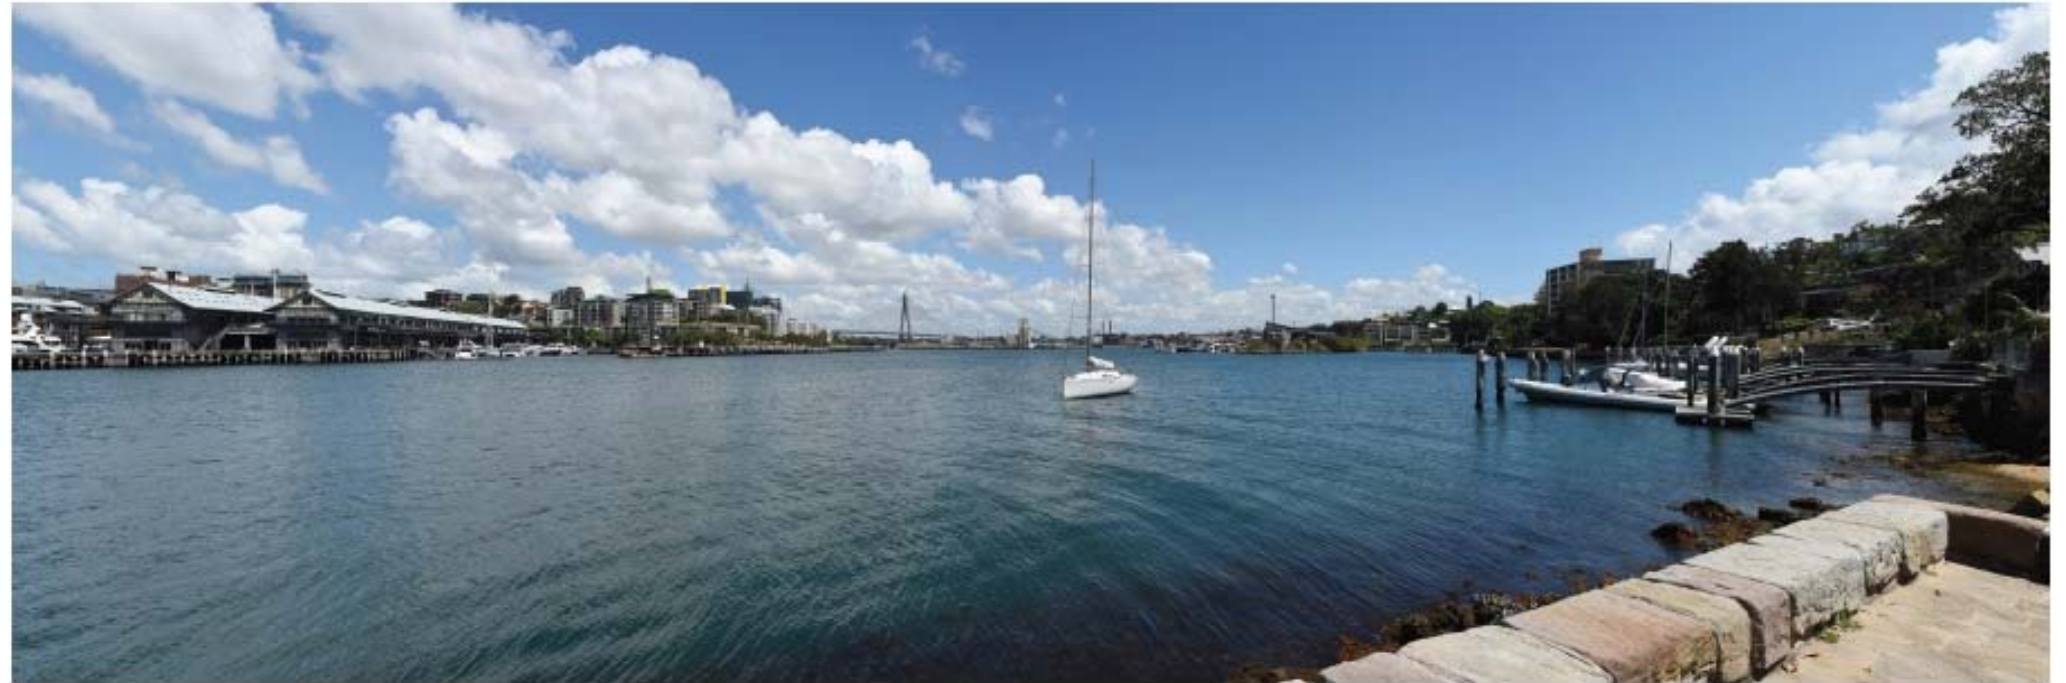
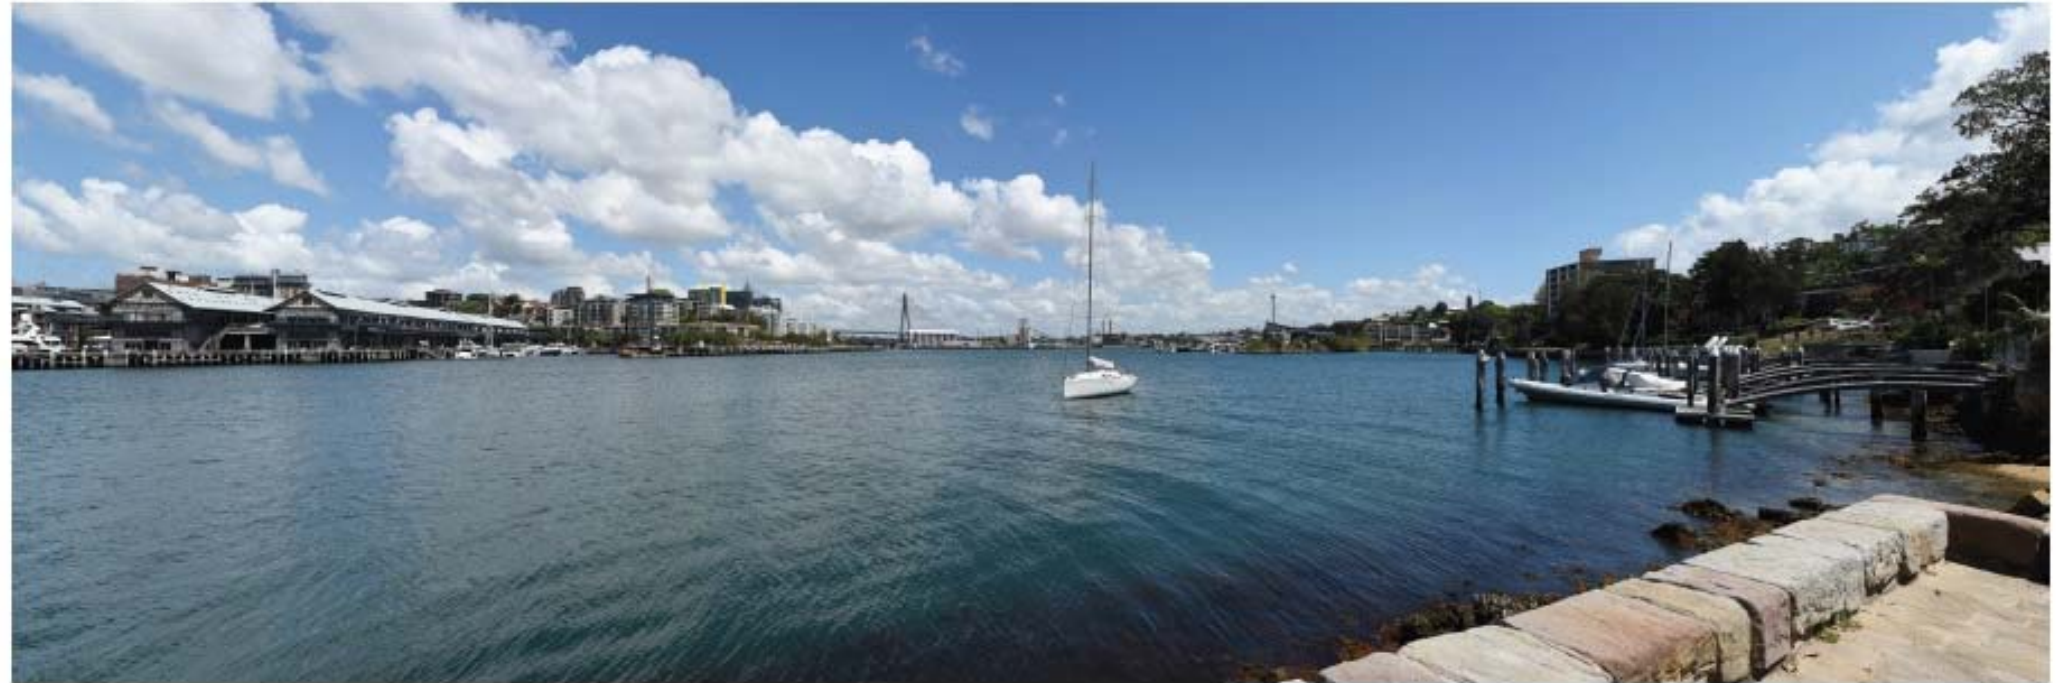
Figure 18 Before and after construction visual impact assessment view from OL1 Peacock Point, Balmain East

The views from Peacock Point (East Balmain) will not be interrupted as the Site is located to the west and do not block the view to the bridge. The view to the bridge is currently obscured from the existing waterfront infrastructure along the east side of Johnstons Bay, and is overshadowed by the existing Anzac Bridge and apartment blocks on Refinery Drive (to the east of the bridge) (Figure 18).

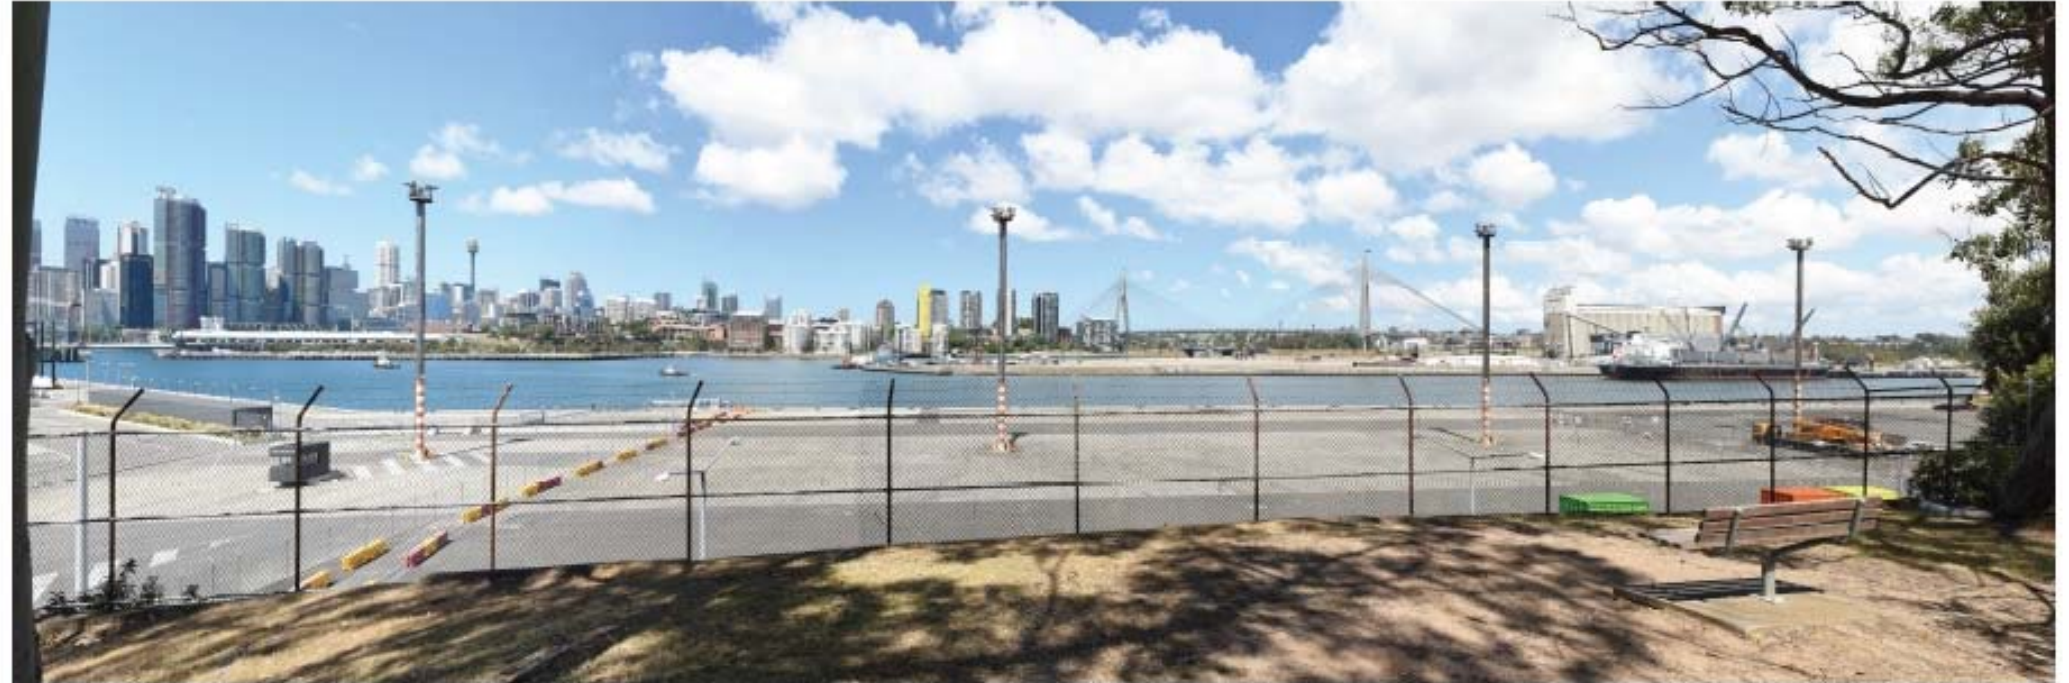
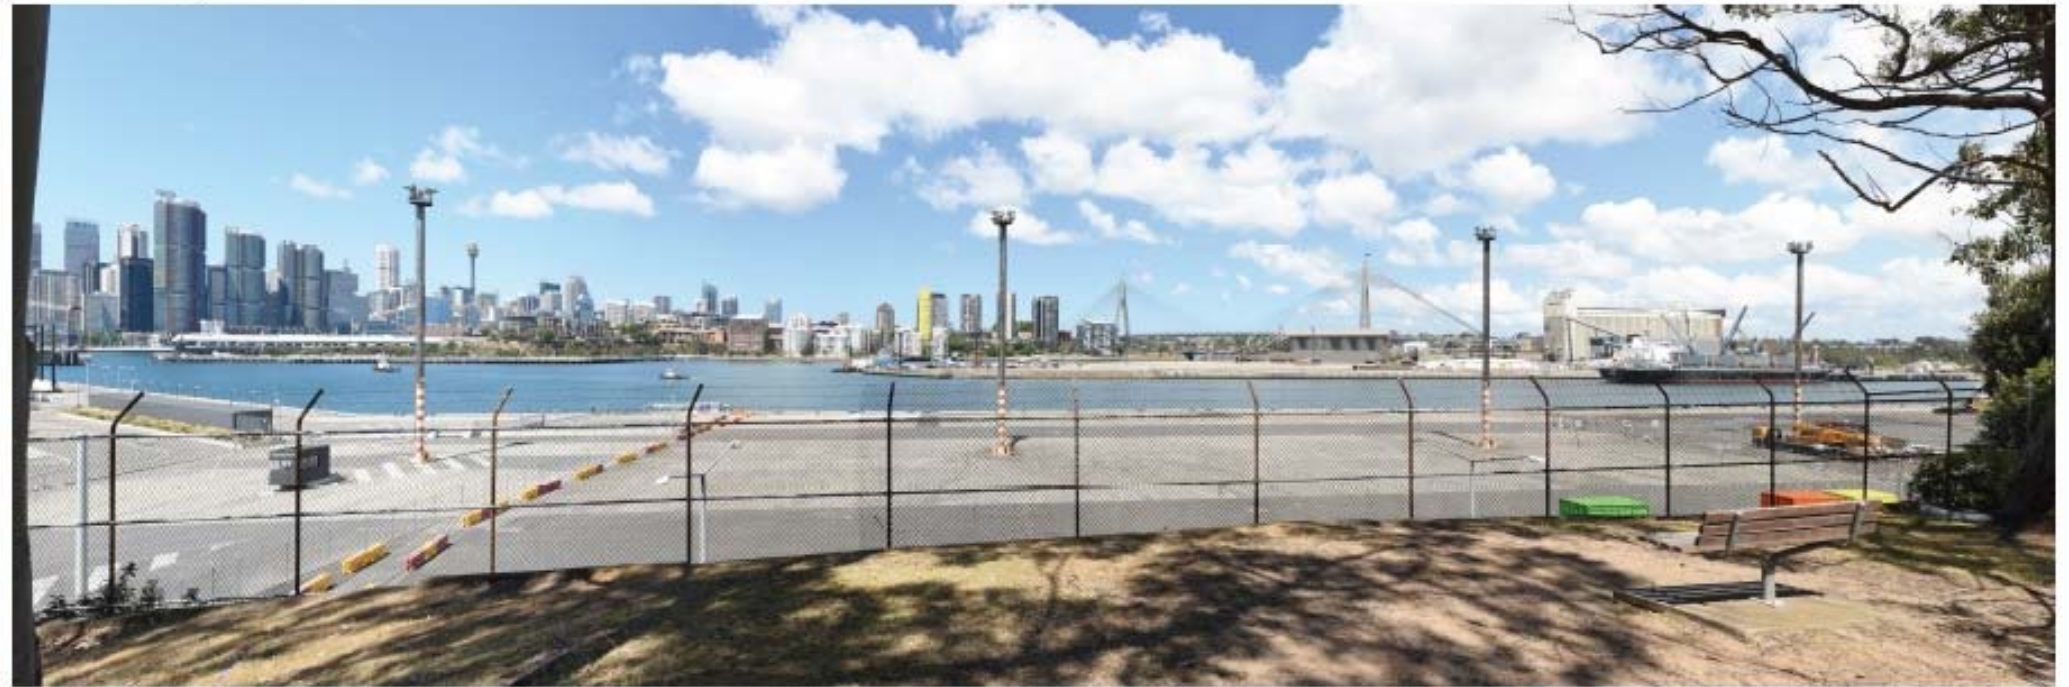
Figure 19 Before and after construction visual impact assessment view from OL2 Birrung Park, Balmain

The general view from Balmain was recorded from Birrung Park, Balmain. This view looks across the Glebe Island Births from above. The view to the bridge will be obscured slightly from the placement of the shipping containers along the eastern boundary of the Site that will act as a sound and visual barrier to the batching plant from the east. Moving further around to the east from this park, the view to the bridge would become less obscured from this shipping container wall. A view from Grafton Street, where the view outlined in the CMP was identified from, will not have this impact as the view looks directly down Johnstons Bay to the bridge (Figure 19).

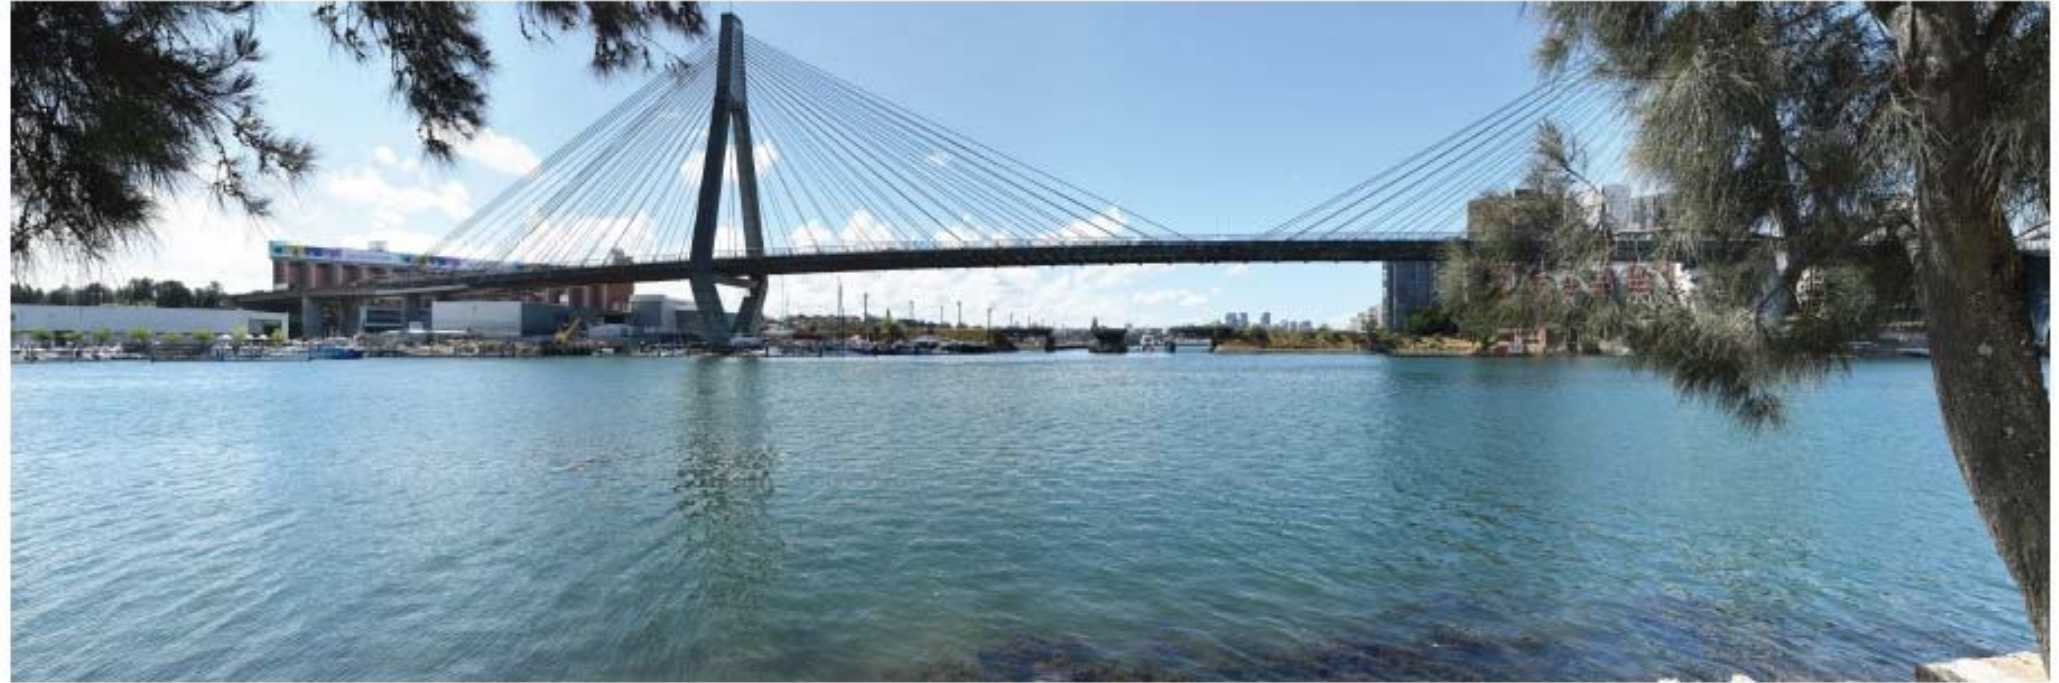
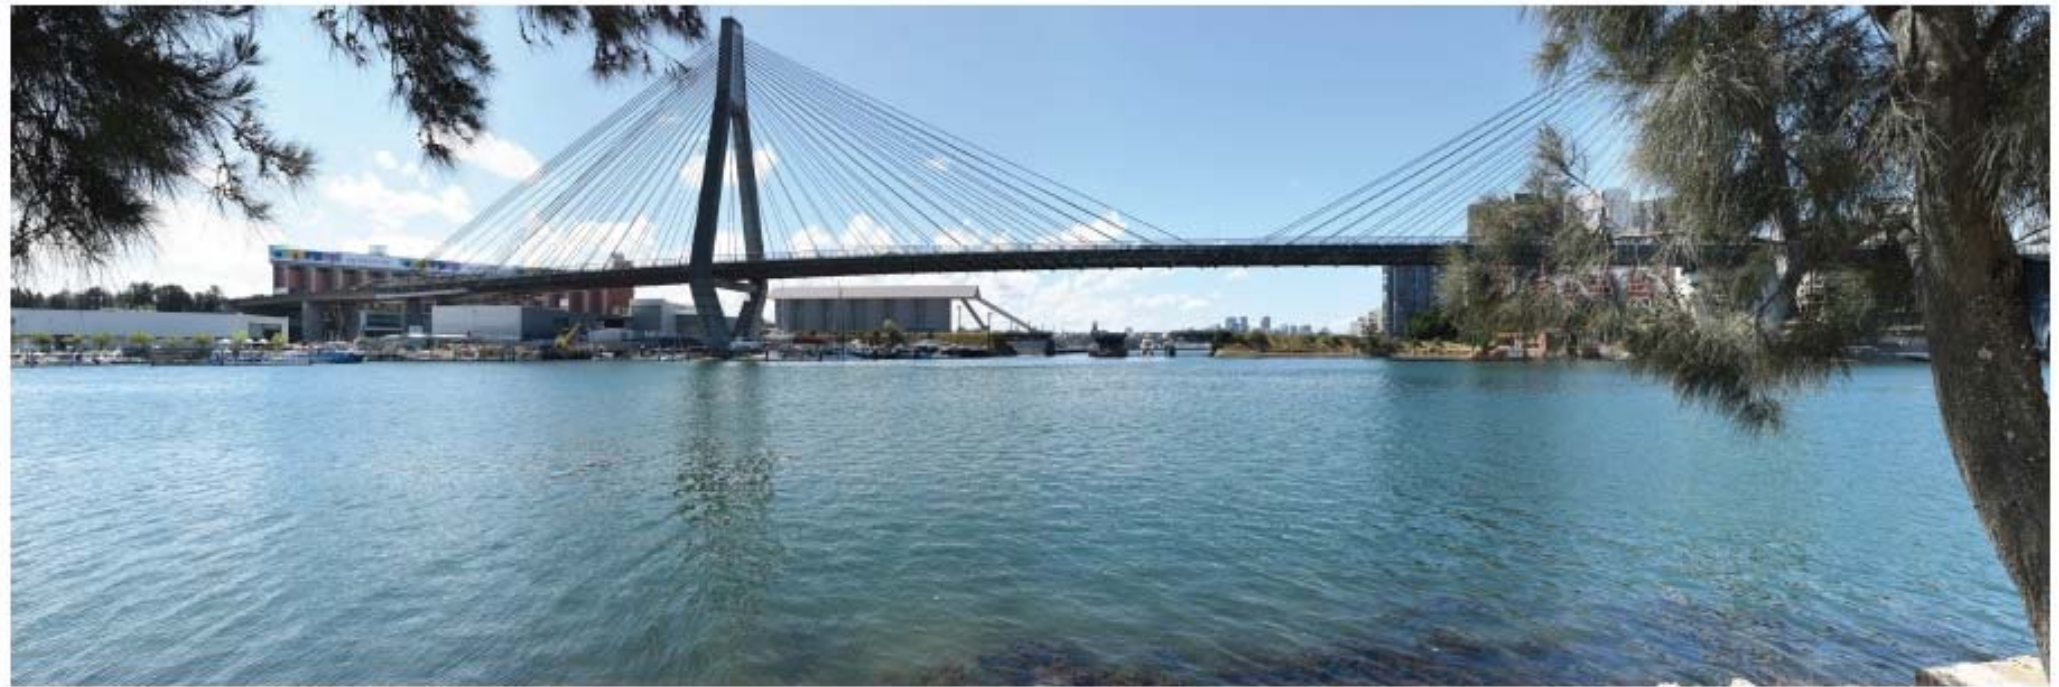
Figure 20 Before and after construction visual impact assessment view from OL4 Glebe Foreshore Walk, Blackwattle Bay

From the south, the view from Glebe Foreshore Walk at Blackwattle Bay shows that the concrete batching plant will not impact views to the Glebe Island Bridge. From this view, the current marina does block some of the view to the western approach, and the Anzac Bridge can be seen to over shadow, but not block, the view to the Glebe Island Bridge (Figure 20).

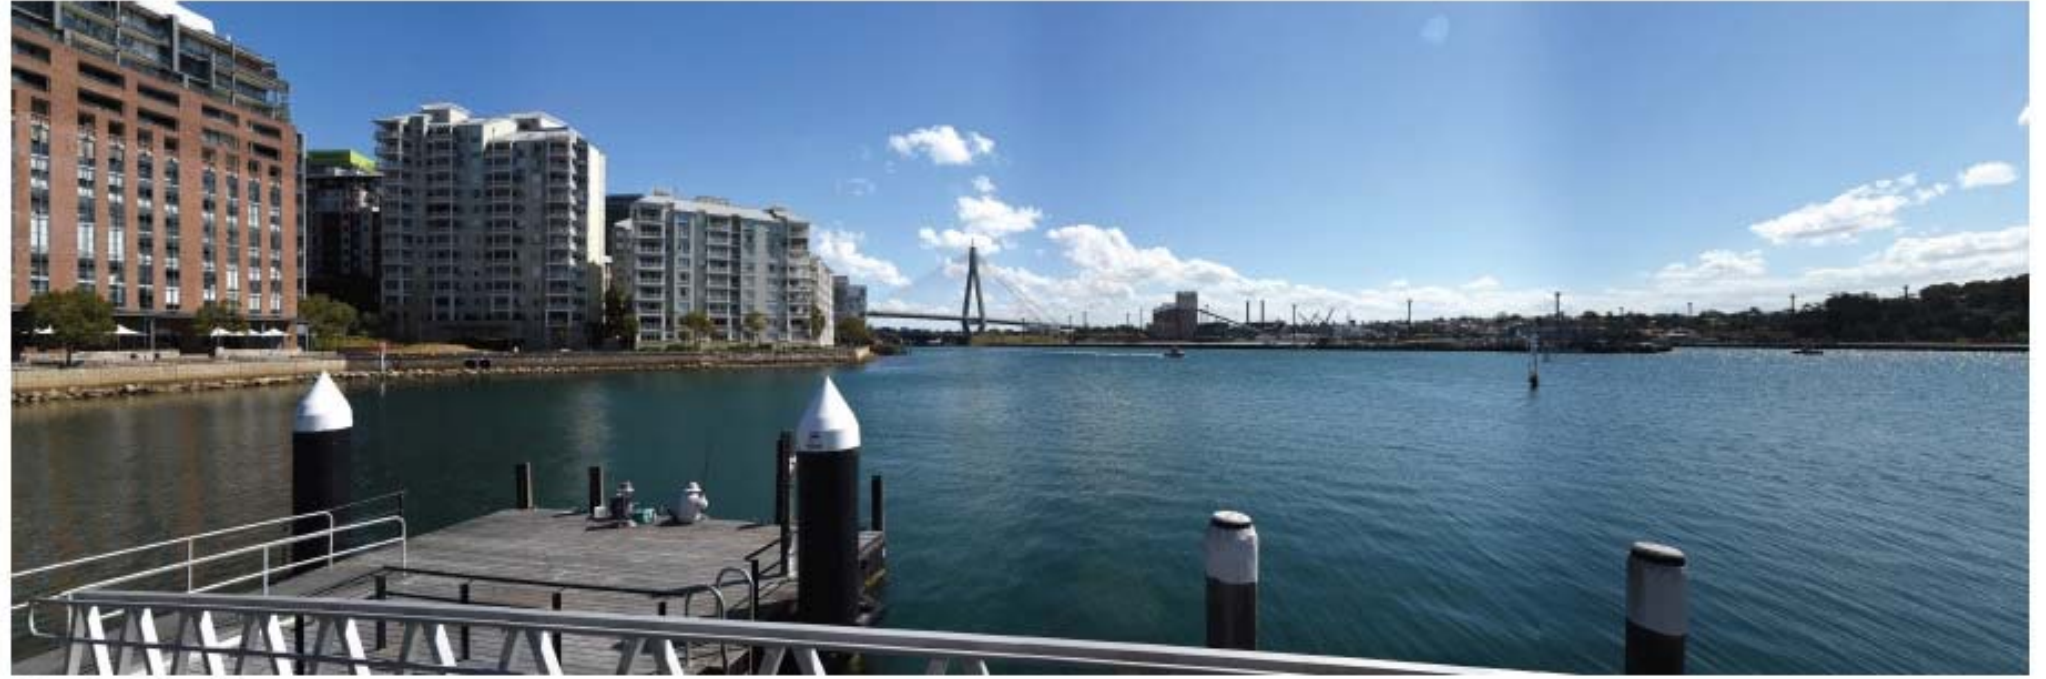
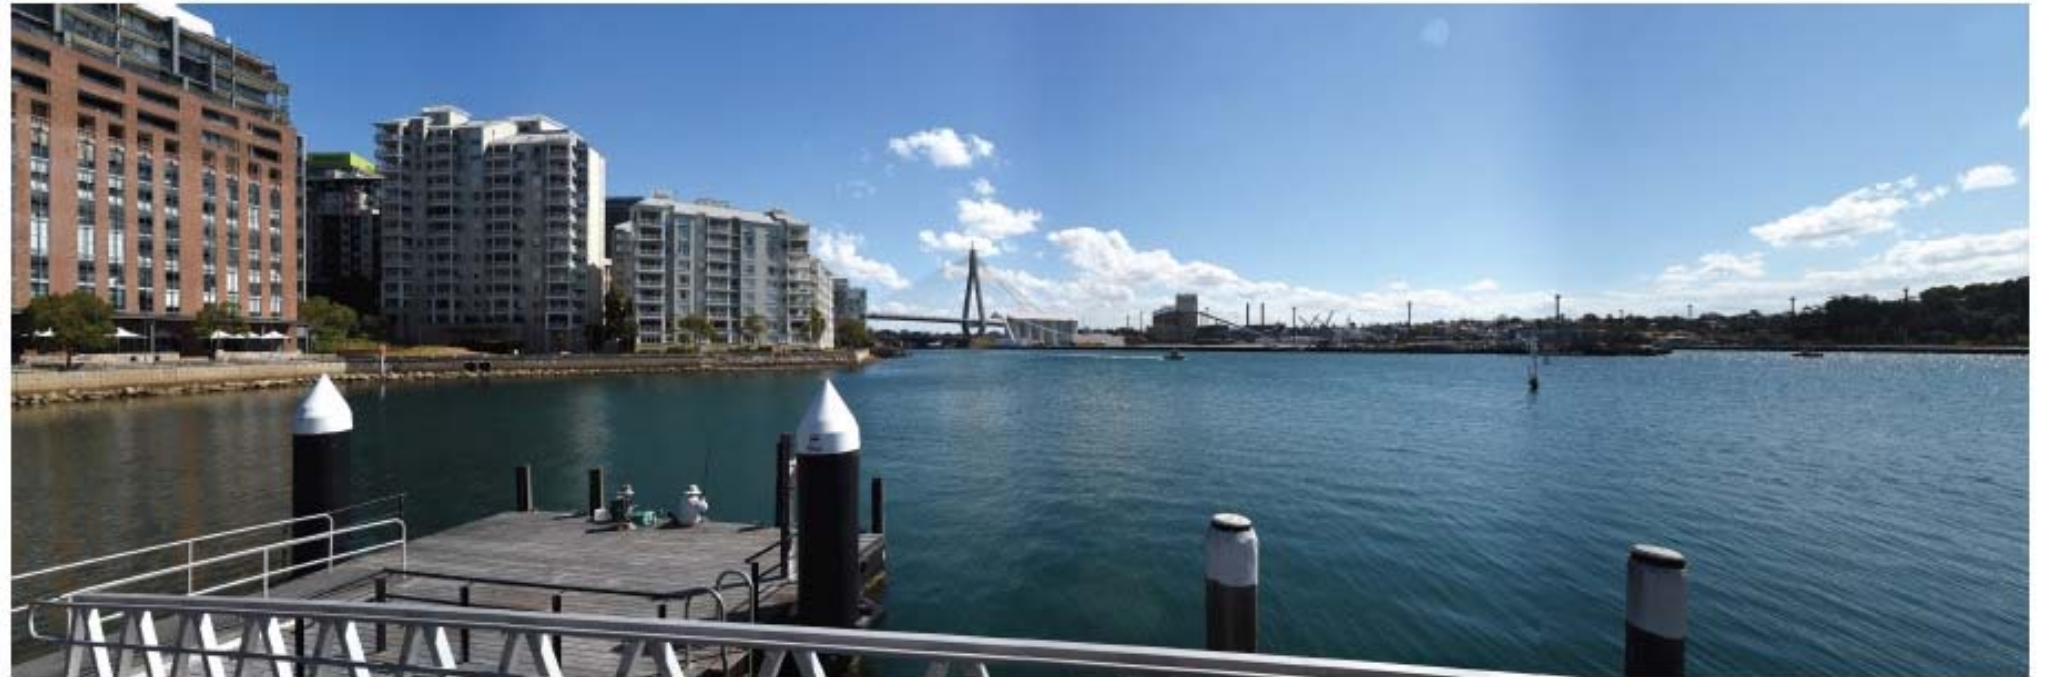
Figure 21 Before and after construction visual impact assessment view from OL6 Pirrama Park, Pyrmont

The visualisation from Pirrama Park at Pyrmont Point, Pyrmont is similar to the view from Peacock Point, that is, the concrete batching plant will not obscure the view from Pirrama Park to the Glebe Island Bridge as the Site is located to the west of the bridge. The silos will, however, block the view to the western approach to the bridge. The presence of the new concrete batching plant will create a large scale structure immediately adjacent to the Glebe Island Bridge. This can be seen as having the potential to crowd the area and take the view away from the Glebe Island Bridge, however, the reality is that the presence of the Anzac Bridge and the Apartments on Regatta Wharf already crowd the view (Figure 21).

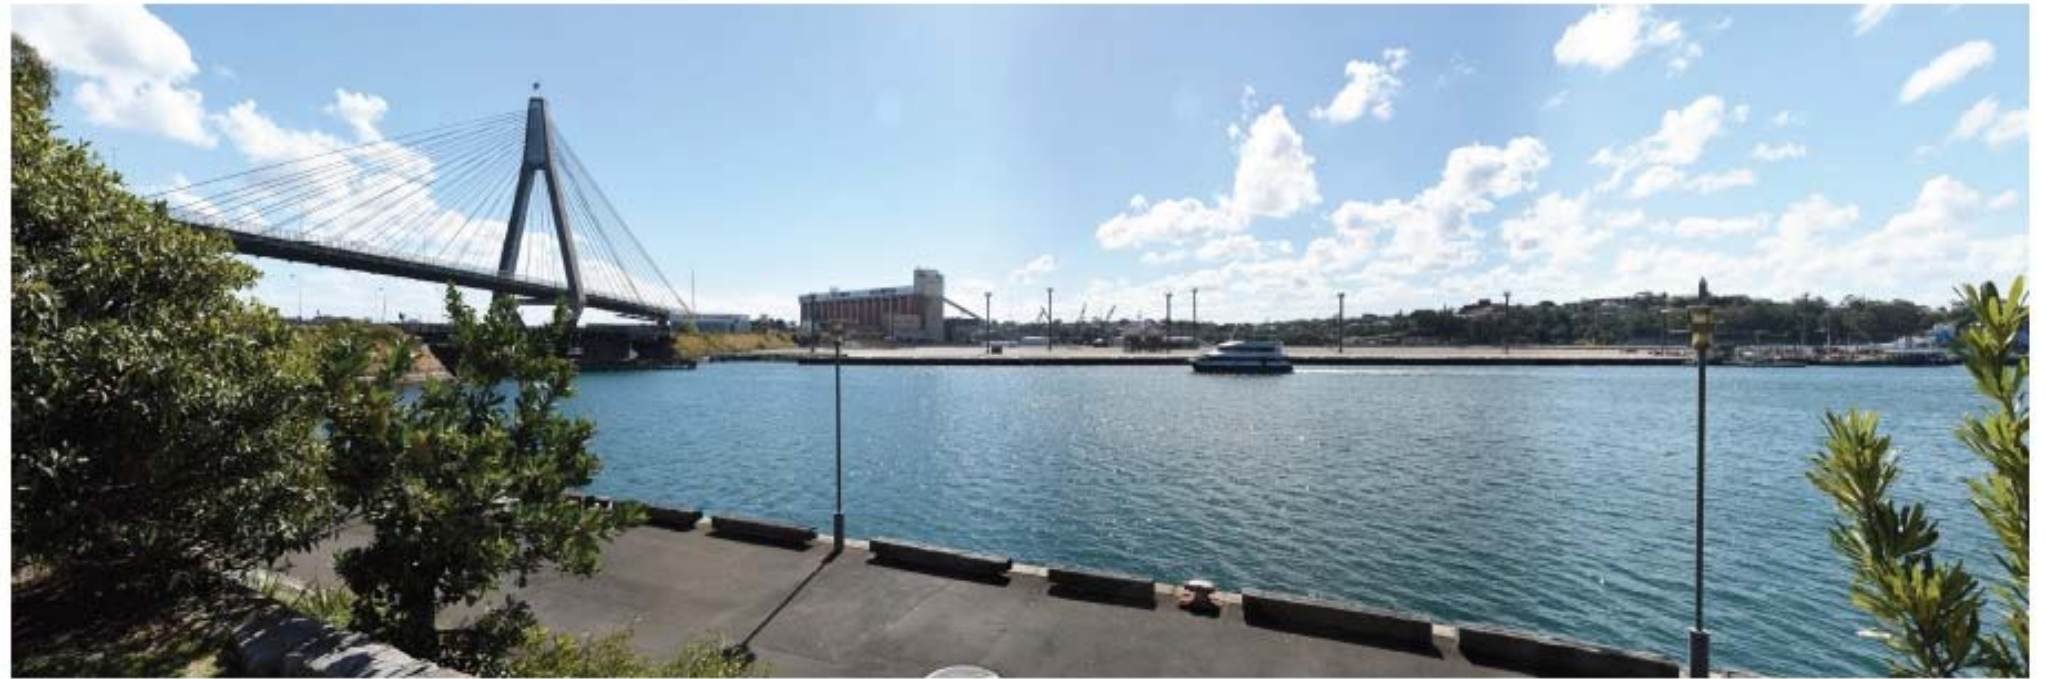
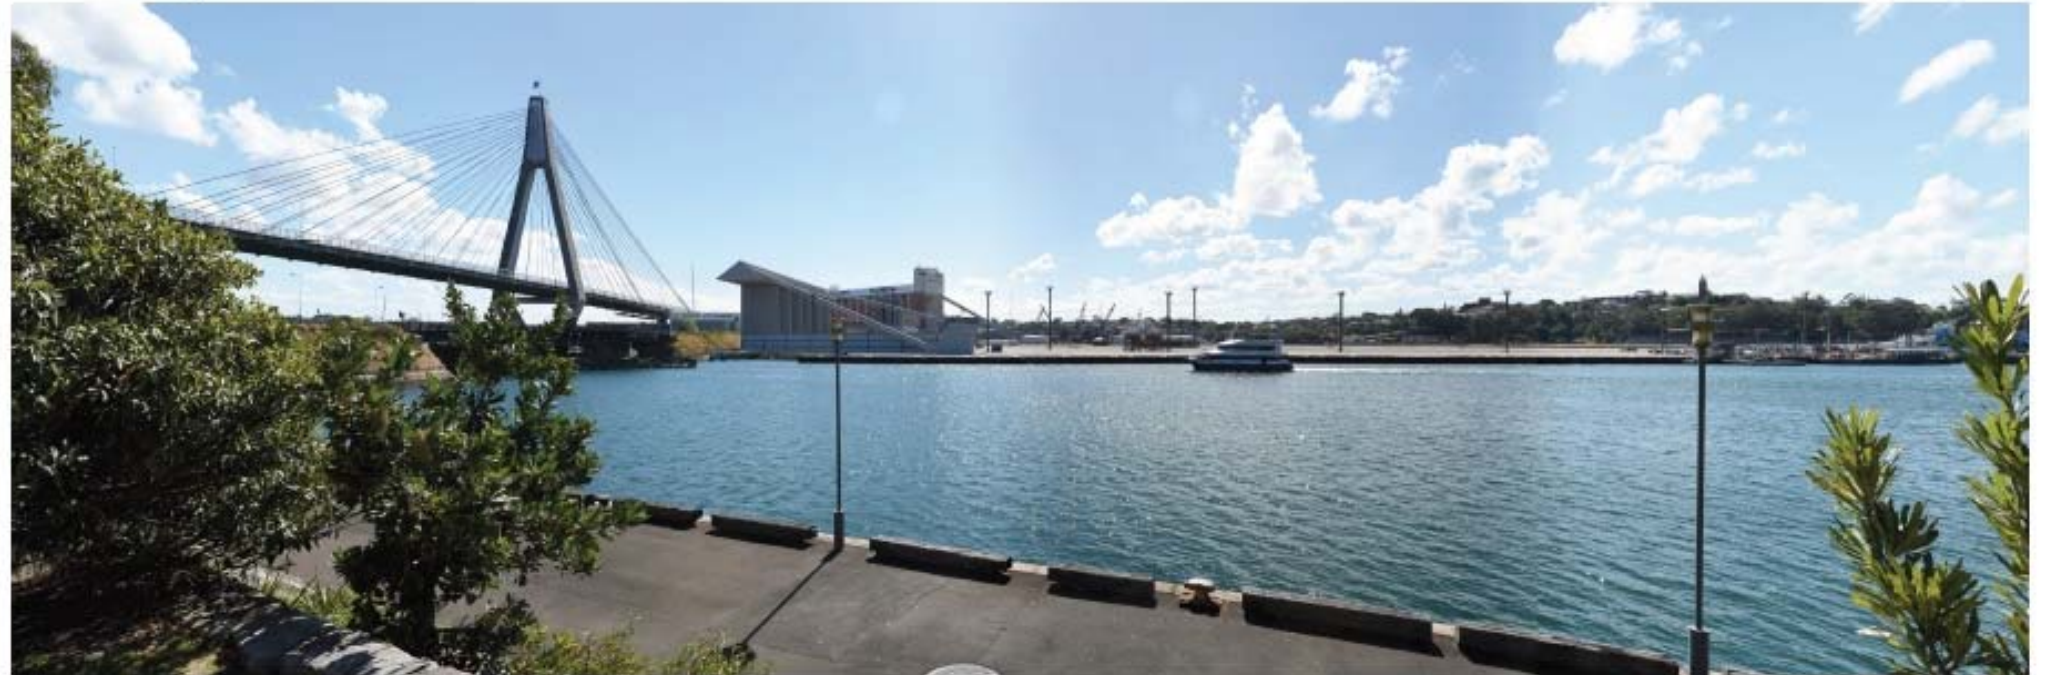
Figure 22 Before and after construction visual impact assessment view from OL7 Waterfront Park, Pyrmont

The last visualisation that was created was from the waterfront on the eastern side of Johnstons Bay from Regatta Wharf. The visualisations shows the concrete batch plant will not hinder or obscure any part of the Glebe Island Bridge (Figure 22).
