# MANGOOLA OPEN CUT

## Translocation of Threatened Flora Species Management Plan

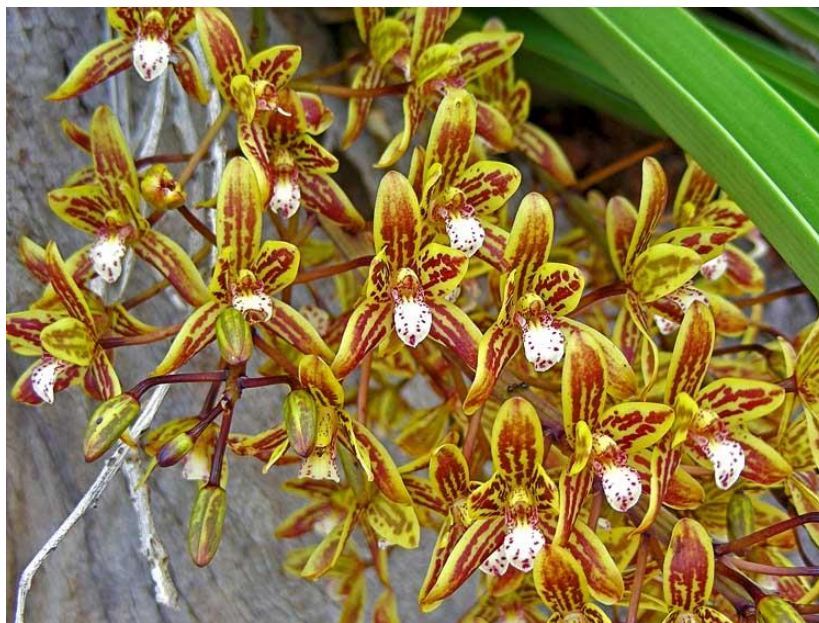
Figure 2.1 – *Cymbidium canaliculatum*

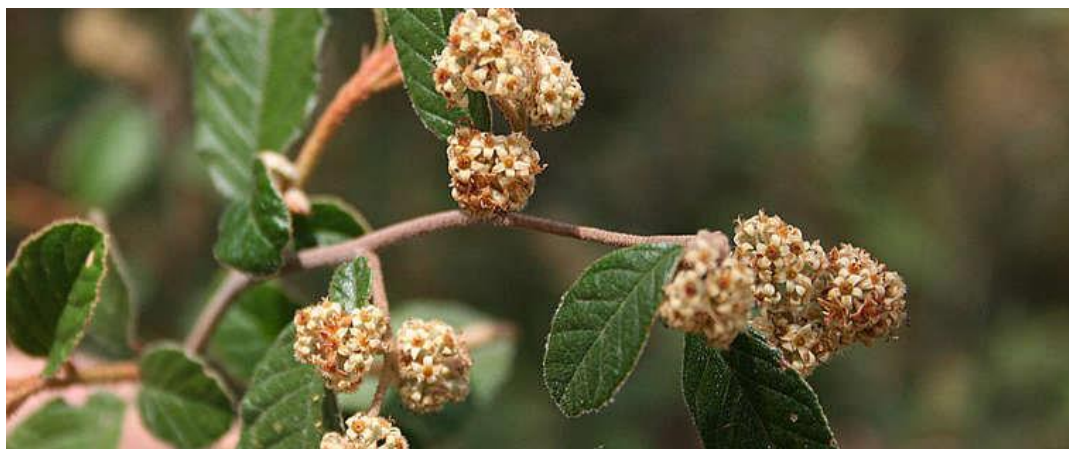
Figure 2.6 – *Pomaderris queenslandica*

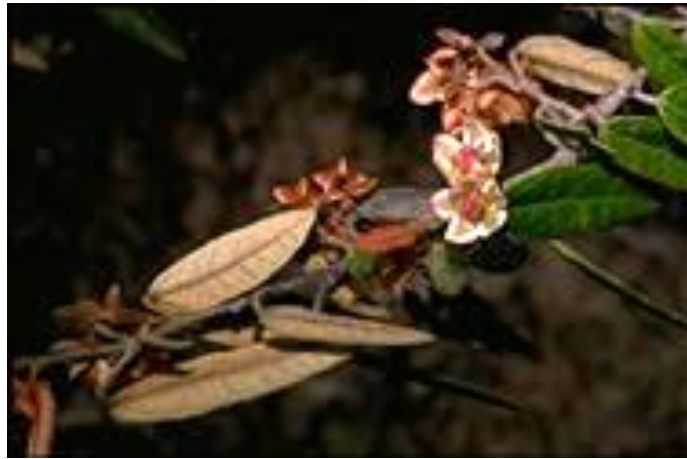
Figure 2.8 – *Lasiopetalum longistamineum*

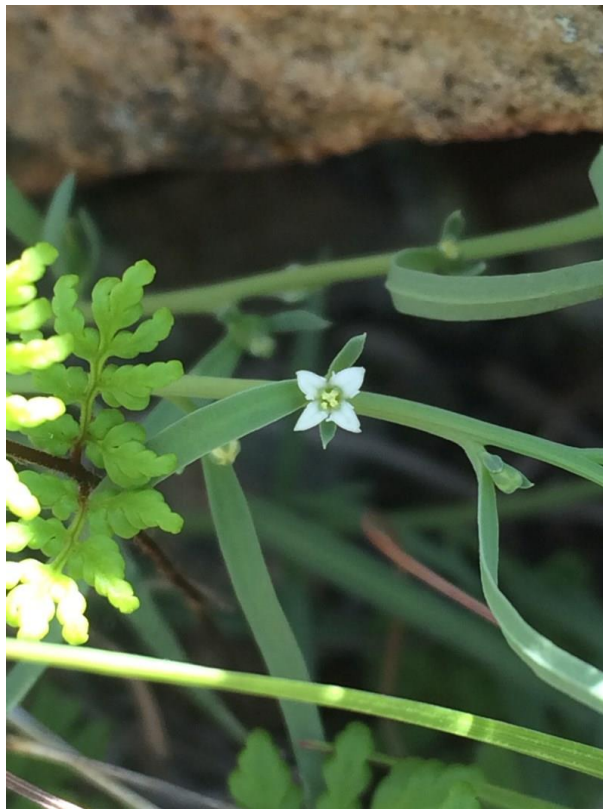
Figure 2.11 – *Thesium australe*
