**REMEDIAL ACTION PLAN  
FOR REDEVELOPMENT  
WORKS, ARMIDALE HIGH  
SCHOOL**

BUTLER STREET,  
ARMIDALE NSW 2350

SEPTEMBER 2018

Remedial action plan for redevelopment works, Armidale High School  
Butler Street, Armidale NSW 2350

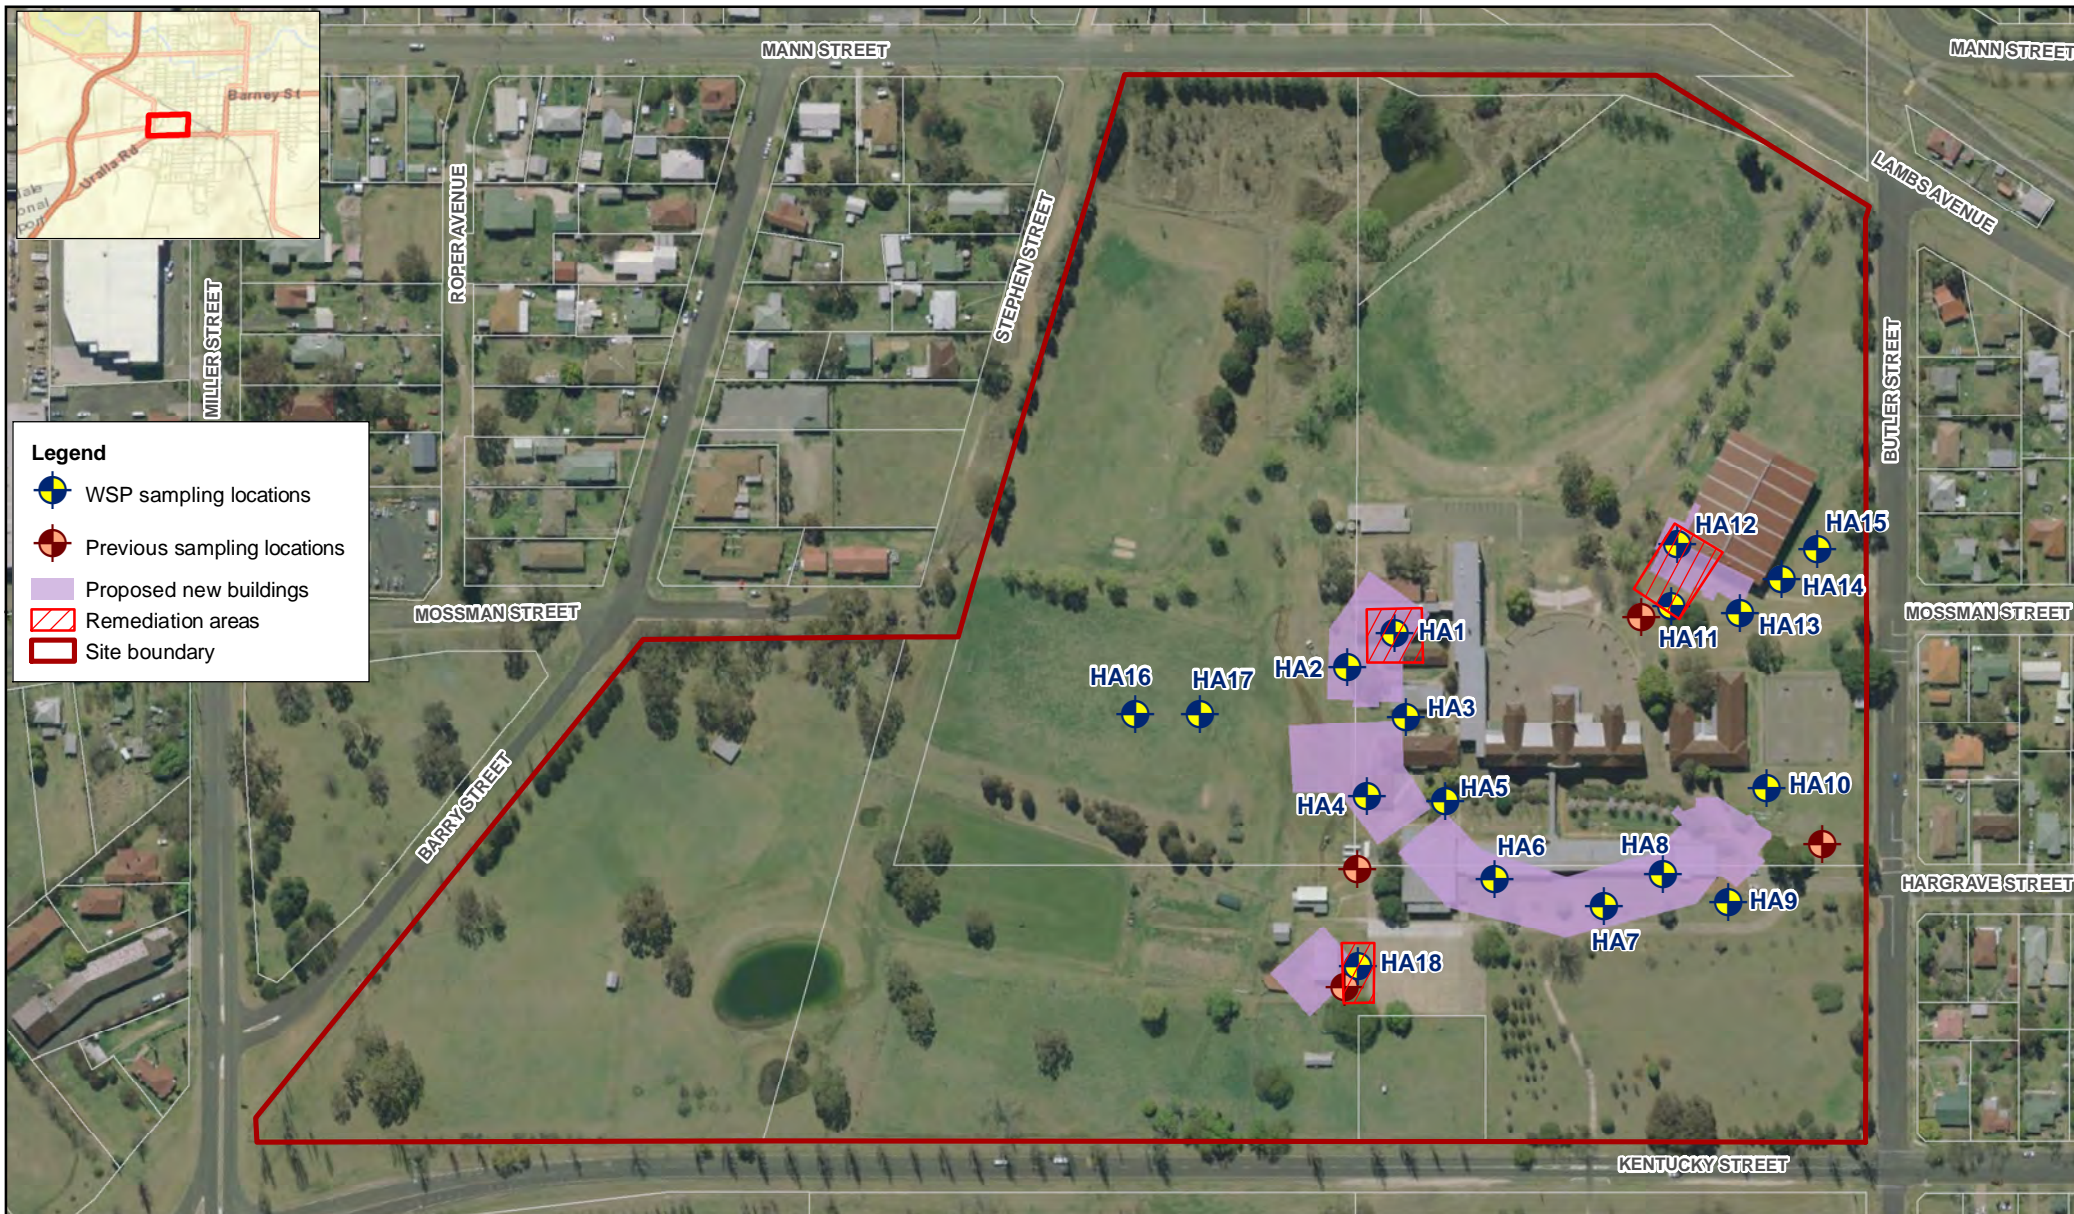
NBRS & Partners Pty Ltd (NBRS) commissioned WSP Australia Pty Ltd (WSP) to prepare a remedial action plan (RAP) for Armidale High School located at Butler St, Armidale, NSW 2350 (the site). A site plan is provided as Figure 1, Appendix A.

Soil investigations targeted areas where the proposed redevelopment will occur and the previously identified PAHs. Exceedances of health-based criteria that require remediation were identified in shallow fill material at HA1, in the centre of the site where the new school building will be constructed, HA11 and HA12 where the gymnasium extension will be constructed and HA18, adjacent to the southern car park. It is noted that the most recent design plans provided do not show the gymnasium extension extending as far as HA11, and some additional excavation in this area will be required.
