REHABILITATION STRATEGY
REPORT

SALT ASH SAND OPERATIONS REHABILITATION AND RELINQUISHMENT REPORT

Report Number: MS-036 Final
Prepared for: Holcim Australia Pty Ltd
Prepared by: Minesoils Pty Ltd

October 2022

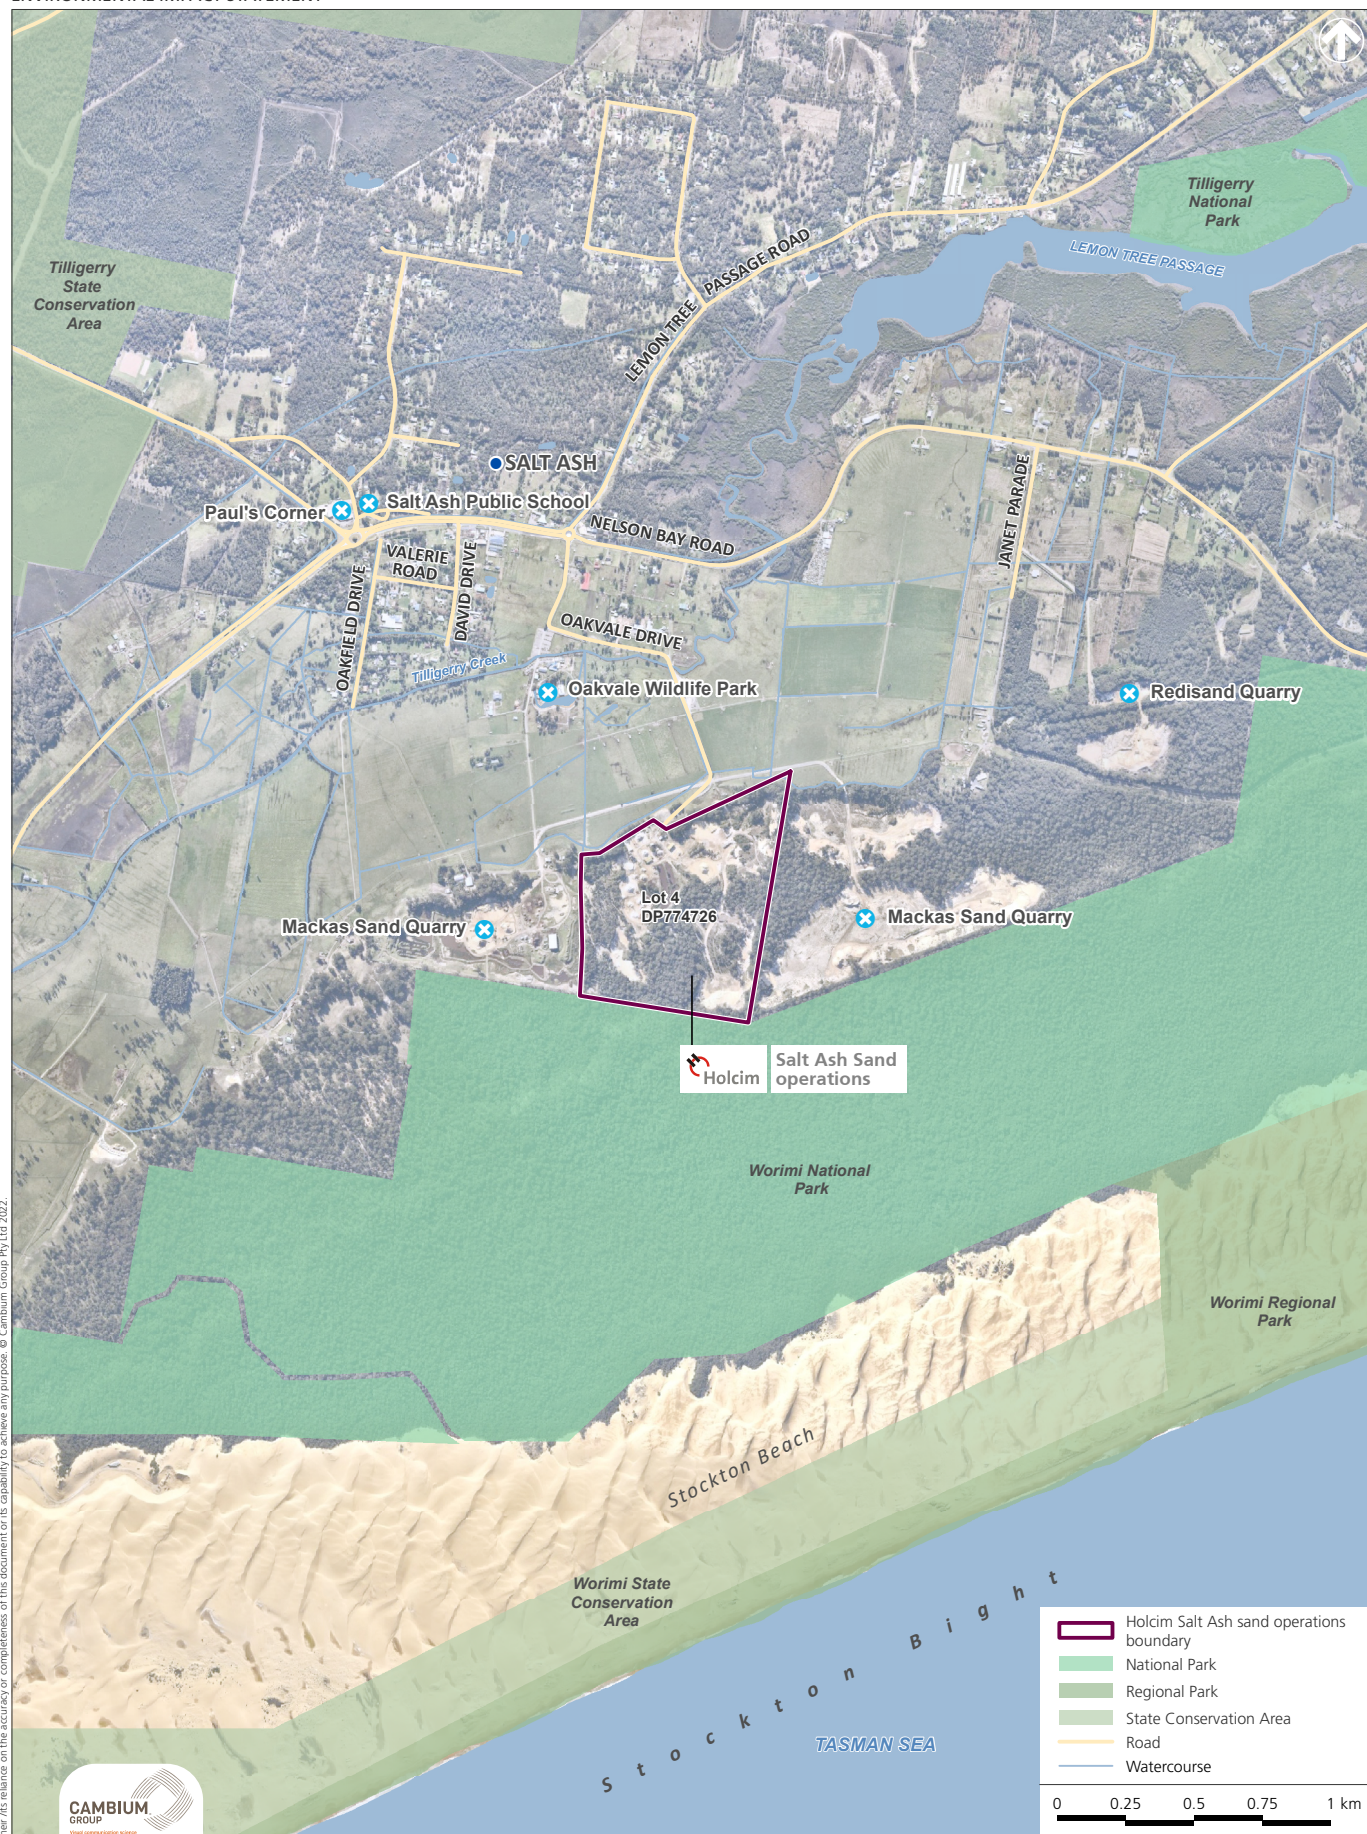
Figure 1
Local context

The proposed disturbance footprint of the project covers an area of approximately 35.4 hectares (ha) (refer **Figure 1**) and encompasses all areas to be disturbed by sand extraction (dry extraction and dredging), internal access roadways (including slope batters) and processing operations and encompasses all areas of vegetation clearing.

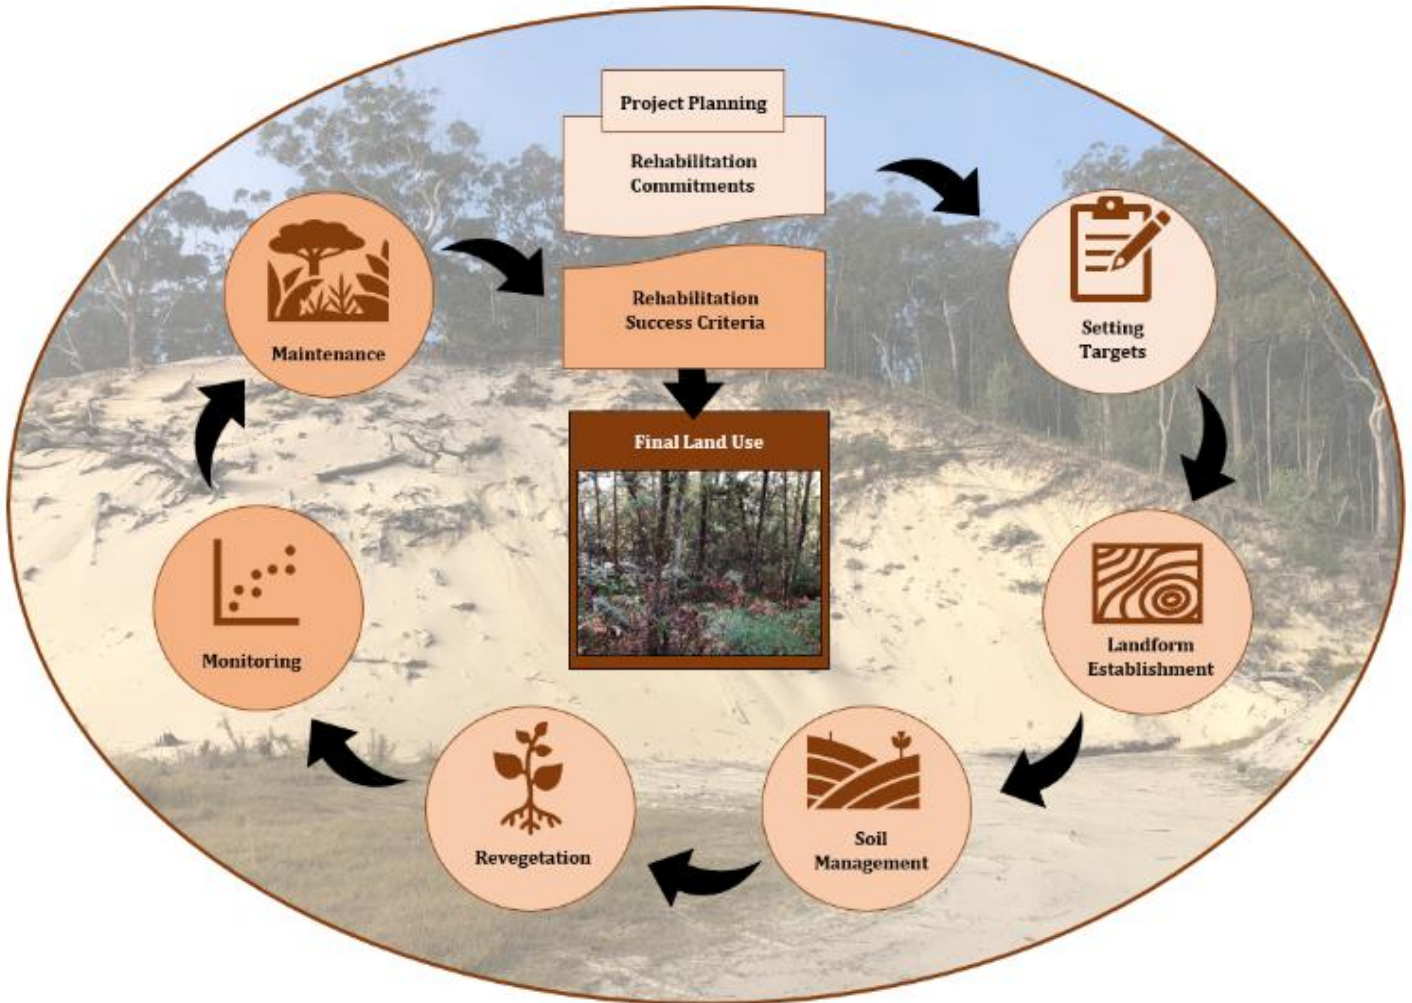
Figure 2: Rehabilitation Process Overview

A conceptual overview of land rehabilitation is presented in **Figure 2** below and outlines the process from a project planning phase through to the achievement of a final land use that meets the successful rehabilitation criteria, whereby the site can then be relinquished.

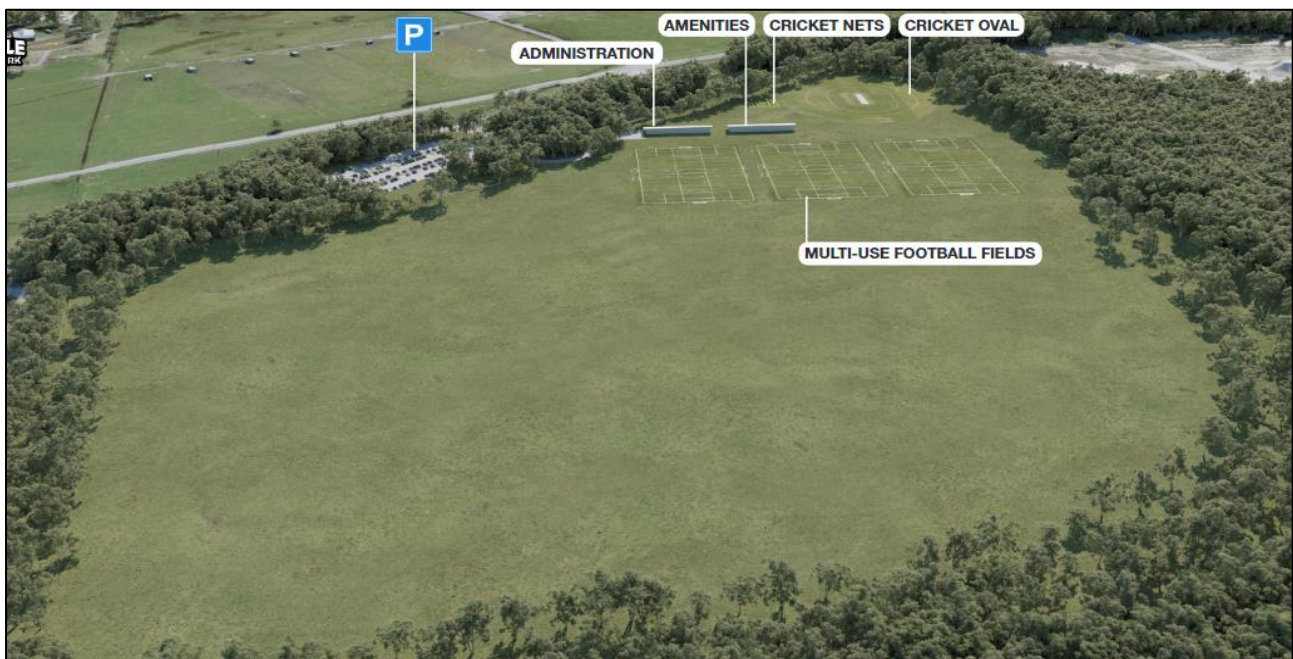
Figure 3: Option 1 final land use concept

Option 1 accounts for the potential to fill the site to a nominated level for community use and /or environmental conservation. Community use may include sporting fields, off leash dog park, etc. The conservation approach would involve revegetation with endemic coastal woodland vegetation to restore the Project Site to an equivalent of its original condition. This may also include the establishment of typical dune topography, undulation, and swales into the landform to emulate local hind dune geomorphology. Alternatively, a portion of the Project Site may be developed for community use, while the remainder is allocated for conservation.

This option is conceptualised (as an example only) in the following graphic developed by Cambium Group Pty Ltd and presented during community information sessions for the Project.

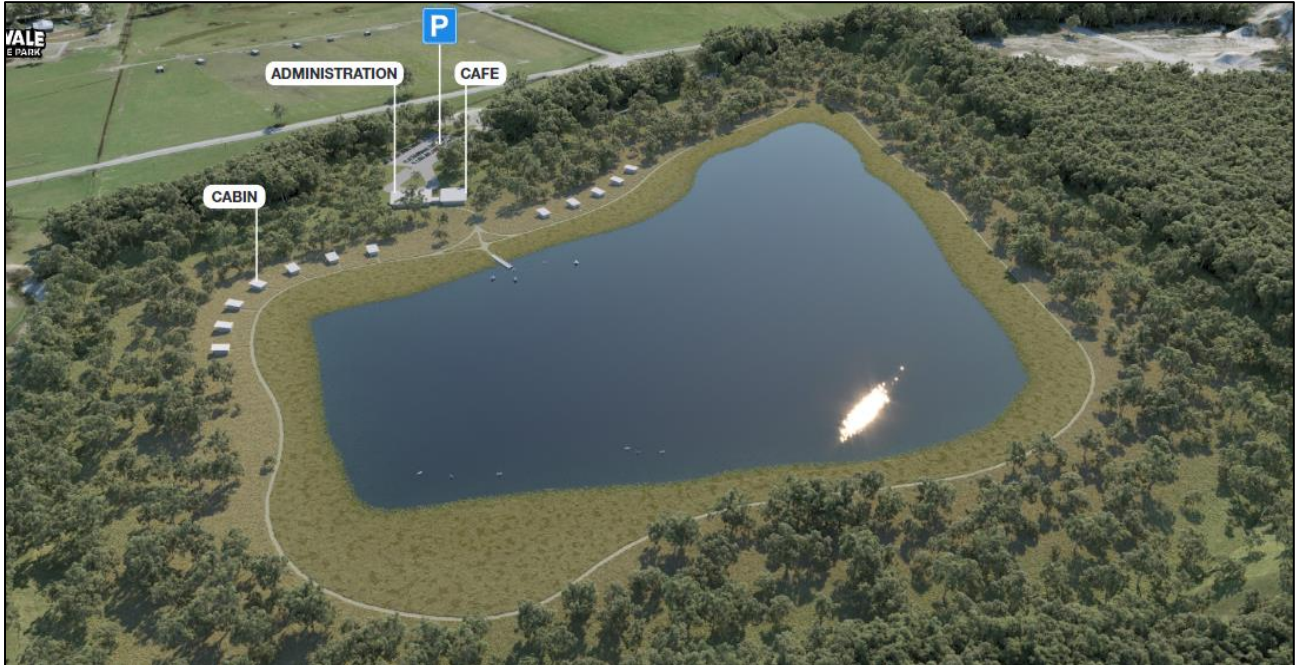
Figure 4: Option 2 final land use concept

The conservation approach would involve rehabilitating the pond edges and disturbed area to restore native woodland, as well as establish native aquatic vegetation on pond edges to mitigate erosion.

This option is conceptualised (as an example only) in the following graphic developed by Cambium Group Pty Ltd and presented during community information sessions for the Project.

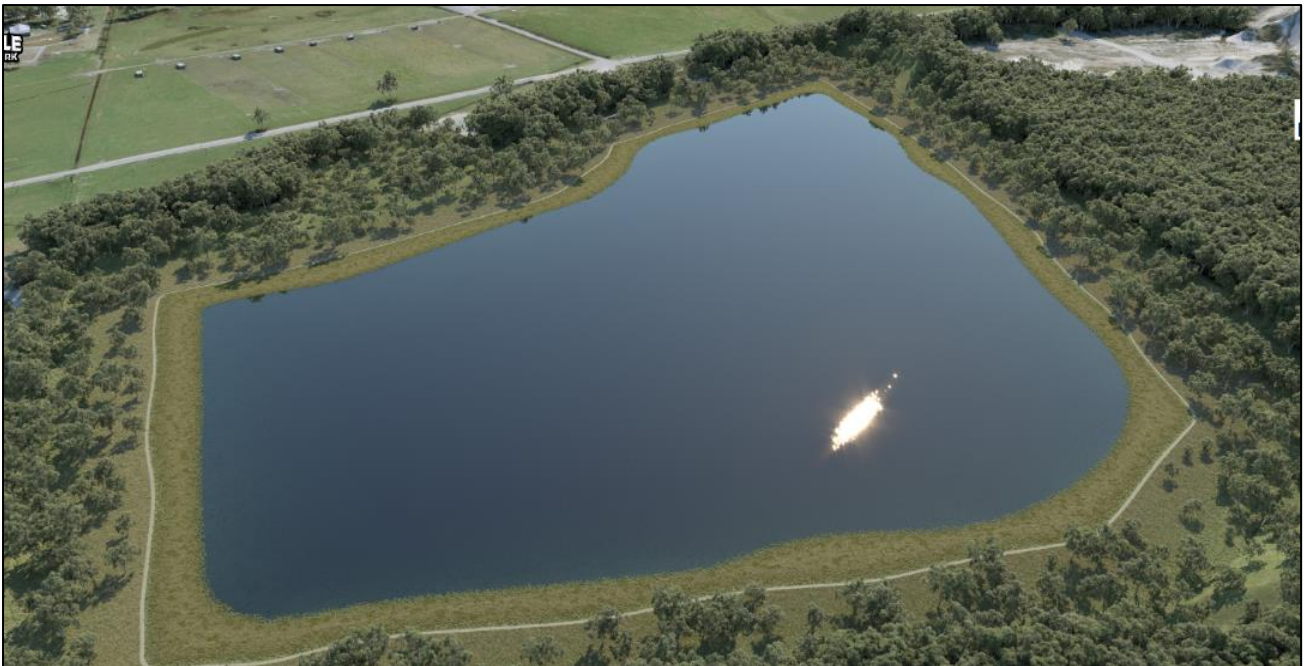
Figure 5: Option 3 final land use concept

This option is conceptualised (as an example only) in the following graphic developed by Cambium Group Pty Ltd and presented during community information sessions for the Project.

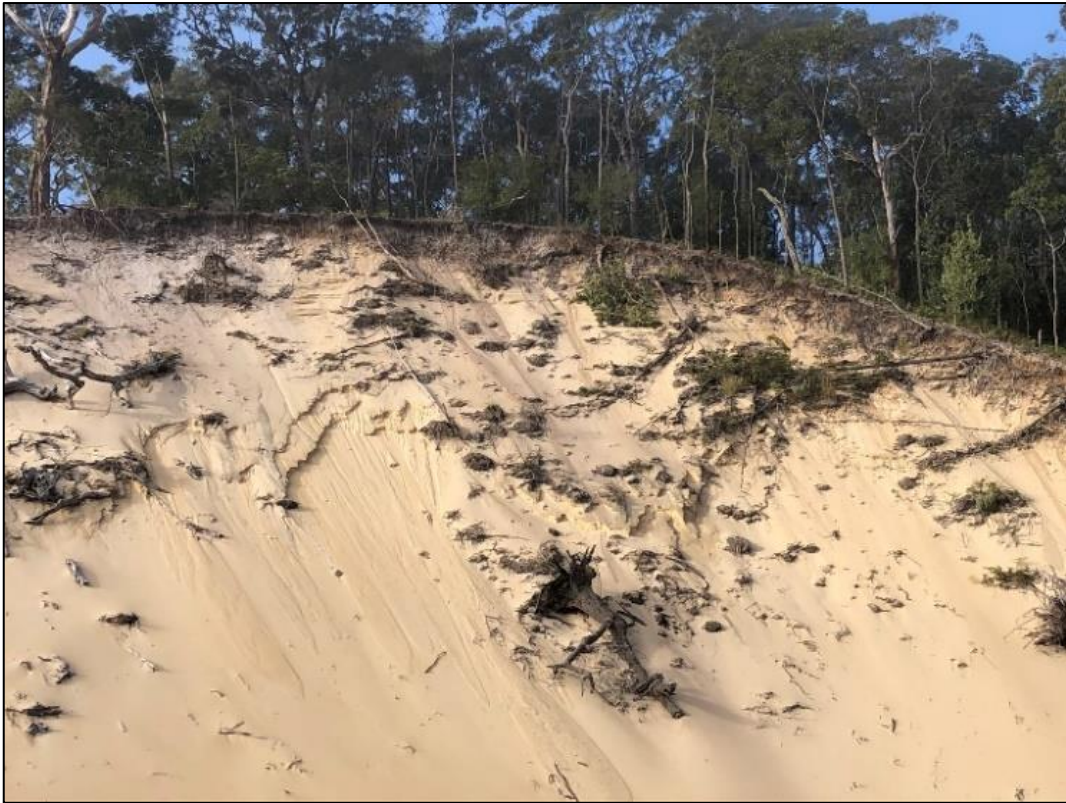
Plate 1: Example of unstable angle of repose on existing landform to be intersected with 20° batter.

The final landform options all involve landform instability risk due to the requirement to batter existing slopes. The design criteria approach for a slope stability analysis of a selected final landform will be based on the minimum required factor of safety ("FoS") for the appropriate consequence of failure. The adopted FoS will be in accordance with those typically adopted within the industry for slope stability assessments and in general accordance with NSW Health and Safety at Quarries Guidelines.

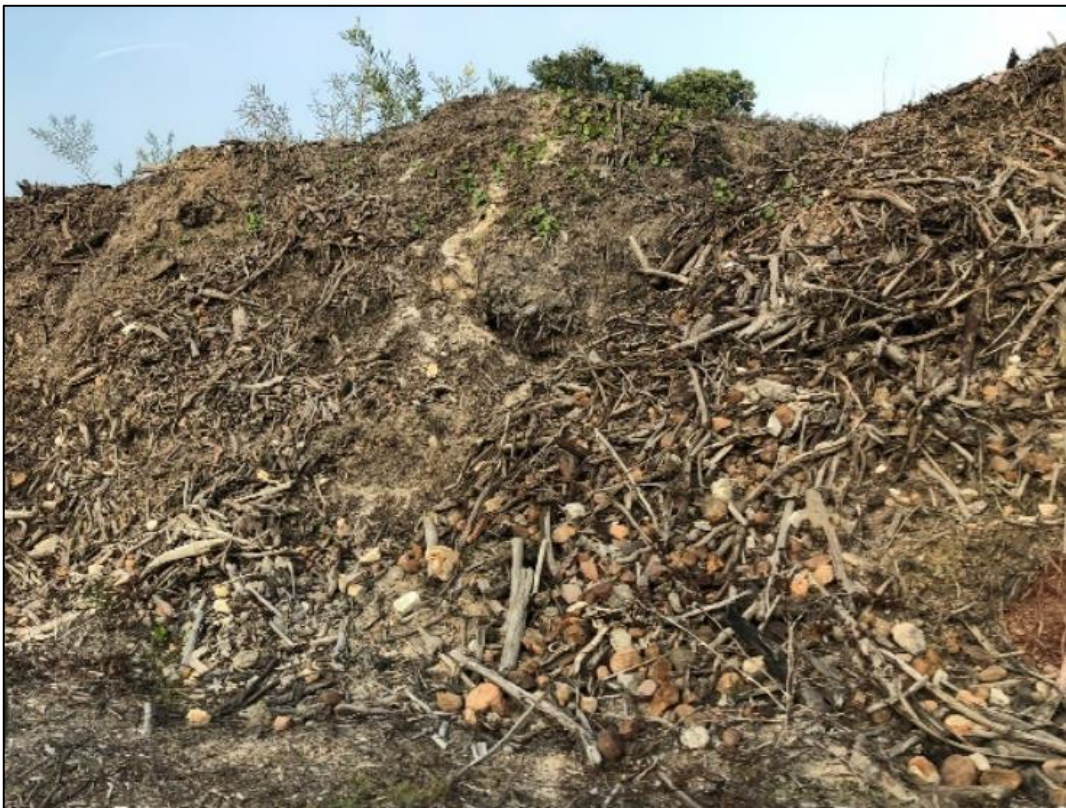
Plate 2: Example of using coarse material as protective cover to stockpile onsite.

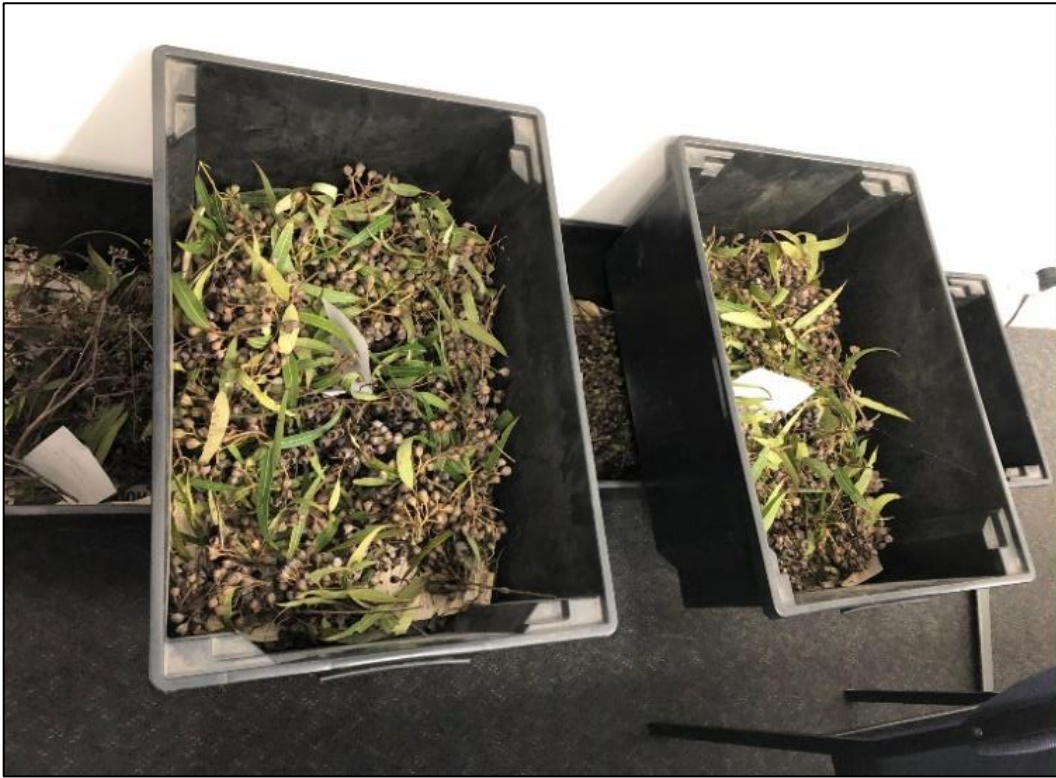
Plate 3: Seedbank store for rehabilitation purposes.

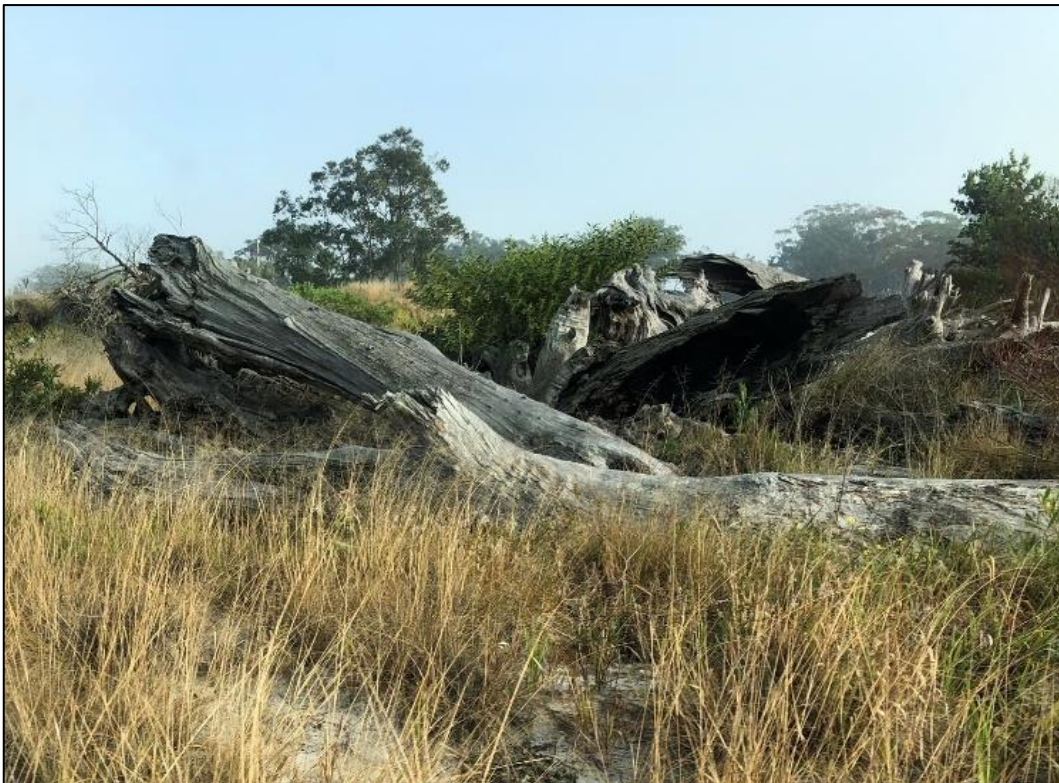
Plate 4. Felled trees stored for use in rehabilitation as fauna habitat and erosion control.

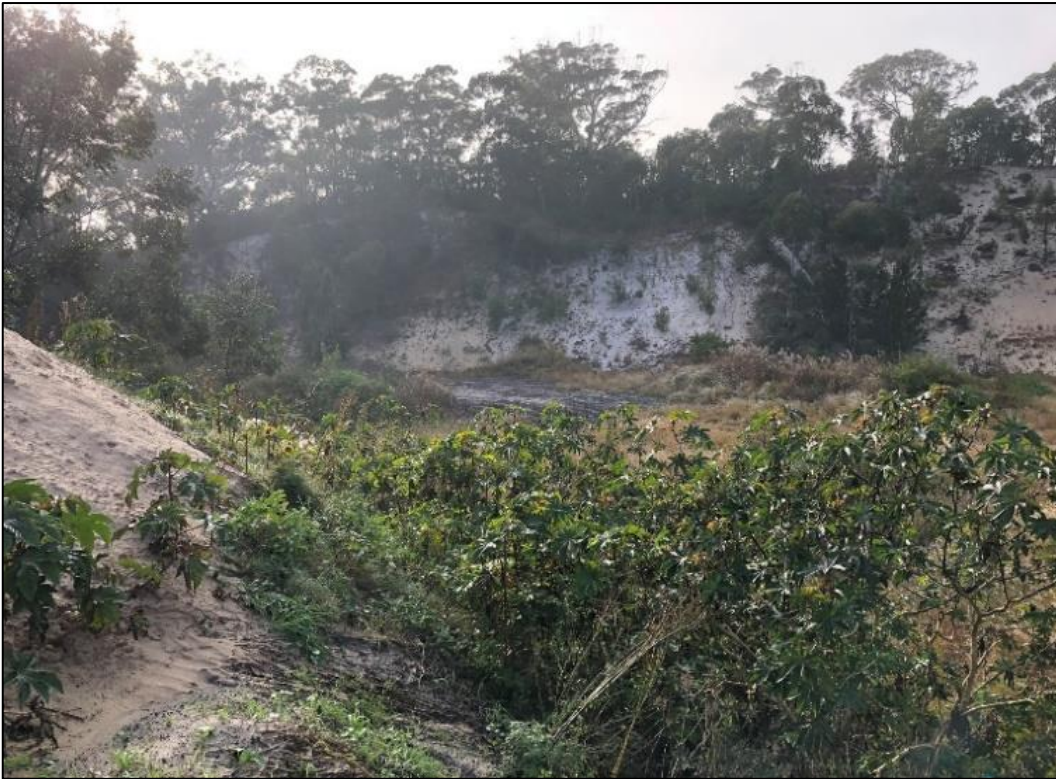
Plate 5: Identified weed species including *Ricinus communis* (foreground) to be eliminated as part of pest management measures.

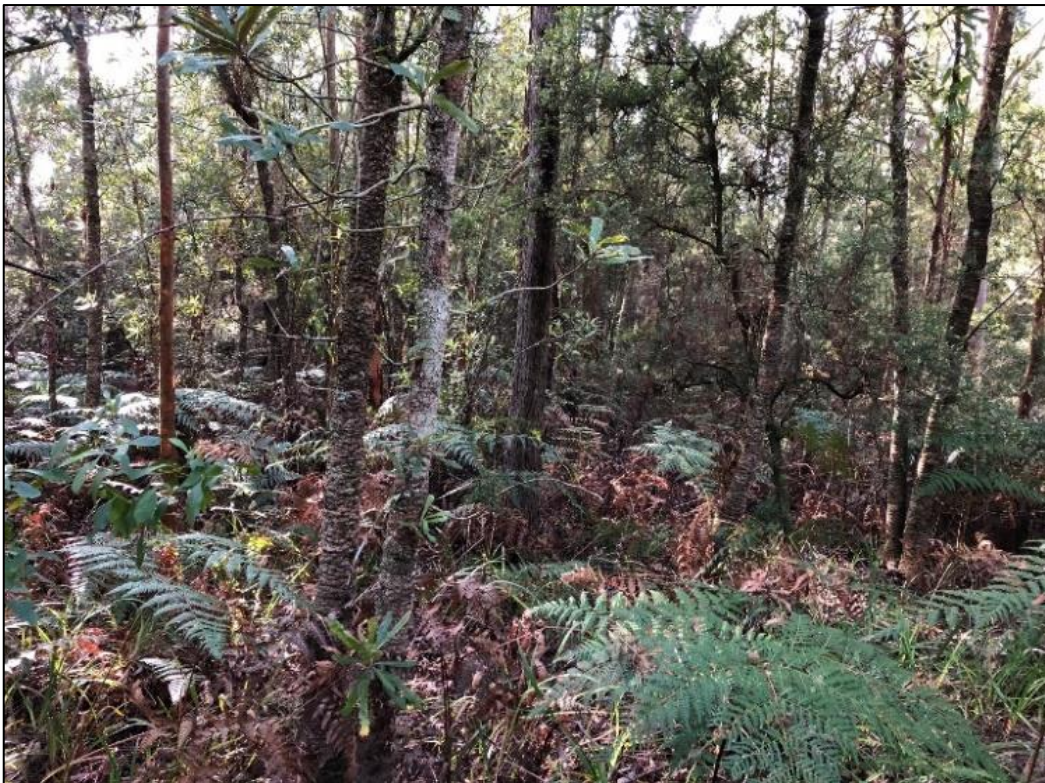
Plate 6. Coastal woodland native species including *Banksia Serrata* (foreground), target rehabilitation species; observed June 2020.
