ALEX AVENUE PUBLIC SCHOOL
NO: 1157

CONSTRUCTION ENVIRONMENTAL MANAGEMENT PLAN (CEMP)

15 January 2021

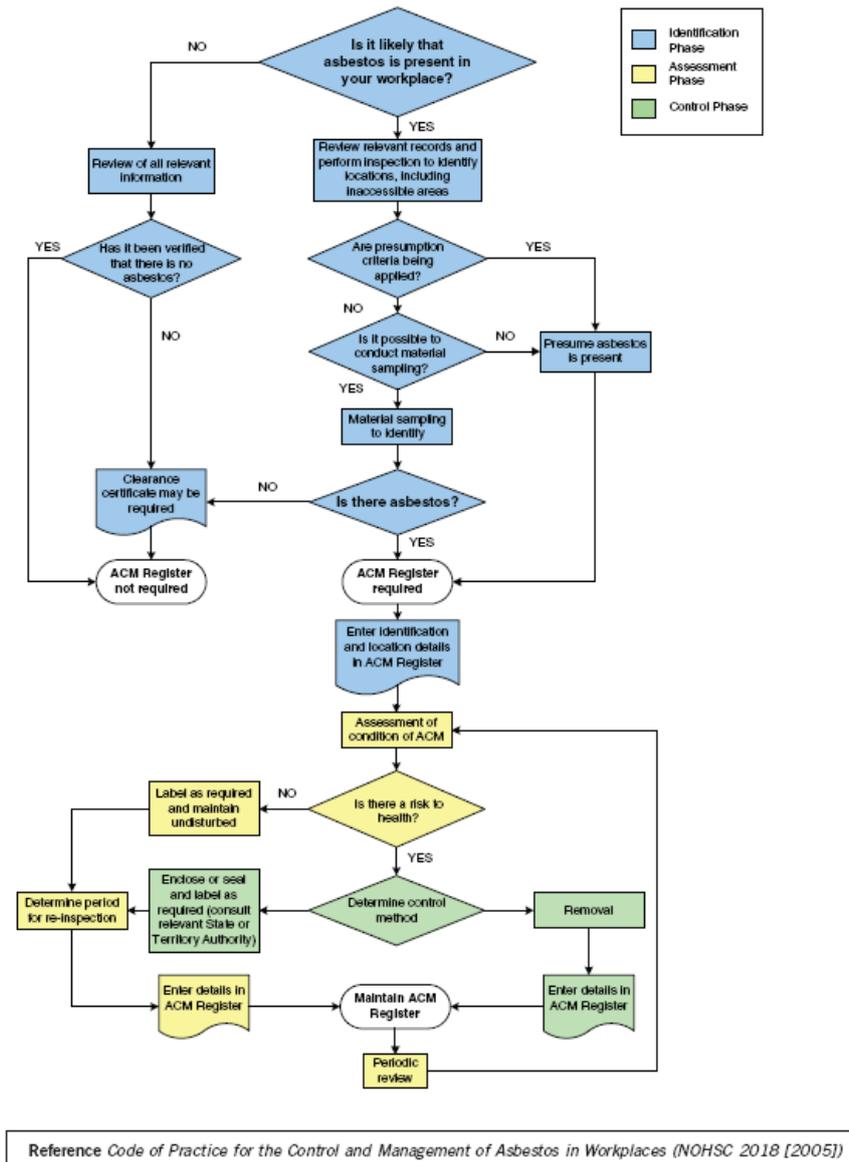
Figure 1: General principles of an asbestos management plan

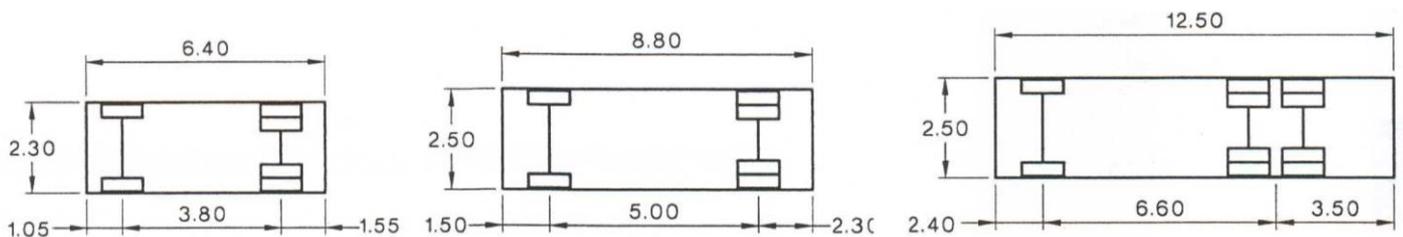
Loading and unloading of vehicles will be done onsite within the property boundaries. There will be a combination of small rigid vehicles (SRV’s 6.4m), medium rigid vehicles (MRV’s 8.8m), Heavy Rigid Vehicles (HRV’s 12.5m) and Bulk Excavation/Block Delivery vehicles (AV’s 19m) accessing and egressing from the site. The largest vehicle accessing and egressing the site will be an AV.

(a) Small rigid vehicle
Clearance height 3.50
Design turning radius 7.1

(b) Medium rigid vehicle
Clearance height 4.50
Design turning radius 10.0

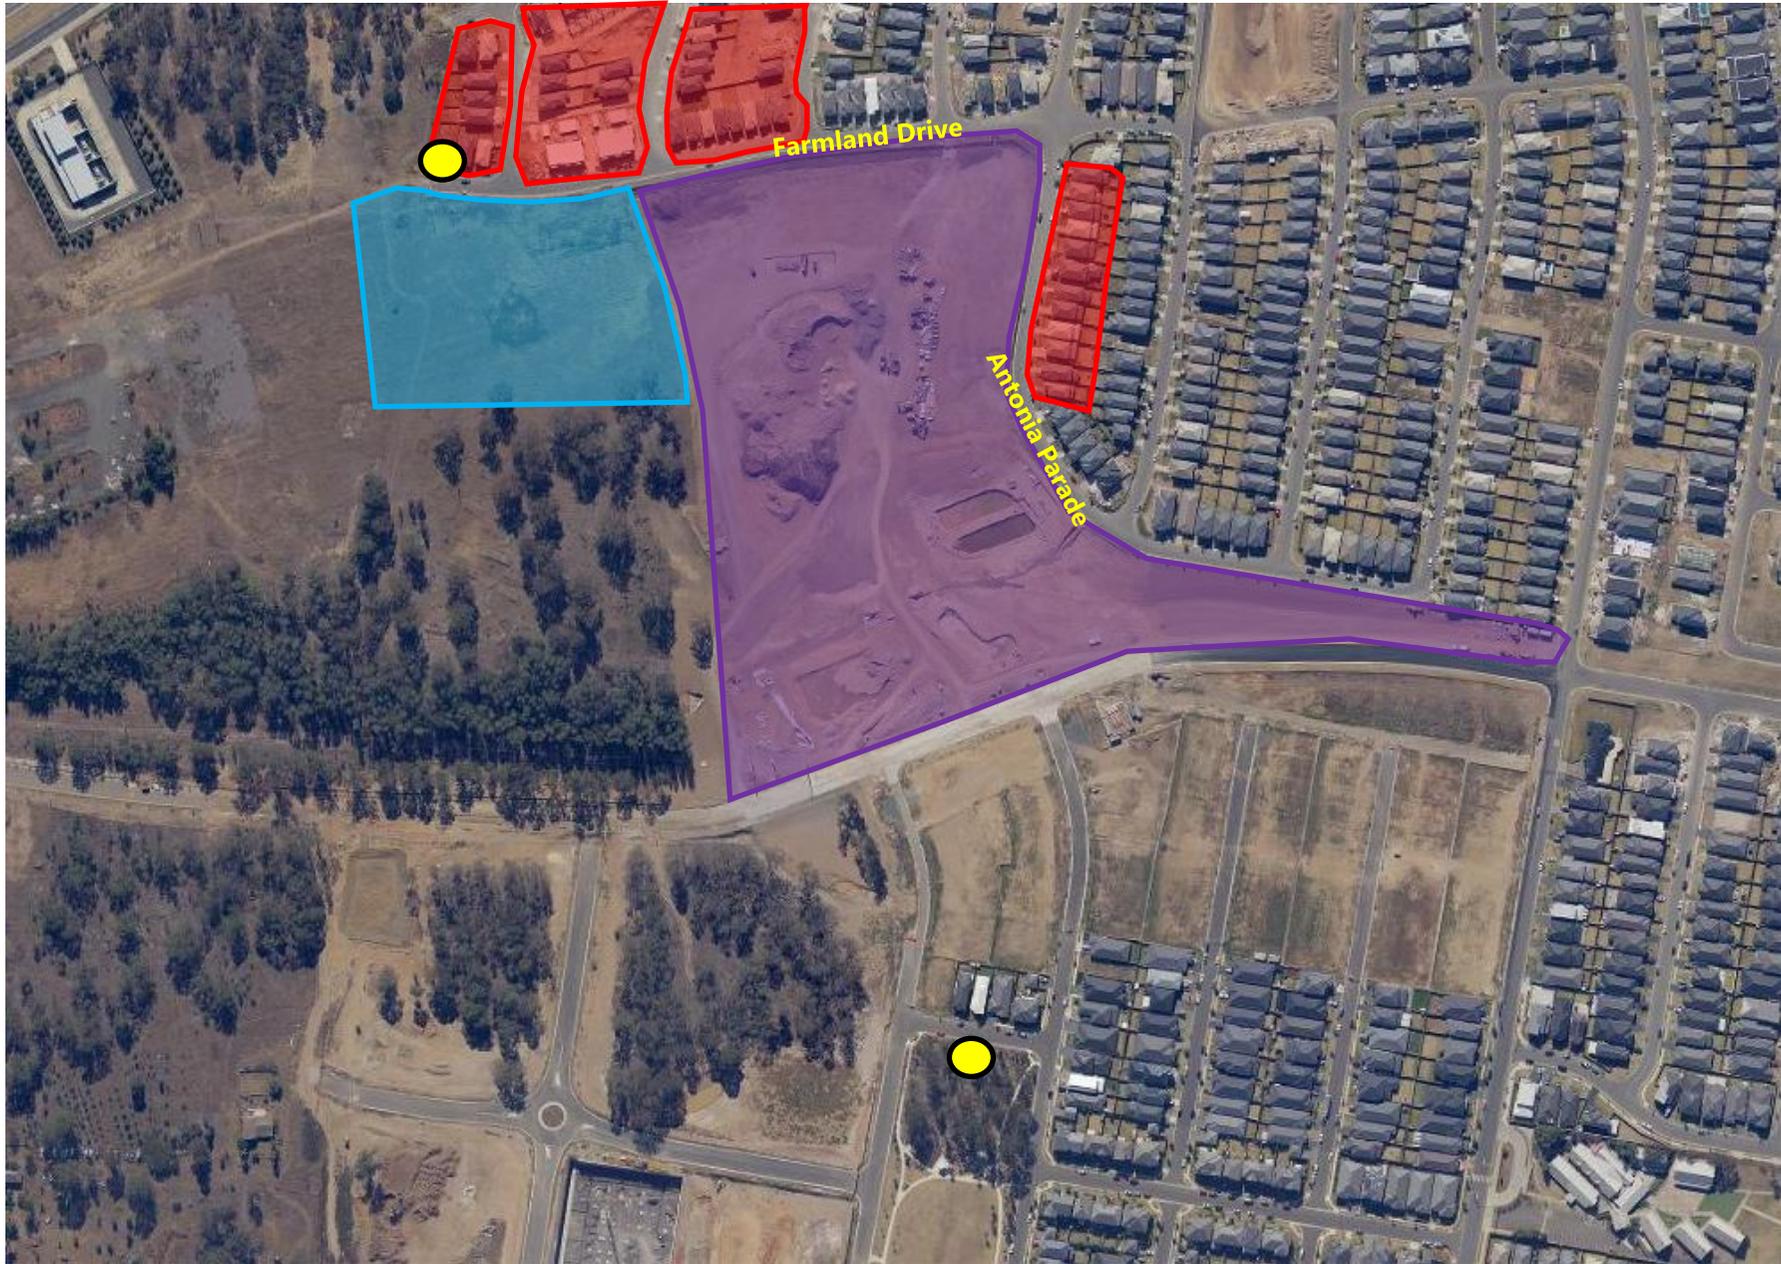
Receiver 2 – Residential dwellings located to the east of the project site, Antonia Parade.

Figure 1 – Site Map and Receiver Locations Sourced from SixMaps NSW

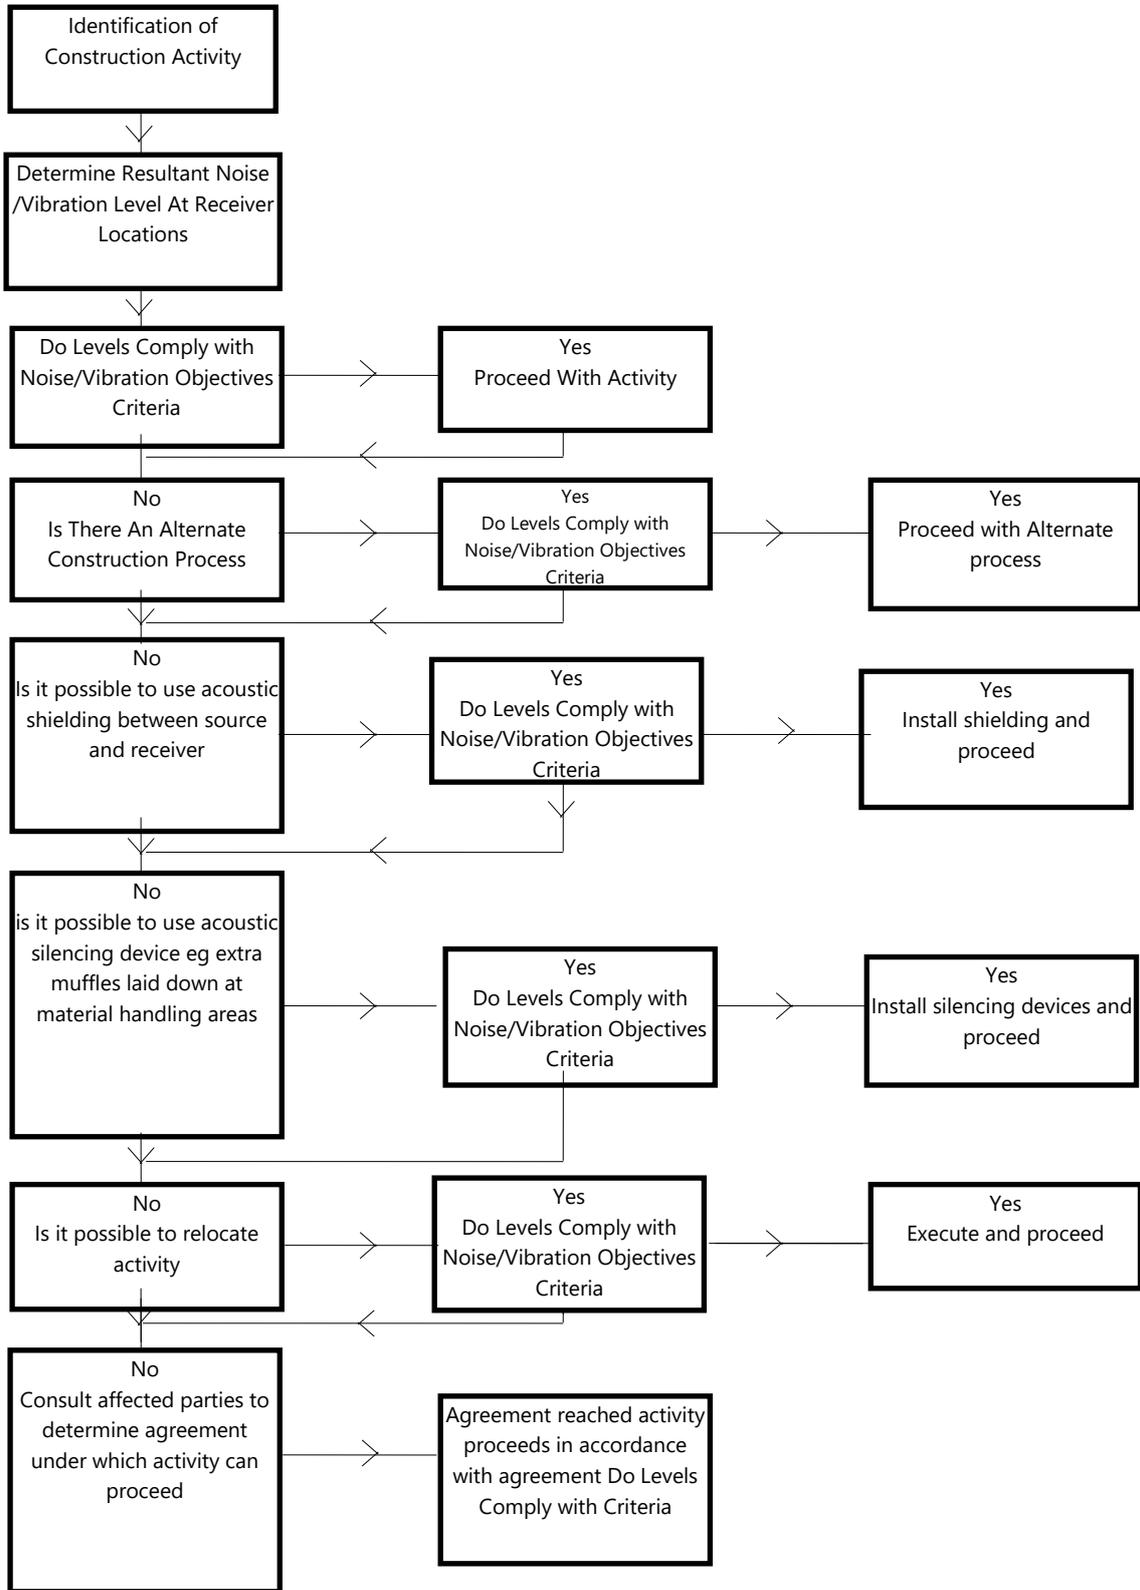
Figure 2 – Process Flowchart

The flow chart presented in Figure 2 illustrates the process that will be followed in assessing construction activities.

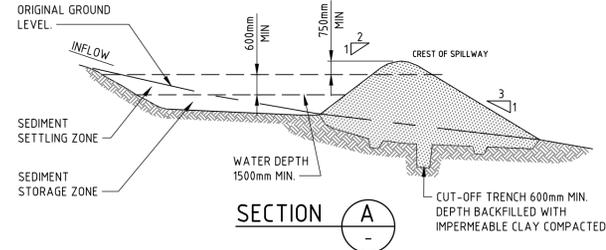
NOTE: ONLY TO BE USED AS TEMPORARY BANK WHERE MAXIMUM UPSLOPE LENGTH IS 80 METRES.
DRAINAGE SWALE

1. REMOVE ALL VEGETATION AND TOPSOIL FROM UNDER THE DAM WALL AND FROM WITHIN THE STORAGE AREA.
2. CONSTRUCT A CUT-OFF TRENCH 500mm DEEP AND 1200mm WIDE ALONG THE CENTRELINE OF THE EMBANKMENT EXTENDING TO A POINT ON THE GULLY WALL LEVEL WITH THE RISER CREST.
3. MAINTAIN THE TRENCH FREE OF WATER AND RECOMPACT THE MATERIALS WITH EQUIPMENT AS SPECIFIED IN THE SWMP TO 95 PER CENT STANDARD PROCTOR DENSITY.
4. SELECT FILL FOLLOWING THE SWMP THAT IS FREE OF ROOTS, WOOD, ROCK, LARGE STONE OR FOREIGN MATERIAL.
5. PREPARE THE SITE UNDER THE EMBANKMENT BY RIPPING TO AT LEAST 100mm TO HELP BOND COMPACTED FILL TO THE EXISTING SUBSTRATE.
6. SPREAD THE FILL IN 100mm TO 150mm LAYERS AND COMPACT IT AT OPTIMUM MOISTURE CONTENT FOLLOWING THE SWMP.
7. CONSTRUCT THE EMERGENCY SPILLWAY.
8. REHABILITATE THE STRUCTURE FOLLOWING THE SWMP.

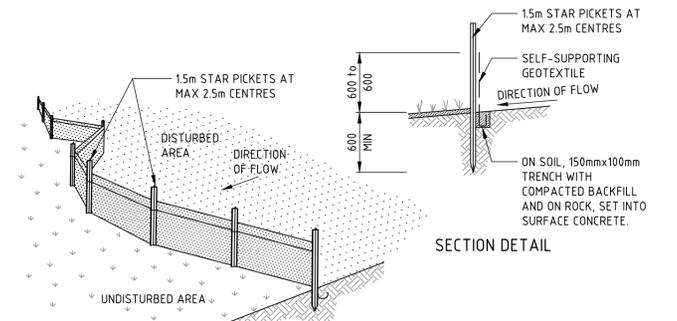
(APPLIES TO 'TYPE D' AND 'TYPE F' SOILS ONLY)
SEDIMENT BASIN

1. CONSTRUCT SEDIMENT FENCES AS CLOSE AS POSSIBLE TO BEING PARALLEL TO THE CONTOURS OF THE SITE, BUT WITH SMALL RETURNS AS SHOWN IN THE DRAWING TO LIMIT THE CATCHMENT AREA OF ANY ONE SECTION. THE CATCHMENT AREA SHOULD BE SMALL ENOUGH TO LIMIT WATER FLOW IF CONCENTRATED AT ONE POINT TO 50 LITRES PER SECOND IN THE DESIGN STORM EVENT, USUALLY THE 10-YEAR EVENT.

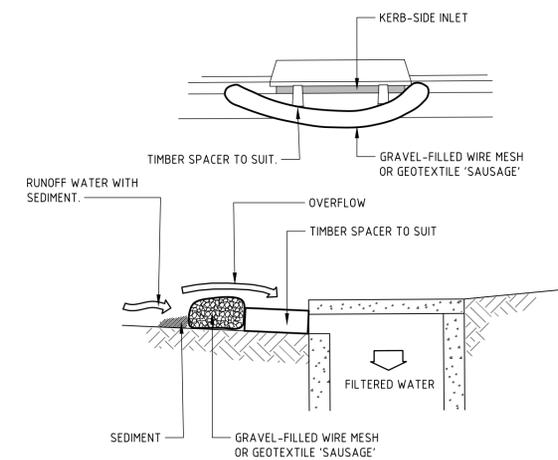
SEDIMENT FENCE

1. INSTALL FILTERS TO KERB INLETS ONLY AT SAG POINTS.
2. FABRICATE A SLEEVE MADE FROM GEOTEXTILE OR WIRE MESH LONGER THAN THE LENGTH OF THE INLET PIT AND FILL IT WITH 25mm TO 50mm GRAVEL.
3. FORM AN ELLIPTICAL CROSS-SECTION ABOUT 150mm HIGH x 400mm WIDE.
4. PLACE THE FILTER AT THE OPENING LEAVING AT LEAST A 100mm SPACE BETWEEN IT AND THE KERB INLET. MAINTAIN THE OPENING WITH SPACER BLOCKS.
5. FORM A SEAL WITH THE KERB TO PREVENT SEDIMENT BYPASSING THE FILTER.
6. SANDBAGS FILLED WITH GRAVEL CAN SUBSTITUTE FOR THE MESH OR GEOTEXTILE PROVIDING THEY ARE PLACED SO THAT THEY FIRMLY ABUT EACH OTHER AND SEDIMENT-LADEN WATERS CANNOT PASS BETWEEN.

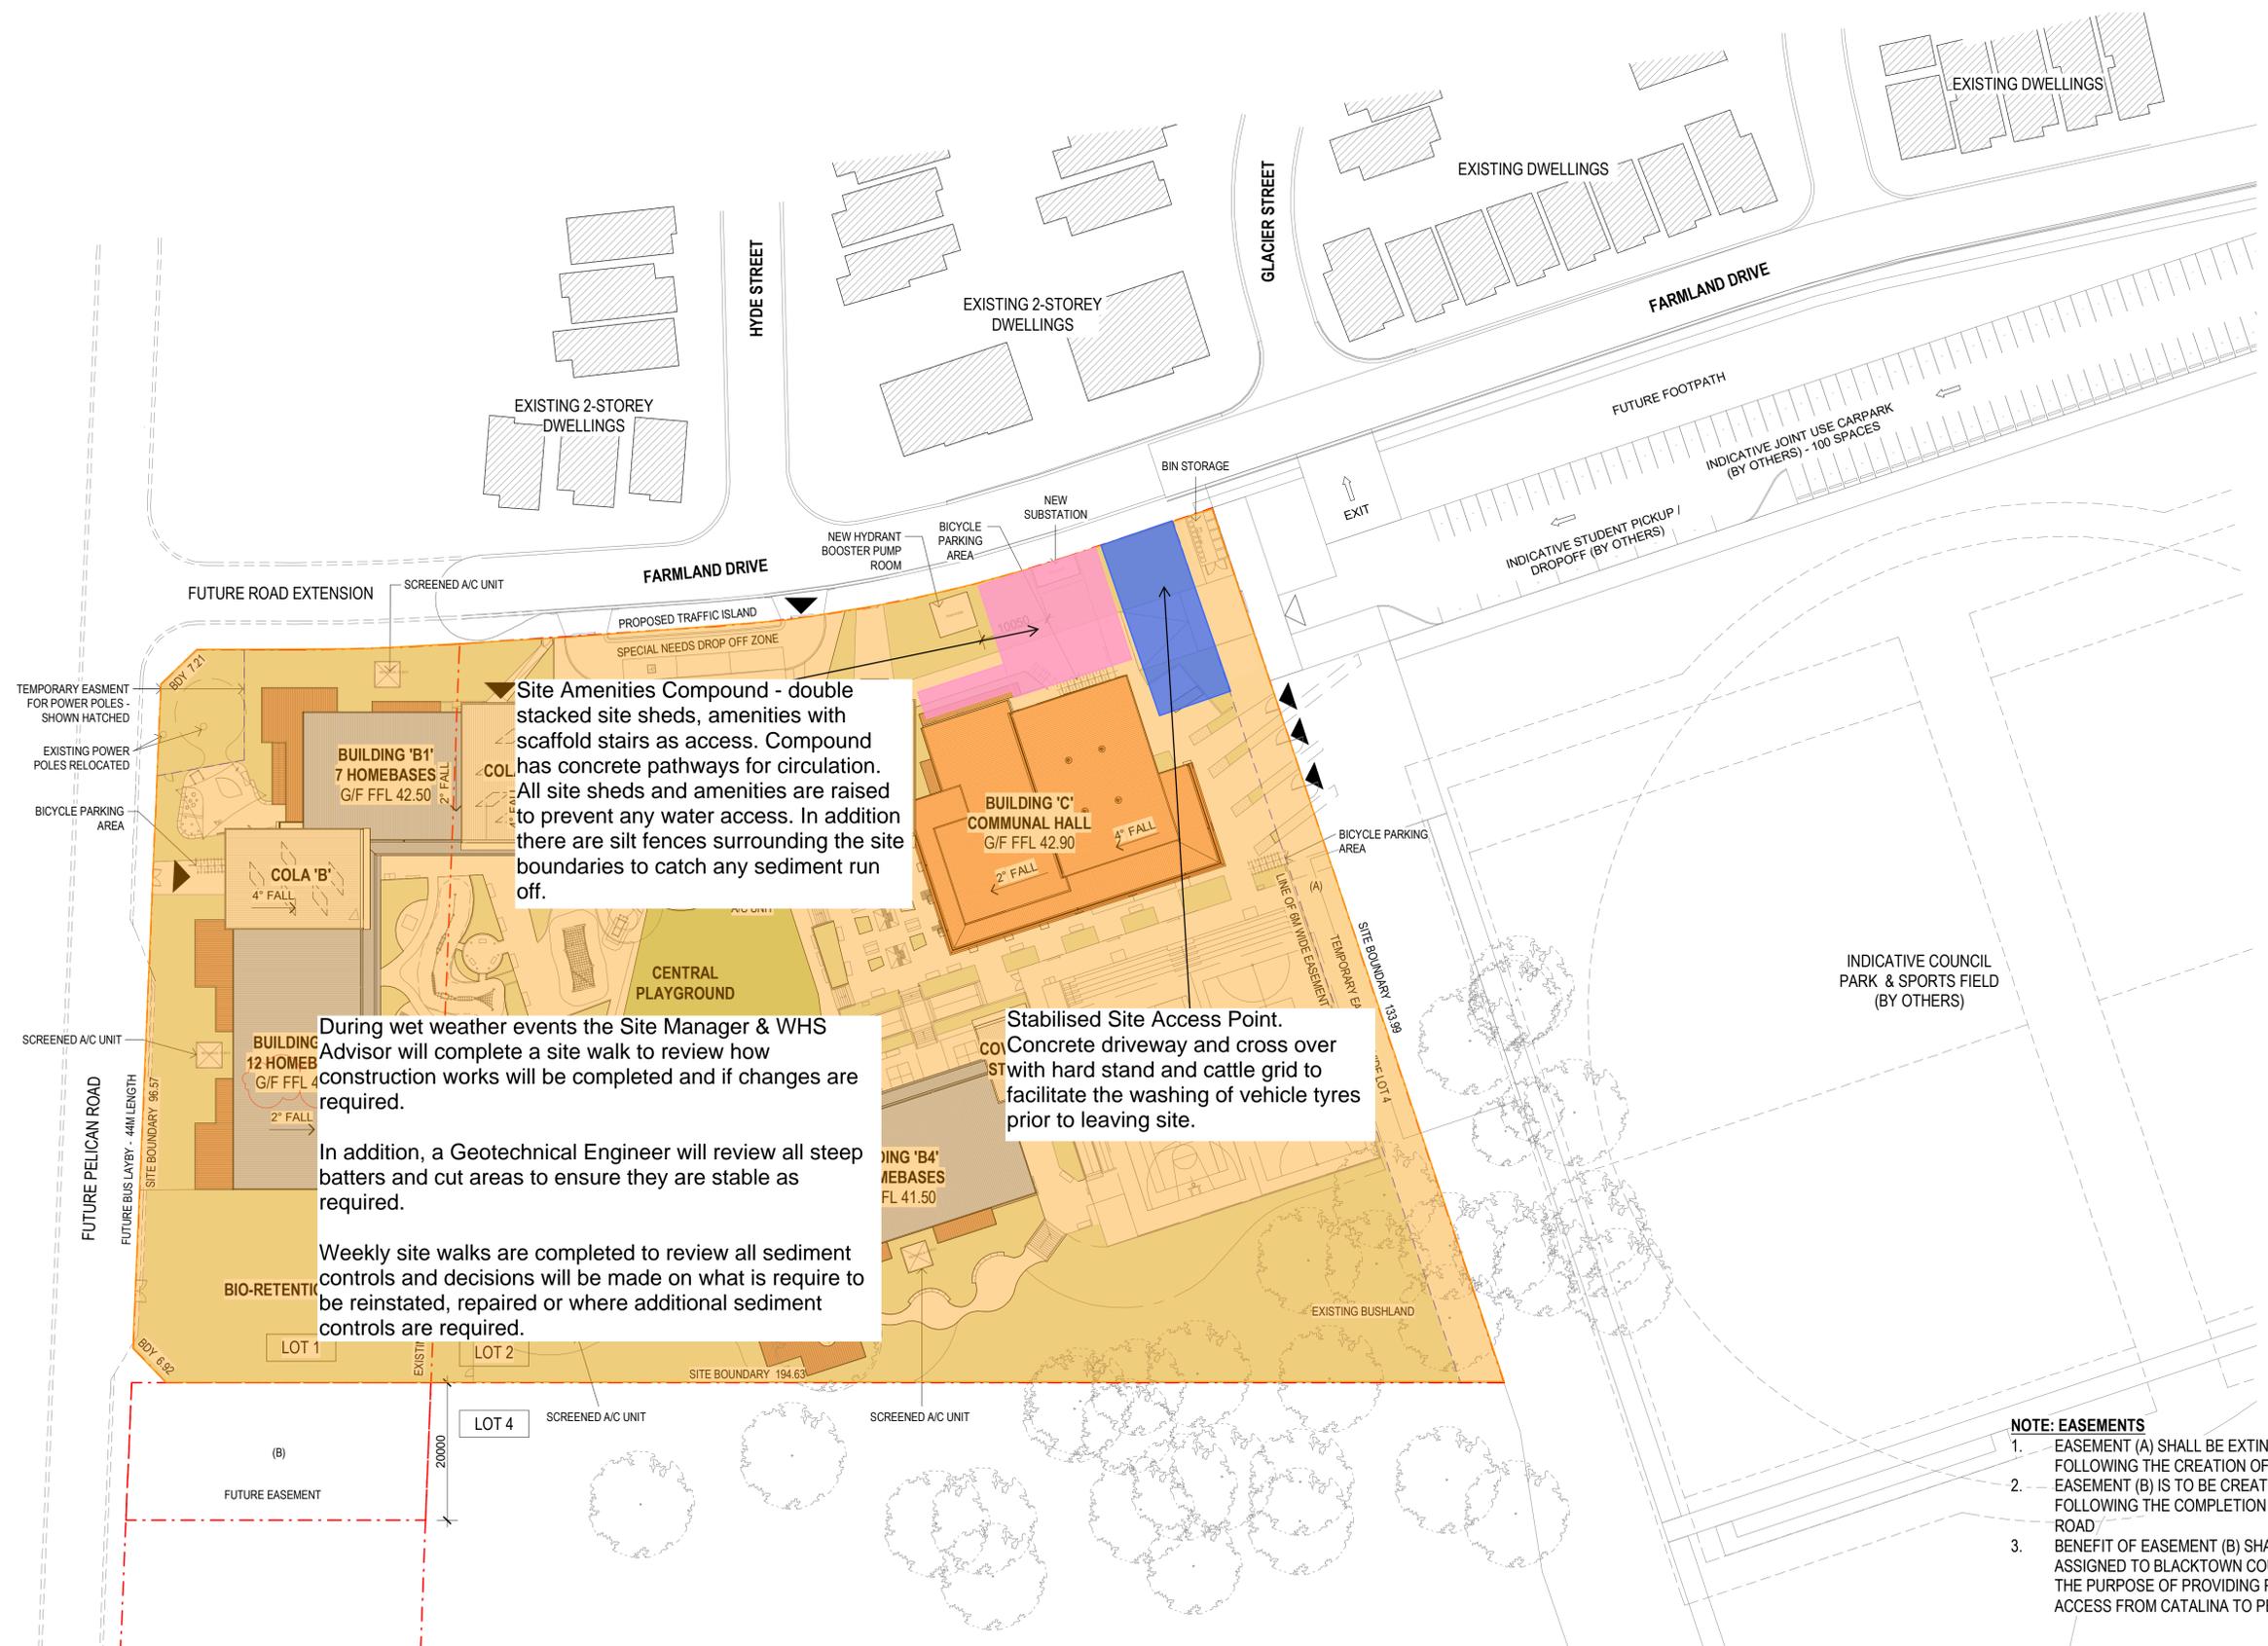
Scale @ A1	1 : 500
Drawing Created (date)	30/05/2019
Drawing Created (by)	DN
Plotted and checked by	DN
Verified	JS
Approved	MB
Project No	180645
Drawing No	AA-AR-1100
Issue	2

Site Amenities Compound - double stacked site sheds, amenities with scaffold stairs as access. Compound has concrete pathways for circulation. All site sheds and amenities are raised to prevent any water access. In addition there are silt fences surrounding the site boundaries to catch any sediment run off.

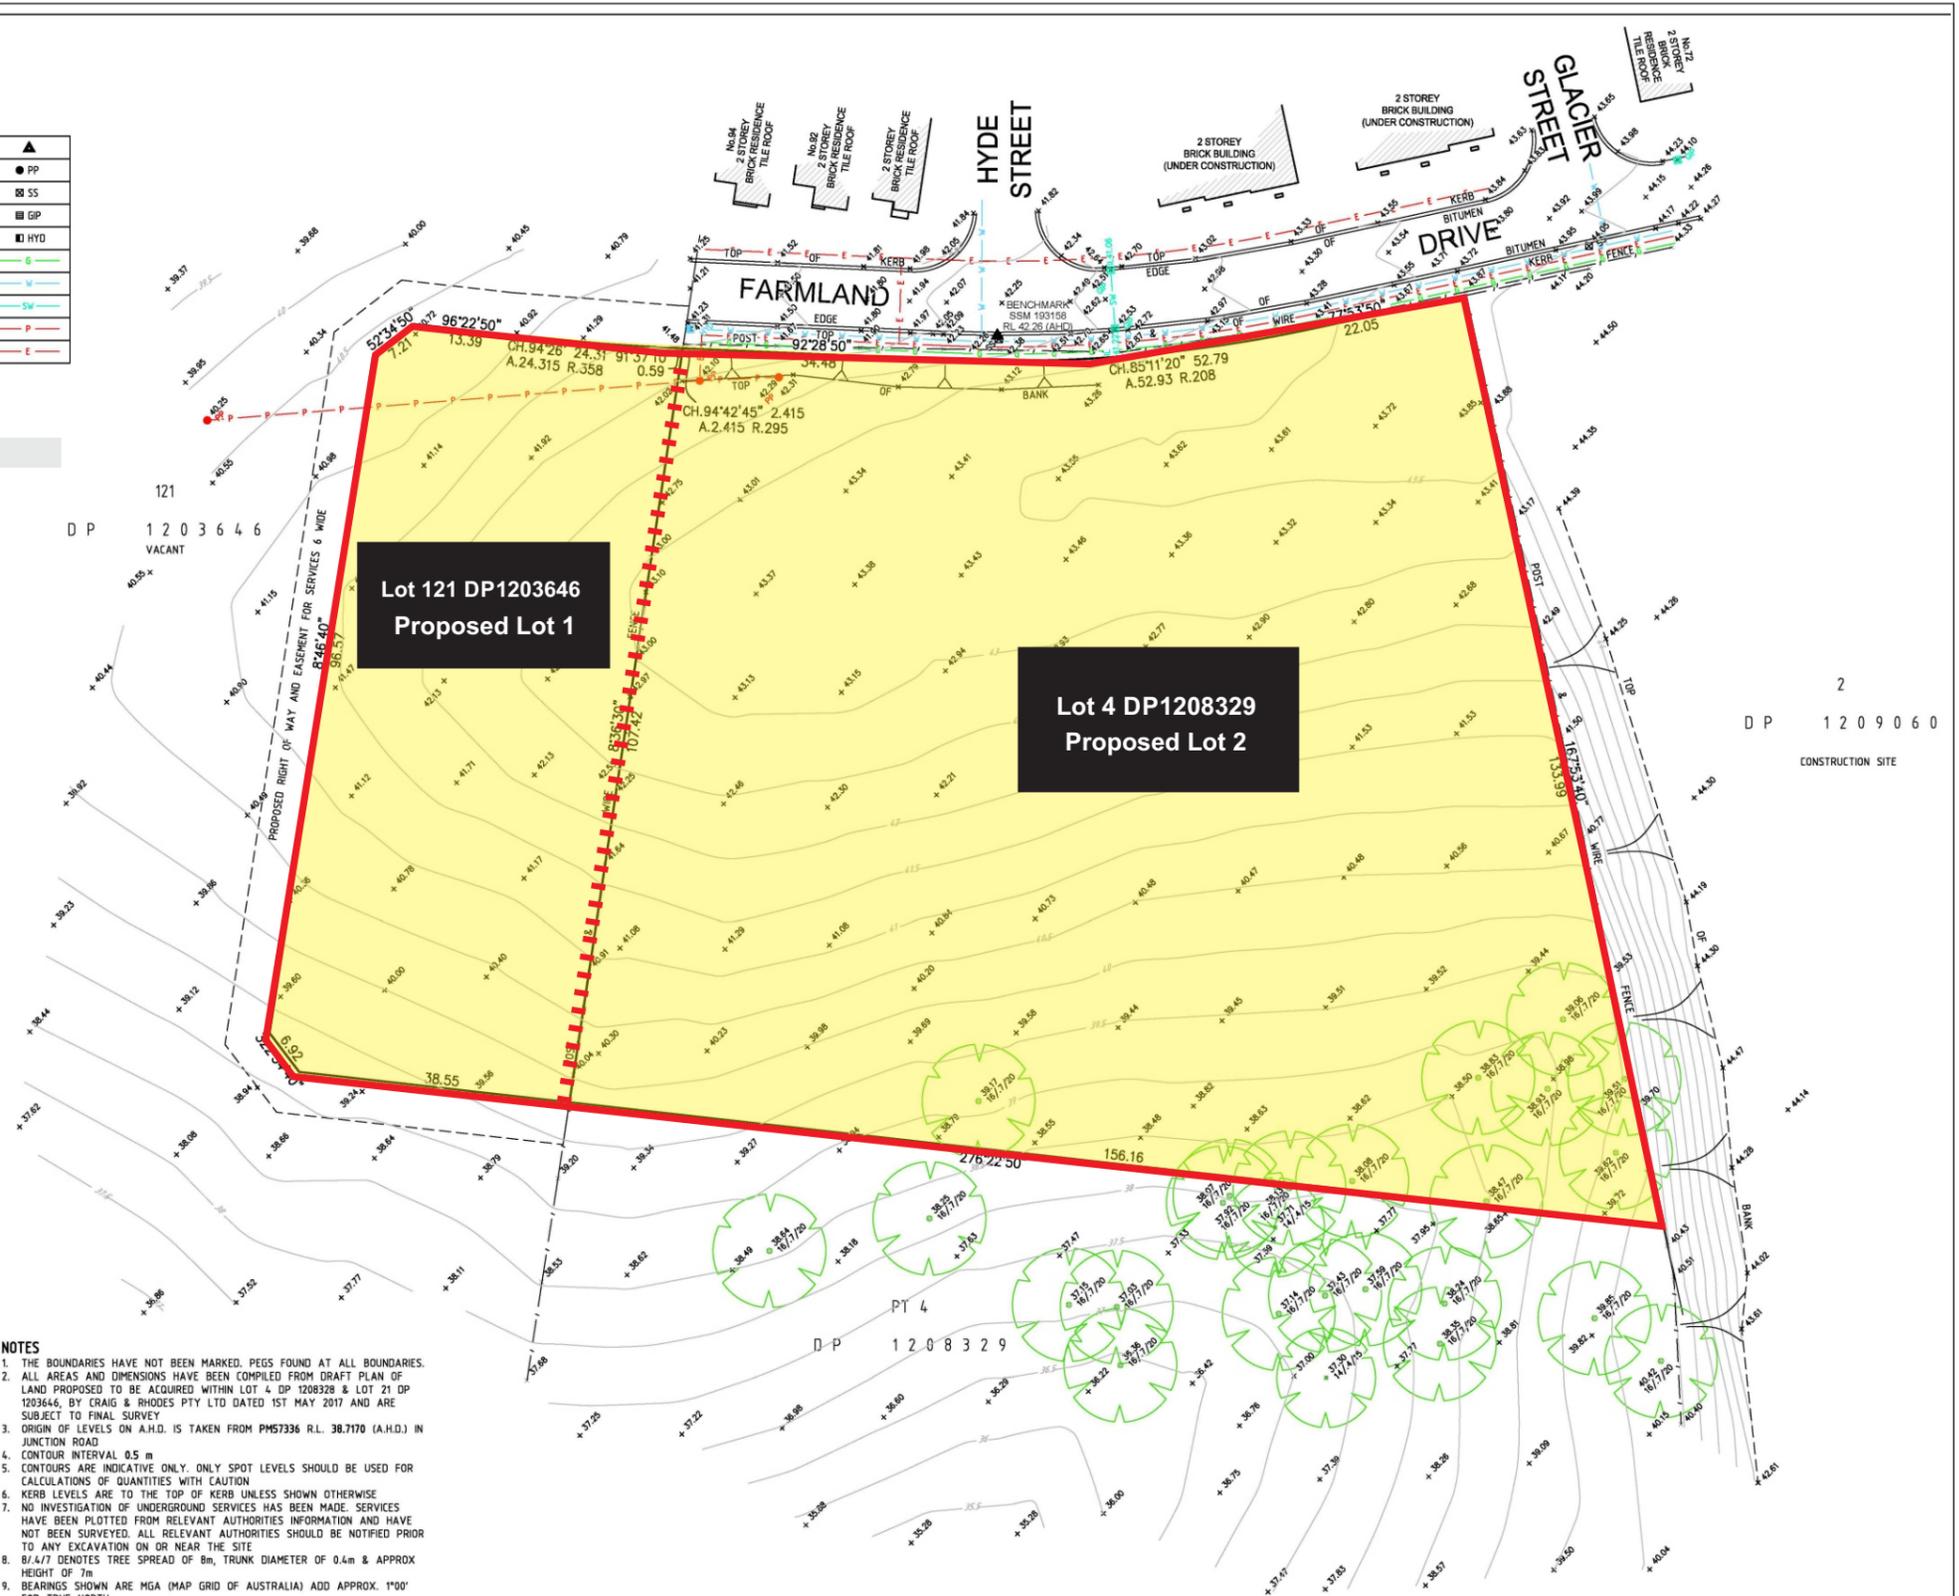
LEGEND	
BENCH MARK	▲
POWER POLE	●
STREET SIGN	⊠
GRATED INLET PIT	⊞
HYDRANT	■
GAS (DBYD)	— G —
WATER (DBYD)	— W —
STORMWATER (DBYD)	— SW —
ELECTRICITY (OVERHEAD)	— P —
ELECTRICITY (UNDERGROUND) (DBYD)	— E —

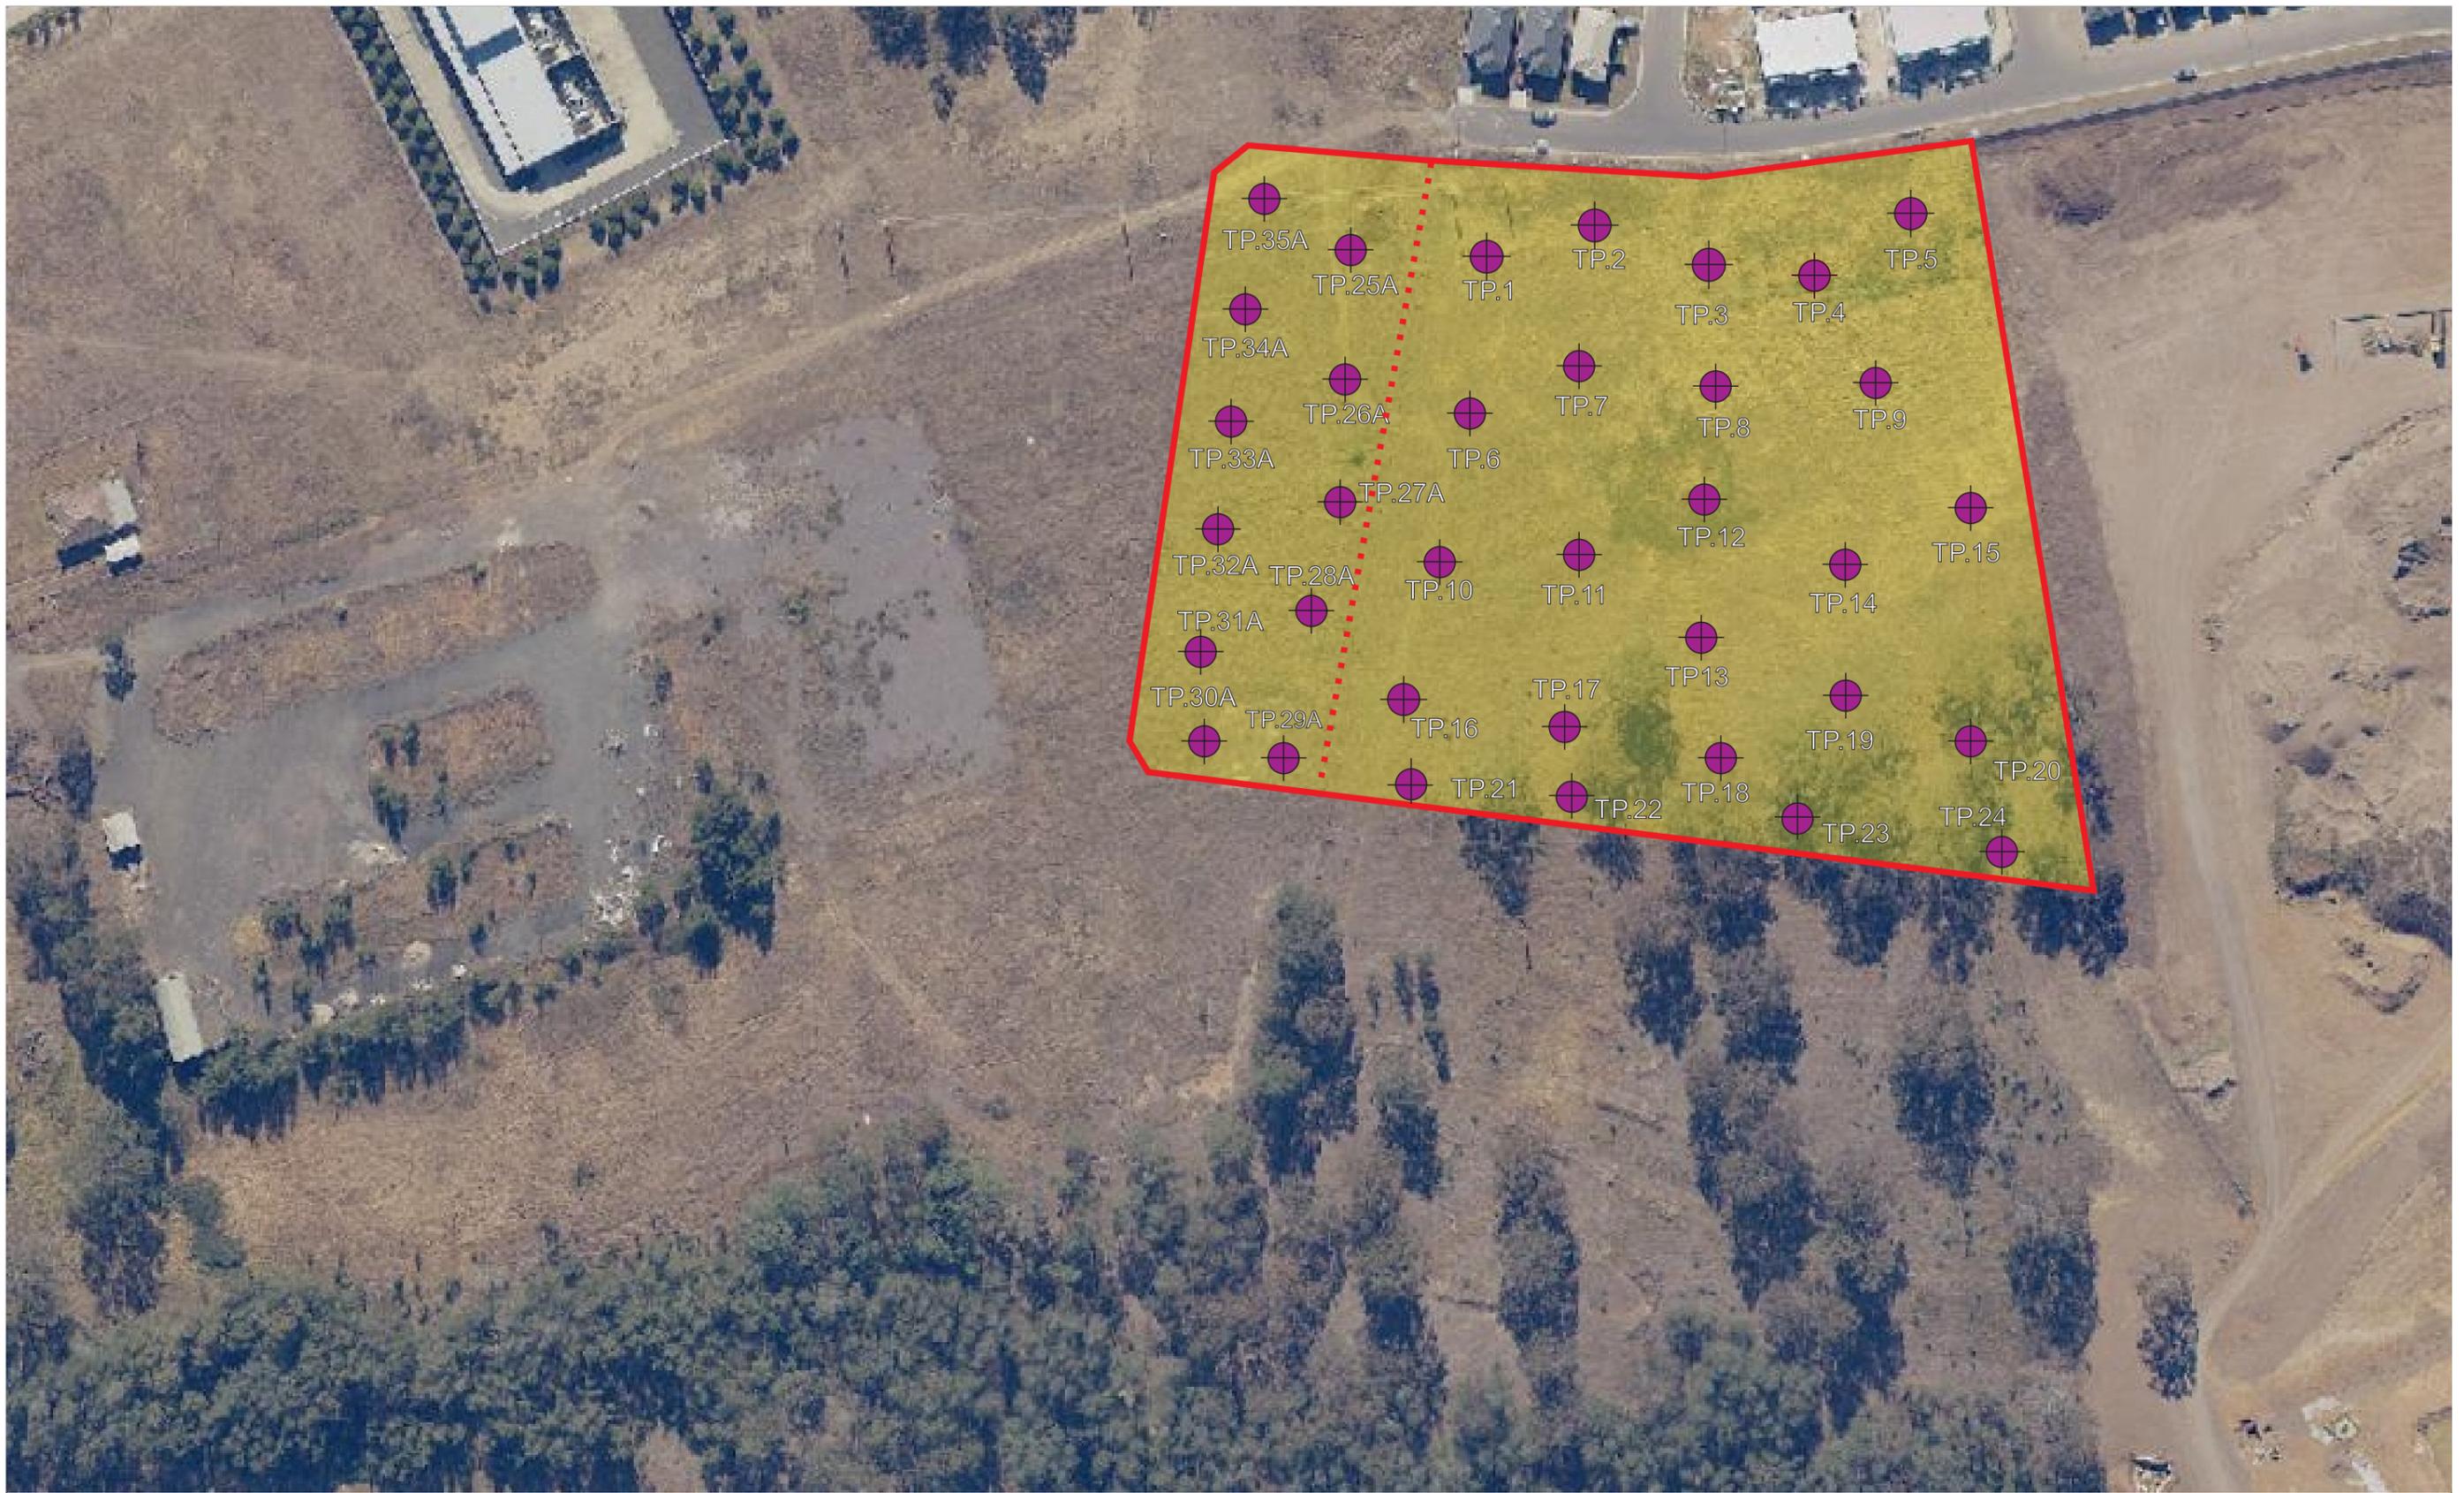
- Site Boundary
- Test-pit Sample Locations

In the scope of this assessment 35 surface samples were collected and analysed. As depicted in Figure 2, sample locations were selected in a grid pattern to ensure adequate site coverage.

Fill material consisted of brown clay-silt or silt and contained some organic plant root material and foreign material such as ceramic, plastic and bituminous asphalt fragments. The surface silt material encountered in the following test pits was deemed to be fill material: TP1, TP2, TP4, TP8, TP9 and TP12. Refer to Figure 2, Appendix A.

- Greencap conducted salinity analytical testing at 5 locations across the site. These locations were selected based on the results of the initial surface walkover inspection, as well as for the purposes of ensuring adequate coverage of the site and the encountered soil-types. Field logs from each test pit and borehole location are included in Appendix D and contain a description of the soil profile material, odours, and any other pertinent information. Test pit locations are indicated on Figure 2.

Using the guidelines for categorising soil sodicty provided in the DPI Salinity Manual, the Sodicty of the analysed samples are summarised below. Refer to Figure 2 for sample locations.

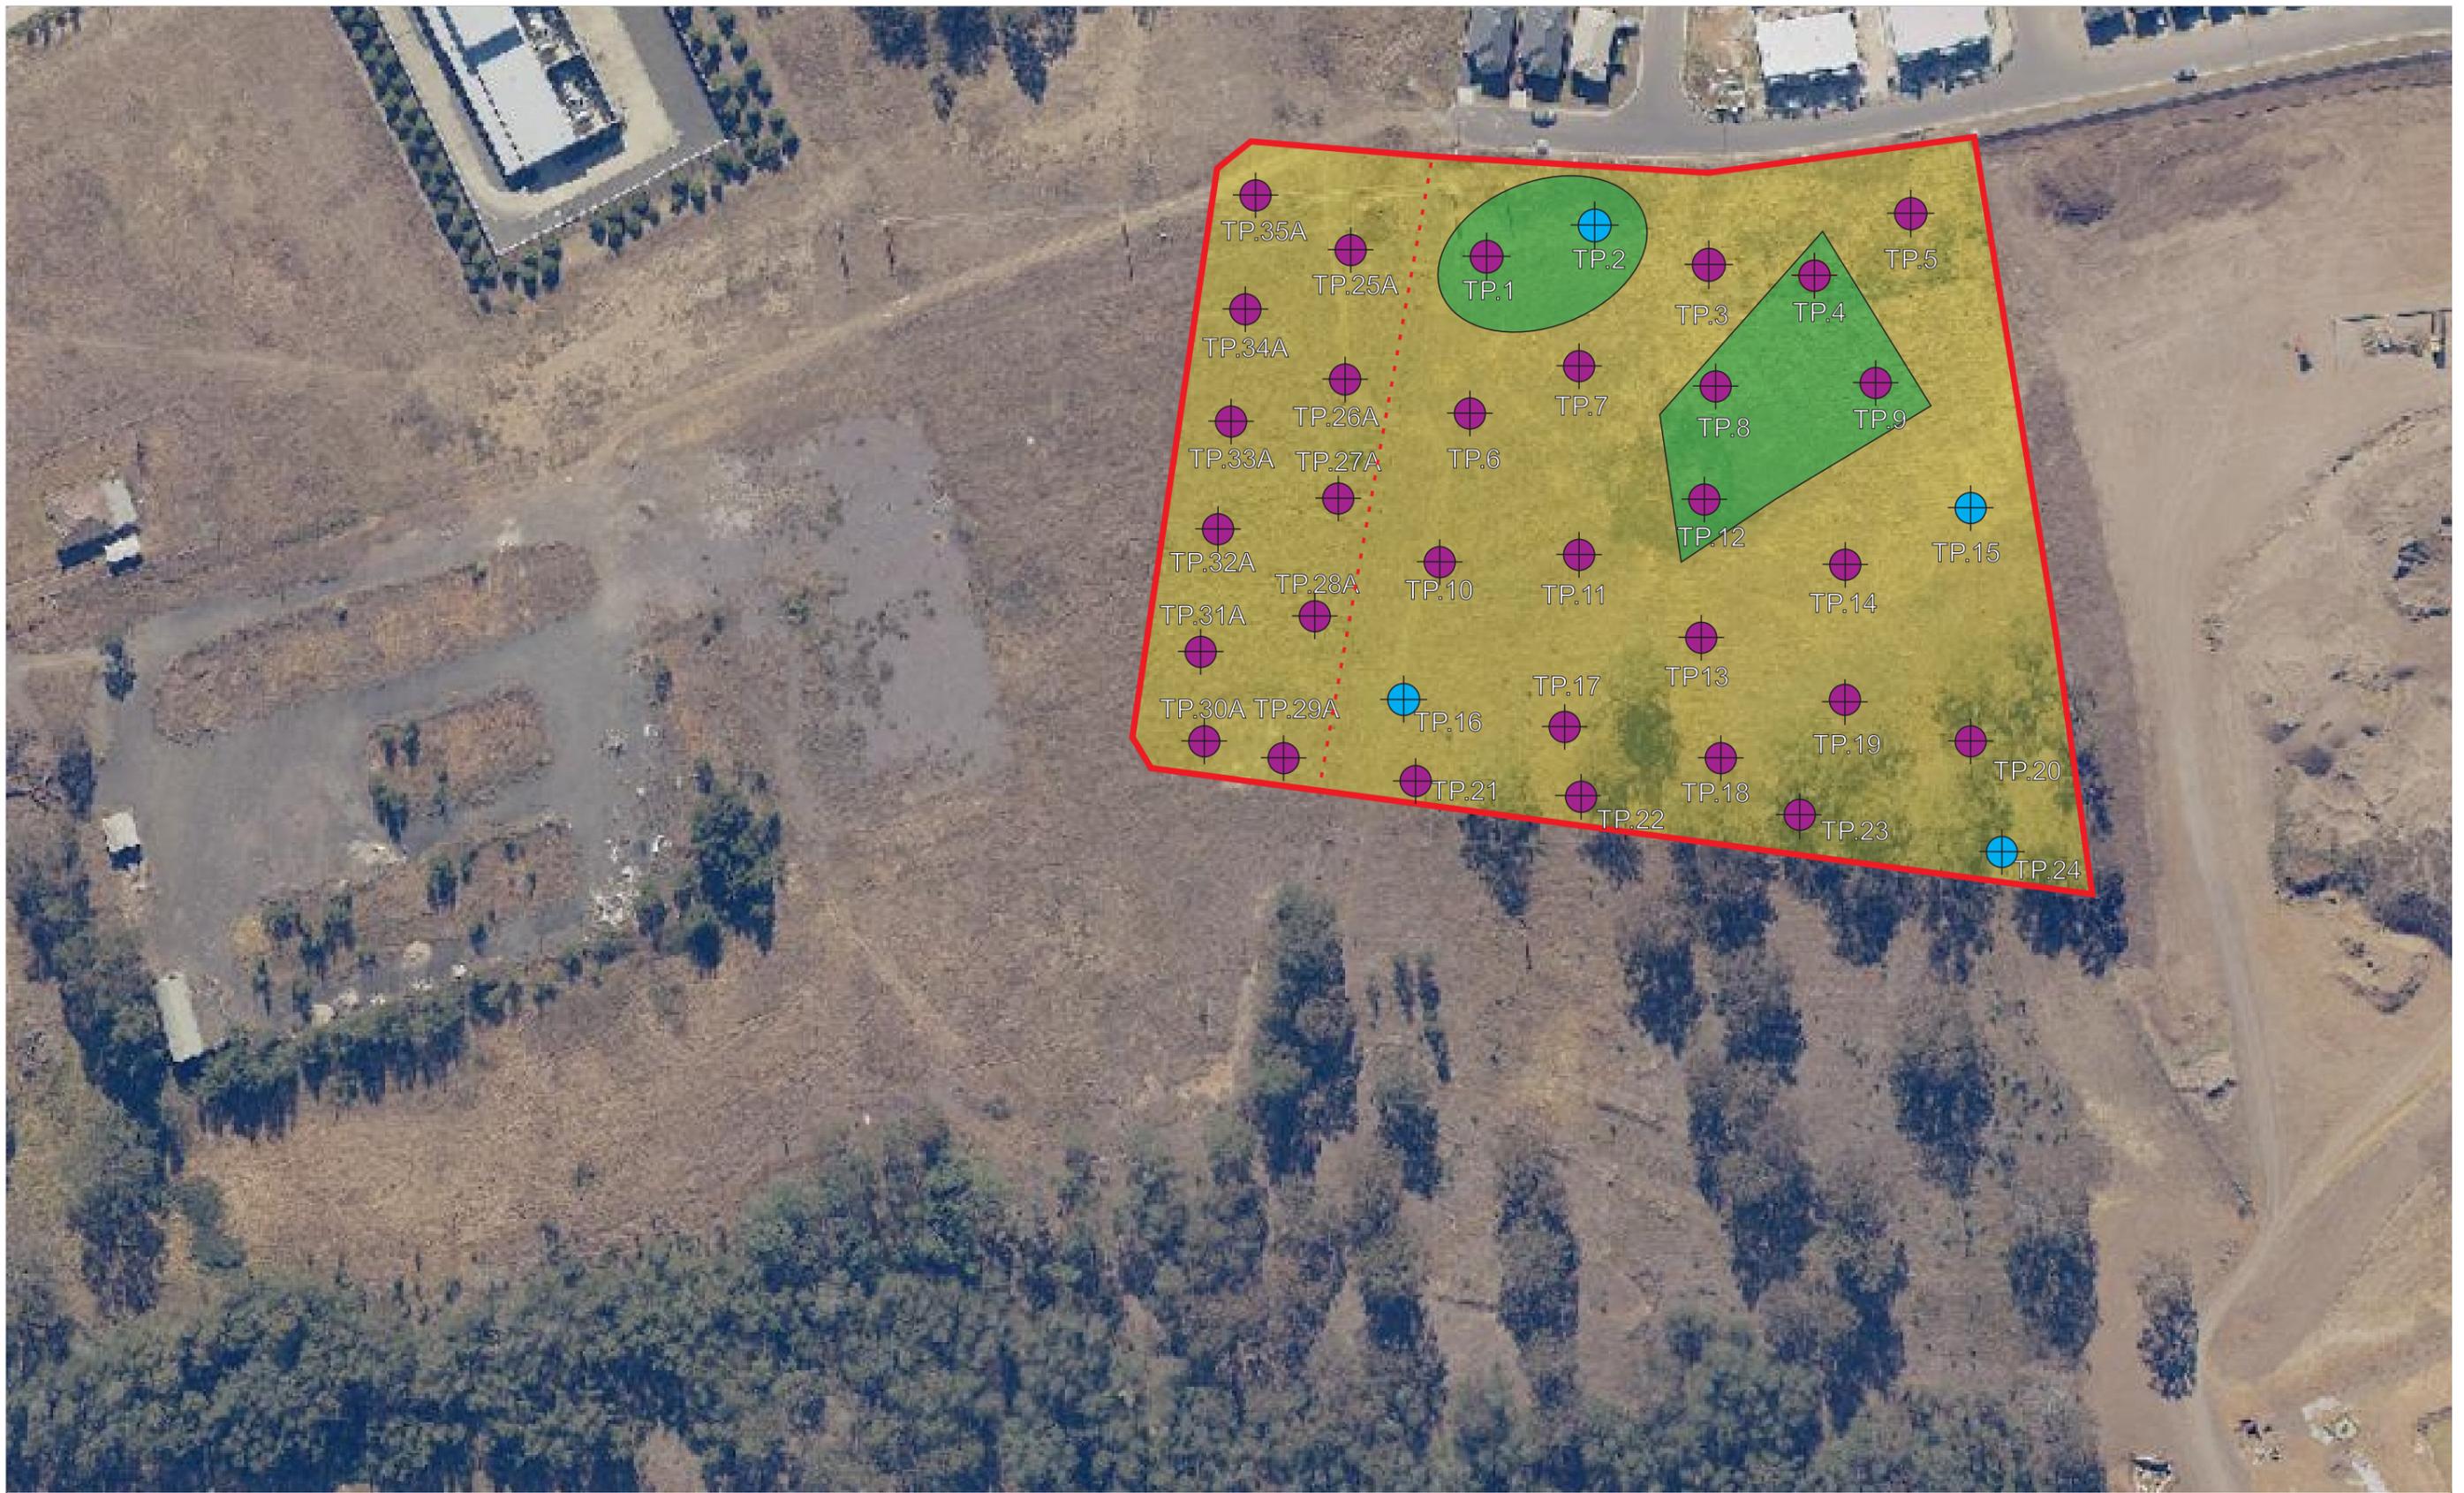
- Site Boundary
- Test-pit Sample Locations
- Locations of Salinity Tested Samples
- Test-pit Locations Containing Fill Material

- A visible indicator of salinity was identified on proposed Lot 1 of the site in the form of a bare/scaled patch of soil at test pit location TP29A (refer to Figure 2 for test pit locations), suggesting dryland salinity impact to vegetation growth. However, no visible salt crystals, white crusts, or black soil staining was observed in this location, nor on the remainder of the site. Vegetation growth immediately surrounding the observed clear patch appeared consistent with the remainder of the site vegetation type, and did not suggest salt-impacted vegetation species occurrence (refer to Photo 11).

- One bare/scaled patch of soil was identified at test pit location TP29A (refer to Figure 2 for test pit locations), suggesting potential dryland salinity impact to vegetation growth. However, no additional indicators (e.g. salt crystals, black soil staining etc) were observed in this location. Vegetation growth immediately surrounding the observed clear patch appeared consistent with the remainder of the site vegetation type, and did not suggest salt-impacted vegetation species occurrence (refer to Photo 11).

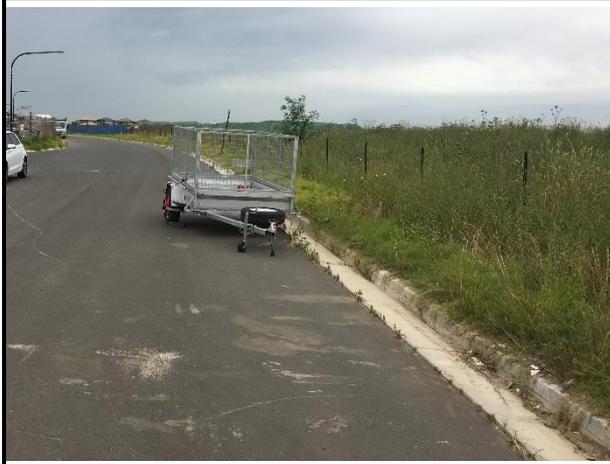
Photo 1. Northern boundary of site along Schofields Road, view east.

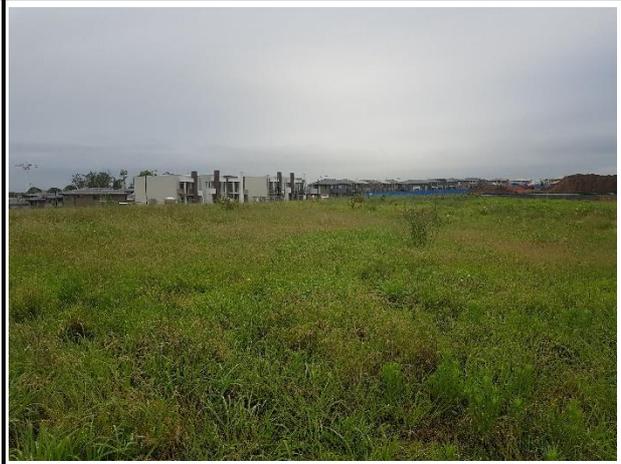
Photo 2. Proposed Lot 1, view north-east.

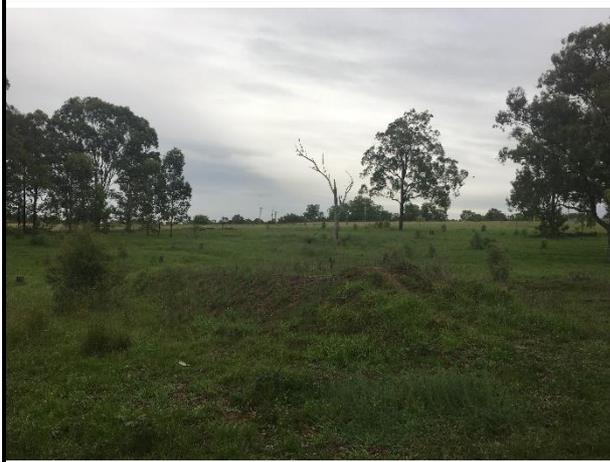
Photo 3. Proposed Lot 2, view north-west
