ALEX AVENUE PUBLIC SCHOOL
NO: 1157

CONSTRUCTION ENVIRONMENTAL MANAGEMENT PLAN (CEMP)

15 January 2021

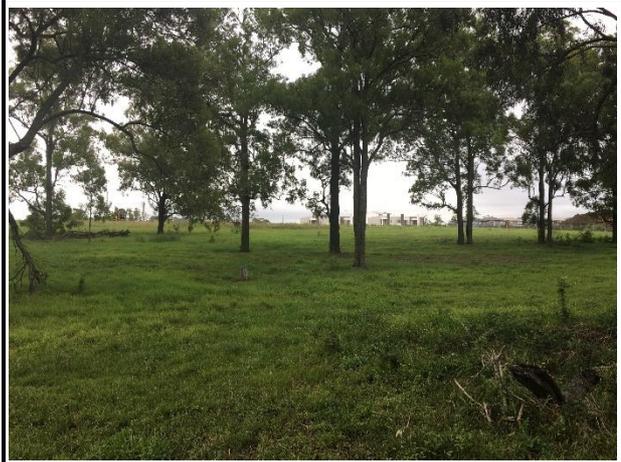
Photo 4. Proposed Lot 2, south of the site, view north

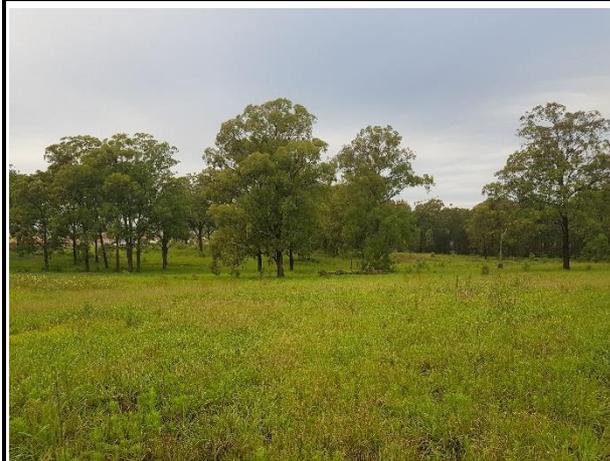
Photo 5. Proposed Lot 2, view south.

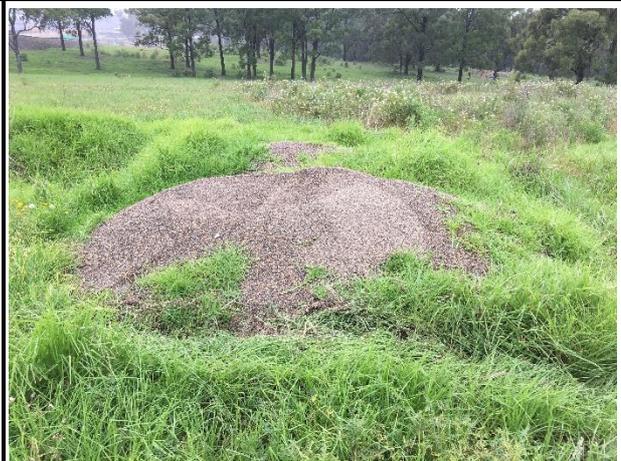
Photo 6. Two stockpiles observed on proposed Lot 2, corresponding to description and location of those identified in the PSI.

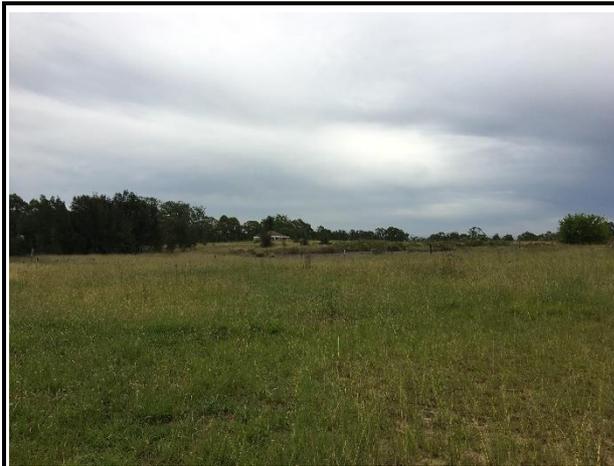
Photo 7. Proposed Lot 1, view west.

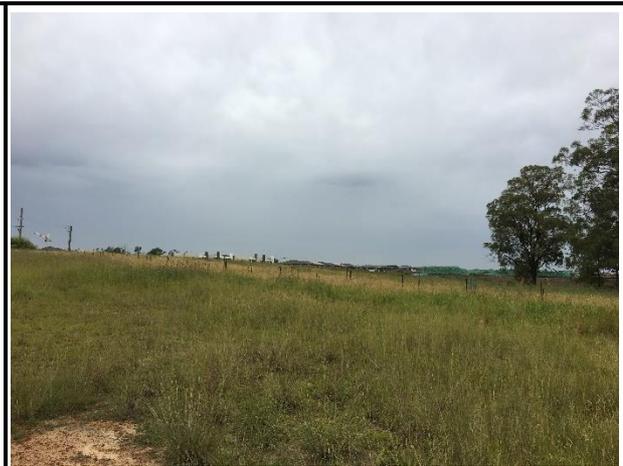
Photo 8. Proposed Lot 1 (and Lot 21), view north-east.

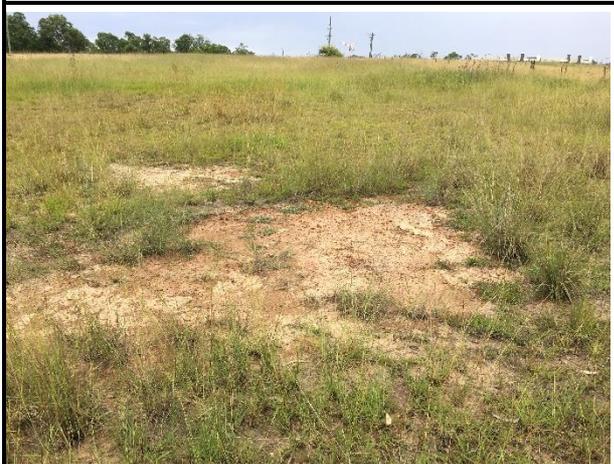
Photo 9. Identified path of bare soil, indicating potential dryland salinity impact, view north.

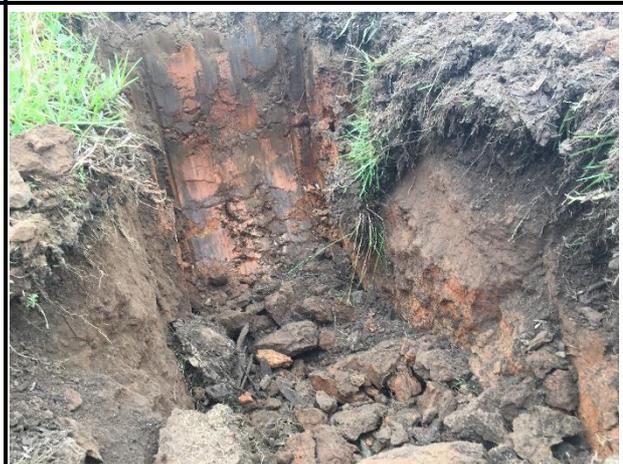
Photo 10. TP3 with visible soil profile transition on the right-hand side from silt to clay.

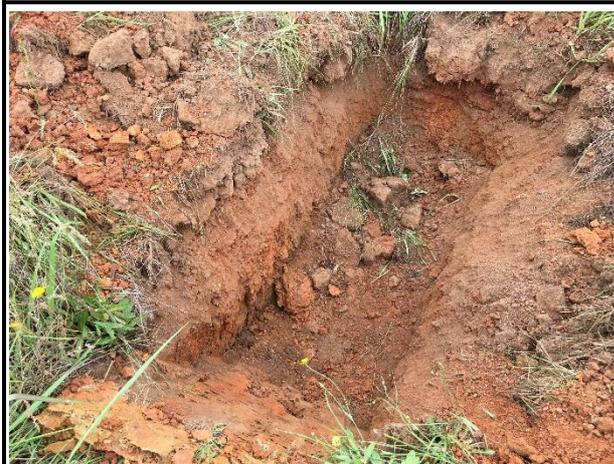
Photo 11. TP6 – minimal upper layer of silt, followed by clay characteristic of the site.

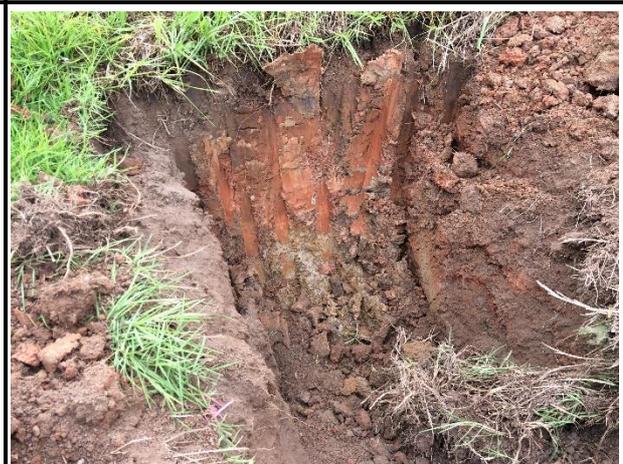
Photo 12. TP15, red clay followed by red and grey mottled clay
