ENVIRONMENTAL REPRESENTATIVE SITE INSPECTION REPORT

From:	Carl Vincent carl.vincent@ersed.com.au	Date:	21/04/21	DATE OF INSPECTION	20/04/21
To:	Naiem Teghlobi Naiem.Teghlobi@frasersproperty.com.au	Construction Activities: <ul style="list-style-type: none"> Initial works to create access plus formation works for the future main site compound Fencing activities along eastern extent Importation of material Demolition of buildings and structures along Bakers Lane Investigation and survey (archaeological) at the western extent. Dewatering of existing farm pond 		Weather Conditions	Fine
CC:				Rainfall previous 24hrs	NIL
				Rainfall forecast next 24hrs	NIL
Project	SSD 9522: Kemps Creek Warehouse, Logistics and Industrial Facilities Hub (THE YARDS)			http://www.bom.gov.au/jsp/ncc/cdio/weatherData/av?p_nccObsCode=136&p_display_type=dailyDataFile&p_startYear=&p_c=&p_stn_num=067066	
Attendees	Lachlan Paton – AWJ Tim Culmone – AWJ Mathew Mikhail – AWJ Joe Goonan – AWJ Naiem Teghlobi – Frasers Mark Wilson – Costin Roe Consulting Daniel Restuccia - Barker Ryan Stuart			Project Status RISK - LOW COMPLIANT

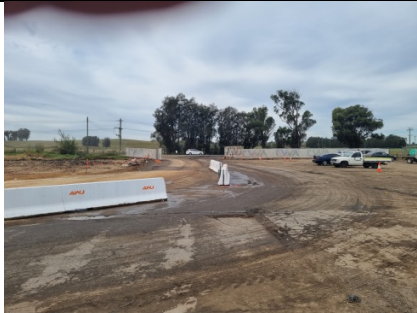
CONTRACT		AWJ	DATE OF INSPECTION		20 APRIL 21	
ITEM	LOCATION	DETAILS OF ISSUE	PRIORITY/ RISK	COMMENT / ACTION	DATE FOR CLOSE OUT	RESPONSE/CLOSE OUT
1.	Temporary site entrance

OBSERVATION	<p>A temporary construction access has been created off Mamre road at the southern extent of the boundary</p> <p>The access has a gravelled entrance in and a cattle grid at the exit</p>	NA	
2.	Site entrance area

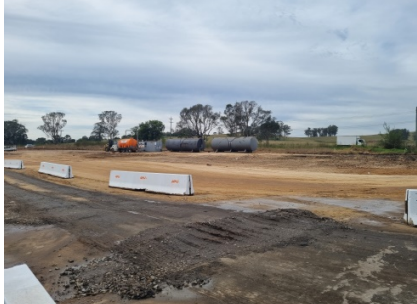
OBSERVATION	<p>Two large water tanks have been imported to supply site water for construction and dust control purposes. It was indicated that these are filled from a standpipe on Mamre Road</p> <p>It was also indicated that existing and planned dams/ponds and basins will be utilised throughout the construction</p>	NA

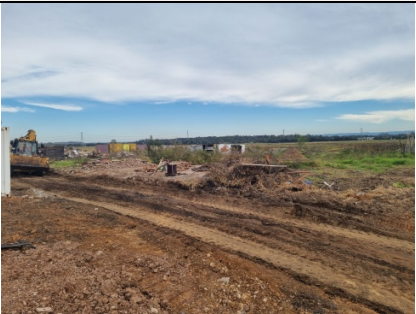
CONTRACT		AWJ	DATE OF INSPECTION		20 APRIL 21	
ITEM	LOCATION	DETAILS OF ISSUE	PRIORITY/ RISK	COMMENT / ACTION	DATE FOR CLOSE OUT	RESPONSE/CLOSE OUT
3.	West of temporary site compound

MED	<p>The area behind the temporary site compound is being used for stockpiling and sorting of waste left at the site.</p> <p>This site isn't defined by site measures ESC for this area is not defined</p> <ul style="list-style-type: none"> • Provide visual delineation of this management area • Formalise the ESC for this area and detail on a PESCP for the initial works activities 	24 APRIL 21

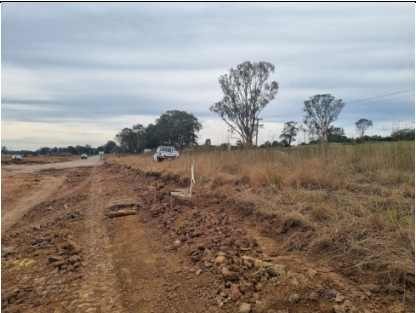
4.	Eastern site boundary –

OBSERVATION	<p>The new fence line / project boundary is being installed along Mamre road</p> <p>It was discussed that the existing boundary has been surveyed and has been flagged to identify the limit of the project initially. Once the eastern fence line has been installed this will become the functional limit to the project infrastructure works</p>	NA

- Along the eastern boundary the existing fence line has been surveyed and flagged to confirm as an appropriate boundary location. The future internal fence boundary is being installed and will become the new boundary
- Along the southern boundary the existing rural fence has been maintained. This is assumed as the accurate boundary however it was indicated that the location is to be re surveyed to confirm. Unless otherwise confirmed the existing fence is the assumed boundary.
- It was indicated that the other project extents to the north and the west have been surveyed and pegged and will more formally delineated prior to any works progressing in these areas. **The ER will inspect these areas and boundaries prior to works progressing in these locations**

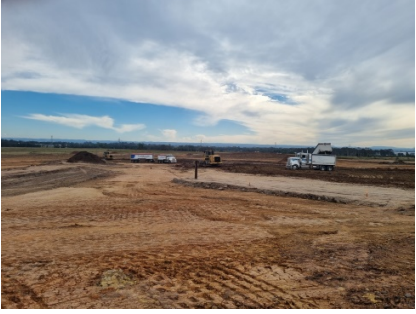
5.	Site facilities site establishment

OBSERVATION	<p>Works have commenced in and around the central area of the works as part of the establishment of the future main site compound. Earthworks have also established extended further North and West beyond what is required for establishment of the initial site compound.</p> <p>It was communicated by the ER that this is believed to be commencement of construction.</p> <p>See details and discussions regarding non-compliance within Part A of this report.</p>	7 days per Condition C11

- This is the first inspection by the ER.
- Works including demolition (construction) have commenced without the ESCs in place per the approved Soil and Water Management Plan /CEMP- as required by Condition B22
- A letter has not been issued by the ER as required by condition B24

1. Detail the current erosion sediment controls in place for the current works within a Progressive Erosion and Sediment Control Plan prepared by an appropriately qualified person
2. The same person indicated within 1 above should review the existing works and detail additional controls required to appropriately manage the erosion and sedimentation risk associated with the current works
3. Provide detail of all current works at the site and confirm those items which are considered to be construction and/or bulk earthworks in respect to the requirements of conditions B22 and B24
4. Prepare a report and report in accordance with conditions below
5. **Further construction activities should not progress until these controls are in place and appropriate AND confirmed by the ER in writing to the Secretary as required by Condition B24**

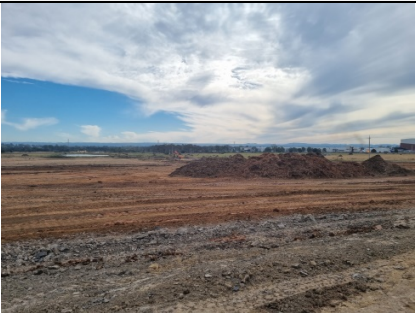
CONTRACT		AWJ	DATE OF INSPECTION		20 APRIL 21	
ITEM	LOCATION	DETAILS OF ISSUE	PRIORITY/ RISK	COMMENT / ACTION	DATE FOR CLOSE OUT	RESPONSE/CLOSE OUT
6.	Central area to Main farm pond & Demolition Site.

OBSERVATION	<p>Demolition of the buildings and structures located to the south of the Bakers Lane access road has occurred.</p> <p>The ground has been cleared in this vicinity and to the eastern extent at Mamre Road.</p> <p>See details and discussions regarding non-compliance within Part A of this report.</p> <p><u>Request</u> Confirmation and clearance from the demolition contractor or hygienist that the asbestos has been cleared and appropriately managed from the demolition (if present).</p>	7 days per Condition C11	
7.	South west corner

1.5 Confirmation and clearance from the demolition contractor or hygienist that the asbestos has been cleared and appropriately managed from the demolition works being undertaken (if present).

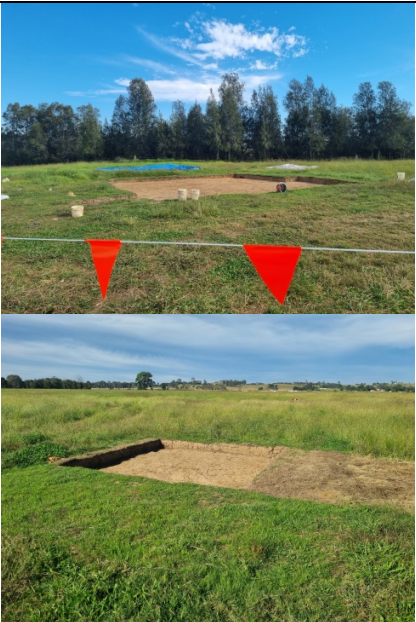
OBSERVATION	Ongoing investigation/ archaeological test digs are progressing in this area.	NA

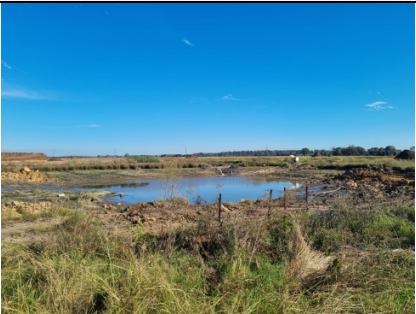
CONTRACT		AWJ	DATE OF INSPECTION		20 APRIL 21	
ITEM	LOCATION	DETAILS OF ISSUE	PRIORITY/ RISK	COMMENT / ACTION	DATE FOR CLOSE OUT	RESPONSE/CLOSE OUT
8.	Dewatering farm pond

OBSERVATION	<p>The farm dam/pond is being dewatered with adjacent wet areas being drained into the pond</p> <p>It was indicated that the project ecologist has been involved in the process and will be requested to do a final clearance of the pond prior to deleting the pond.</p> <p><u>Request</u> Correspondence from project ecologist confirming final clearance of this pond prior to deletion of the habitat.</p>	26 APRIL 21

1.6 Correspondence from project ecologist confirming final clearance of ponds prior to deletion of the habitat.

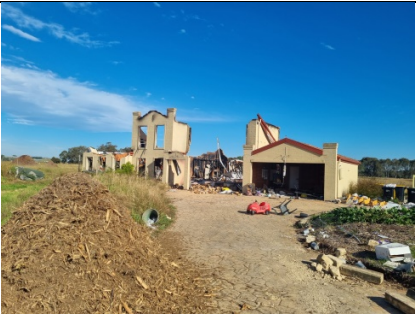
9.	Residences – western extent

OBSERVATION	<p>These buildings are to be demolished</p> <p>This demolition should not be progressed until the erosion sediment controls in this area are confirmed and a letter issued to that affect by the ER.</p> <p><u>Request</u> Confirmation and clearance from the demolition contractor or hygienist that the asbestos has been cleared and appropriately managed from the demolition (if present).</p>	Prior to demolition works
