DARLINGTON PUBLIC SCHOOL REDEVELOPMENT

Appendix R — Remediation Action Plan

Remediation Action Plan

Proposed Upgrade Works
417 Abercrombie Street, Darlington, NSW

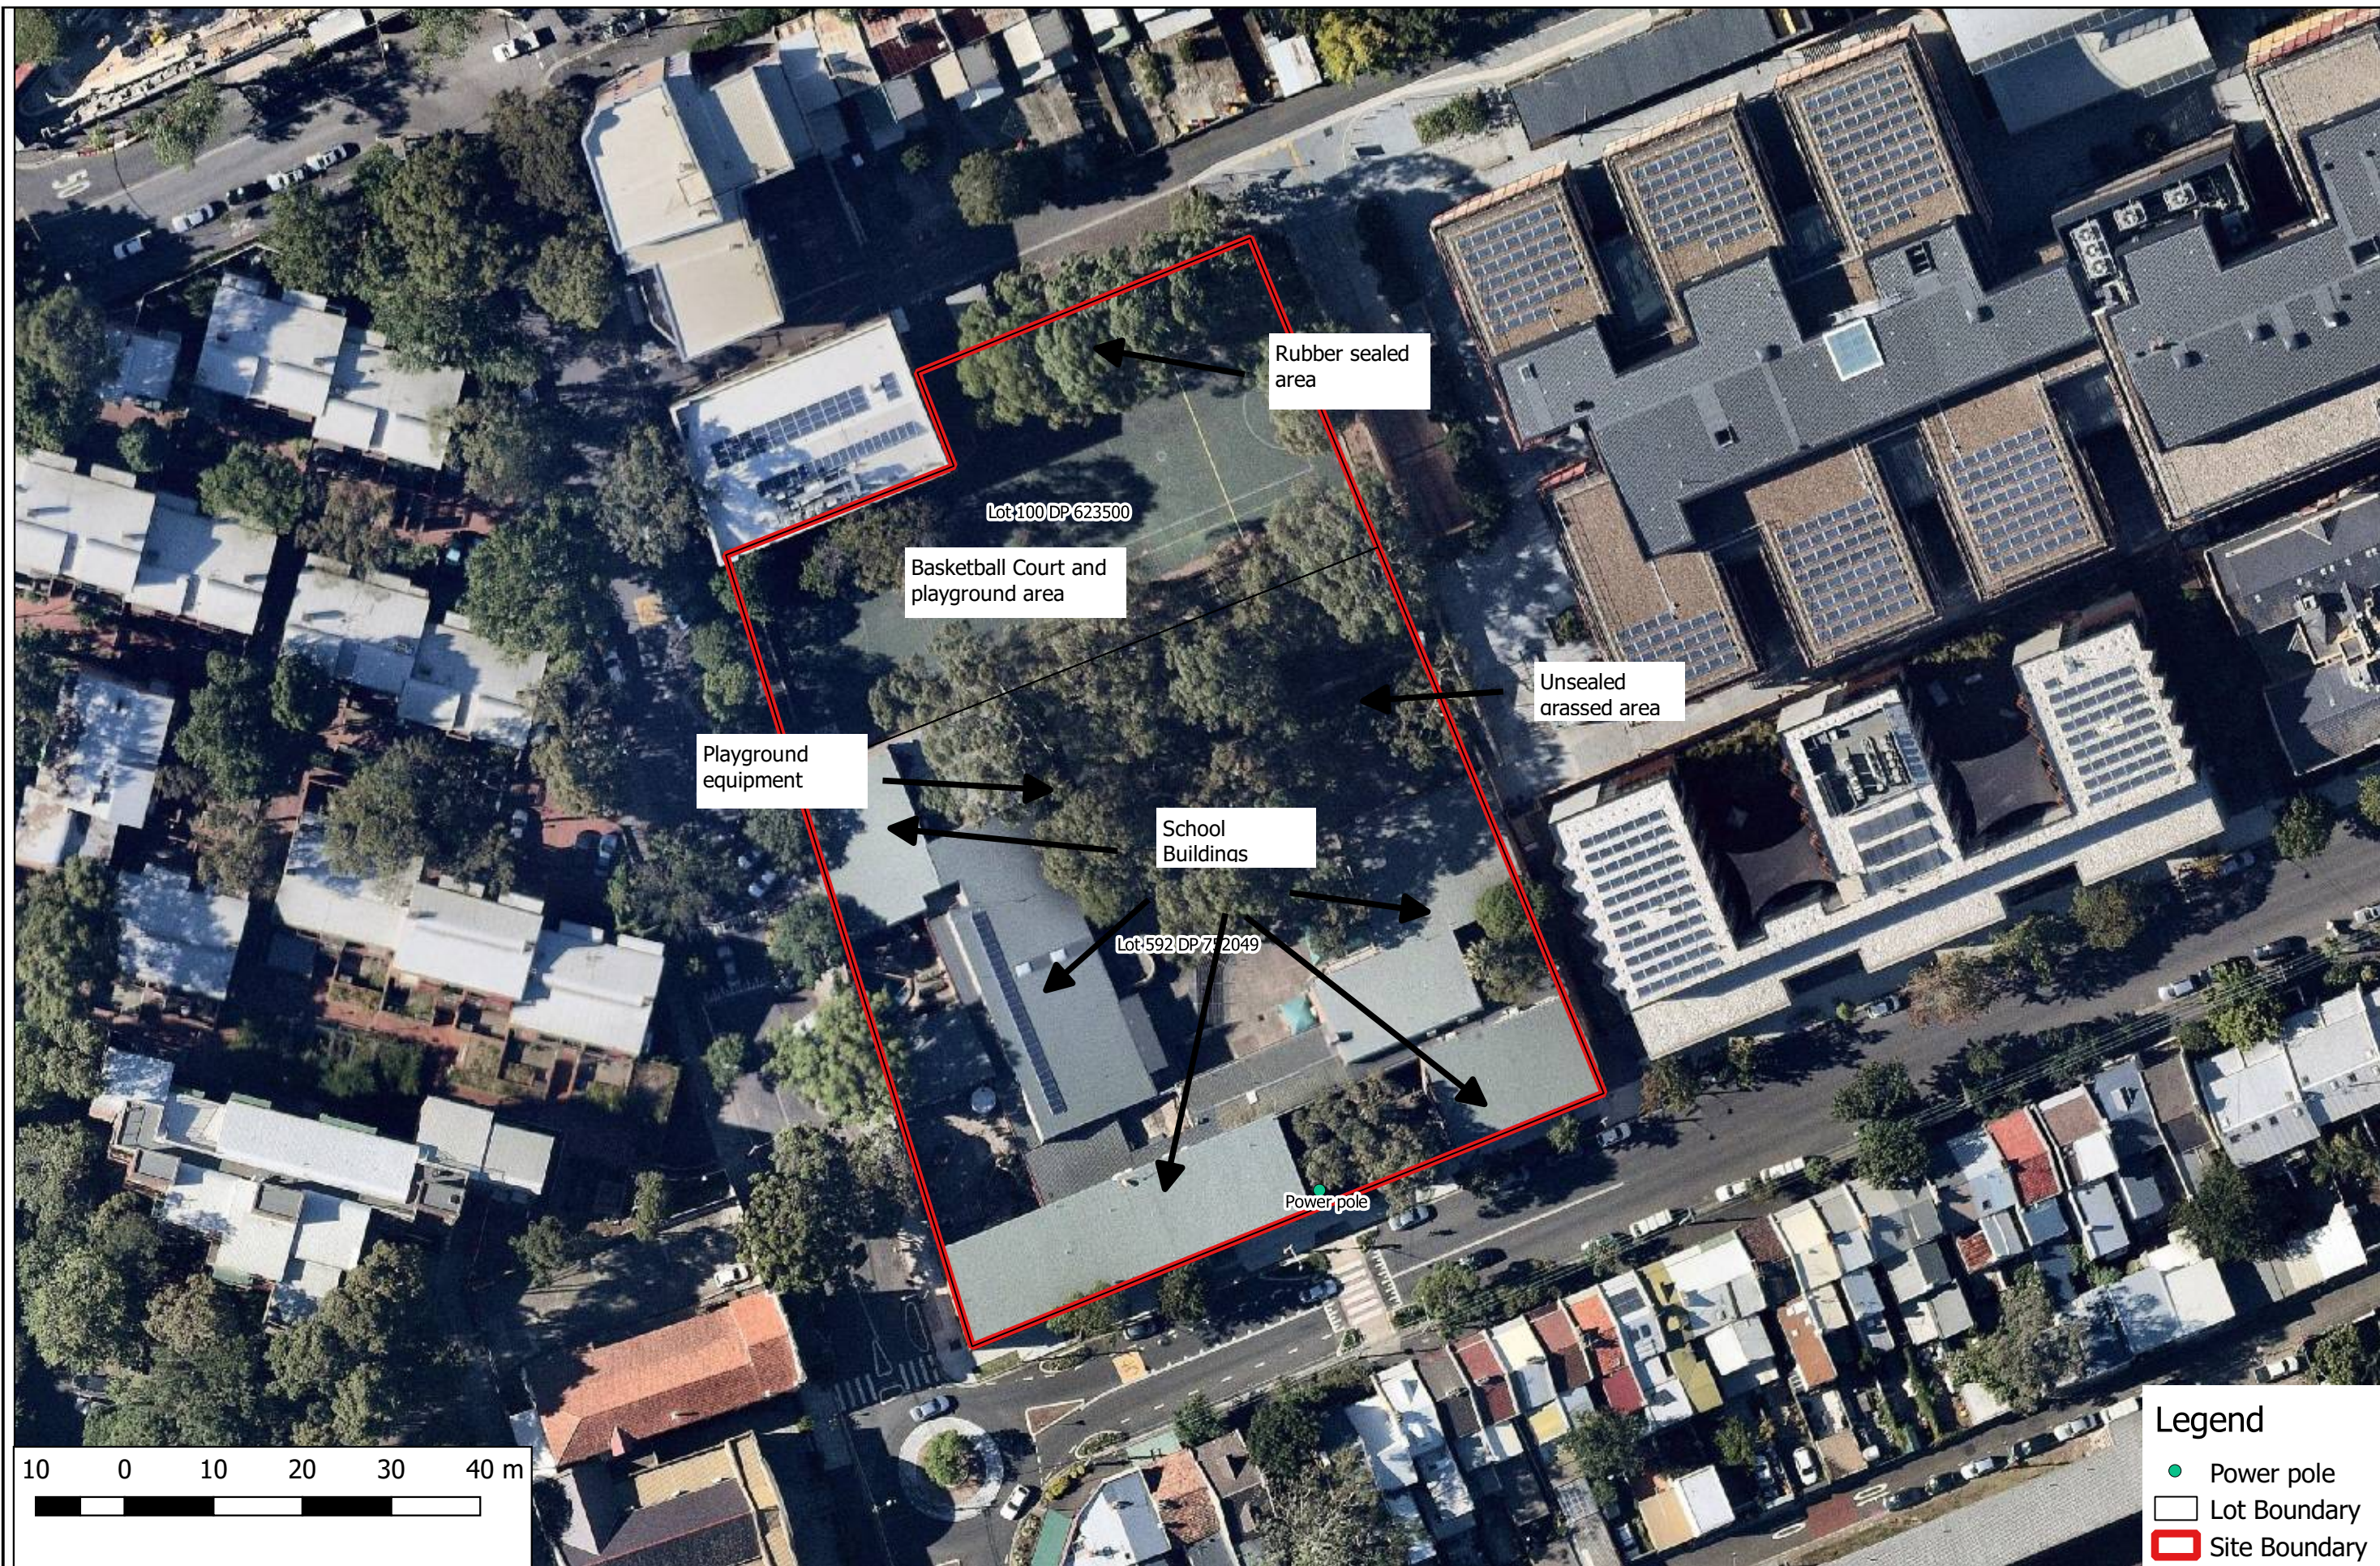
Prominent site features are presented on Drawing 2 (Appendix A).

Lot 592 DP 752049

This lot is roughly square shaped and comprises the majority of the school grounds and buildings. A large two storey rectangular building is located in the south western corner of the lot which comprises several school offices and classrooms. The building is constructed of brick walls, concrete slab floors and sheet metal roofing. Several interior walls and ceilings of the building appeared to be constructed of fibre cement sheeting (FCS), possibly containing asbestos. A courtyard is located to the immediate east of the building and is mostly concrete sealed with two small unsealed garden areas containing large established trees and shrubs. Another brick building is located to the immediate east of the courtyard and is also constructed of brick walls, concrete slab floor and metal sheeting roofing.

Another large rectangular shaped building is located across the central western portion of the lot and comprises the school hall and a number of classrooms. The building is constructed similarly to the other buildings onsite. An extension of the building is located to the immediate northwest. An area containing play equipment is located to the immediate east of the building. The play equipment area is sealed with a “soft-fall” safety surface material. A concrete path is located immediately adjacent to the east of the play area with an unsealed garden located further to the east.

Another S – shaped class room building is located across the central south eastern portion of the lot which is also constructed similarly to the other buildings onsite. The area to the immediate north of the S-shaped building is concrete sealed with unsealed gardens and a grassed area located further beyond in the north eastern portion of the lot.

Lot 100 DP 623500

This lot is roughly L – shaped and consists of a basketball court and playground area. The lot is elevated slightly above the remainder of the site (adjacent lot to the south) indicating that the area has likely been historically filled. The majority of the area is sealed with asphalt and concrete. The far northern portion of the lot is elevated further above the remainder of the lot and is covered with a “soft-fall” safety surface material. Several large established trees also exist within the northern portion of the site. An unsealed garden bed is located along the eastern boundary of the lot and contains several small shrubs.

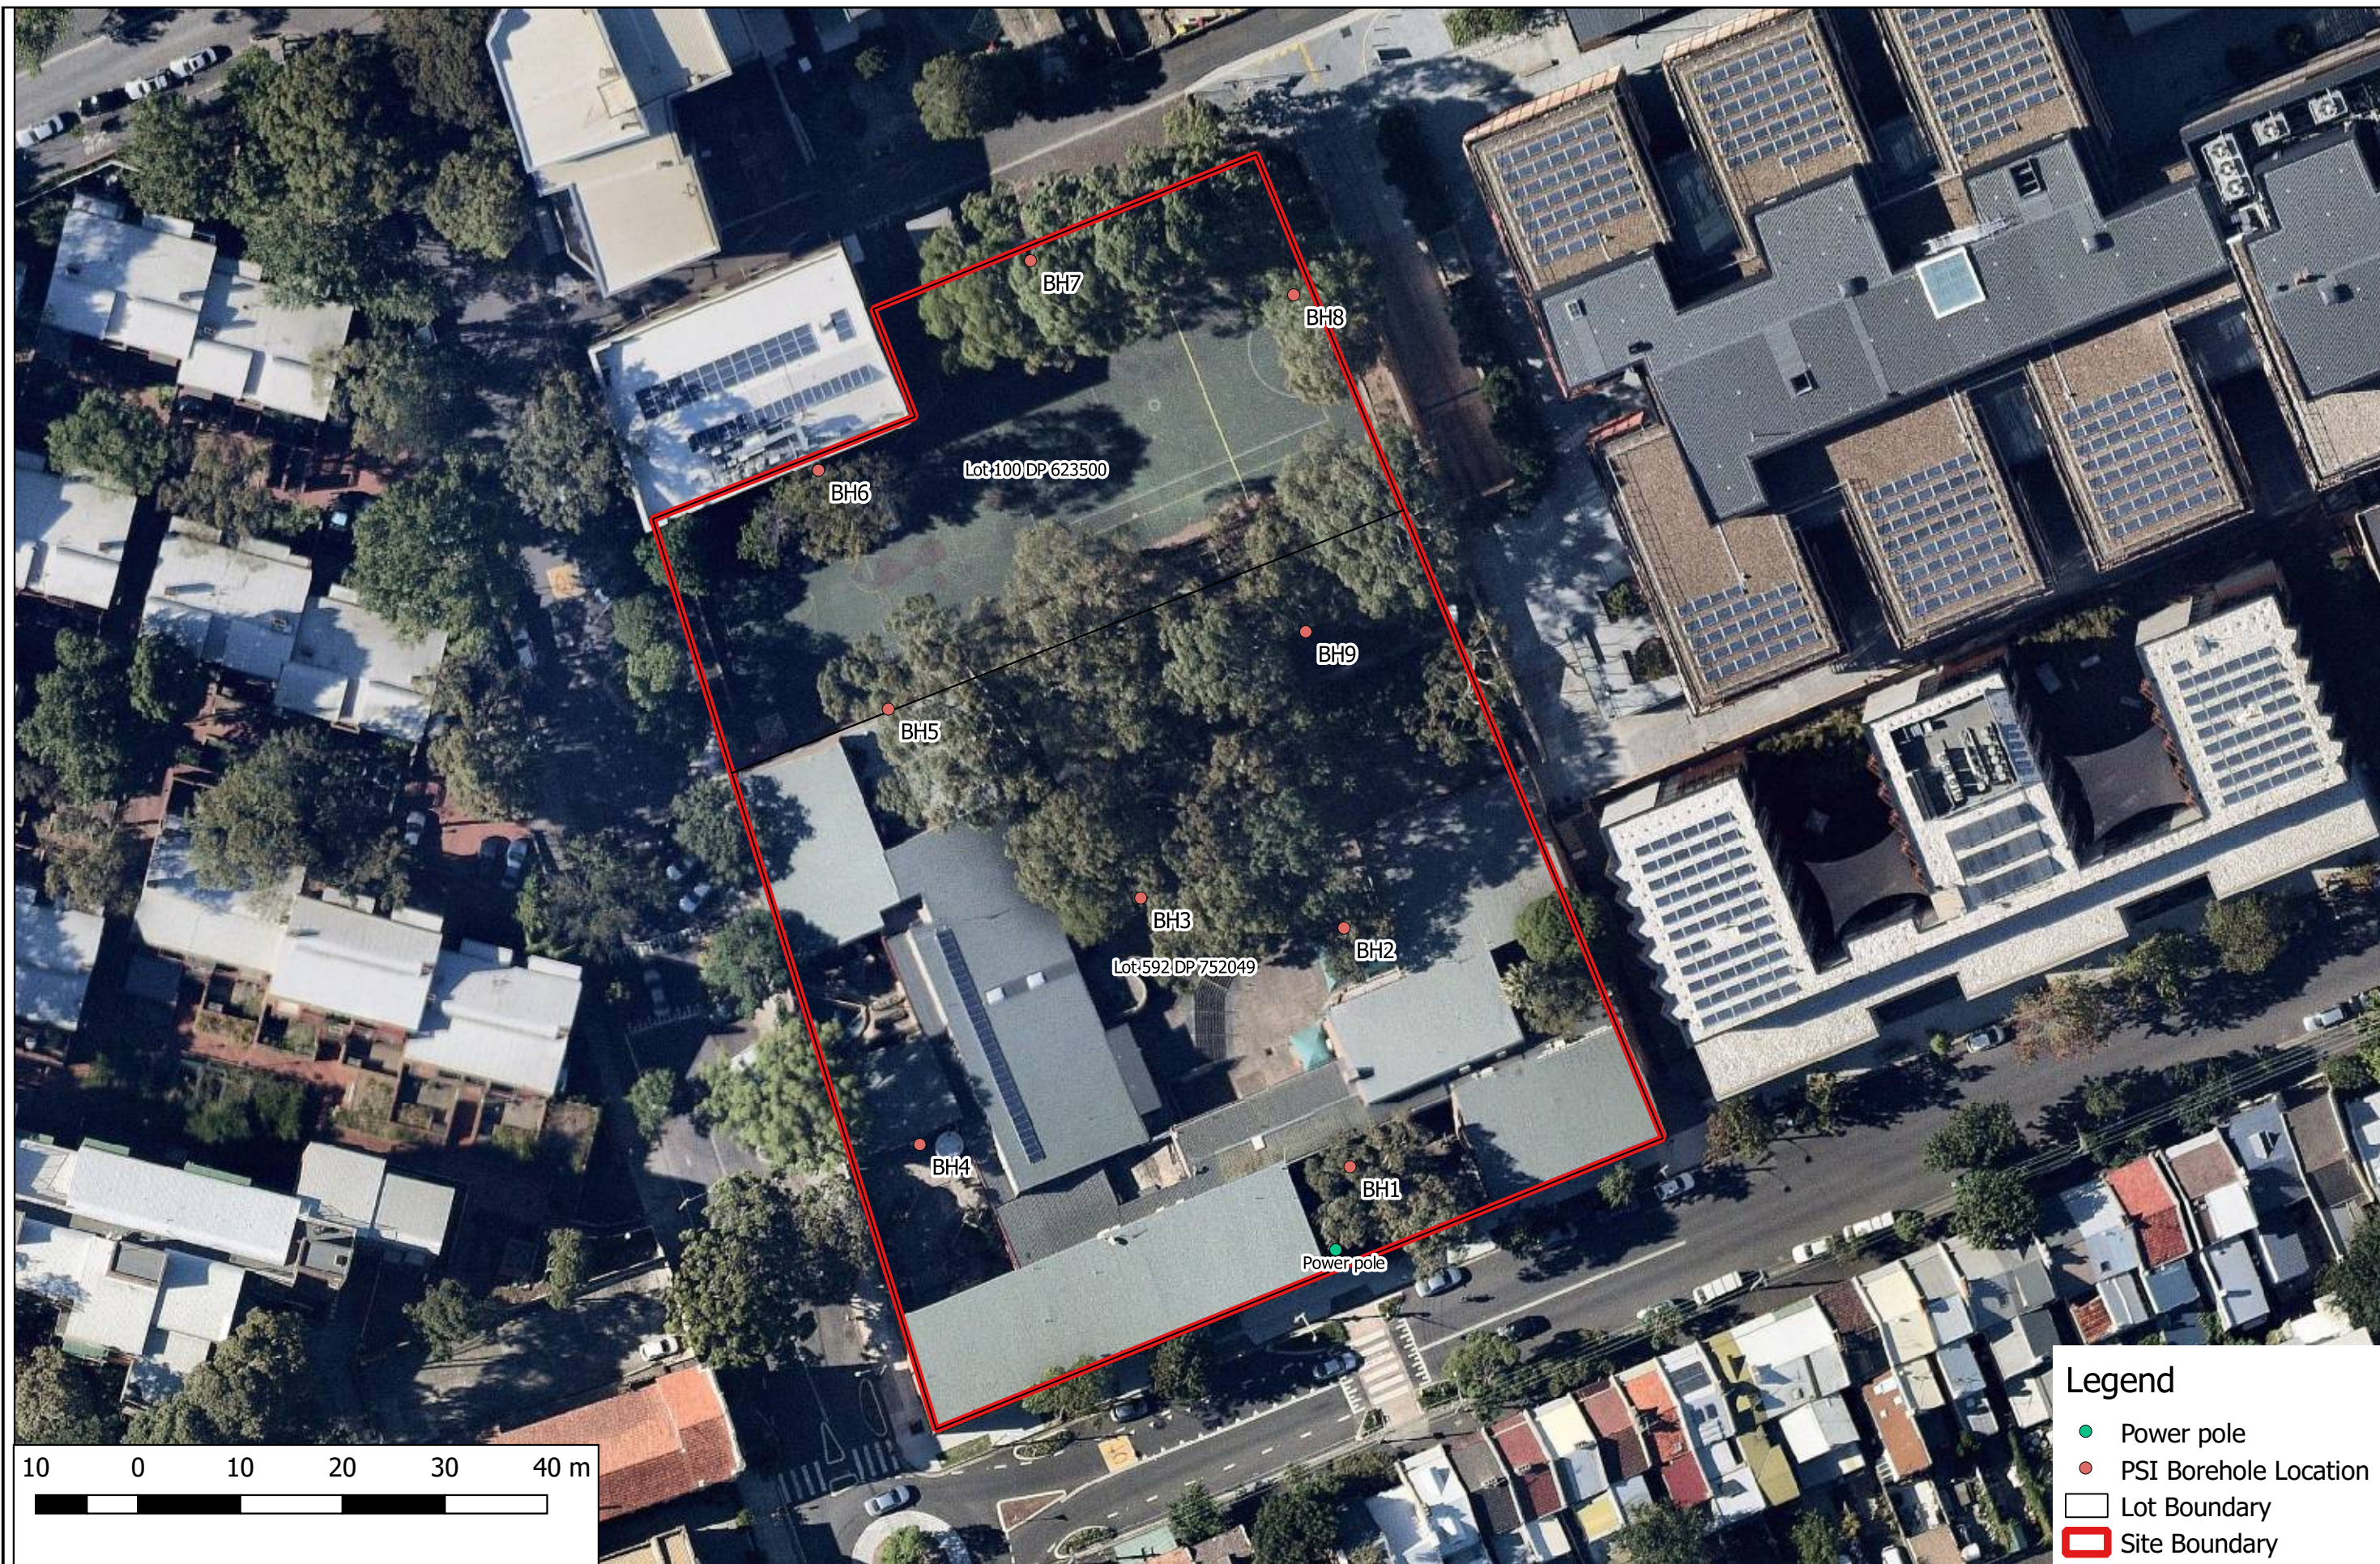
The PSI sample locations are shown on Drawing 3 (Appendix A).

- Power pole
- PSI Borehole Location
- Lot Boundary
- ▭ Site Boundary

Targeted sampling was undertaken at ten locations across the site within identified AEC in the vicinity of former/current site structures and areas of fill (BH1 to BH6, BH8 and BH9), the former road/laneway (BH7) and a power pole onsite (Power pole). The results of site inspection and soil sampling identified the following that will require remediation, management and/or risk assessment or further investigation for the site to be considered suitable for the proposed upgrading works and ongoing use as a primary/pre-school:

- TRH, PAH and lead impact was variously identified in shallow fill at two locations in the north western portion of the site (BH5 and BH6) and one location in the south eastern portion of the site (BH2). Given the identification of slag and charcoal type material within fill at these locations contamination of the fill is considered to be potentially associated with historic fill from an industrial site with blast furnace activities;

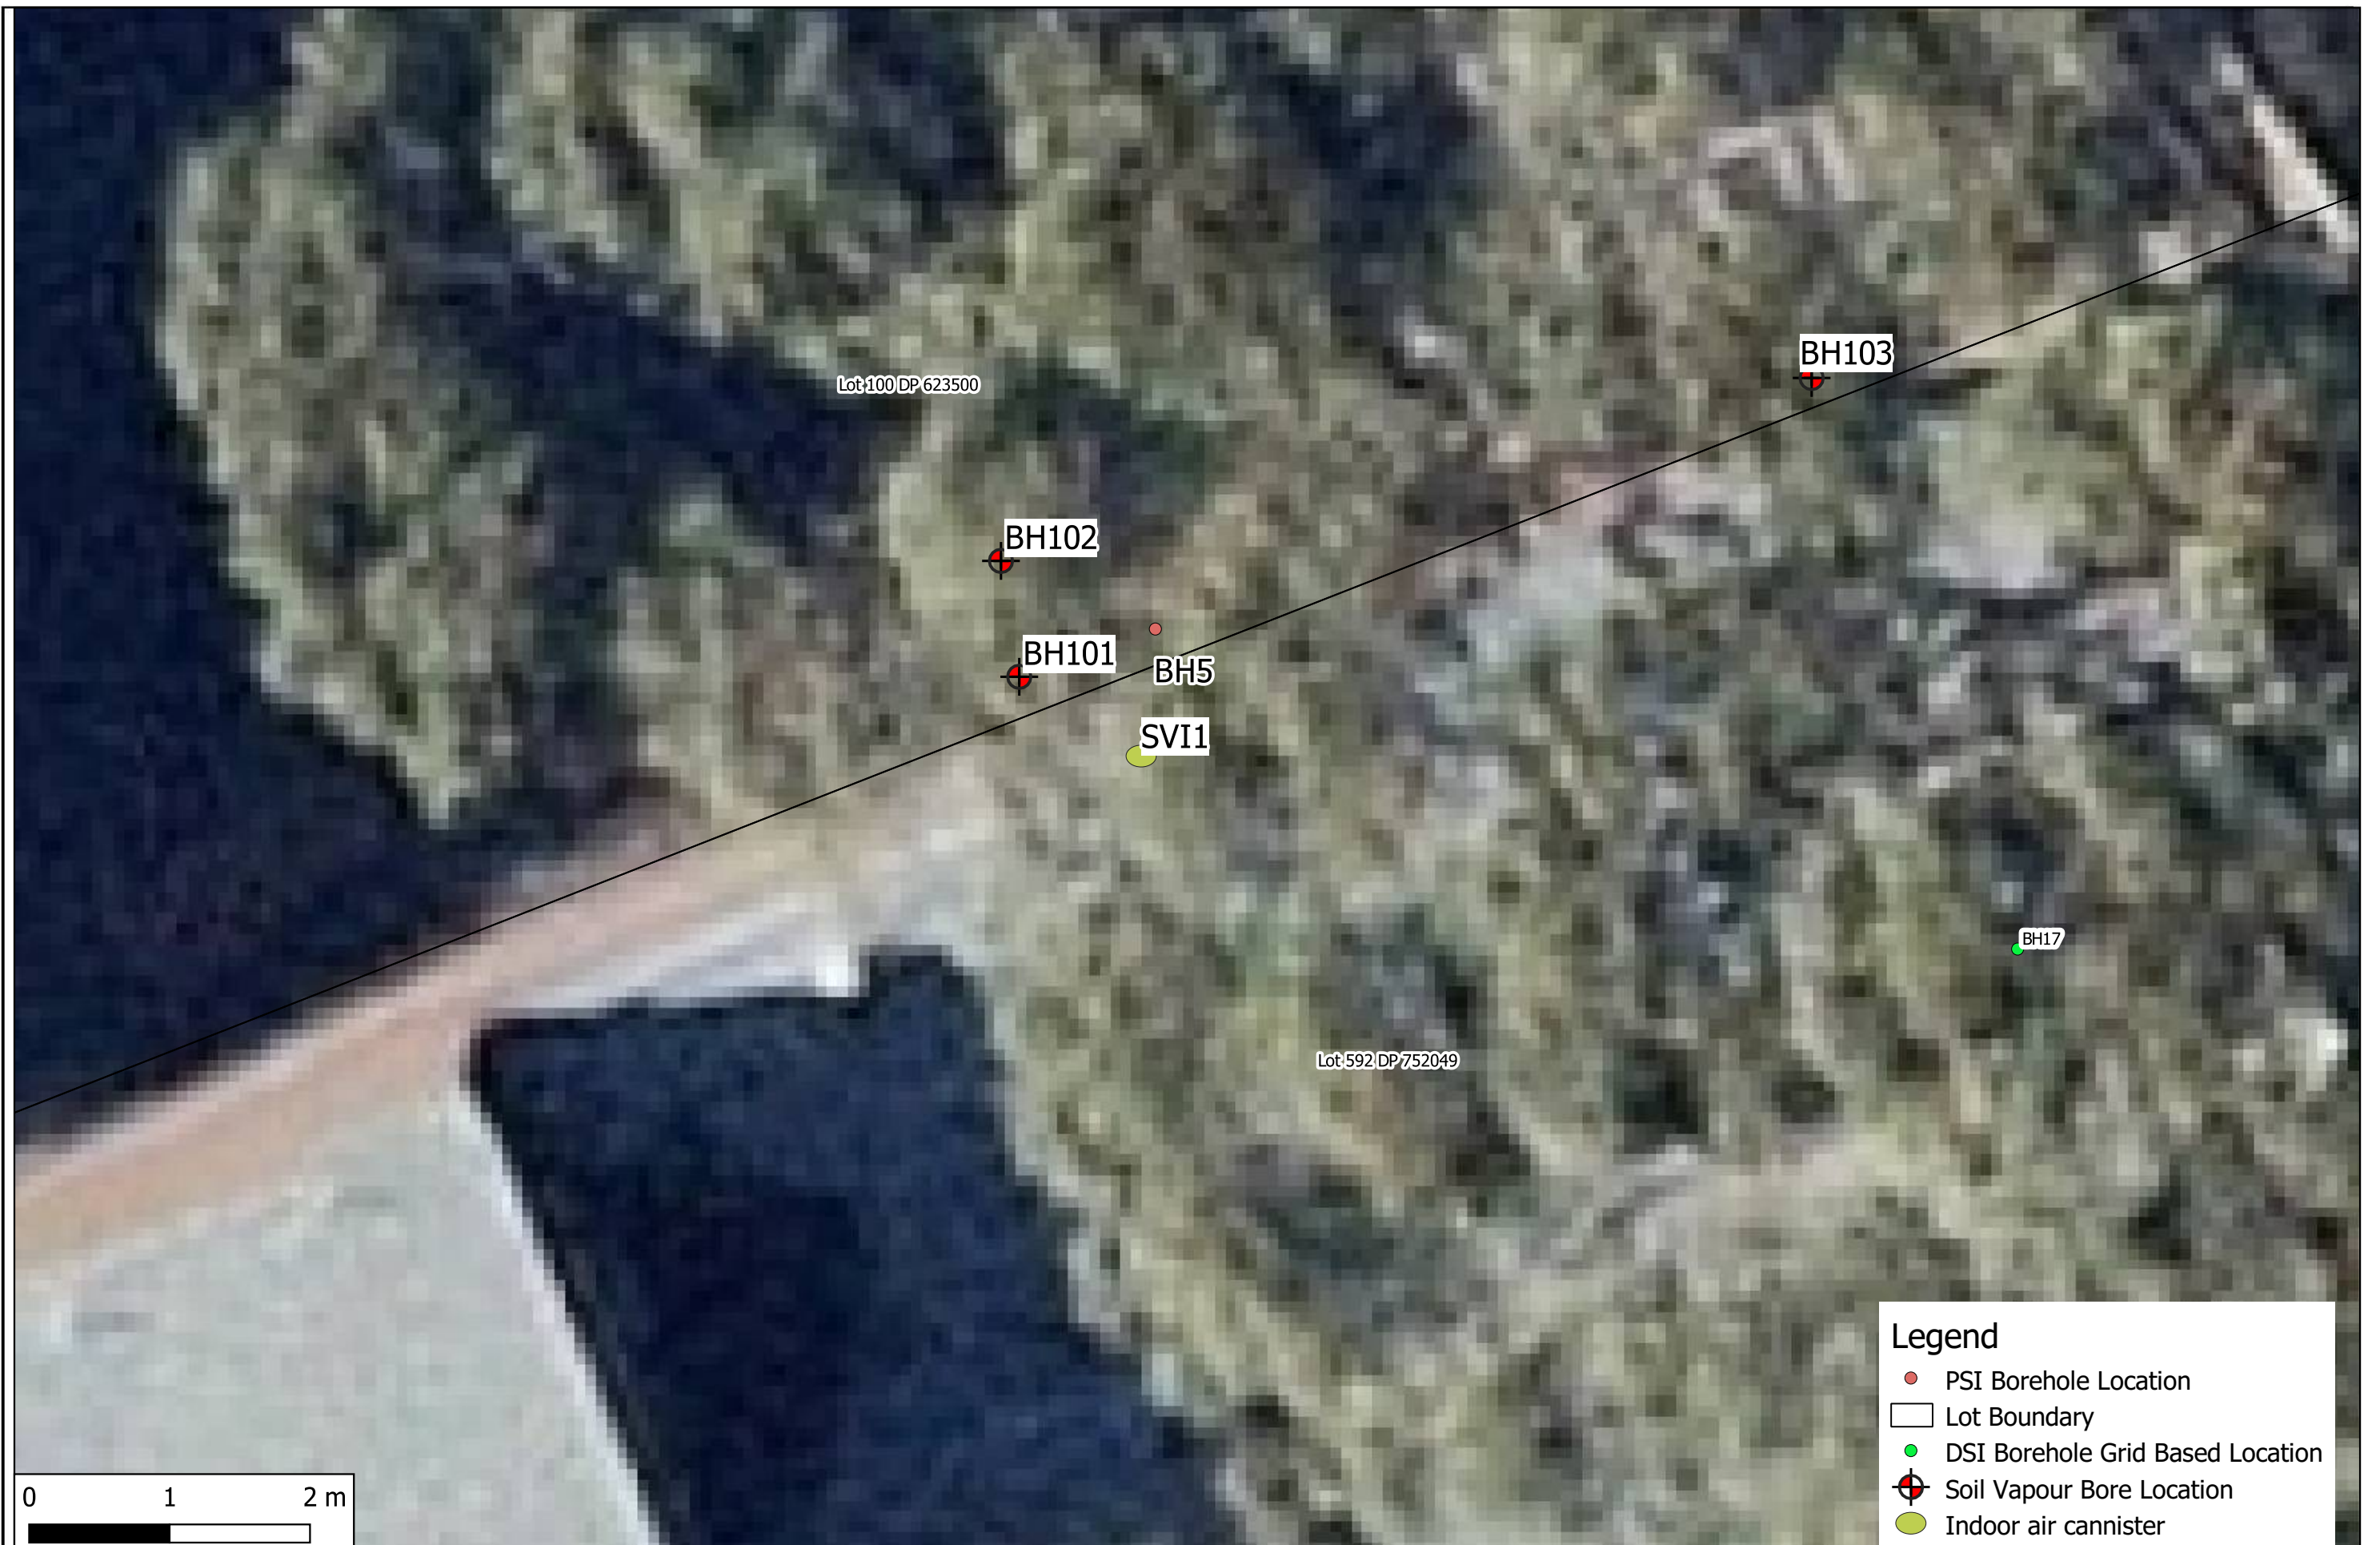
The SVA sample locations are shown on Drawing 5 (Appendix A).

- PSI Borehole Location
- Lot Boundary
- DSI Borehole Grid Based Location
- ⊕ Soil Vapour Bore Location
- Indoor air cannister

- Completion of three hand auger boreholes (BH101 to BH103) and collection of additional fill samples in the vicinity of BH5 on 28 April 2020 to determine the approximate lateral extent of F2 and naphthalene impact to fill presenting a potential vapour risk;
- Installation of Waterloo passive soil vapour samplers (WMGS) within the boreholes completed in the vicinity of BH5. Each WMGS was left for a period of approximately 24 hours before retrieval and sent to the laboratory for F2 (TRH C10-C16 less Naphthalene) and naphthalene analysis; and
- Placement of a summa cannister air gas sampler (SVI1) within the nearest building to the immediate south of BH5 to assess the current indoor air concentrations. The indoor air sample was also collected over an approximate 24-hour period and sent to the laboratory for F2 and naphthalene analysis.

Results of the investigation did not identify F2 and naphthalene at concentrations above the adopted Site Assessment Criteria (SAC) in any of the soil, soil vapour or indoor air samples submitted for laboratory analysis.
