<b>Project</b>	Power Enabling Works, 33kV Rozelle	<b>Report No.</b>	055	<b>Date Collected</b>	30/06/2022	<b>Time Collected</b>	21:05-01:53
<b>Data &amp; Report By:</b>	D. Mutkins	<b>Works</b>	Cable Pulling 33kV		<b>Purpose of Data Collection</b>	Ongoing monitoring / model validation	
<b>Location of construction activity (see Attachment)</b>				<b>Monitoring locations</b>			
				<ol style="list-style-type: none"> <li>1. Robert Street</li> <li>2. 18 Waterloo Street</li> <li>3. 34 Waterloo Street</li> </ol>			
<b>Observed construction activity</b>							
Cable Pull from Waterloo Joint Bay to Mansfield Joint Bay

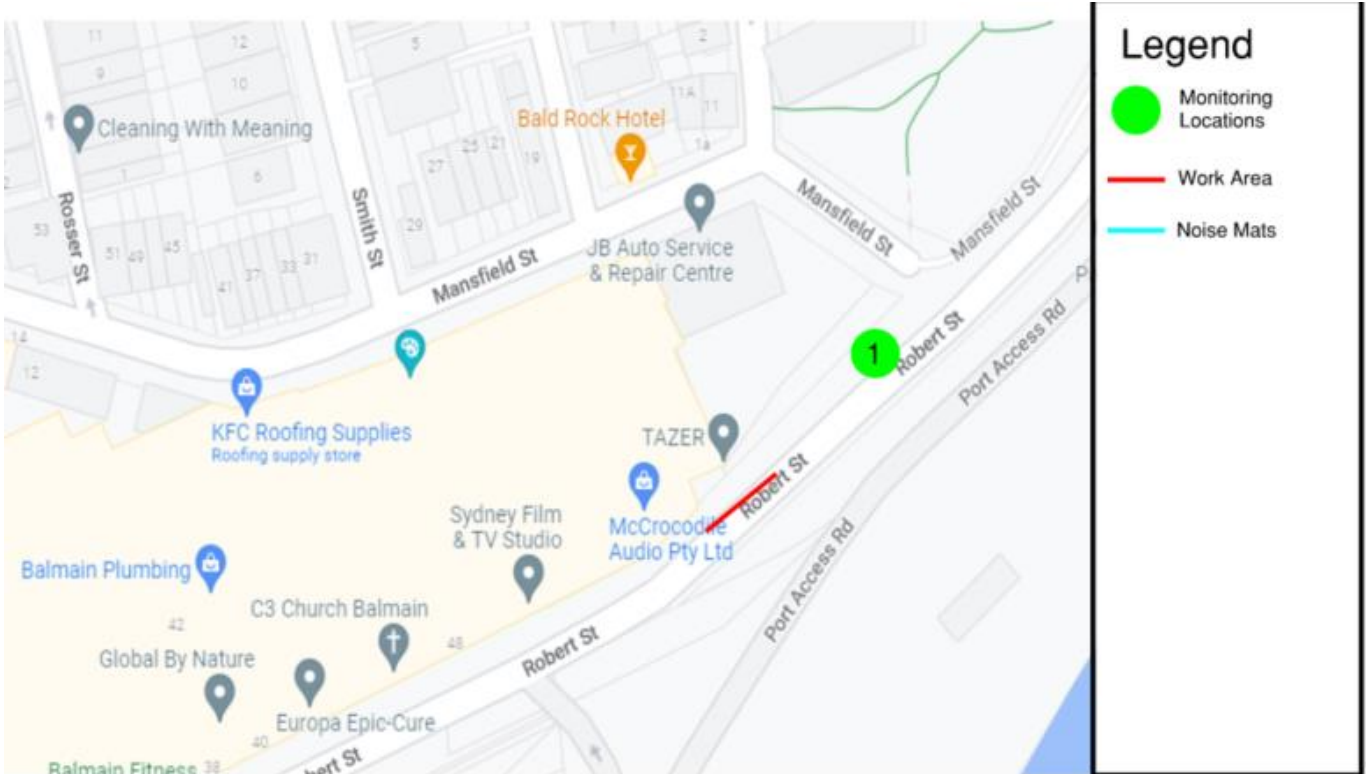
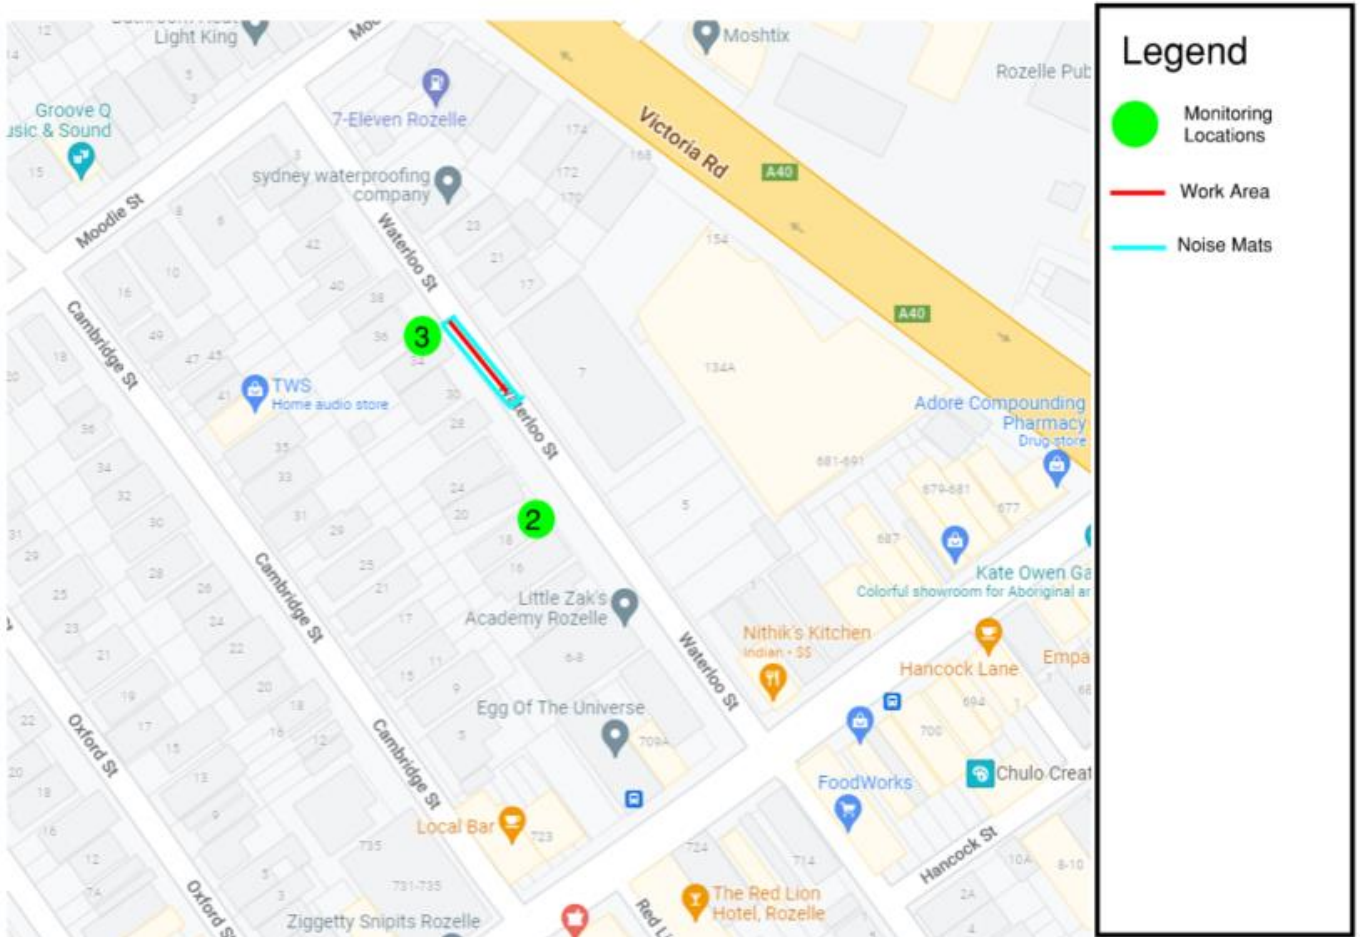
## Attachment 1 Monitoring Locations

Results						
Particulars			Actual Recording(s)			KNOWnoise Prediction(s)
Location	Time	Observations	LAeq	LA90	LAmix	LAeq
1	21:06-21:21	Robert Street saw cutting, removing asphalt to begin trenching. Cutting completed early in the shift. 20m cut up and back shielded by industrial buildings. Monitoring taken down past industrial buildings towards the east. LAeq 66dBA, with an LAmix of 79dBA when saw is pulled above the ground.	66	53	79	N/A
2	22:14-22:29	Day maker behind noise mats. Cable trailer not operating, daymaker generator recorded at LAeq 57dBA. Vehicles frequently passing by the monitoring device producing an LAmix value of 74dBA	57	56	74	62
3	01:37-01:52	Cable trailer on idle preparing for initial pull. Noting that there was an issue with the winch rope and the trailer never went into full gear to turn the cable drum. LAeq 58dBA, LAmix when trailer is turned on 68dBA.	58	45	68	61
Result Summary
