# **The Northern Road – Mersey Road, Bringelly to Glenmore Parkway, Glenmore Park**

## **Environmental Representative Monthly Report**

**April 2021**

## ER ENVIRONMENTAL SITE INSPECTION REPORT

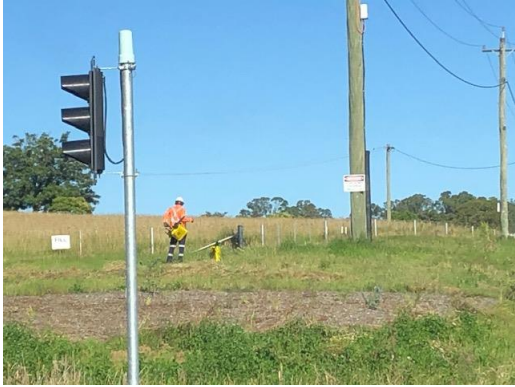
1	Adams Road	<p>Positive observation – weed spraying being undertaken by landscaping sub-contractor.</p> <p>Landscaping is generally looking healthy and is being well maintained.</p>

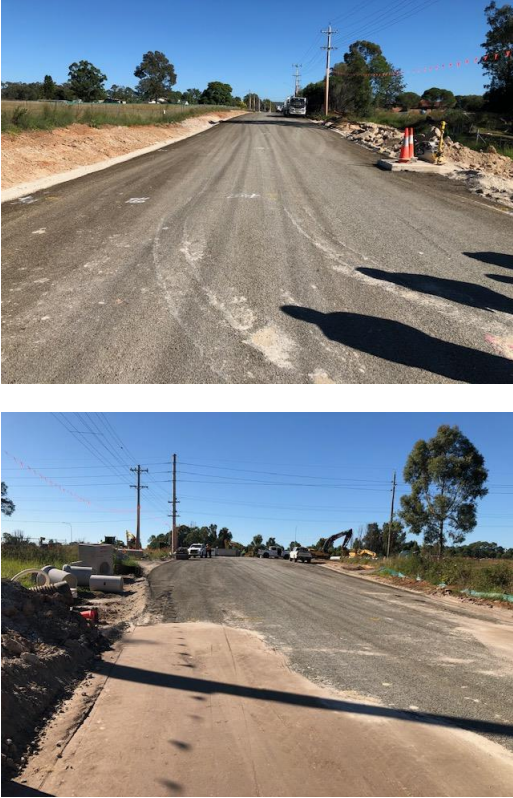
N/A	N/A	N/A	N/A
2	Chain-of-Ponds Road	Works in progress – road being paved today and tomorrow. Progress on open drains will continue	N/A	N/A	N/A	N/A

<p>soon after that to start getting the road ready for re-opening.</p>

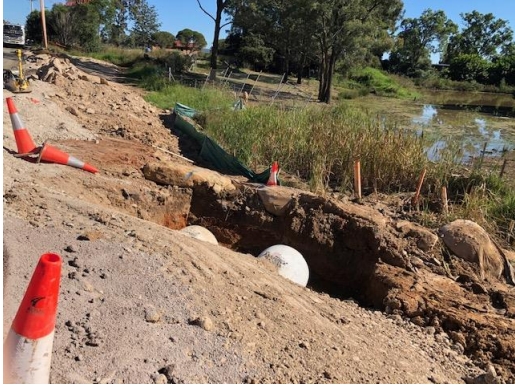
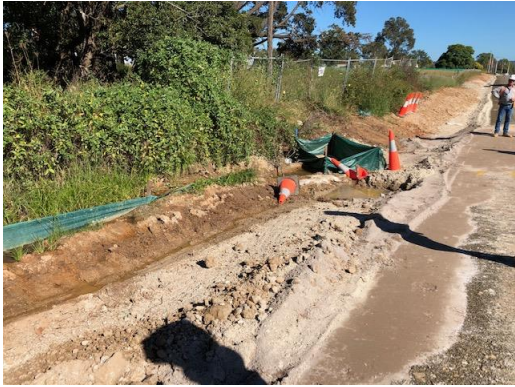
3	Chain-of-ponds Road	<p>Works in progress – culvert outlet and inlet are being prepared and are planned to be completed this week after the asphalt paving is complete.</p>	M	<p>The inlet and outlet protection needs to be completed as per the plan, to ensure the risk of erosion and sedimentation off-site is minimised.</p>	21/04/21	<p>Noted. The inlet and outlet protection was constructed ongoingly from the week commencing 19<sup>th</sup> April 2021 and largely finalised by the week of the 26<sup>th</sup> April 2021 with minor rock additions and implementation of surrounding landscaping.</p>

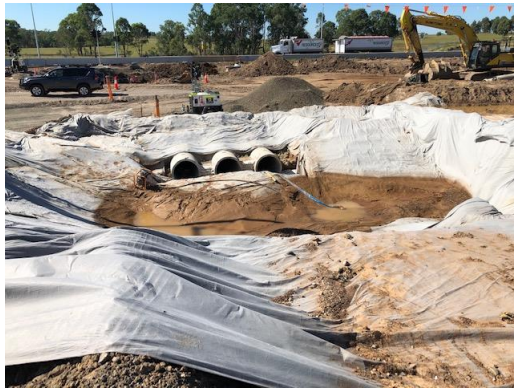
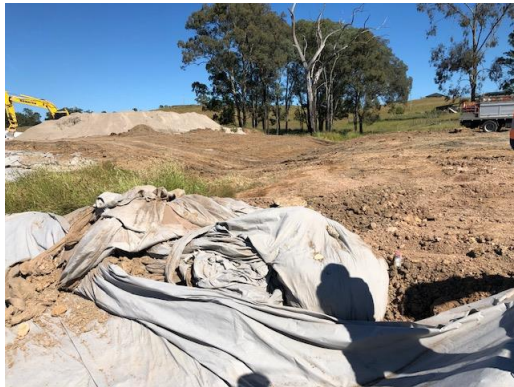
3	Bradley Street	<p>Works in progress – Bradley Street is currently closed for a short period of time to complete the intersection work and re-open prior to Monday 19/04.</p> <p>As there is significant focus on the construction of the road, there is a risk that the completion of the clean-water transverse culvert is not factored into the planning for the completion of the area. Currently the area around the culvert and the upstream area is not ready for rainfall and the area</p>	M	<p>Recommend CPB carry out a brief planning session on how this area will be completed either prior to Bradley Street re-opening or soon after. The planning session should be documented and cover the following:</p> <ul style="list-style-type: none"> <li>What is the design of the upstream drain/depression through the land currently being used for stockpiling. Does it</li> </ul>	<p>Planning session to be held prior to 15/04.</p> <p>Work to be complete as per plan</p>	<p>CPB have conducted daily planning meetings to discuss construction programme and logistics for installing design measures around the triple cell inlet at Bradley Street.</p> <p>Whilst there is no prescriptive design, the project drainage design report indicates that the leased land above the triple cell culvert is to be shaped in order to drain surface runoff towards the triple cell culvert.</p>

needs to be completed prior to the next rainfall event.

- need to be flattened or can a depression/drain be left.
- What will the final be lined with? Can the final drain lining be installed and be kept clean (ie bunds either side and no more access through this area).
- Can the area on the Bradley Street site be completed prior to opening and all access to the culvert and adjacent land be access from the south?
- Can the headwall be installed?
- Can the rip-rap be installed?
- Can this work be done without the risk of re-work?
- Can the clean-water concrete drain be installed and completed prior to, or immediately after the culvert inlet is completed?
- Clean water flow path must be maintained through the disturbed area and through the pipes.
- Determine how soon after earthworks and topsoil is complete can the hydro-mulch and landscaping be installed.

ASAP  
(please  
provide  
update by  
22/04)

Hydromulch will ensure cover crop and interim ground stabilisation is in place and ready for rainfall.

Bradley Street was successfully constructed during a two-week road closure and access to the triple cell culvert for the remainder of construction was ensured. This meant all items including headwall construction and rock placement could occur without there being any access issues.

Installation of the rock mattress is to be placed shortly after headwall construction.

Hydro mulch has been sprayed to the clean water drainage line over leased land shortly after this inspection took place. Silt fence was also installed at the same time.
