Quarterly Environment Construction Monitoring Report

Q2 – April to June 2021

Pitt Street Integrated Station Development

Project number:	N01070
Document number:	SMCSWSPS-CPB-STA-EM-REP-000006
TeamBinder:	SMCSWSPU-CPB-SPS-EM-REP-008819
Revision date:	27/07/2021
Revision:	B

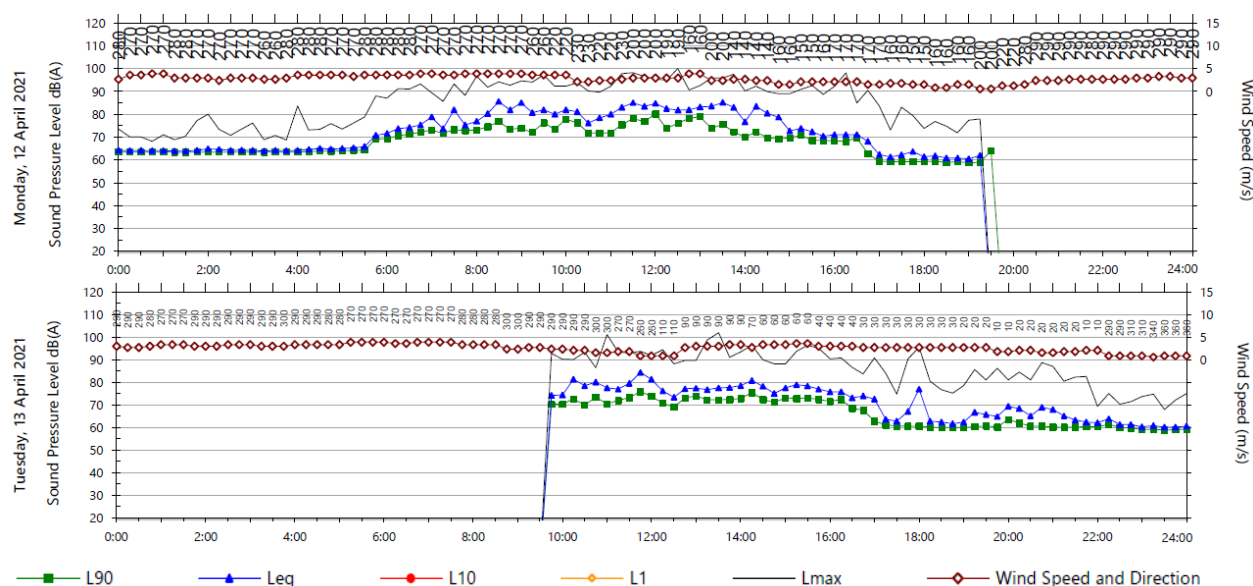
Figure 2-5 Unattended noise monitoring at Pitt Street N3 following the loss of connection on 12-13 April 2021

It is noted that the Pitt Street noise monitor (N3) lost connection from 12 April 22:00 to 13 April 09:30. There were no noise exceedances recorded from the Bathurst Street monitor during the Pitt Street monitor outage period. Investigation into the cause found that this was because of the noise monitor being unplugged.

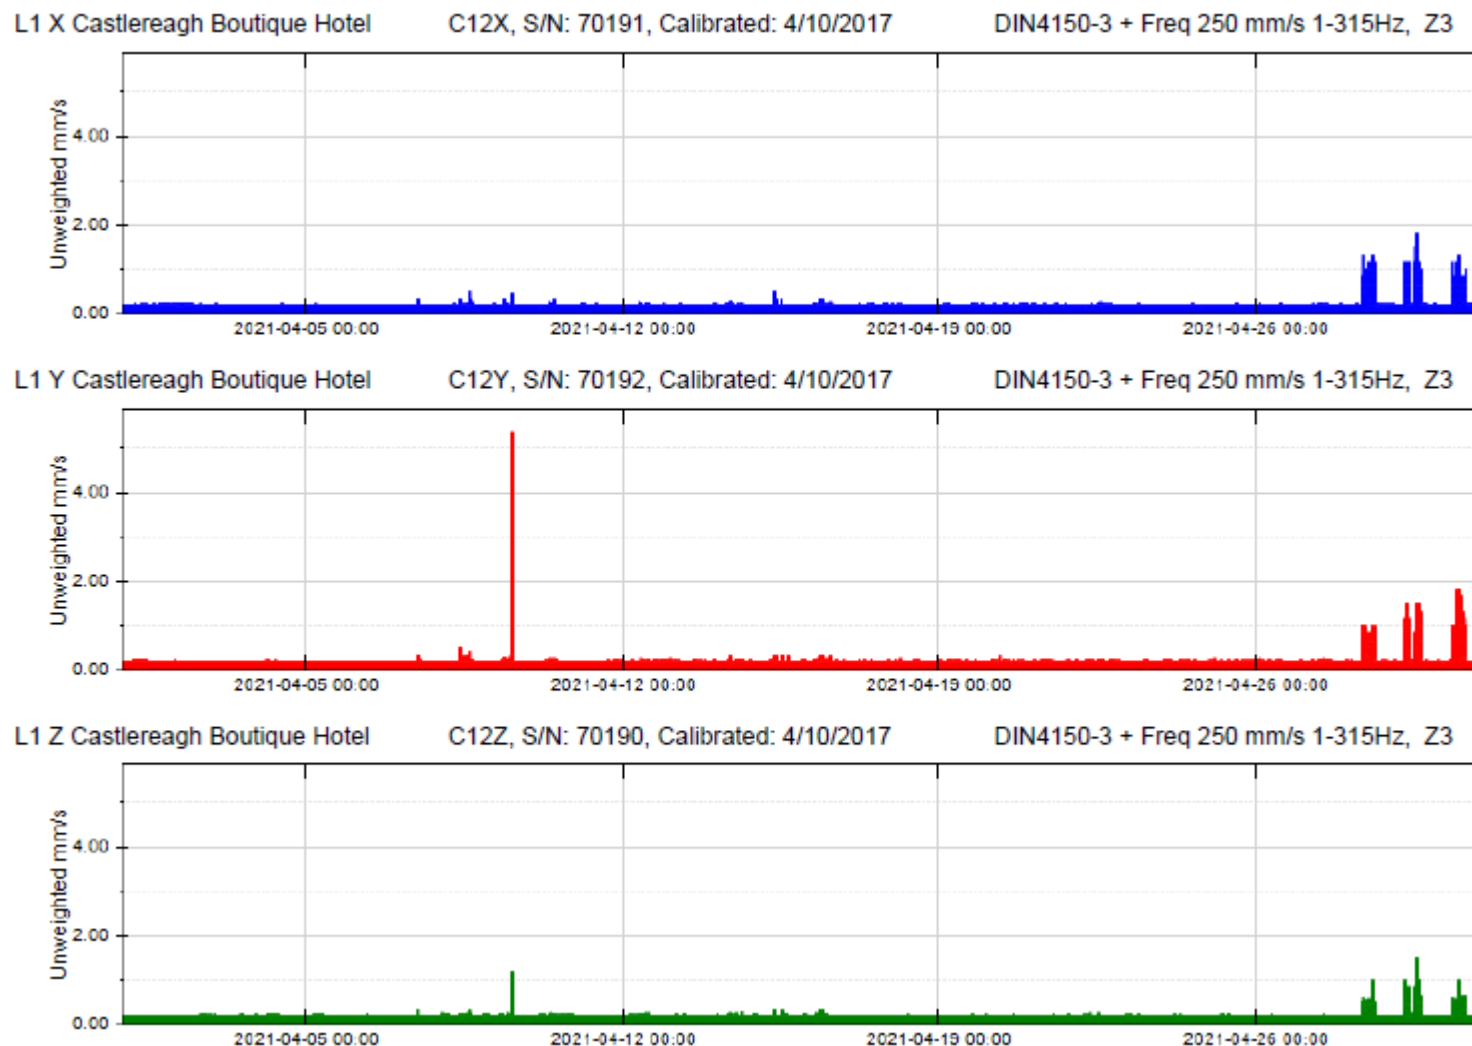
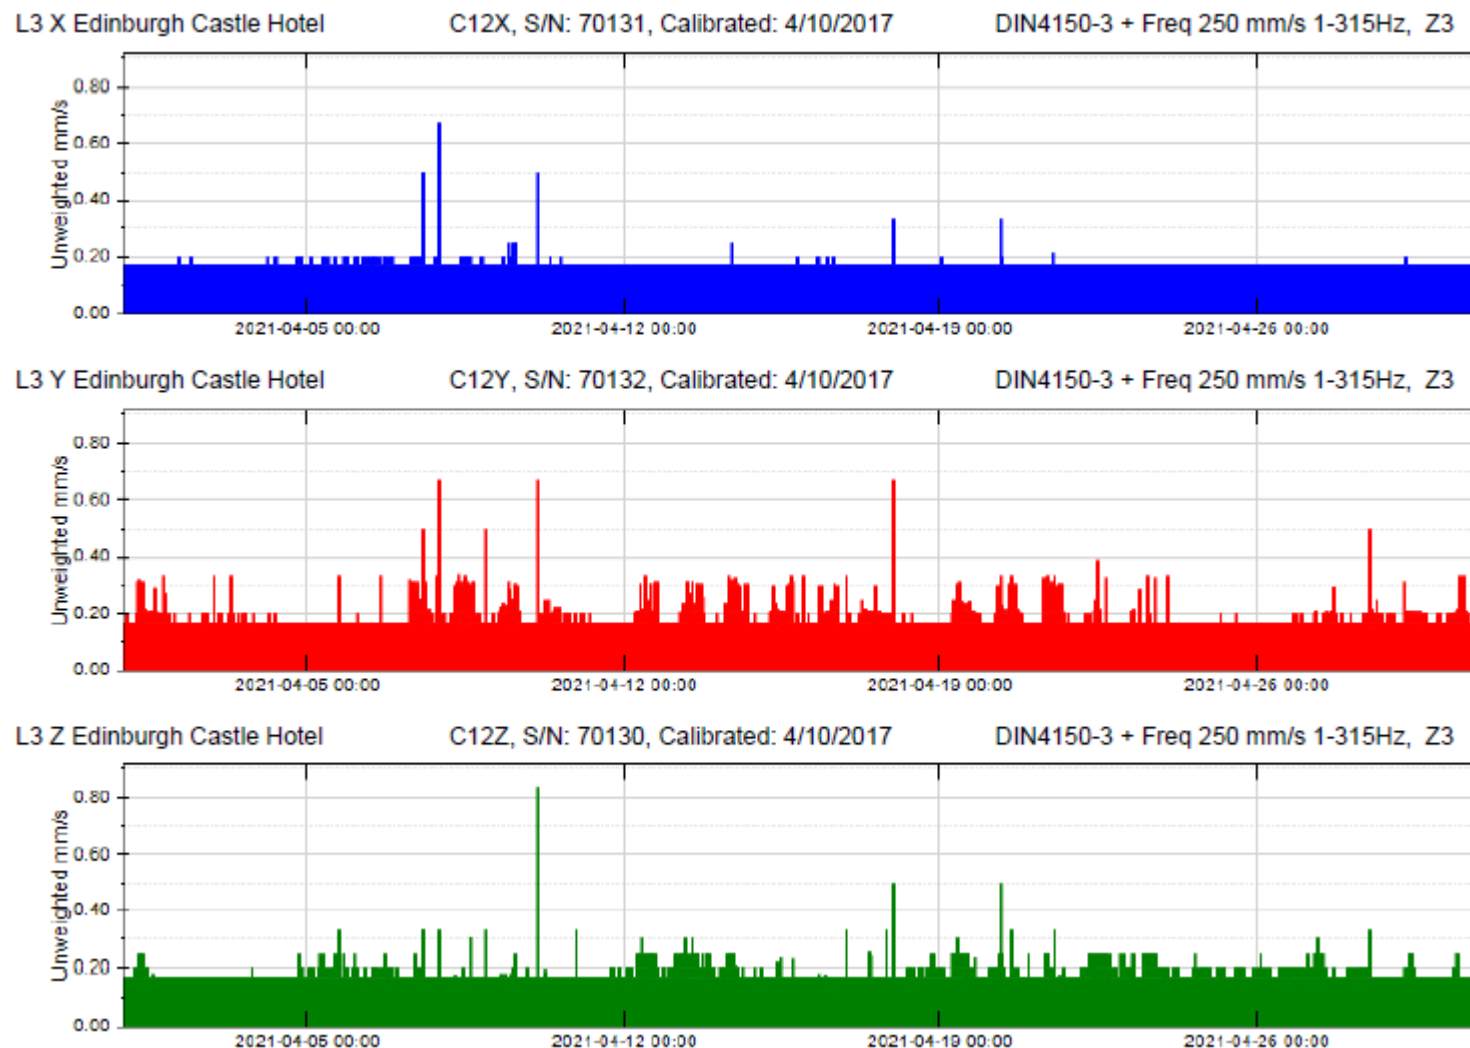
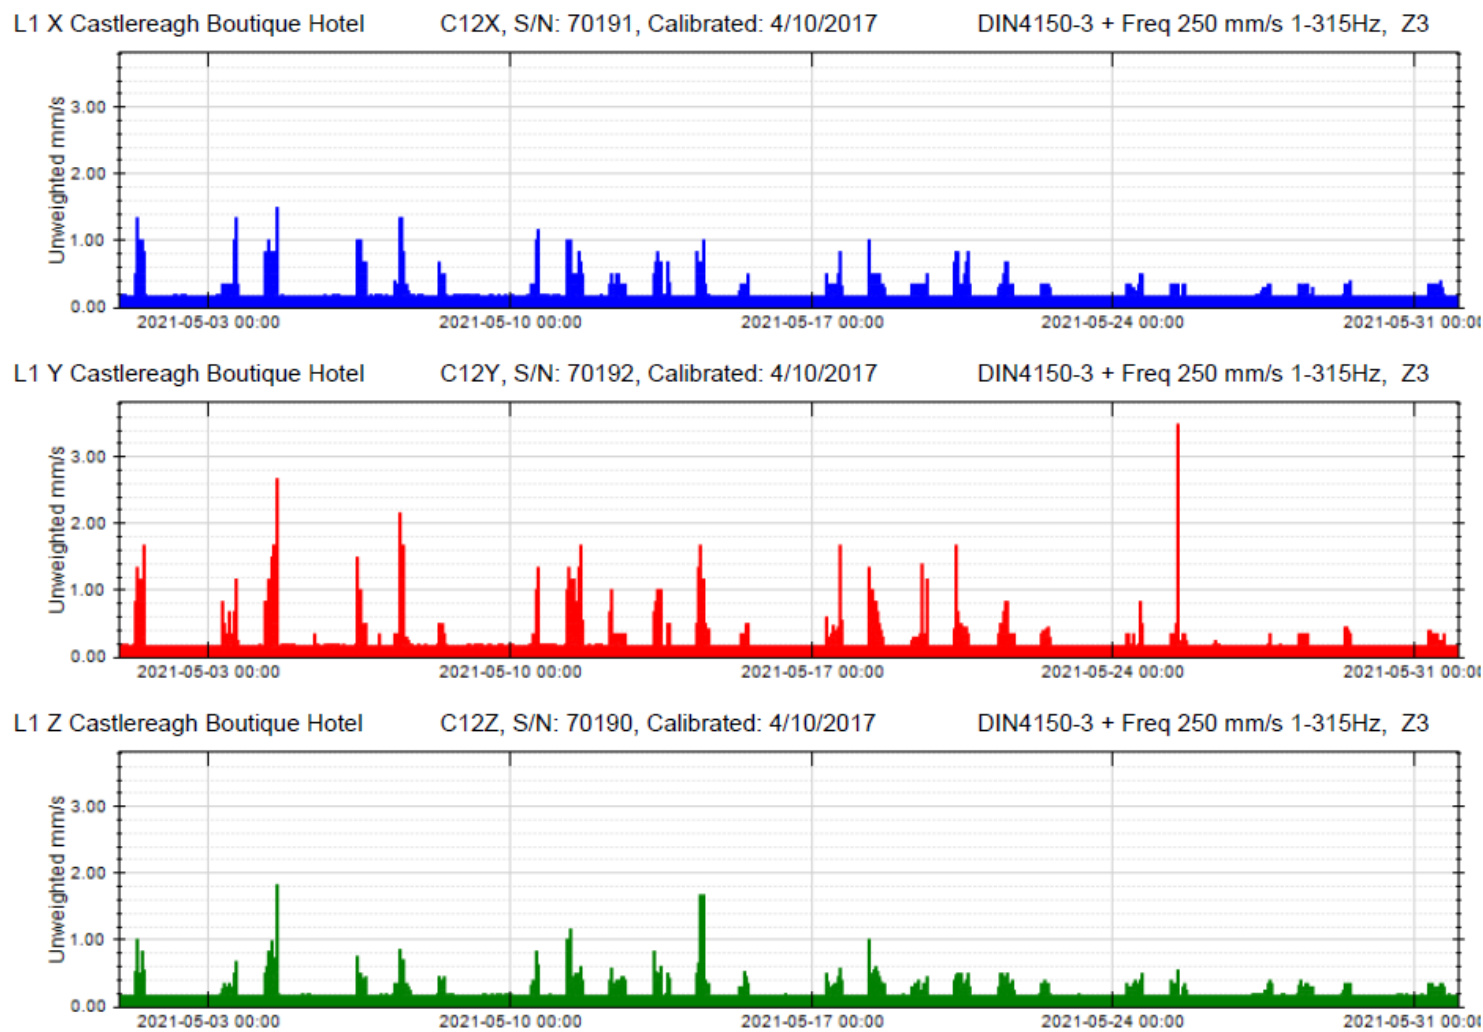
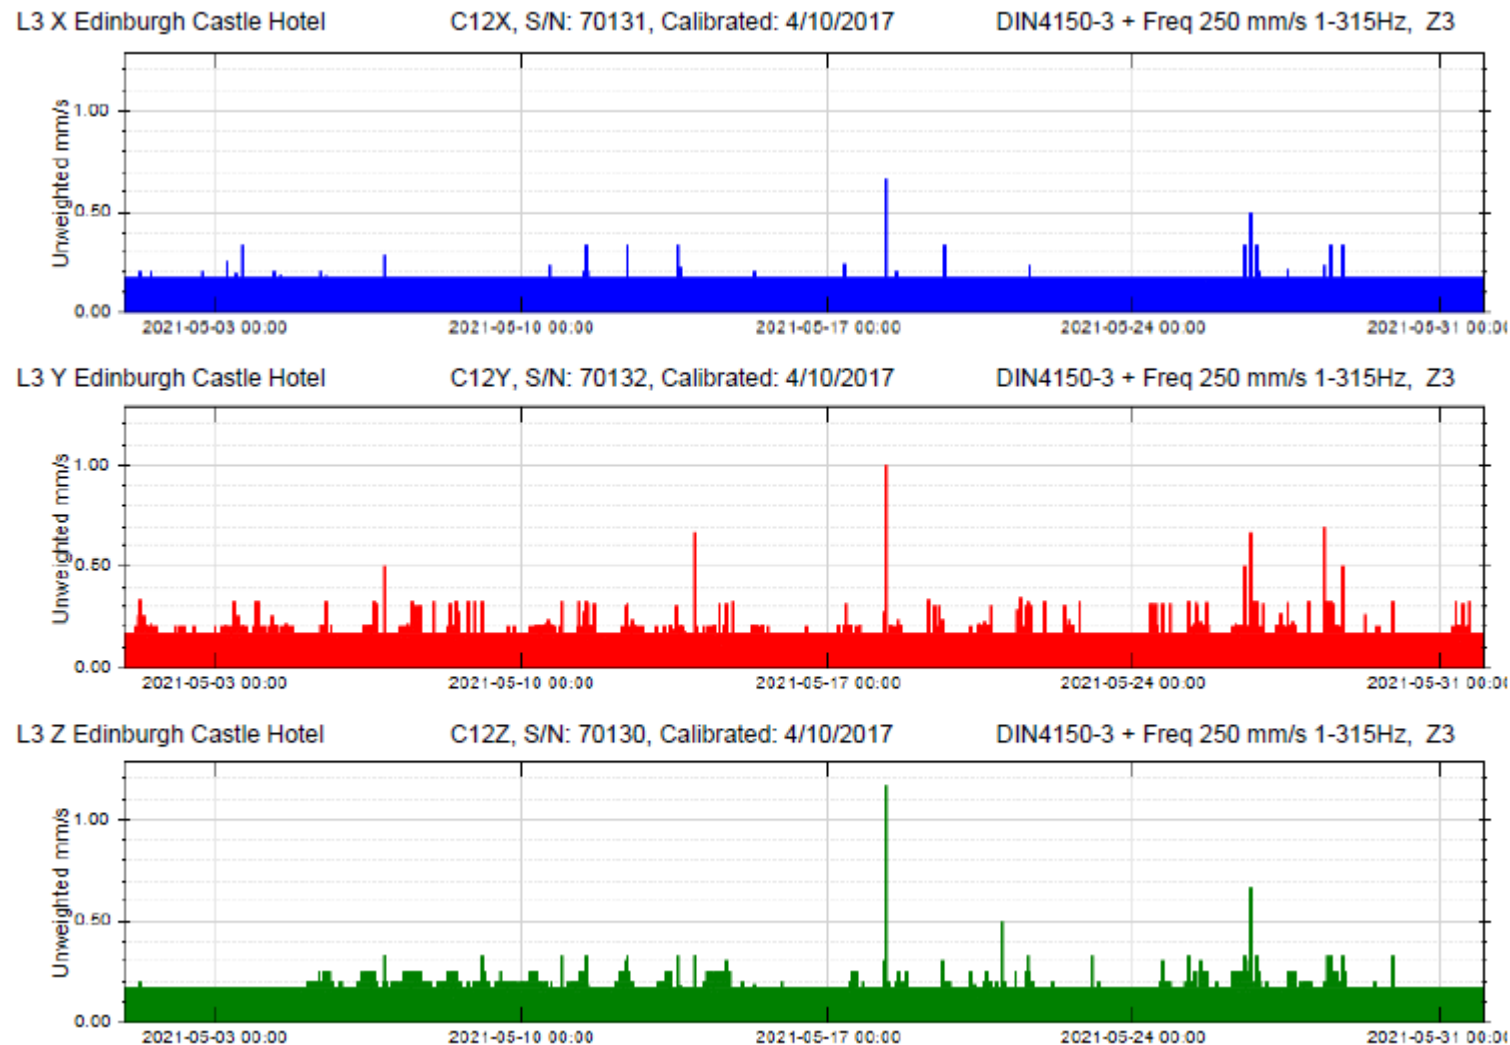
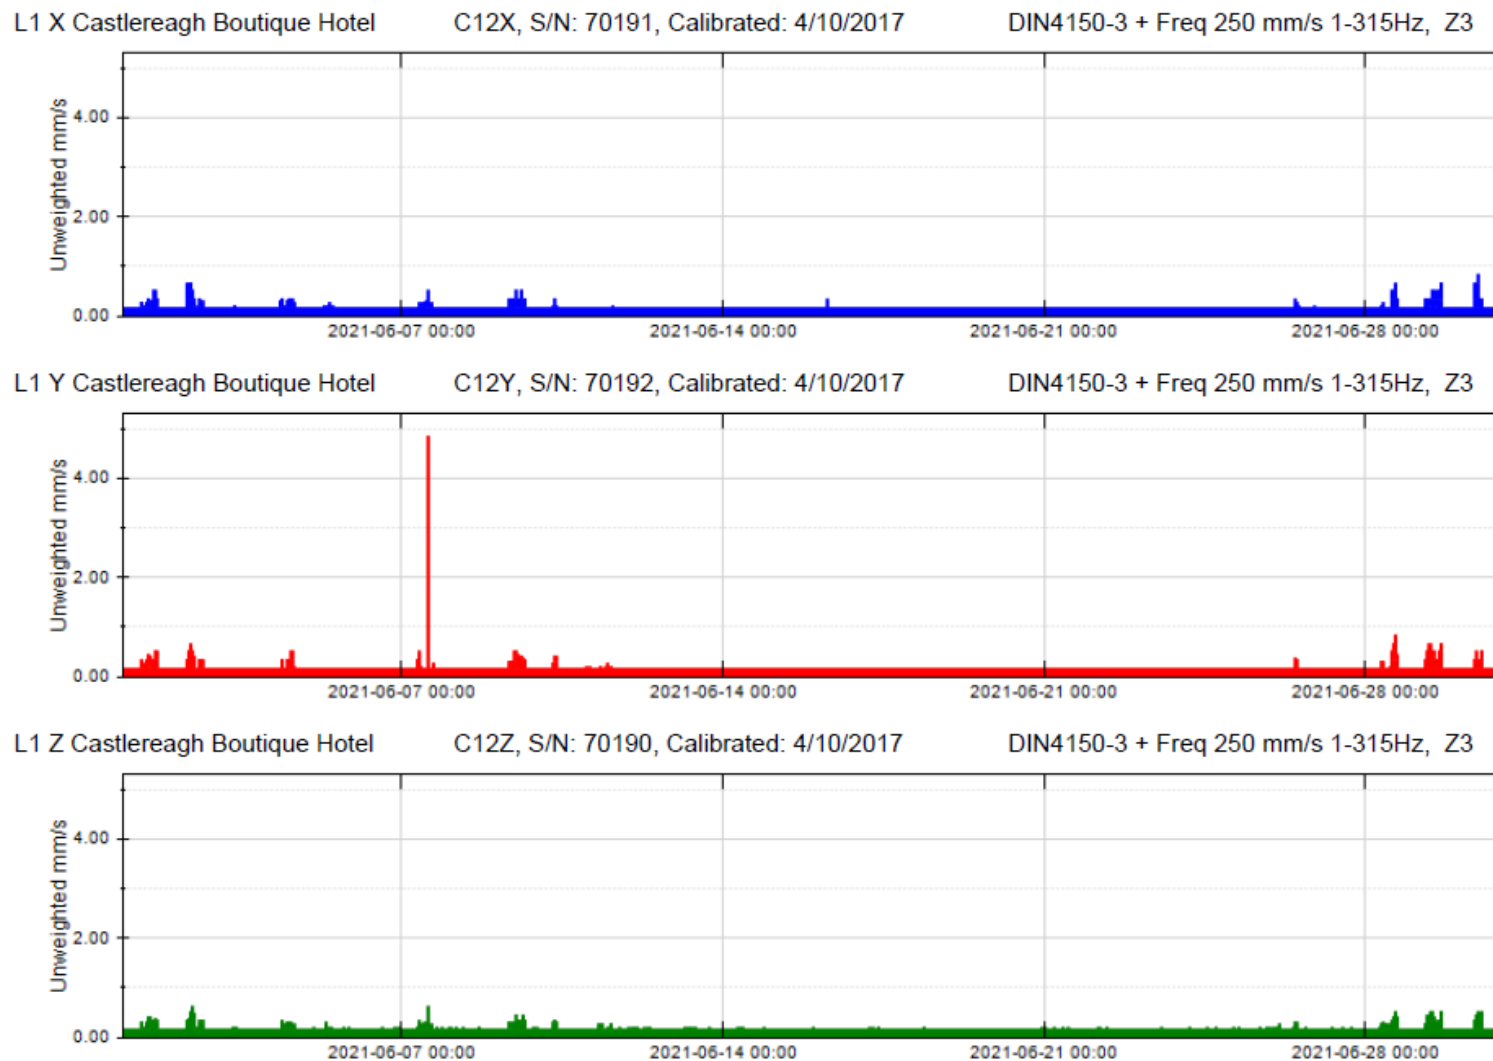
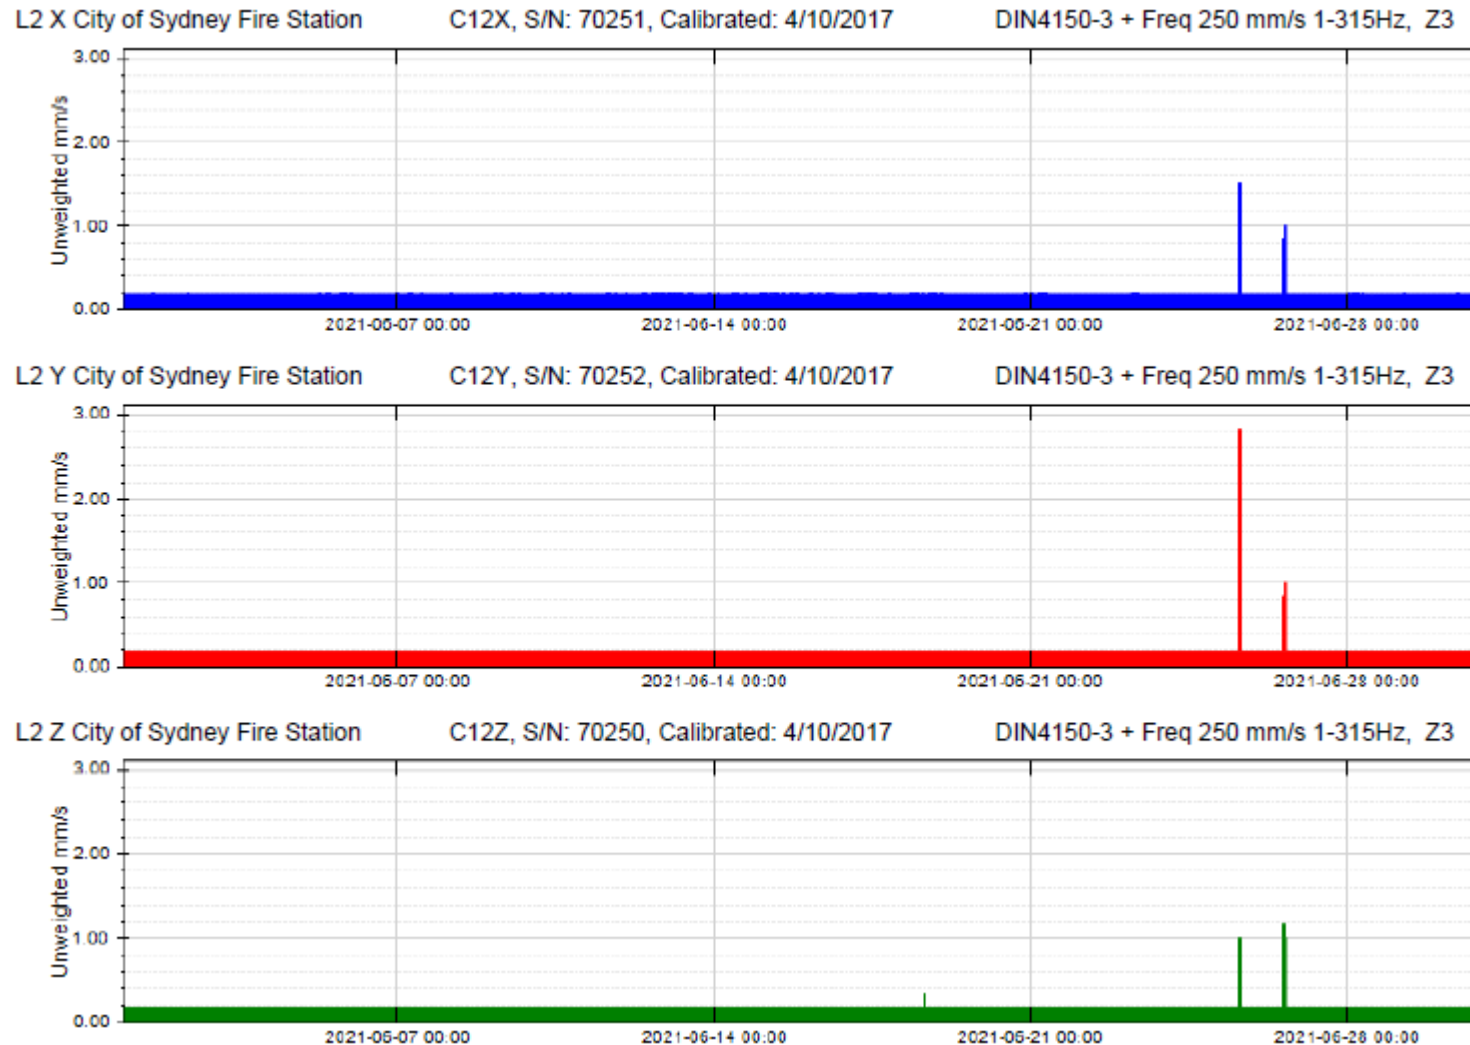
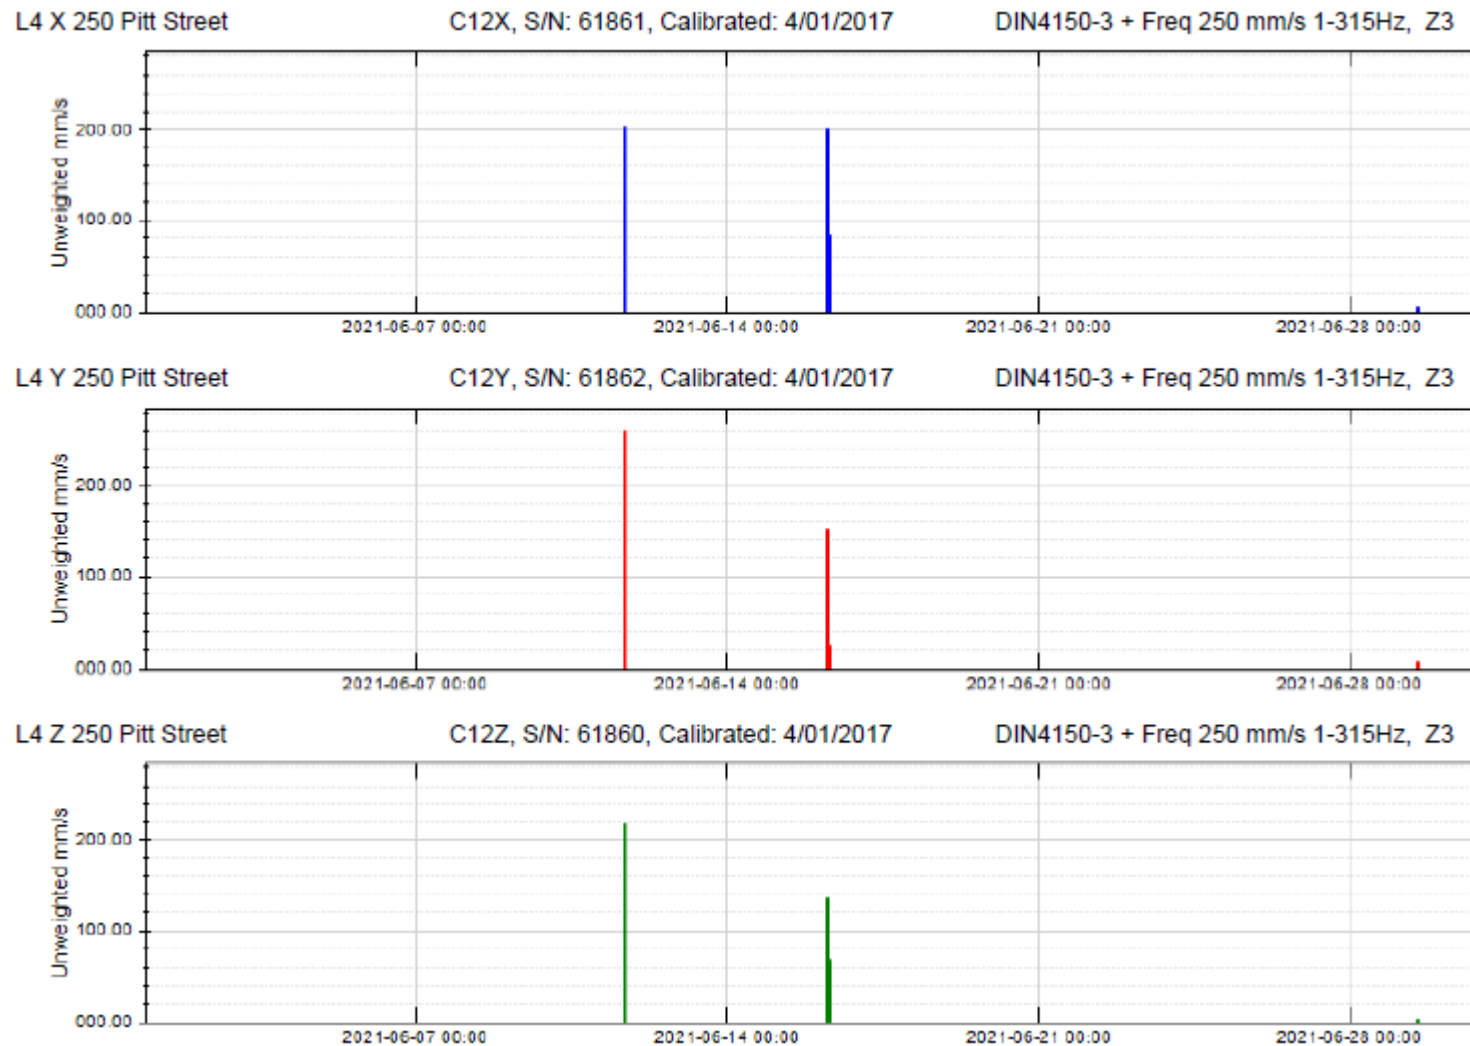
Nine (9) exceedances of the relevant vibration criteria were recorded during the reporting period as detailed below in **Table 2-12**. None of these exceedances are linked to PSISD works. No building damage has been observed to be the result of any PSISD works.

Monthly vibration monitoring results over the reporting period are presented below in **Figures 2-6 to 2-17** for each of the four (4) monitoring sites. It is noted the graphs show the unweighted results.

16/06/2021	250 Pitt Street	5.25 mm/s (18:36)	2.5 mm/s	<p>During the vibration exceedance at the 250 Pitt Street, the corresponding vibration levels measured at the Boutique Hotel are typically below 1.5mm/s. Given that the vibration monitors at the Boutique Hotel and 250 Pitt Street are within close proximity to each other (approximately 24m) it is expected that a noticeable vibration event should have been measured at the Boutique Hotel, especially since the level measured at 250 Pitt Street was significantly high. Furthermore, a singular peak event in vibration is not typical for construction works. Given that there is not a noticeable corresponding vibration event at Boutique Hotel and the atypical nature of the exceedance, it is expected that the vibration exceedance is due to a localised event such as the equipment being bumped.</p> <p>The vibration exceedance is not due PSISD construction works.</p>

29/06/2021	250 Pitt Street	5.70 mm/s (12:59)	2.5 mm/s	<p>During the vibration exceedance at the 250 Pitt Street, the corresponding vibration levels measured at the Boutique Hotel are typically below 1.5mm/s. Given that the vibration monitors at the Boutique Hotel and 250 Pitt Street are within close proximity to each other (approximately 24m) it is expected that a noticeable vibration event should have been measured at the Boutique Hotel, especially since the level measured at 250 Pitt Street was significantly high. Furthermore, a singular peak event in vibration is not typical for construction works. Given that there is not a noticeable corresponding vibration event at Boutique Hotel and the atypical nature of the exceedance, it is expected that the vibration exceedance is due to a localised event such as the equipment being bumped.</p> <p>The vibration exceedance is not due PSISD construction works.</p>
