Green and Golden Bell Frog Plan of Management for the M6 Stage 1

Prepared by AMBS Ecology & Heritage Pty Ltd
for CPB Contractors Pty Limited and Ghella Pty Ltd

Final Report

Document Number M6S1-CGU-NWW-EO-PLN-000426

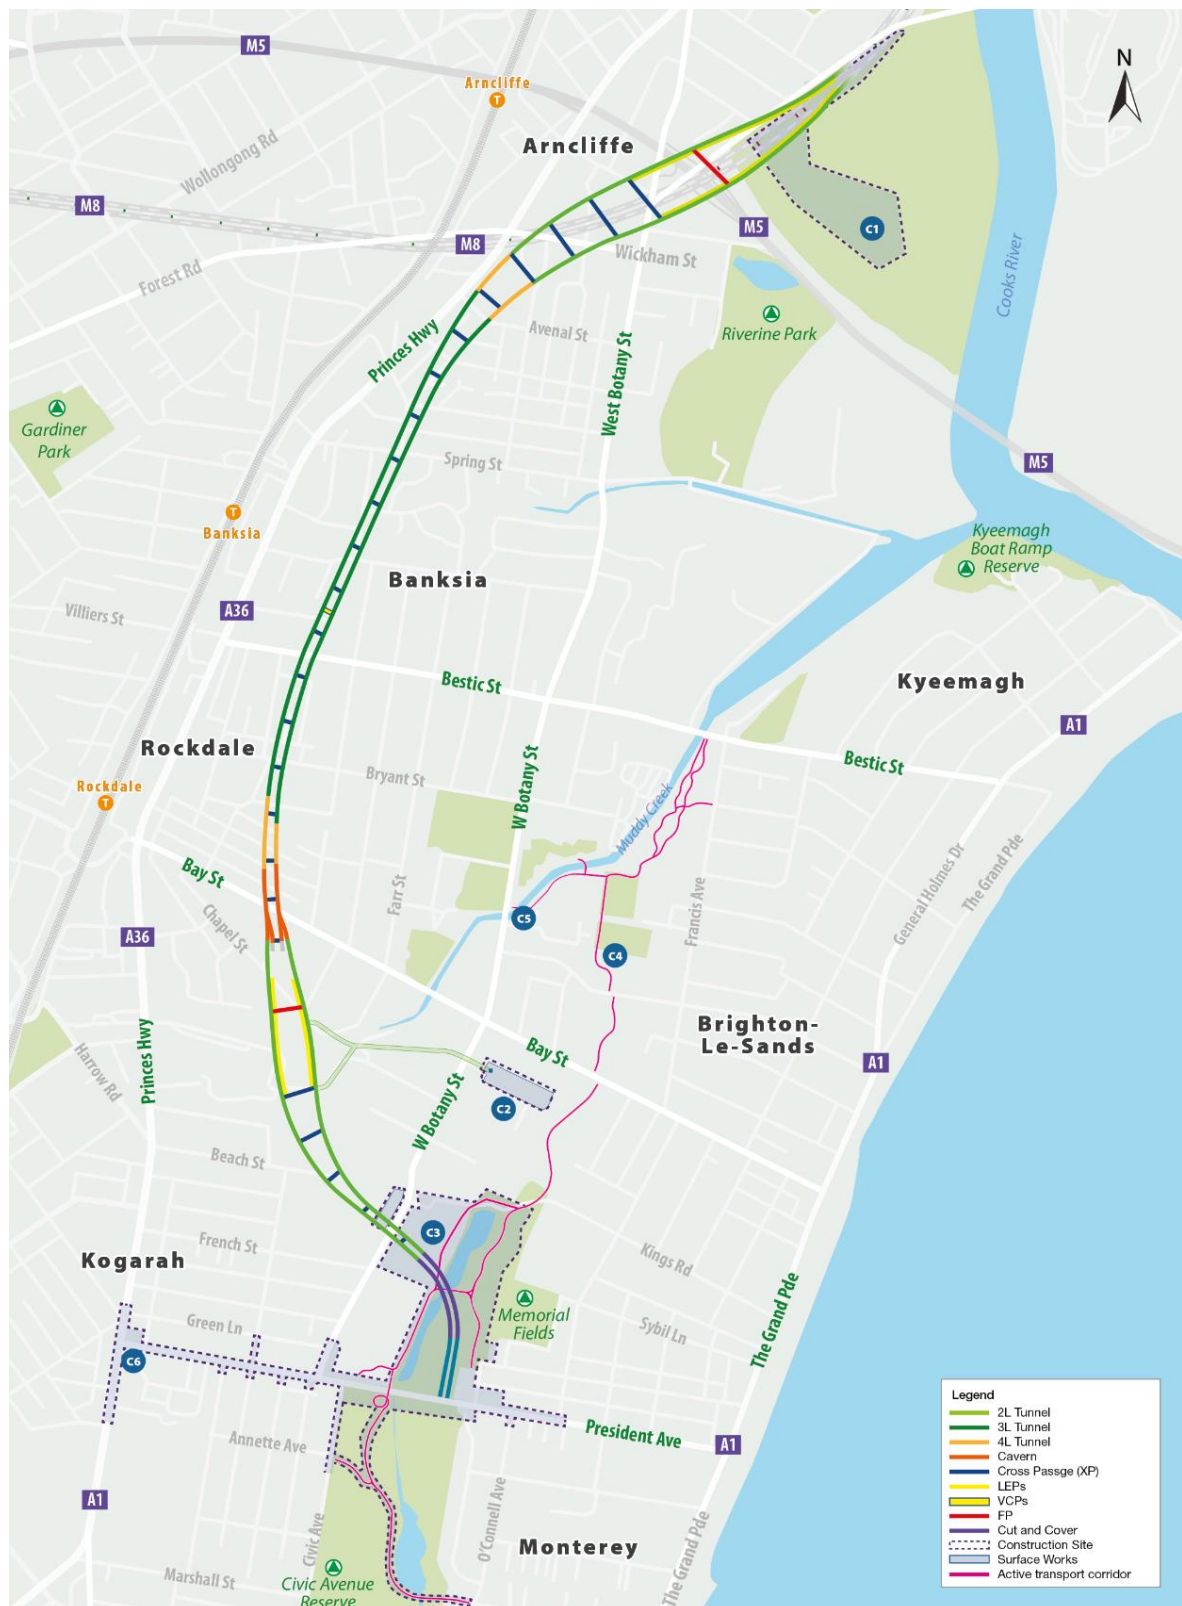
Figure 1.1: Concept Design for the M6 Stage 1. Image provided by CGU.

The M6 Stage 1 will be a new Motorway tunnel linking the recently constructed M8 Motorway in St Peters with President Avenue, Kogarah (Figure 1.1). The northern end of the M6 Stage 1 will be underground at Arncliffe. A 4-kilometre, multi-lane tunnel will connect existing underground “tunnel stubs” to Bicentennial Park in Rockdale. The tunnel will surface on the eastern side of Bicentennial Park, with on and off-ramps passing through Bicentennial Park to a new intersection to be constructed on President Avenue.

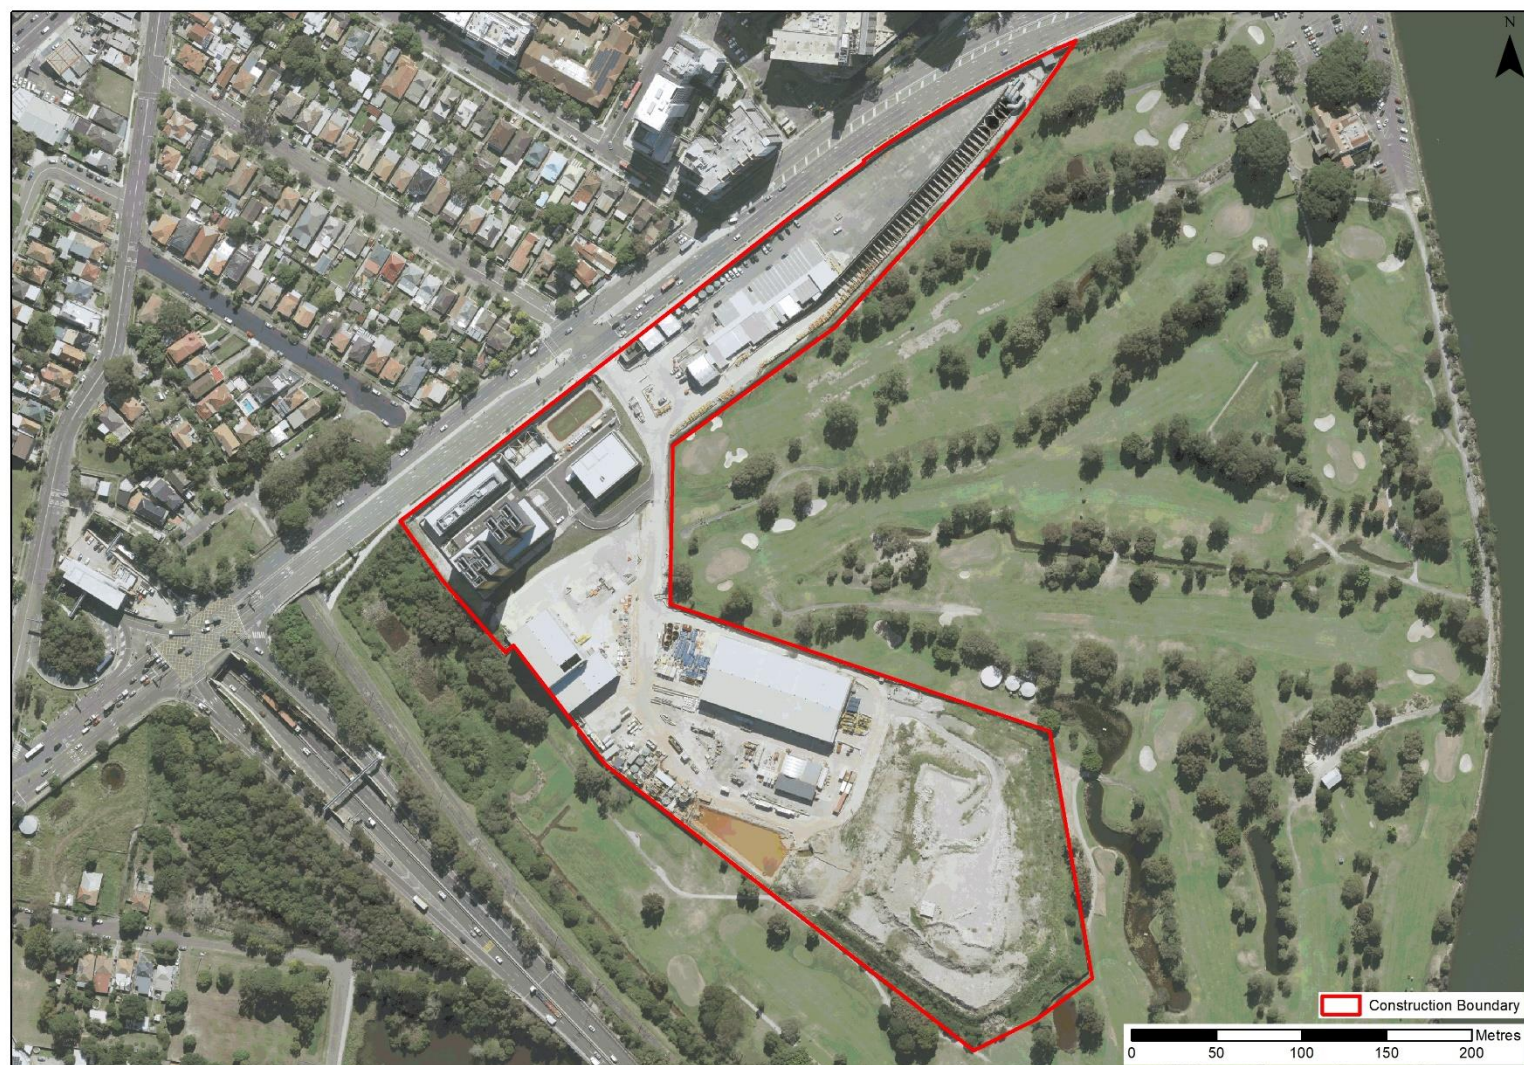
Figure 1.2: Existing site compound at Arncliffe. Image provided by CGU.

A number of “construction compounds” will be needed on the surface in order to complete the work. One of these will be located in Arncliffe, within Kogarah Golf Course. The Arncliffe construction compound will be located within the same construction compound that was established in 2016 for the construction of the M8. This area currently contains site offices, stockpiles, temporary construction facilities, a car park and permanent infrastructure associated with the operation of the M8. The location of the Arncliffe construction compound is shown on Figure 1.1 as “C1” and an aerial image of the site is shown on Figure 1.2.

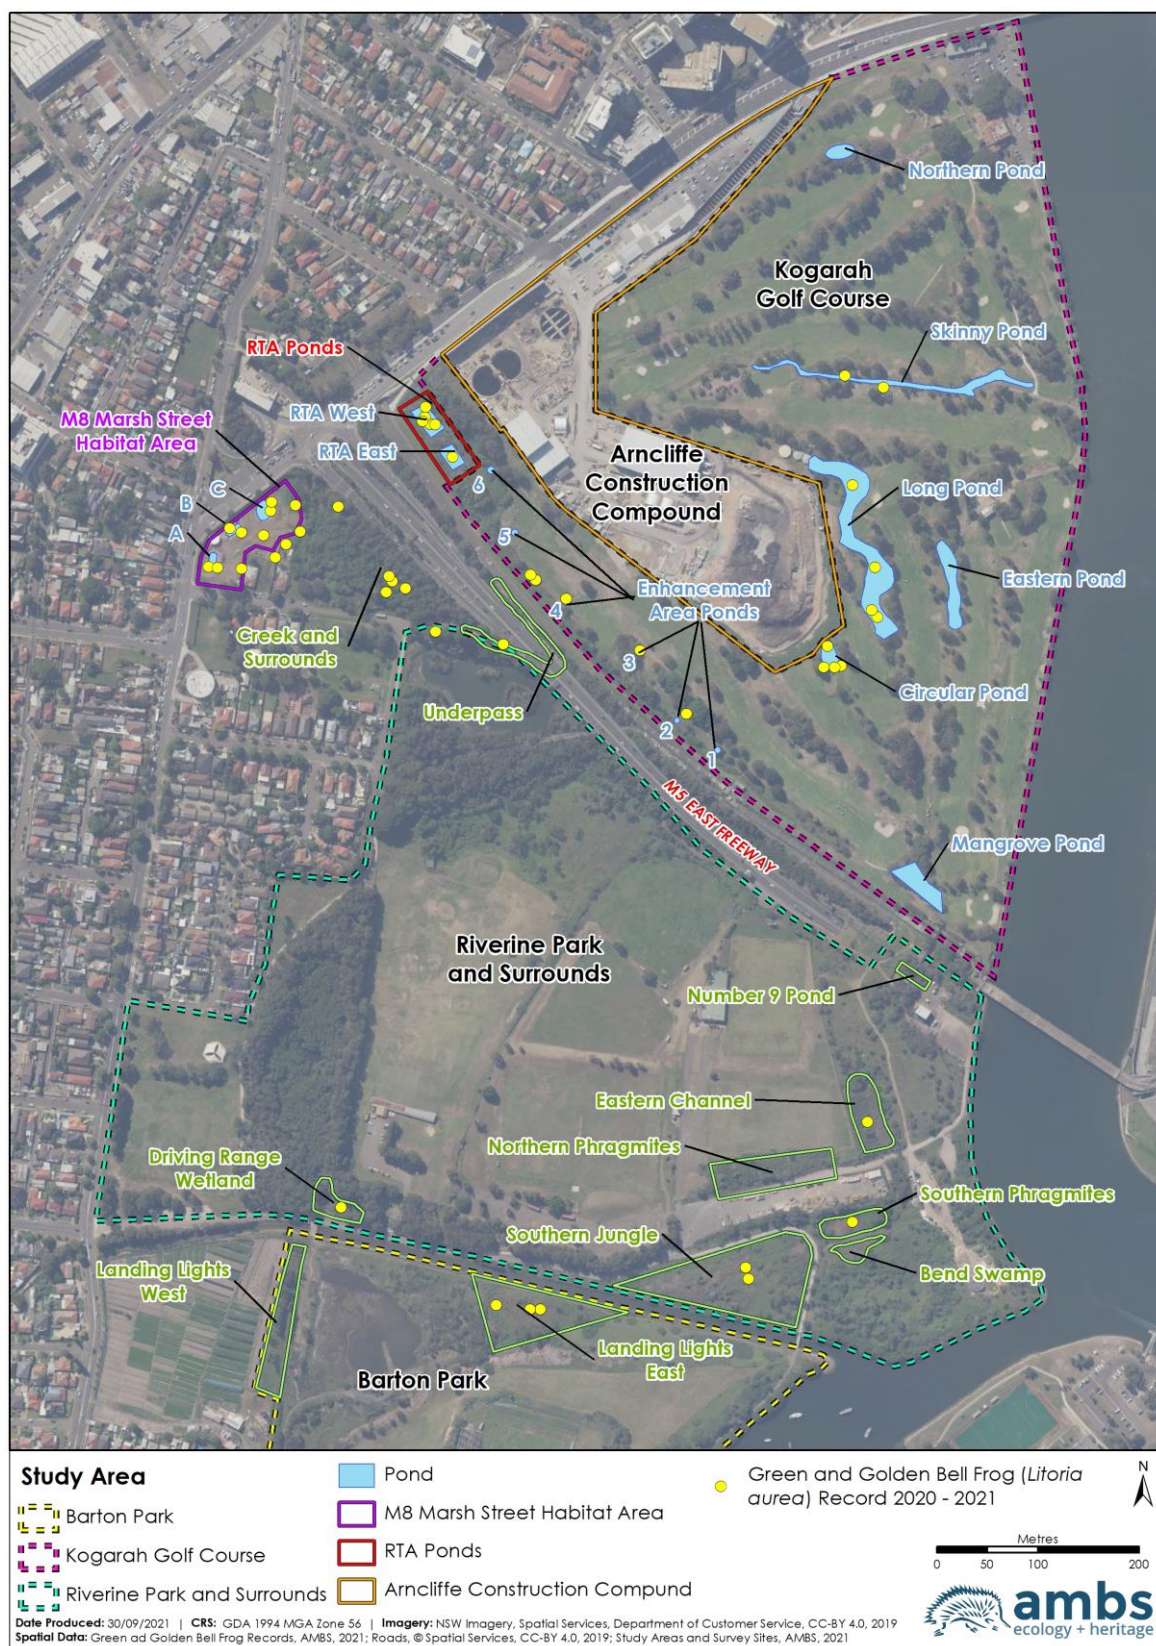
Figure 1.3: Locations where GGBFs were recorded between January 2020 and May 2021.

Note 1: Each record represents a number of sightings.

Note 2: Surveys were not undertaken in the Northern Phragmites or Number 9 Pond in 2020-2021 due to access limitations.

Responsibility for the monitoring of the Arncliffe GGBF population will rest with TfNSW (with two exceptions, being GGBF use of the Enhancement Area and the underpass). This will include the monitoring of the M8 Marsh Street habitat area, the RTA ponds, and GGBF use of other selected ponds and wetlands on Kogarah Golf Course, Riverine Park and surrounds, Barton Park, and the Creek and surrounds (Figure 1.3).

1.3	GGBF have recently been observed on other parts of Kogarah golf course (Figure 1.3) so monitoring of water bodies in parts of the golf course other than the Enhancement Area should also be undertaken.	Monitoring of GGBF use of water bodies in parts of the golf course other than the Enhancement Area will be undertaken by TfNSW.
