| Plan of: | Metford Rehabilitation Domain Areas | Location: | Metford Clay Mine Metford Rd, Metford NSW 2320 | Source: | Contours updated by GPS 22/5/07 Boundaries Monteath & Powys | Our Ref: | V:\Jobs_MT\2013\ClosurePlan\Figs\CPMOPMT.cdr |
| Figure: | Nine (MT13A) | Council: | Maitland City Council | Survey: | AAM Hatch 27/2/06 | Plan By: | LGT |

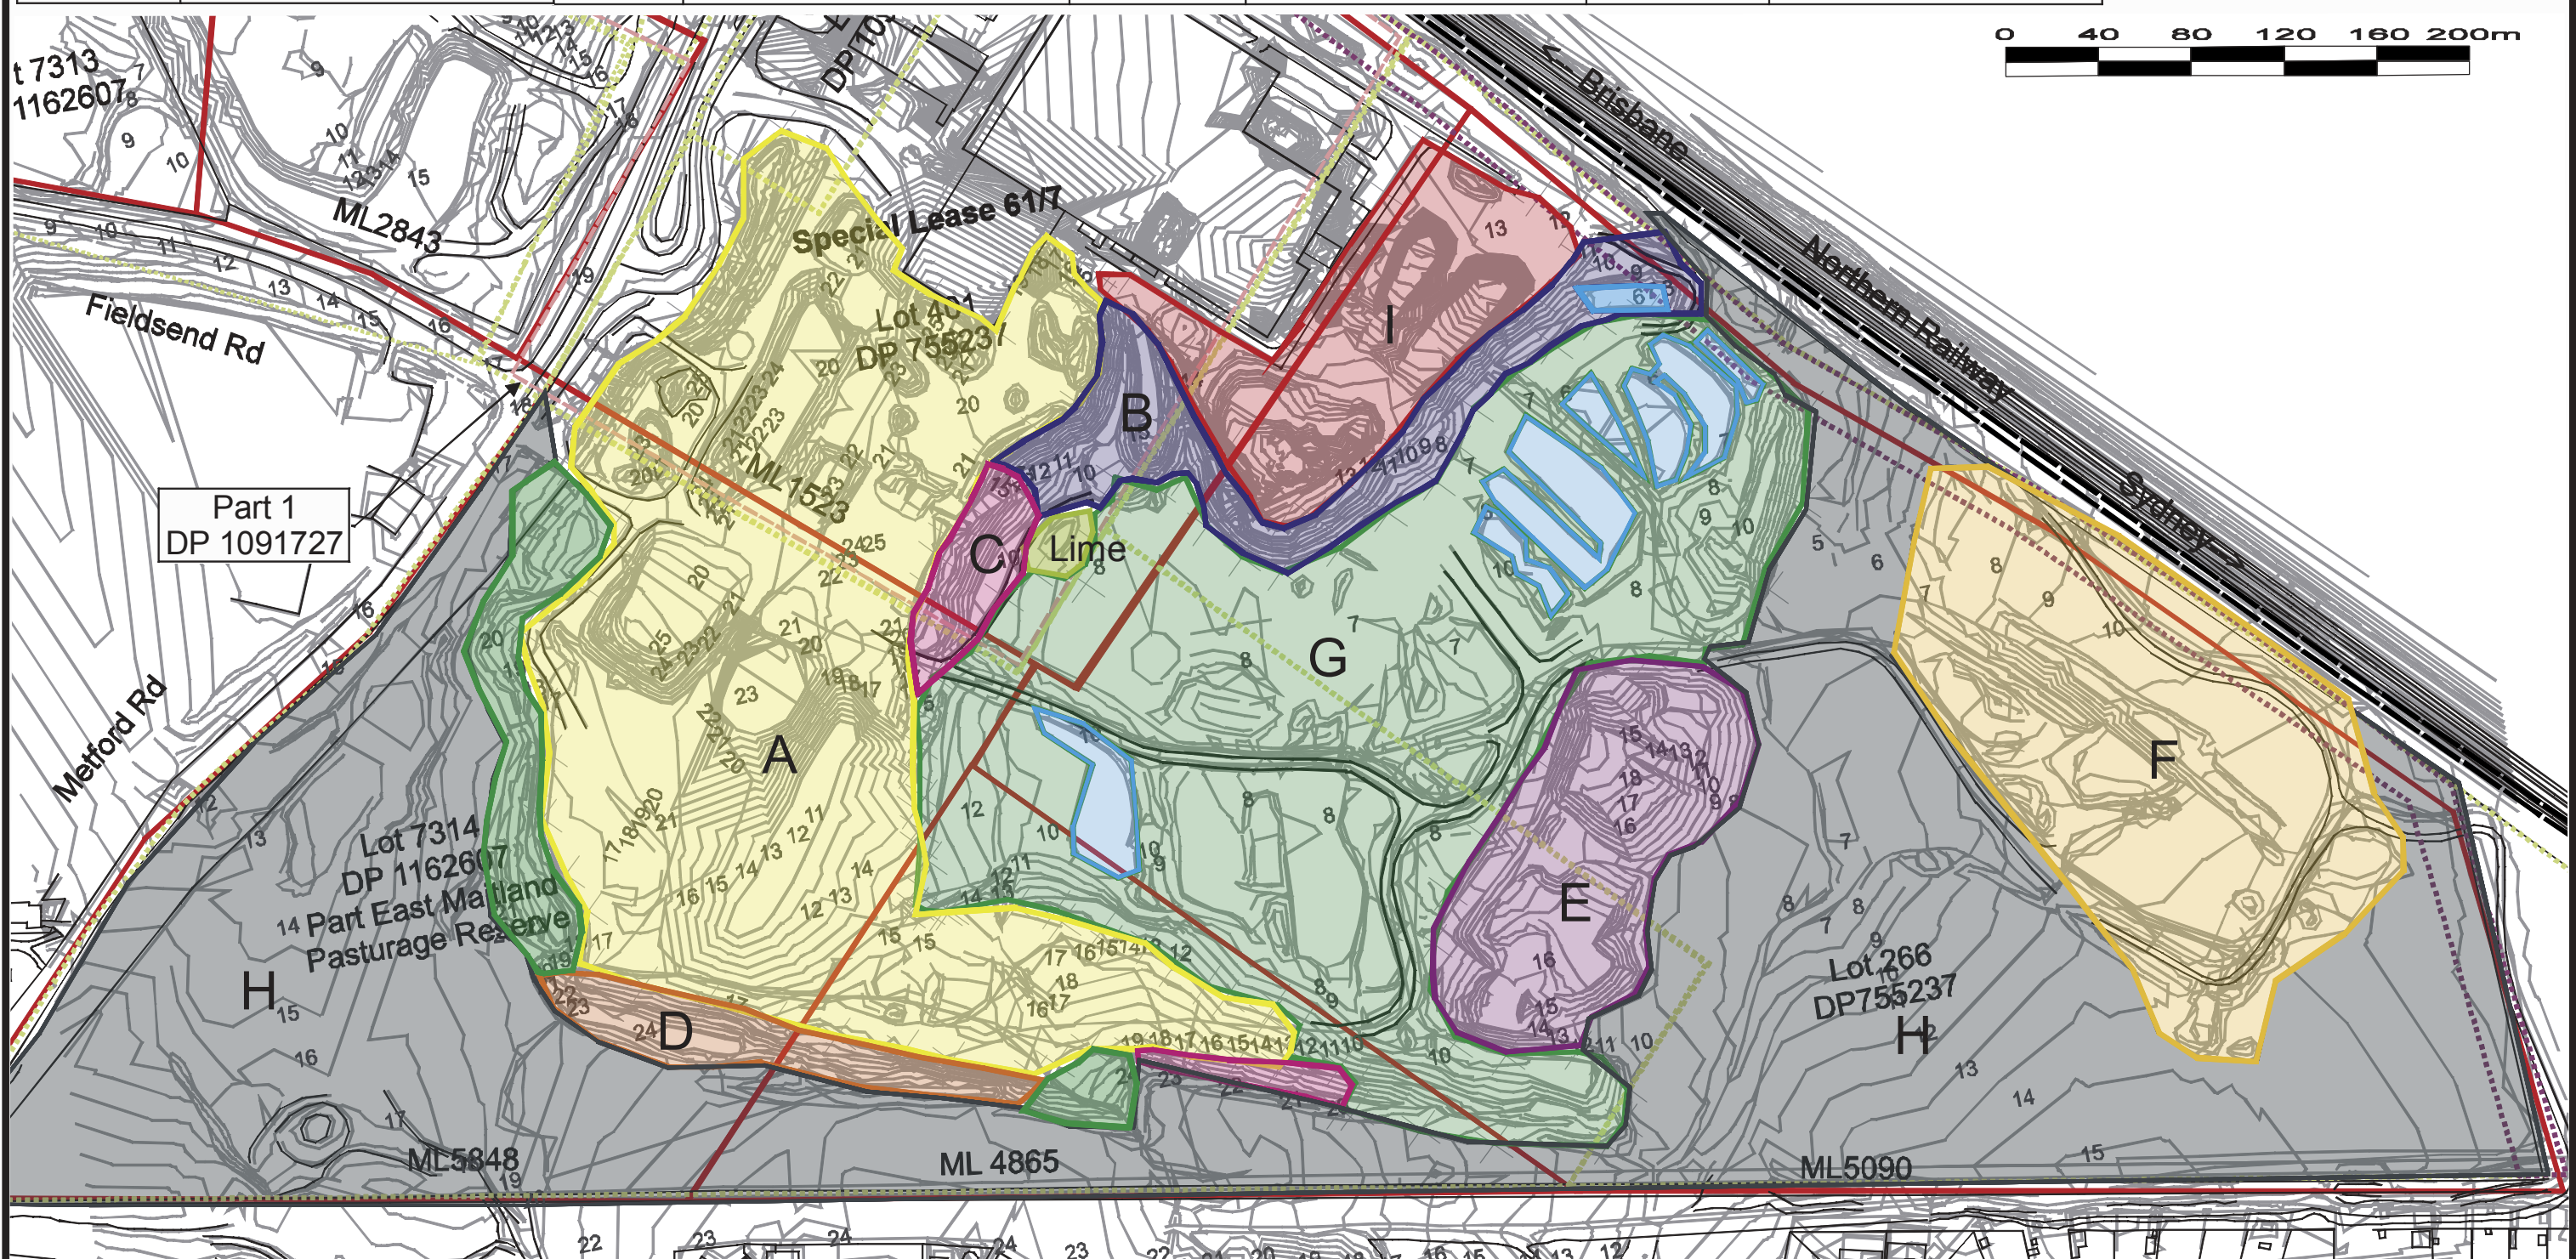
| Legend | | | | | | | |
|---|---|---|---|---|---|---|--|
| Domain A | Disturbed floor and stockpiles. <u>Action:</u> Fill in low lying areas with stockpile materials, shape to self-drain and apply grasses. | Domain C | Natural steep face with good vegetation. <u>Action:</u> Risk assess to potentially leave | Domain E | The Hill- mix of natural and carbonaceous shale stockpiles, vegetated. <u>Action:</u> None | Domain G | Mixed revegetated land and shallow water bodies. <u>Action:</u> Build access tracks for potential pedestrian use. |
| Domain B | Construction & Demolition batter with some vegetation and some steep slopes. <u>Action:</u> Survey, batter back slopes to 3:1 with available material, apply grasses to disturbed faces. | Domain D | Vegetated bund wall atop steep natural slope. <u>Action:</u> Use existing stockpiles, batter face to 3:1, apply grasses. | Domain F | Mostly revegetated with some aggregate stockpiles. <u>Action:</u> Pick out aggregates and apply grasses to disturbed areas | Domain H | Natural <u>Action:</u> None |
| | | | | | | Lime | Lime stockpile <u>Action:</u> Lime will be mixed with soil to assist with revegetation. |
