Biala wind farm photomontage and the subsequent Visual Impact rating.

Photomontage comparison

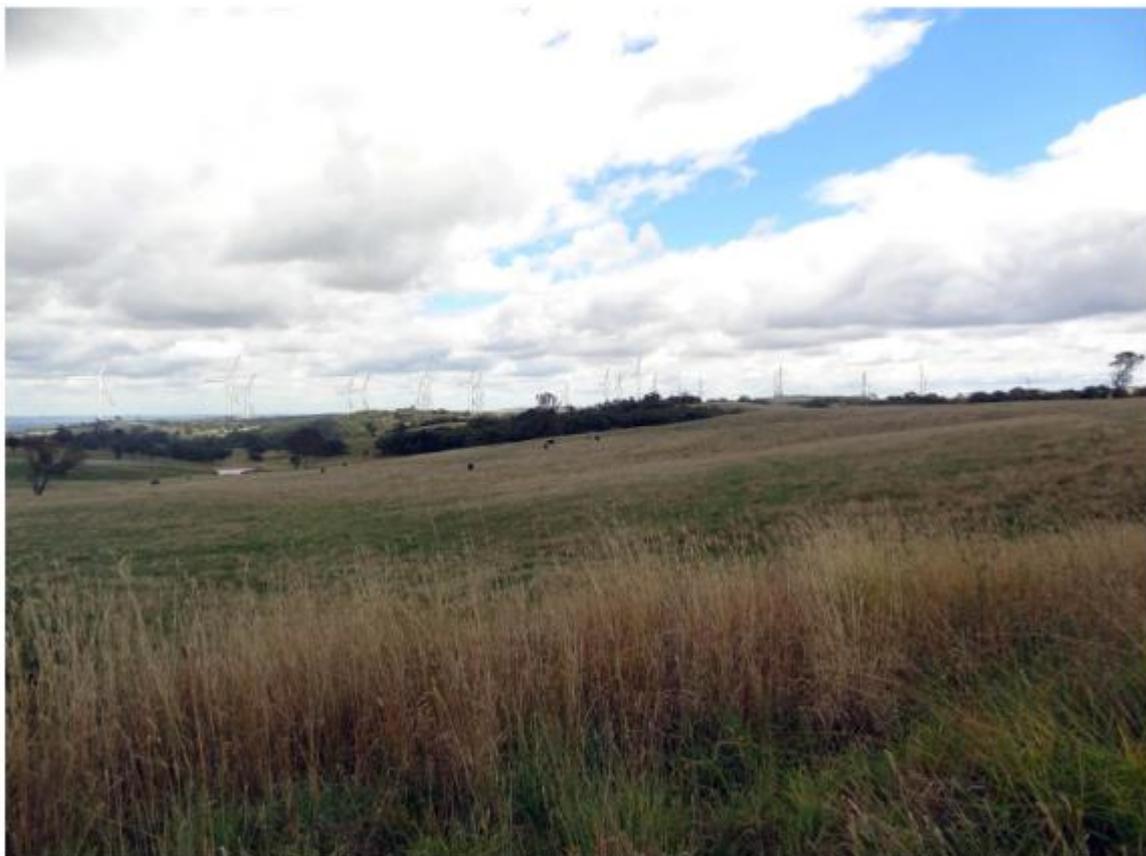
The following photomontage was displayed at the Biala open day in January and is available from the Newtricity web site.

They would appear to be the same photo, cropped and magnified, yet they are obviously different in other respects. There are startling differences in the contrast and overall visibility of the turbines. This is an example of misleading and inconsistent information being provided by the proponent in relation to potential visual impact. It does not inspire any confidence about the accuracy of any other information they have provided

The tallest single tree in the centre of photo 1 is at the right edge of photo 2, so you can see that there are 12 or so turbines to the north cropped from the photo used at the open day and an additional 2 turbines appear in the left half of the LVIA photo.

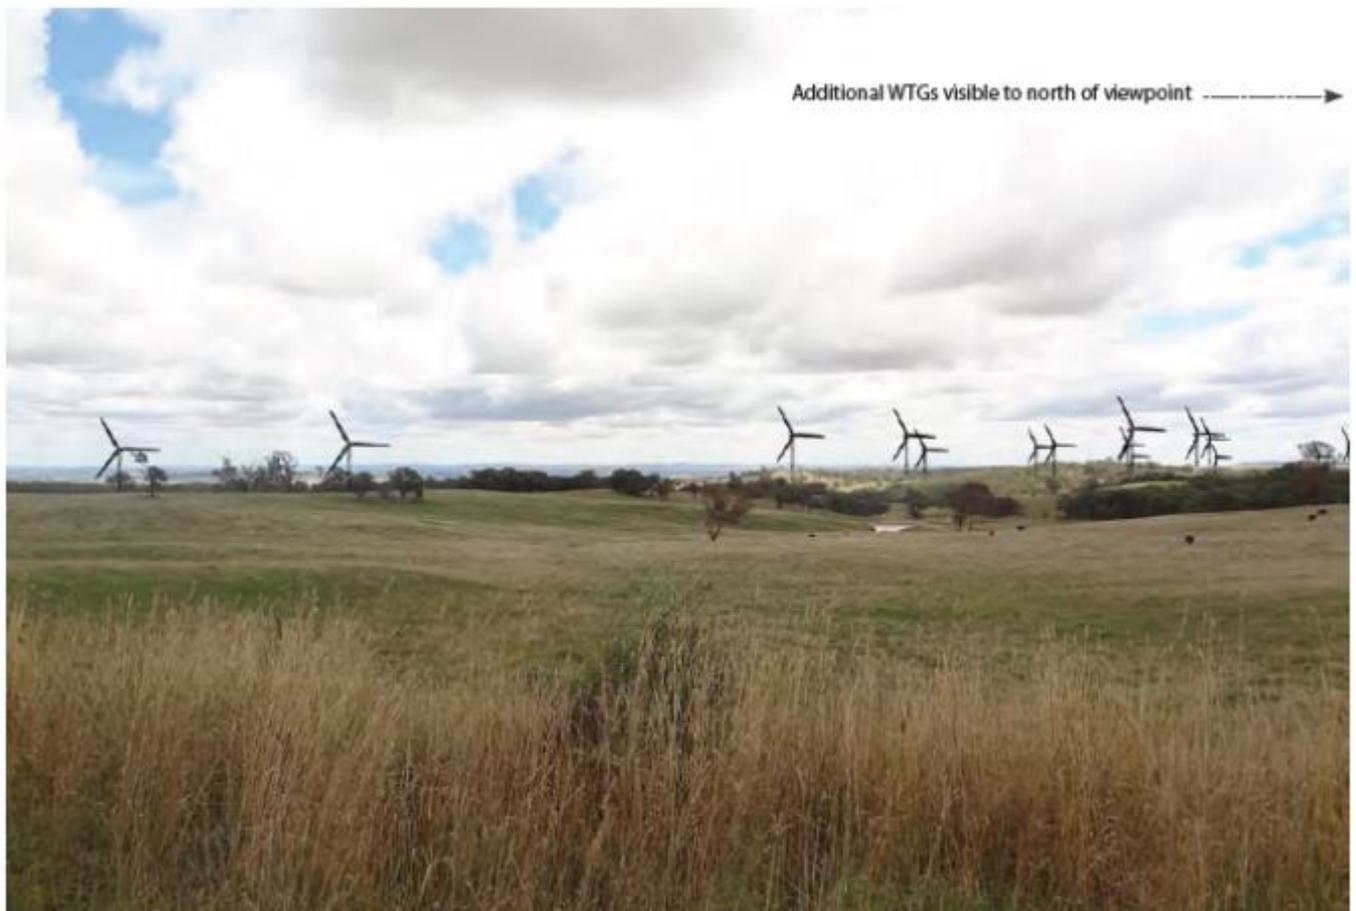
The one below is from Biala LVIA, Page 52.

Neither of these two photomontages, as published by the proponent, provides anywhere near a true assessment of the colossal Visual Impact that 185 metre high turbines, located only 1.7 kms away from the viewpoint will inflict.
