New Grafton Correctional Centre – Environmental Impact Statement

Submission New Grafton Correctional Centre Environmental Impact Statement

# Submission New Grafton Correctional Centre Environmental Impact Statement Barry & Sarah Fletcher

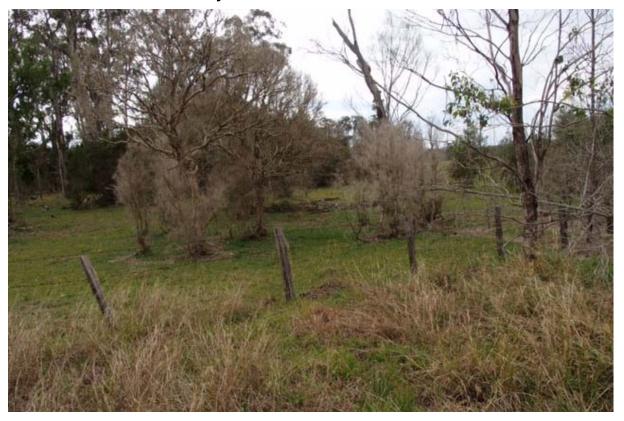
It is of particular interest because some of the identified threatened species (Melaleuca irbyana) as well as other native species in the small area adjacent to the drain delivering storm water from the Project Site under Avenue Road are dead and appear to have died recently.

Photo 1 Dead Melaleuca Irbyana and other trees

There is the possibility that any contaminants that may have been present in the soil have been mobilised and moved into the adjoining property after rainfall events between the time of the excavations and the present, resulting in the death of these trees

All the above suggests that there may well be chemical residues including pre-emergent herbicide still present and active in the soil from a little north of the area opposite Wants Lane towards the north and up to the northern boundary and that any further soil disturbance may mobilise these chemicals further, if indeed they are present, enabling them to move with the surface water or leach out and beyond the boundary of the Project Site.

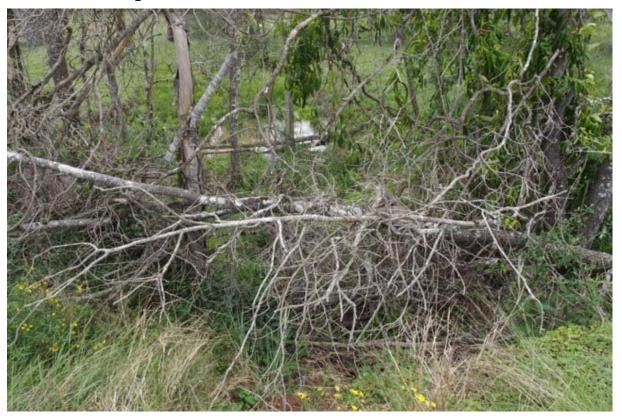
The second which is of particular interest and it is assumed, the one to which page 55 refers, is some 450 meters south of the northern boundary and a little to the east of the Project Site adjacent to a drain outlet directing surface water from the Project Site under Avenue Road.

Photo 2 Ponding & dead tree at drain exit.

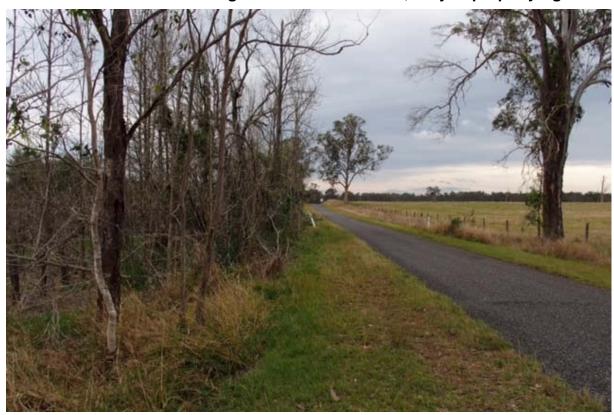
Photo 3 Avenue Road looking south. Dead trees left, Project property right.

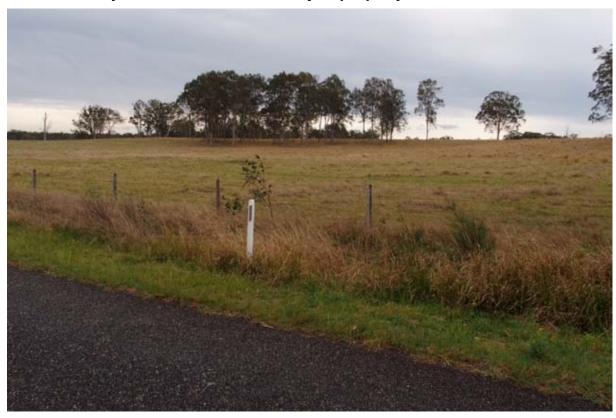
The contour plan (Figure 3-2, page 16, Appendix G) suggests that surface water moving downslope in Lot 26 where the excavations are located would travel along the ephemeral watercourse that finds its way to the drain passing under Avenue Road.

Photo 4 Entry to under-road drain. Project property & catchment area.

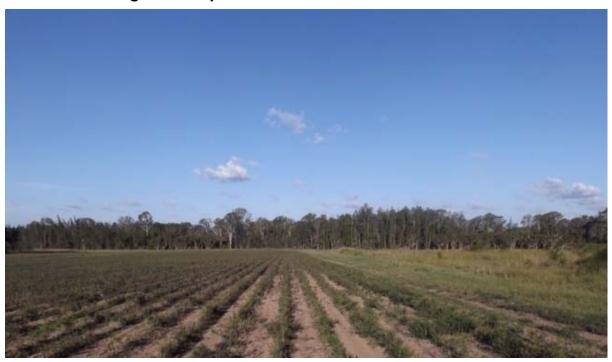
On the eastern side of the Project Site less than 200 metres downslope from Avenue Road in Lot10 DP 1205749 and Lot 11 DP 120549 a tea tree plantation has been established. When planting is completed within the next two years it will occupy over five hectares. Any contamination moving downslope from the Project Site, as detailed above in relation to the threatened species of weeping paperbark will be a serious threat to the viability of the plantation.

Photo 5 Existing Tea tree plantation
