Planisphere Technical Guide View 10 (extended) DCP View 5 (extended)

View looks south east towards Parramatta CBD across Parramatta Park.

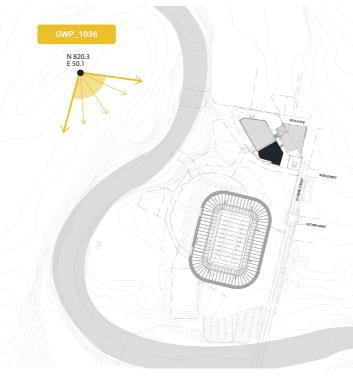
C_03

Planisphere Technical Guide View	10
Relevant conservation agreement height controlled view from DCP fig. 4.3.3.7.7	5
Compliance Achieved

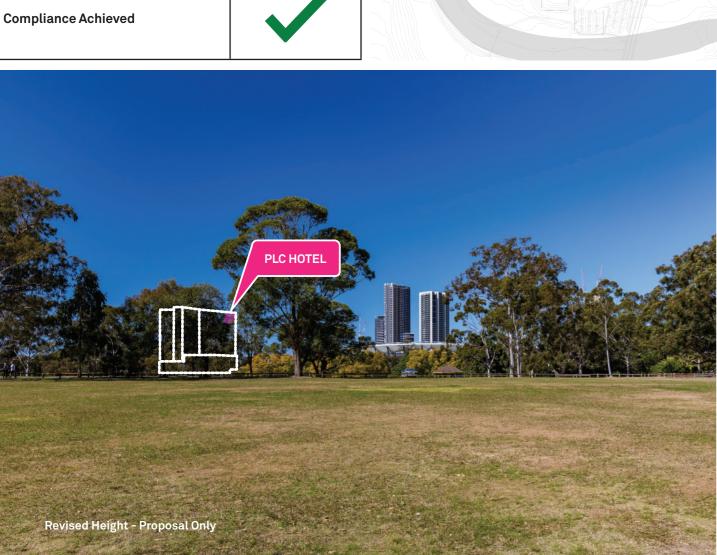
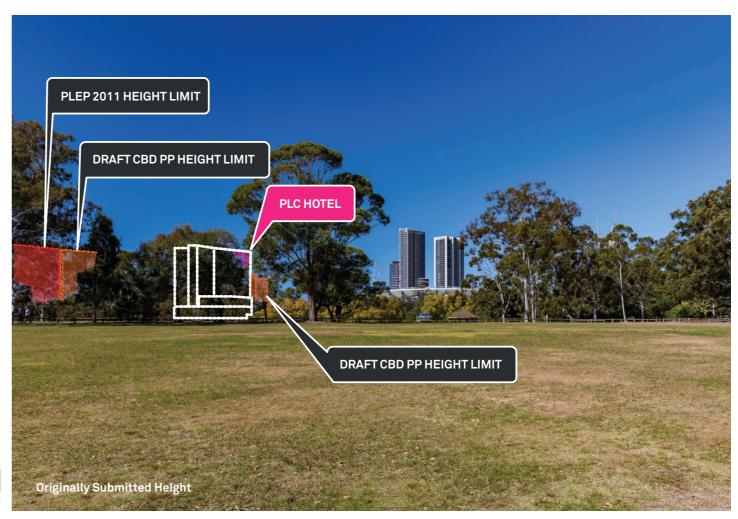
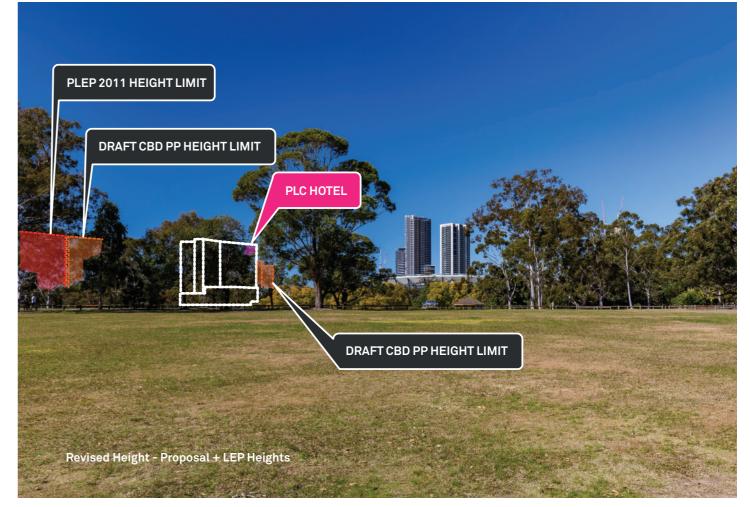
IDENTIFY THE PROPORTION (%) OF THE BUILDING CONTAINED BELOW THE LEVEL OF THE SURROUNDING TREE CANOPY OF PARRAMATTA PARK

95%

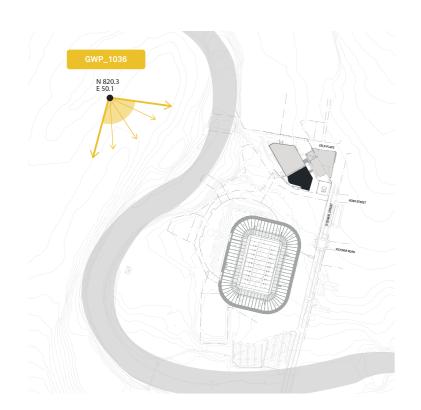
C_03

Planisphere Technical Guide View 10 (extended) DCP View 5 (extended)

View looks south east towards Parramatta CBD across Parramatta Park.

Compliance Achieved

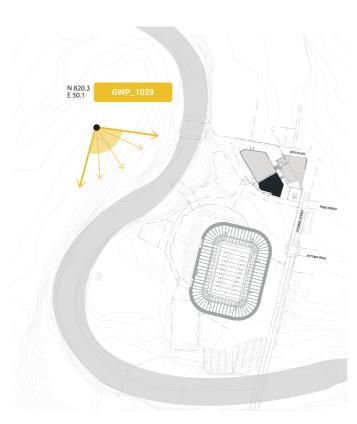
C_04

Planisphere Technical Guide View 10 DCP View 5

View looks south east across open grass to existing treeline behind the historic dairy building.

Planisphere Technical Guide View	10
Relevant conservation agreement height controlled view from DCP fig. 4.3.3.7.7	5
Compliance Achieved

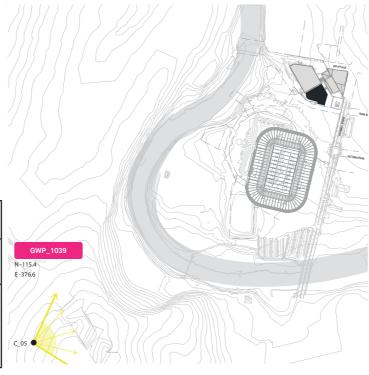
C_05

Planisphere Technical Guide View 16

View looks north-east across Parramatta Park towards the Parramatta CBD.

Compliance Achieved	
Relevant conservation agreement height controlled view from DCP fig. 4.3.3.7.7	N/A
Planisphere Technical Guide View	16

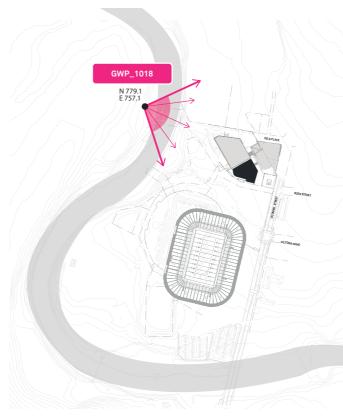
C_06

PNHS CMP View 6

View from Little Coogee Walk.

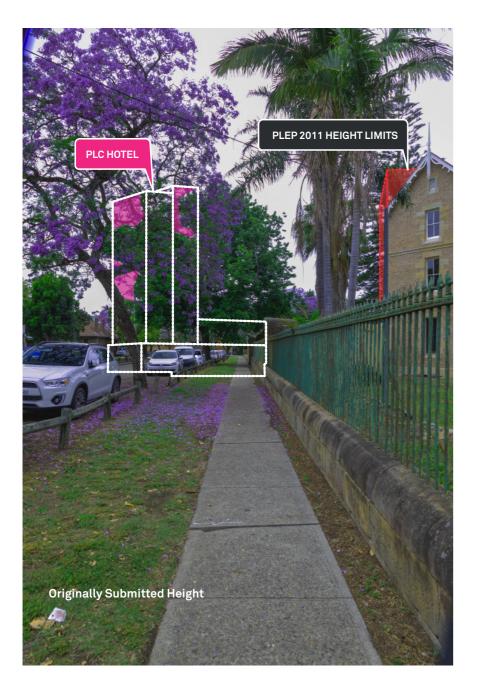
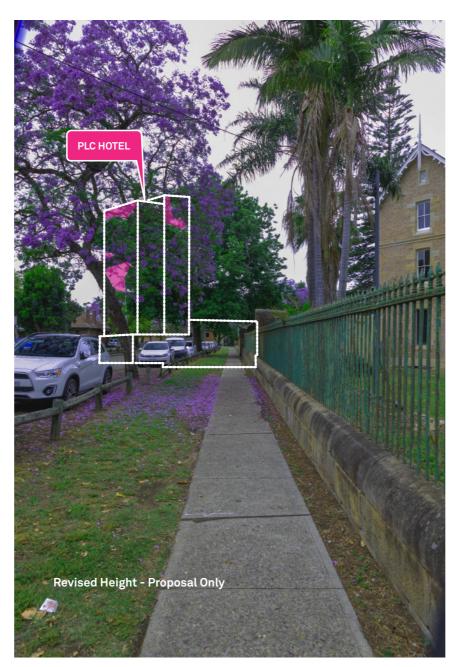
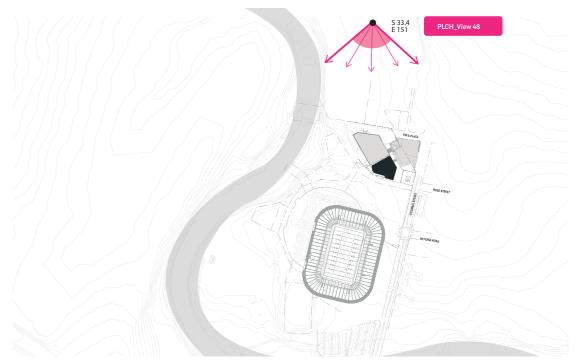
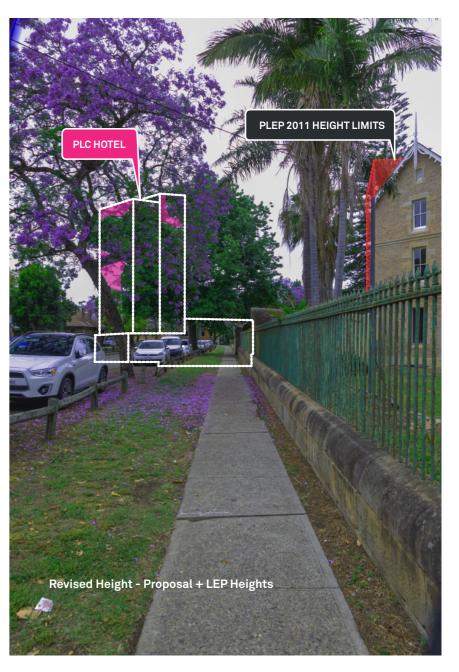
C_07

View from within Norma Parker Centre/Kamballa site between main building and the Superintendents Garden.

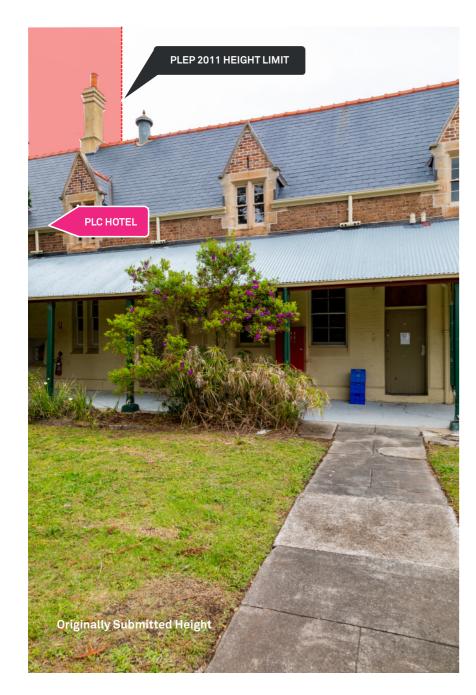
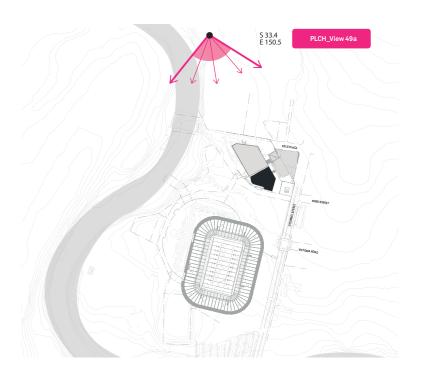
C_08

View from within Norma Parker Centre/Kamballa site - internal courtyard.

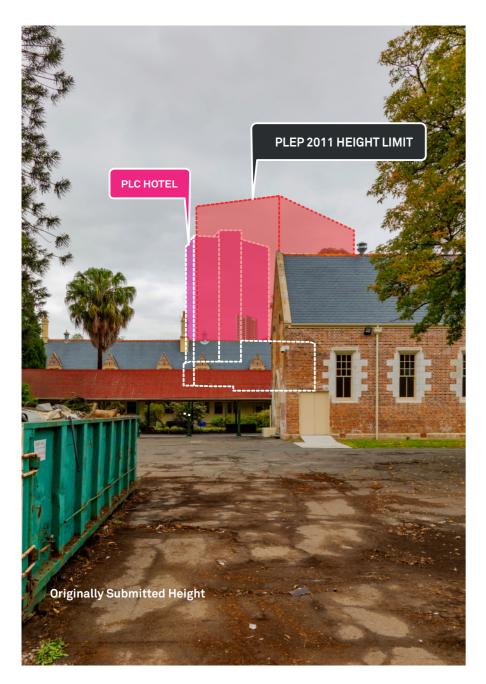
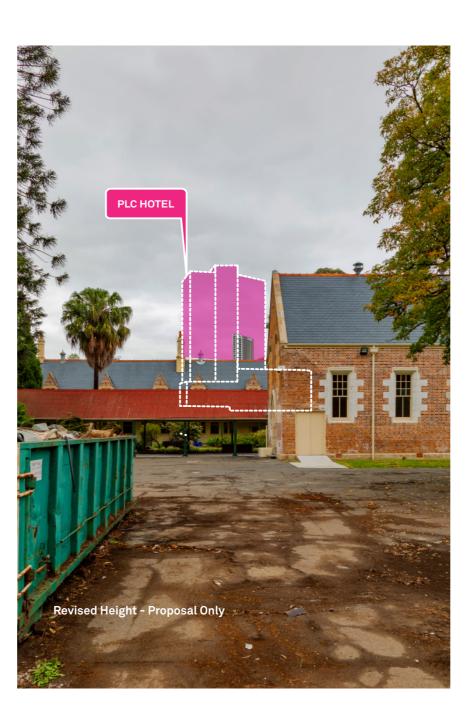
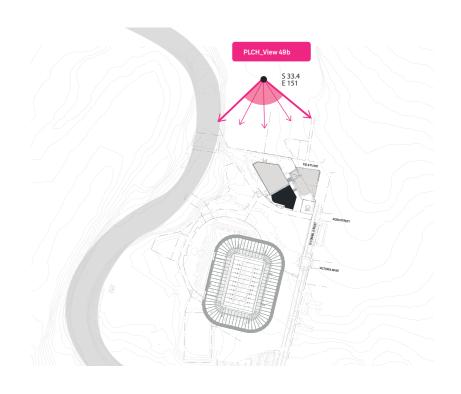
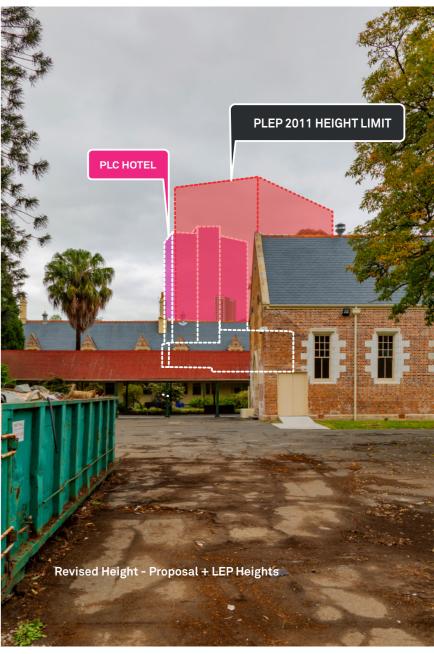
C_09

View from within Norma Parker Centre/Kamballa site - main complex courtyard.

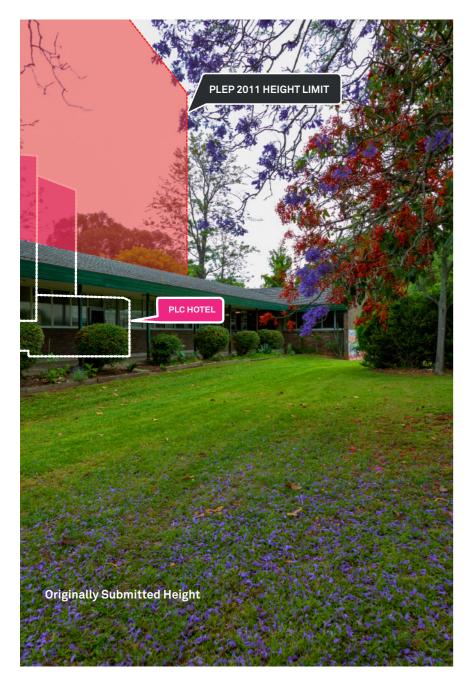
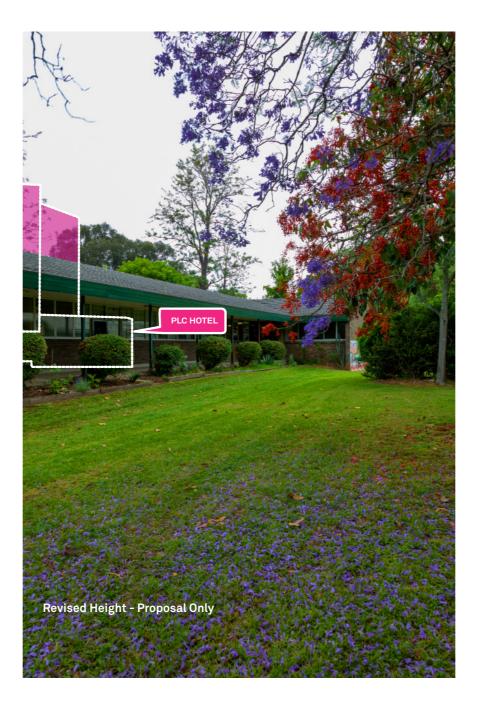
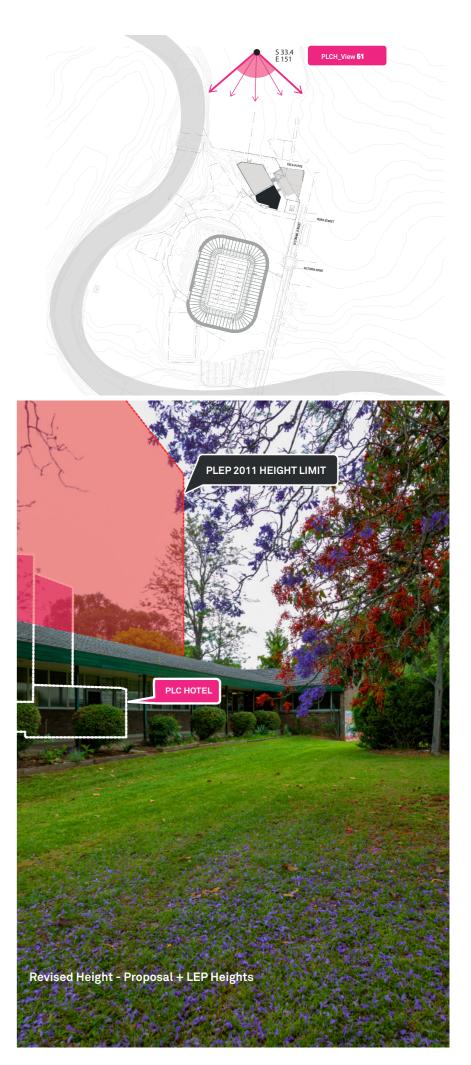
C_10

View from within Norma Parker Centre/Kamballa site - enclosed yard of Bethel House.

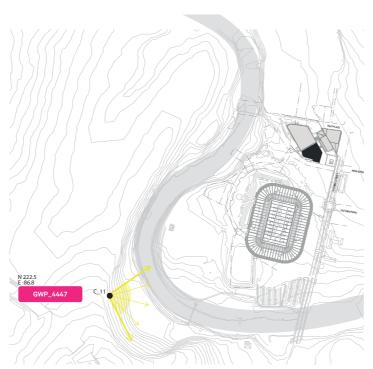
C_11

Planisphere Technical Guide View 9

View towards Parramatta CBD from Northern Crescent steps at location marked.

Compliance Achieved	/
Relevant conservation agreement height controlled view from DCP fig. 4.3.3.7.7	N/A
Planisphere Technical Guide View	9

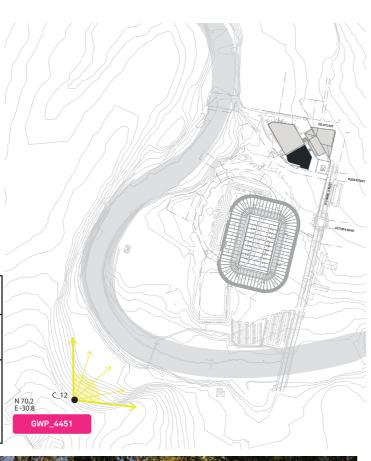
C_12

Planisphere Technical Guide View 4

View to the rear of Old Government House from Crescent North

Planisphere Technical Guide View	4
Relevant conservation agreement height controlled view from DCP fig. 4.3.3.7.7	N/A

Compliance Achieved

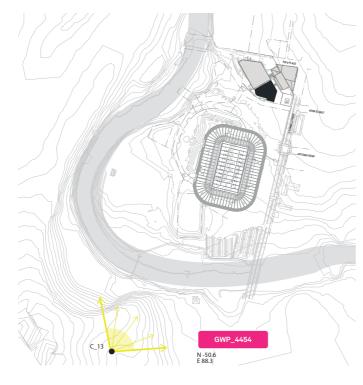
C_13

Planisphere Technical Guide View 2

View looking north east towards Old Government House at location marked.

Compliance Achieved	
Relevant conservation agreement height controlled view from DCP fig. 4.3.3.7.7	N/A
Planisphere Technical Guide View	2
