Typical Boardwalk Section

CHECKED BY:	DAT	CLIENT:	SEAWIDE PTY LTD & MILLAND PTY LTD				
					DATE CREATED:	JULY 2010						
							DRAWING NO:				SHEET:	REVISION:
							14898_Exhibit_6_PA_Rainforest_Walk_Sh2.psd				1	A

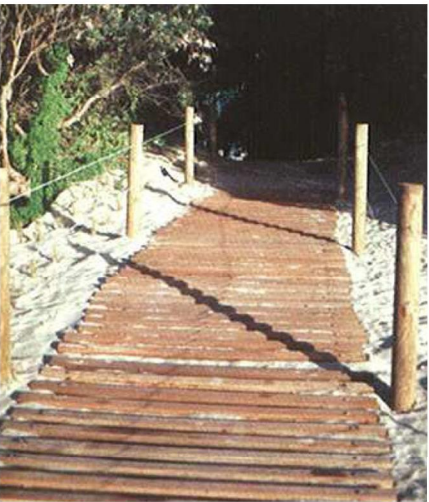
Board and chain accessway (Coastal Dune Management, NSW Government 2007)

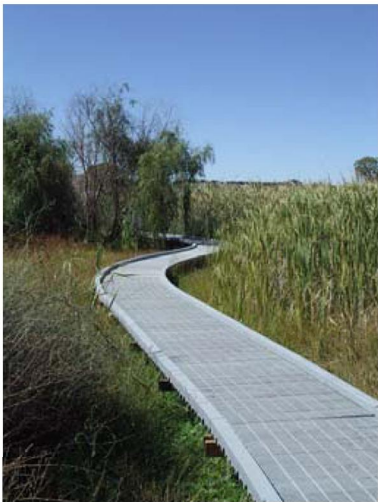
Boardwalk using Replas Enduroplank™

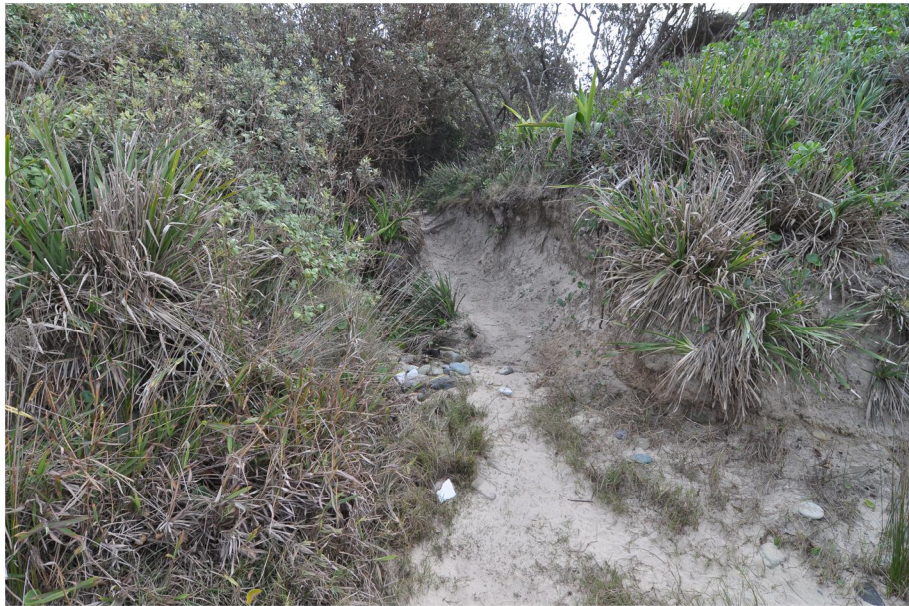
PHOTOGRAPHIC PLATE No. 1: Path access at beach. Some minor bank stabilisation required using Treemax Recover™ or equivalent and planting in accordance with Vegetation Management Plan (VMP)

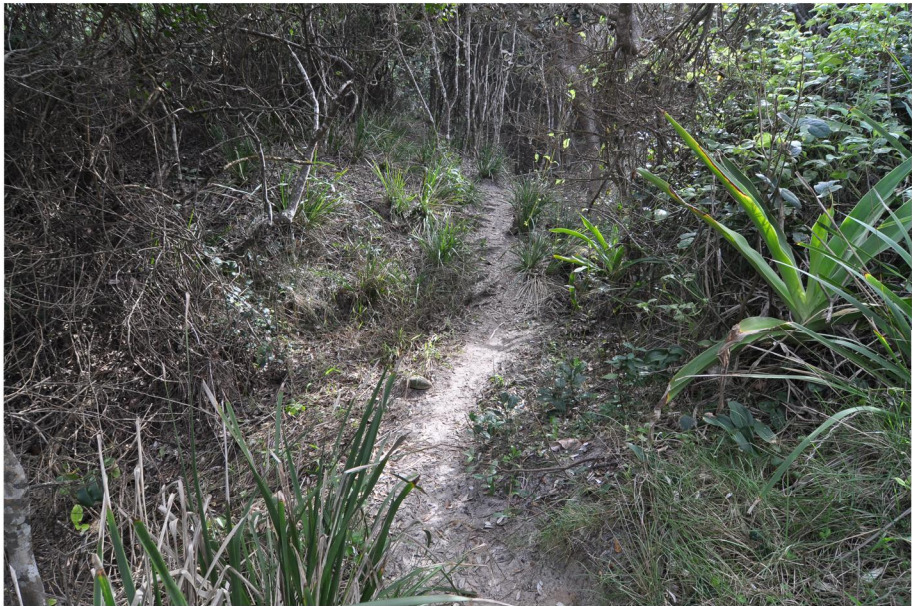
PHOTOGRAPHIC PLATE No. 2: Access path across gully. Boardwalk to board and chain accessway will transition at base of photo

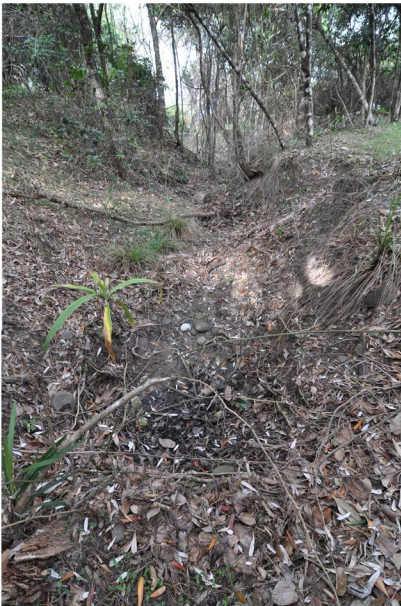
PHOTOGRAPHIC PLATE No. 3: Existing eroded minor gully to be rehabilitated - refer to Vegetation Management Plan (VMP)

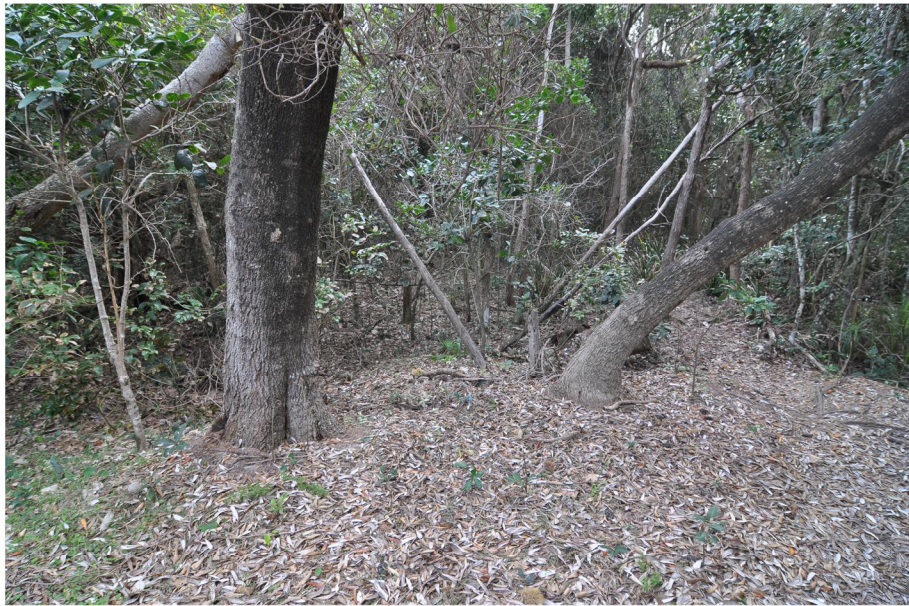
PHOTOGRAPHIC PLATE No. 4: Boardwalk to be aligned carefully between these two trees

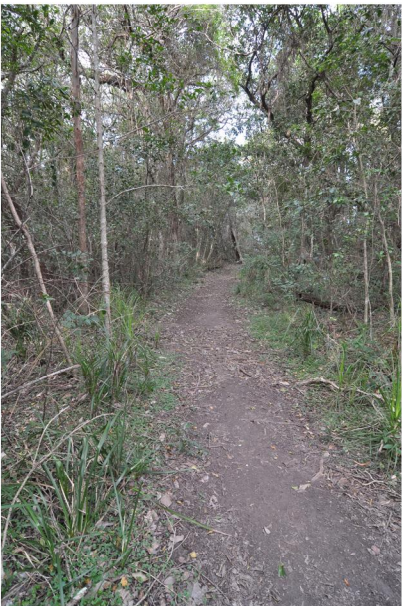
PHOTOGRAPHIC PLATE No. 5: Typical character and width of existing path access. The boardwalk is to be aligned along the path

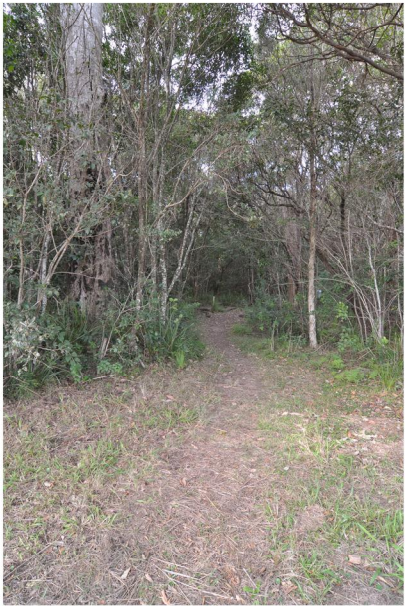
PHOTOGRAPHIC PLATE No. 6: Existing path entry into SEPP 26 Rainforest
