Environmental Management Plan

Pacific Pines, Lennox Head
Part 3A Approval MP_0026

Prepared for: The Royal Bank of Scotland
© GeoLINK, 2012

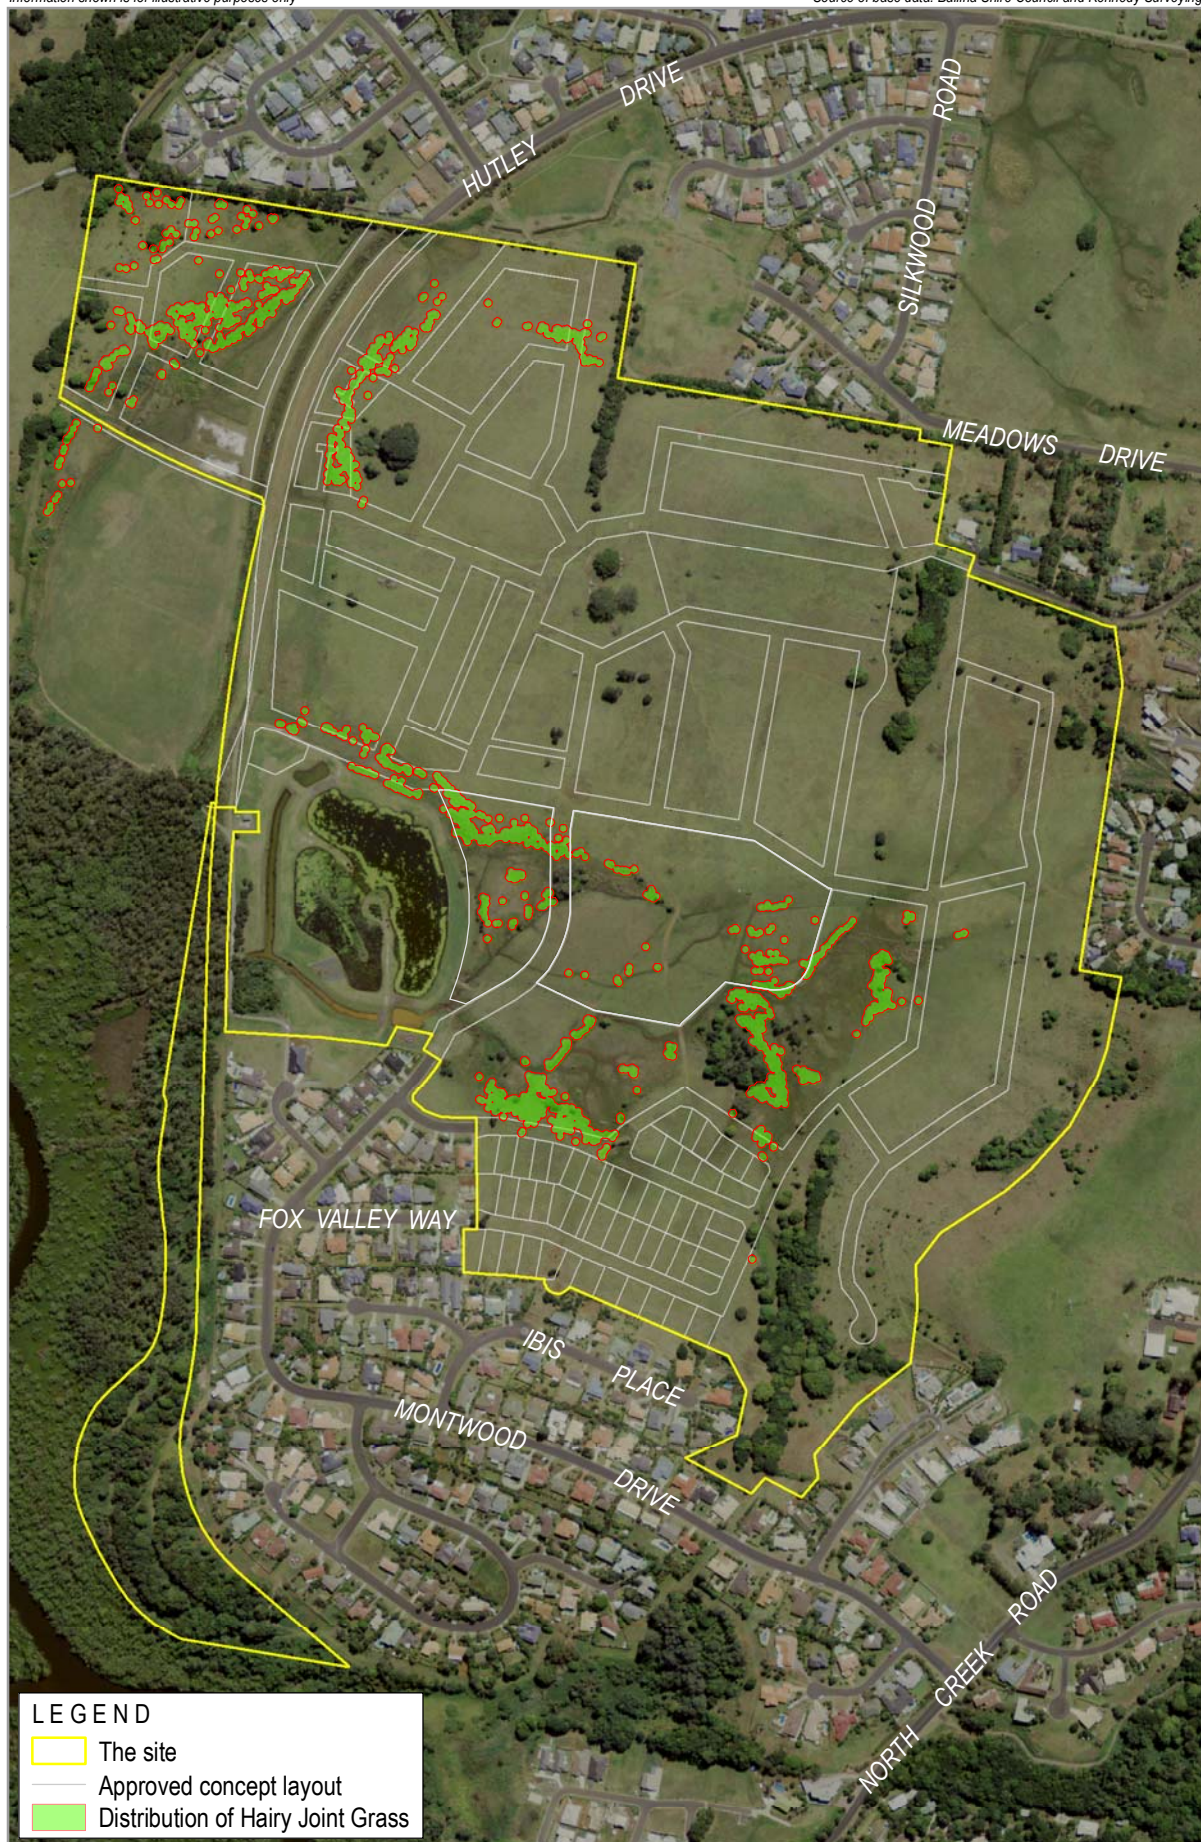
Illustration 3.1

Distribution of Hairy Joint Grass at the Site

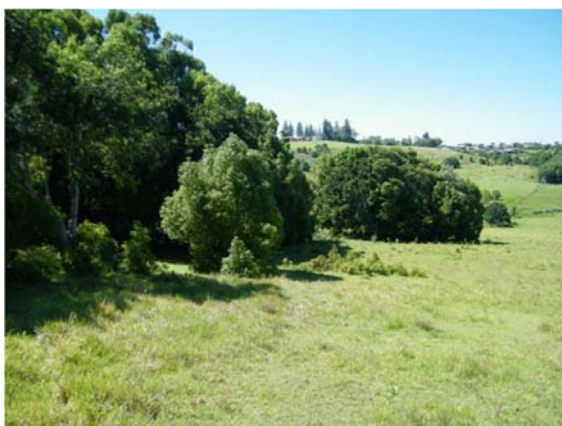
Plate 4.1 Littoral Rainforest / Camphor Forest at north-eastern end of Conservation Zone

The eastern end of this zone includes a relatively large area of littoral rainforest / Camphor Laurel forest, which is largely dominated by tall Guioa and Camphor Laurel trees. A number of threatened rainforest flora species are present within this remnant, including Rough-shelled Bush Nut, Arrow-head Vine and Red Lilly Pilly. Although native species are present in moderate abundance within the lower strata, vegetation in this area generally lacks the diversity of rainforest remnants occurring elsewhere on the site. A number of gaps, suitable for regeneration plantings are present towards the south of the zone.

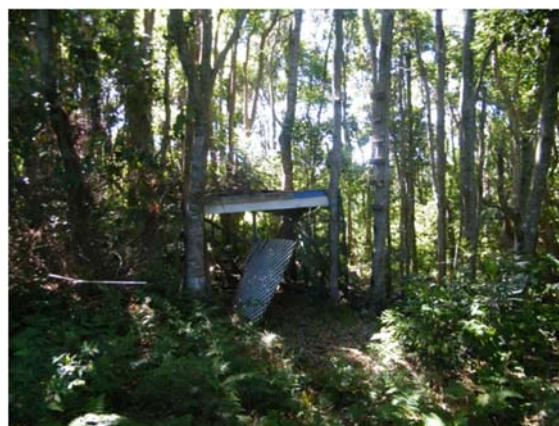
Plate 4.2 General rubbish occurring within the Littoral Rainforest

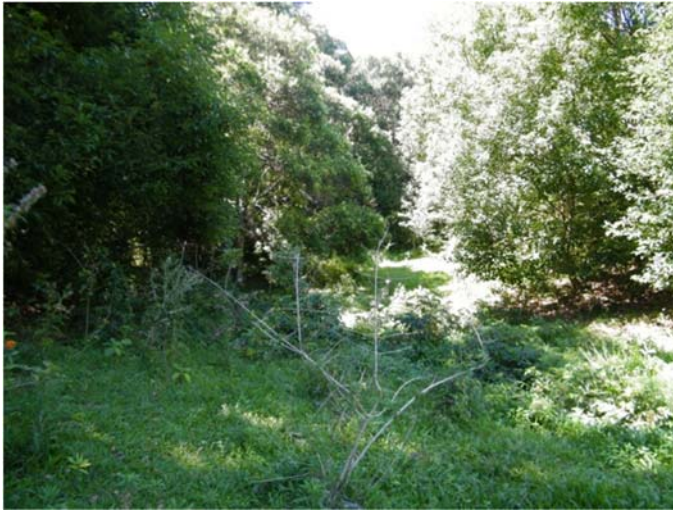
Plate 4.3 Drainage line running through the centre of southern Littoral rainforest area

Another area of littoral rainforest / Camphor-Laurel forest is located in the south-east corner of the Conservation Zone, occurring around a drainage line / ephemeral stream. Part of this drainage line, occurring along the southern portion of the zone, provides habitat for the endangered species, Square-stemmed Spike Rush. Areas surrounding the drainage line around the middle of the zone (refer to Plate 4.3) provide good locations for undertaking rehabilitation plantings to enhance vegetation within this zone. Native vegetation occurring within this zone is largely dominated by Tuckeroo and Guioa although there is a relatively diverse mixture of native species within the lower strata.

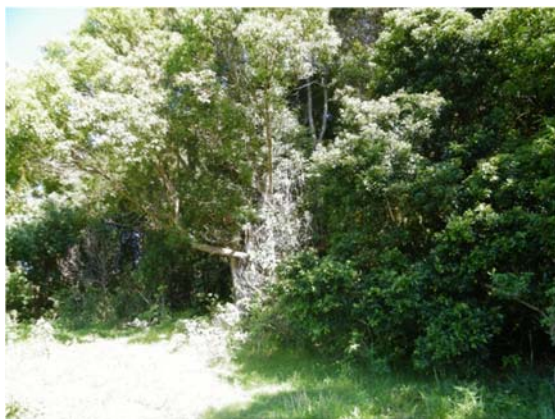
Plate 4.4 Littoral rainforest / Camphor Laurel forest remnant occurring in the north-west corner of the site

Existing native vegetation within Zone 1 includes a remnant of littoral rainforest / Camphor Laurel forest occurring in the far north-western corner of the site (refer to Plate 4.4). Numerous native saplings are present within the lower stratum of this area as well as a suite of weed species, including Lantana (*Lantana camara*), Camphor Laurel (*Cinnamomum camphora*), Asparagus Fern (*Asparagus densiflorus*) and Silver-leaved Desmodium (*Desmodium uncinatum*). There is a relatively high diversity of native species present within this area, which is a consequence of this area being contiguous with larger areas of littoral rainforest to the north. Similar littoral rainforest vegetation and weed species are present within vegetation extending along the northern boundary of the site (refer to Plate 4.5).

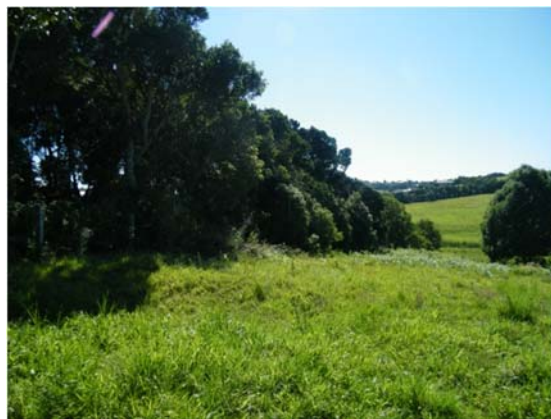
Plate 4.5 Remnant littoral rainforest vegetation extending along the northern boundary of the site

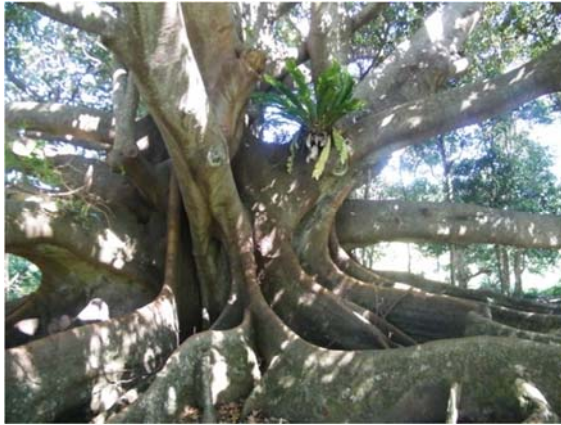
Plate 4.6 Old growth Moreton Bay Fig dominating Zone 3

Zone 3 occurs approximately 150 m to the north-west of the proposed sports fields (refer to Illustration 4.1) and is dominated by a large, old growth Moreton Bay Fig (*Ficus macrophylla*), shown in Plate 4.6. A number of mature Guioia (*Guioa semiglauc*) are present around this fig. A suite of weed species are present beneath and adjacent to the canopy of the fig, including numerous small to medium Camphor Laurel, Tobacco Bush (*Solanum mauritianum*) and Fishbone Fern (*Nephrolepis cordifolia*). A large infestation of Duranta (*Duranta erecta*) is also present within this area and appears to be spreading (refer to Plate 4.7).

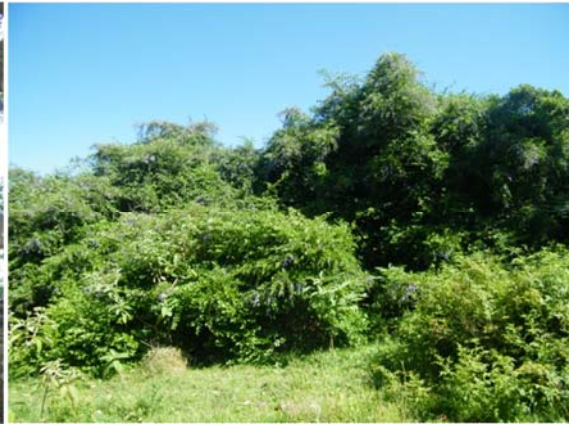
Plate 4.7 Significant weed infestation of Duranta

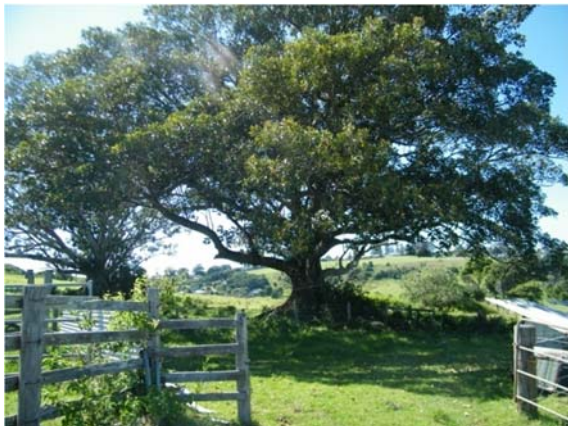
Plate 4.8 Mature Moreton Bay Figs within Zone 4

Zone 4 occurs in a central portion of the site to the north of the designated Conservation Zone (refer to Illustration 4.1). Native vegetation within this area is limited to three mature Moreton Bay Figs as shown in Plate 4.8. Additionally, pasture grasses and a number of weed species including Lantana, Tobacco Bush and Camphor Laurel saplings are present within the zone. A number of fences and cattle handling yards are currently installed in this zone.

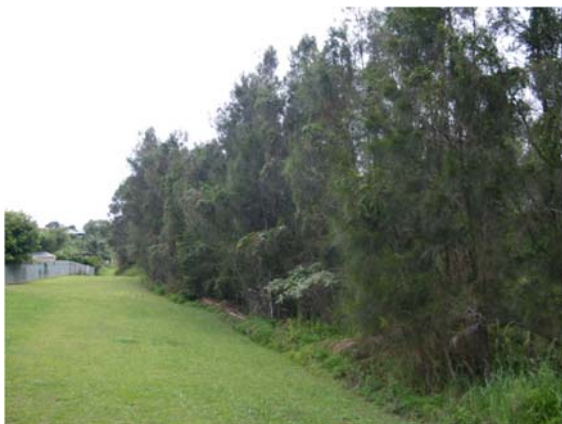
Plate 4.9 Eastern edge of Swamp Oak forest occurring with Zone 5

Zone 5 is located to the south-west of the site (refer to Illustration 4.1) and occurs as a portion of vegetation along the eastern boundary of the Ballina Nature Reserve. This area comprises largely intact Swamp Oak Forest indicative of Swamp Oak Forest EEC. Dense woody weed infestations are present within this area, including Lantana, Winter Senna and Groundsel Bush (*Baccharis halimifolia*), which form dense aggregations along the eastern edge of this zone. Vines comprising Silver-leaved Desmodium, Coastal Morning Glory (*Ipomoea cairica*) and Climbing Nightshade (*Solanum seaforthianum*) are present ascending into the canopy of Swamp Oaks. Additionally, a number of Camphor Laurel and Coral Trees occur within this zone. This zone is to be managed in accordance with the Ballina Nature Reserve Plan of Management.

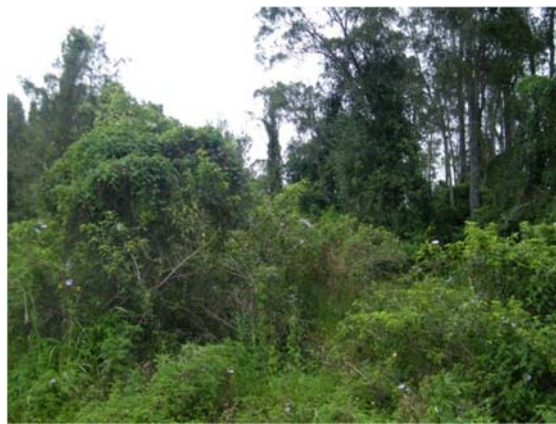
Plate 4.10 Dense weed infestations within Zone 5, including Coastal Morning Glory and Lantana

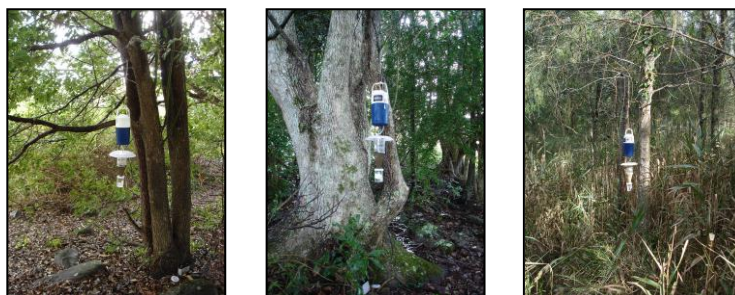
Plate 1: Pacific Pines Light Trap Sites 3, 4 and 5.

Mosquitos were collected in May 2007 from the Pacific Pines site using light traps set over 6 locations (Plate 2). The traps (Plate 1) were baited with CO₂ (as dry ice) and the mosquito chemo-attractant, Octenol. On a given night, 4 light traps were operated between 4 pm to 8 am on 4 occasions between 16 May and 29 May 2007. Adult mosquitoes were identified to species by microscopy by the author.

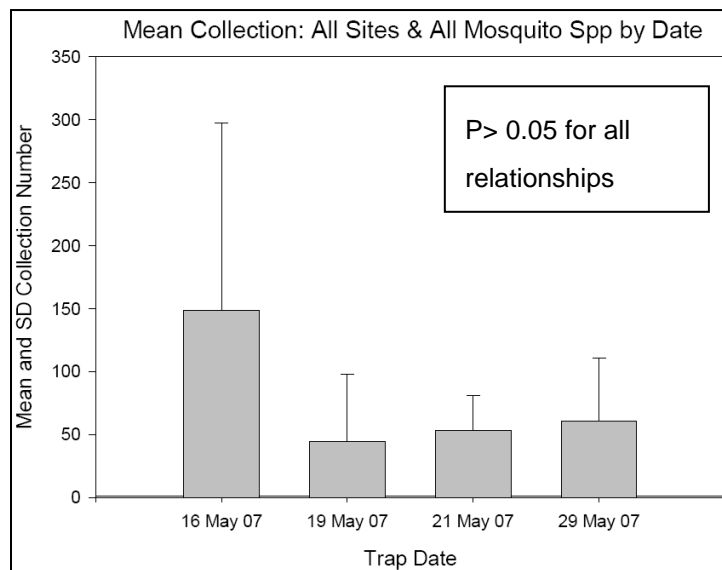
Graph 1:

Statistical analysis of the 2007 Pacific Pines collections was undertaken to assess the consistency of data across the study. Graph 1 is the mean collections of all mosquito species for each trap date. Analysis by t-test produced P values greater than 0.05 for collections across all dates and shows there is no statistical difference in mosquito abundance between any of the collecting nights. This suggests there were no important weather differences acting to significantly suppress or amplify mosquito activity over the study period. This is consistent with the recorded similar temperature and relative humidity records for the collecting nights.

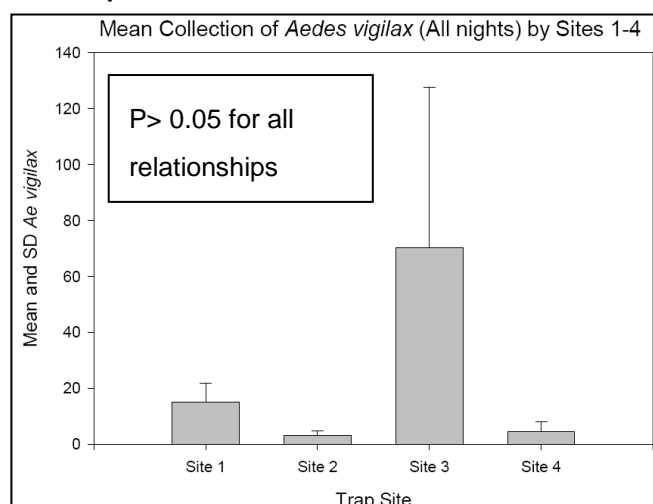
Graph 2:

Aedes vigilax is considered one of the high risk mosquito species along coastal Australia for both biting attack and disease transmission. This species was most highly represented in the study collections. This species however has a very wide distribution and its ability to disperse over many kilometres from its salt-marsh breeding habitat makes it a regional problem. The intensity of *Aedes vigilax* biting attack reduces somewhat as a function of distance from breeding habitat until a general background level of activity across a wider region is experienced. Analysis of *Aedes vigilax* collections across 4 sites on Pacific Pines was undertaken to assess if it was present in reducing intensity with increased distance from the Ballina Nature Reserve (a potential local source of breeding and harbourage) or if it was present more as generally uniform background activity. Graph 2 is the mean *Aedes vigilax* collections by trap location. Analysis by t-test showed there was no significant difference ($P > 0.05$) in its abundance across the 4 sites from which it is concluded to be representative of a more general background level of activity.

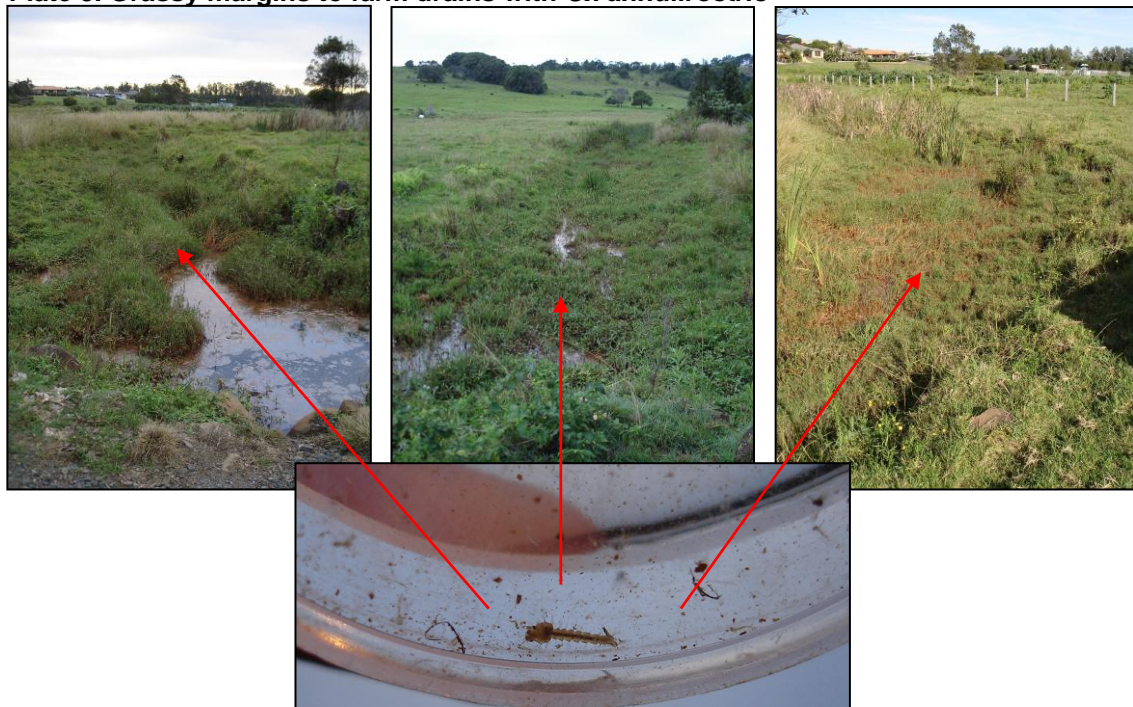
Plate 3. Grassy margins to farm drains with *Cx annulirostris*

Existing on-site mosquito habitat was sampled for presence of breeding. Drains, remnant wetlands, the existing water course adjacent to proposed playing fields and the Ballina Nature Reserve boundary interface were inspected and sampled. Sampling showed that *Culex annulirostris* was breeding in grassy ground pools including the margins of portions of drains (Plate 3.)

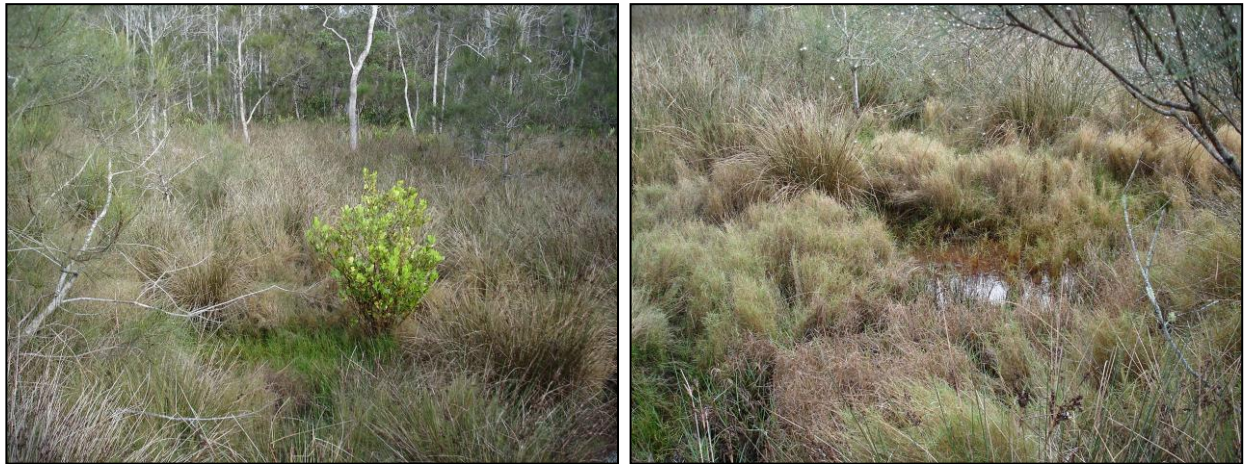
Plate 4. Brackish habitat suitable for *Verrallina funerea*

The boundary with the Ballina Nature Reserve contained areas of potential breeding for the important biting pest and disease vector *Verrallina funerea* (Plate 4).

No *Verrallina funerea* breeding was found in this habitat during the study however the largest abundance adults of this species were collected in trap site 6 located at this site. This site is considered highly likely to produce *Verrallina funerea* from time to time. The habitat transitions into a small area of salt marsh. This area was considered for potential to produce *Aedes vigilax* but was assessed as very low grade habitat. Recent flooding from spring tides around 17 May 07 had flooded the site. No breeding of *Aedes vigilax* was detected. The relatively low numbers of this species recovered in traps 5 and 6 supports the conclusion that this habitat is of low productivity for *Aedes vigilax*.

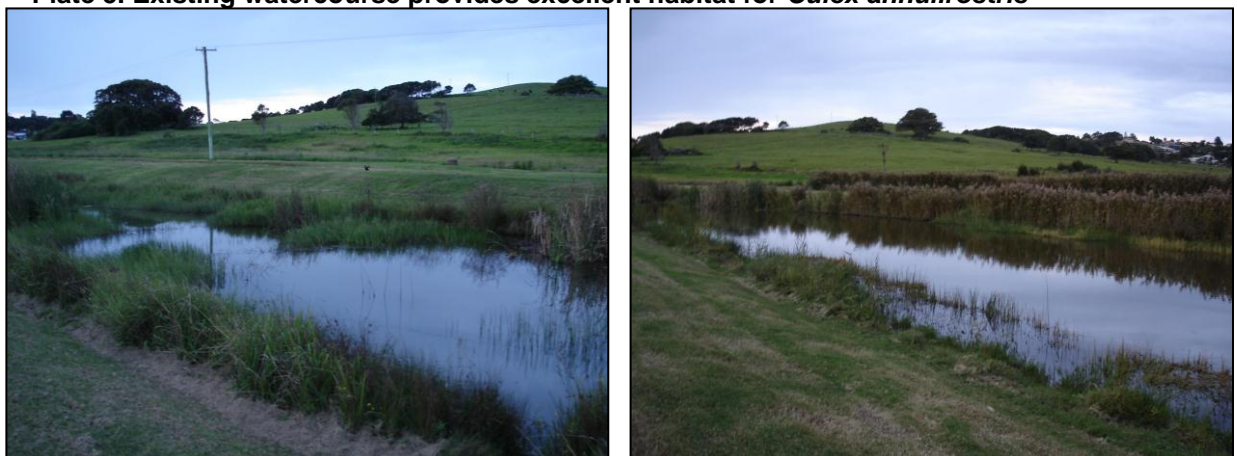
Plate 5. Existing watercourse provides excellent habitat for *Culex annulirostris*

A constructed watercourse east of the proposed playing fields (Plate 5) is currently ideal habitat for *Culex annulirostris*. Relatively shallow water provides opportunity for emergent grass and reeds to provide excellent breeding opportunity also for *Mansoina* and *Coquillettidia* species.
