METROPOLITAN COAL

2021 ANNUAL REVIEW

Project No. MET-22-29
Document No. 01127847

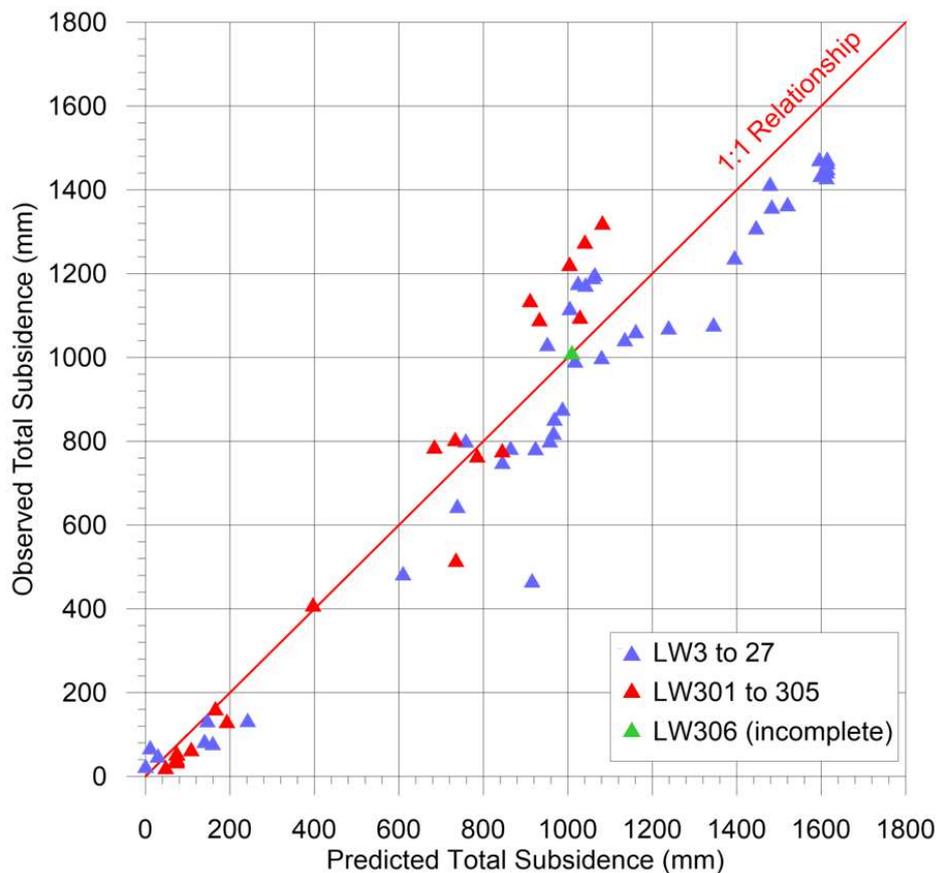
A comparison of the maximum observed and maximum predicted total conventional subsidence for the Project after each longwall for Longwalls 3 to 27 and Longwalls 301 to 306 is shown in Chart 1. The comparison of conventional subsidence effects excludes the valley cross lines which represent non-conventional subsidence movements.

Chart 1 Comparison Between the Maximum Observed and Maximum Predicted Total Conventional Subsidence for Longwalls 3 to 27 and Longwalls 301 to 306 at Metropolitan Colliery

An analysis of the maximum observed versus maximum predicted vertical subsidence was undertaken by MSEC (Appendix A). Based on the results of survey data to date and comparison with predicted conventional subsidence parameters, the profiles of vertical displacement adequately reflect the predictions. The overall subsidence effects of the project do not exceed predictions by more than 15% (Appendix A).

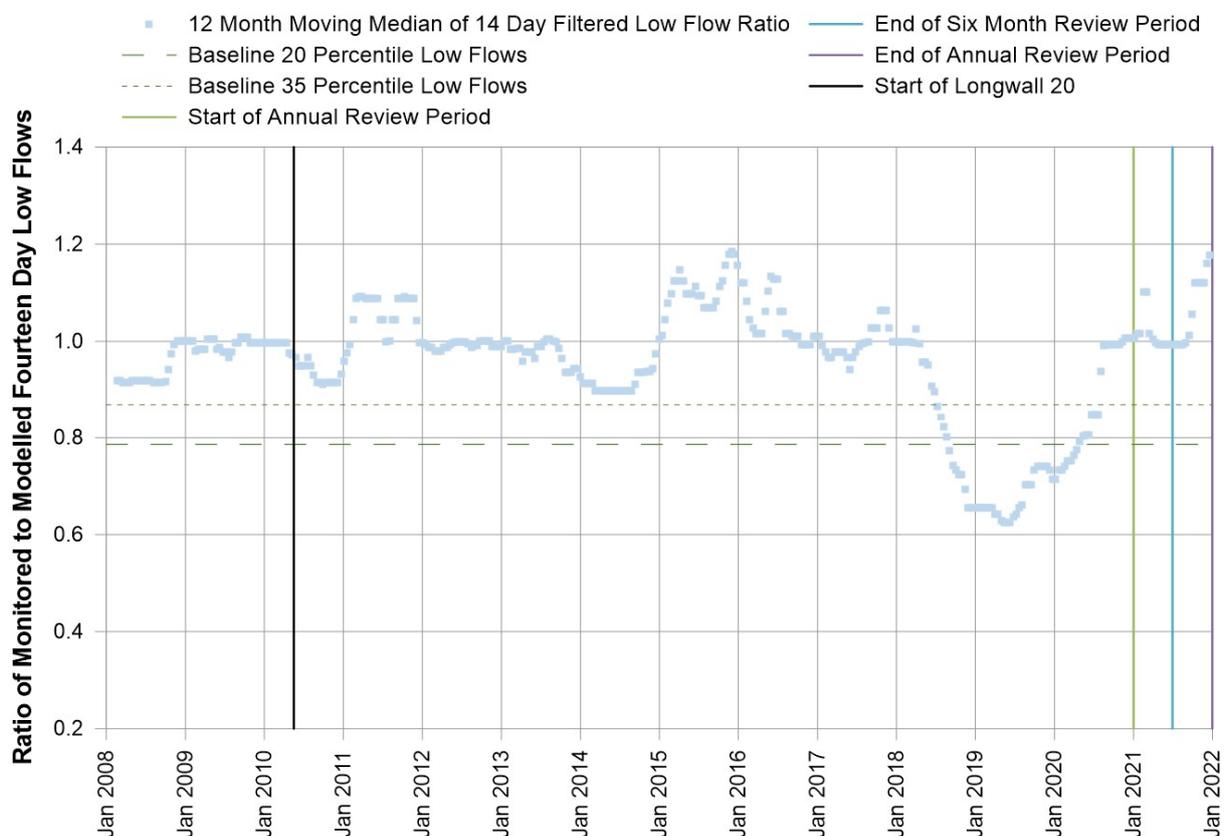
Chart 2 shows a plot of the sliding 12 month median of the ratio of 14 day sums of monitored and modelled flow at Waratah Rivulet (GS 2132102) to 31 December 2021.

Chart 2 One Year Sliding Median for the Ratios of the 14 Day Sums of Monitored and Modelled Flow Rates at Waratah Rivulet (GS 2132102)

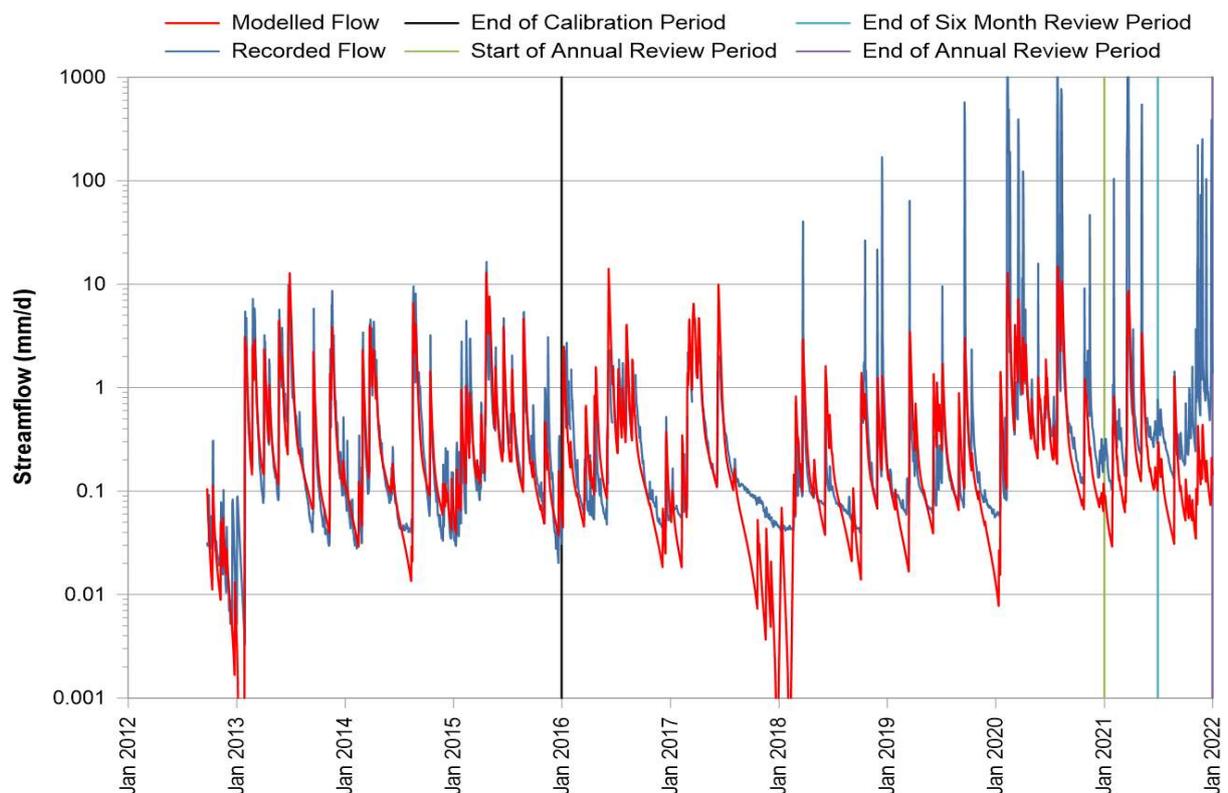
Notwithstanding the above, recorded flow at the gauging station has been above model predictions (Chart 3). This indicates that flows reaching the Woronora Reservoir have not been reduced by mining (Appendices B1 and B2).

Chart 3 Monitored and Model Predicted Flows – Eastern Tributary Upstream of Woronora Reservoir

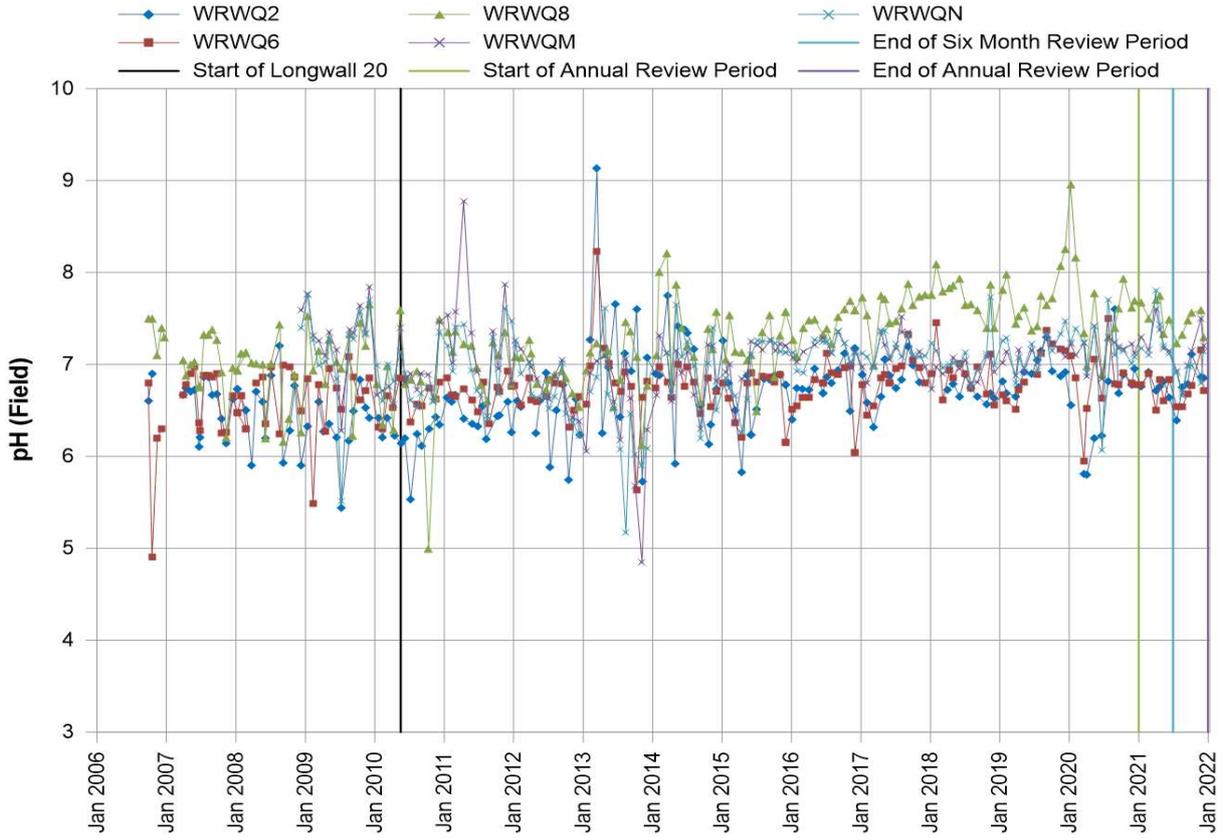
Chart 12 pH Levels Waratah Rivulet – Upper to Middle Reach Sites

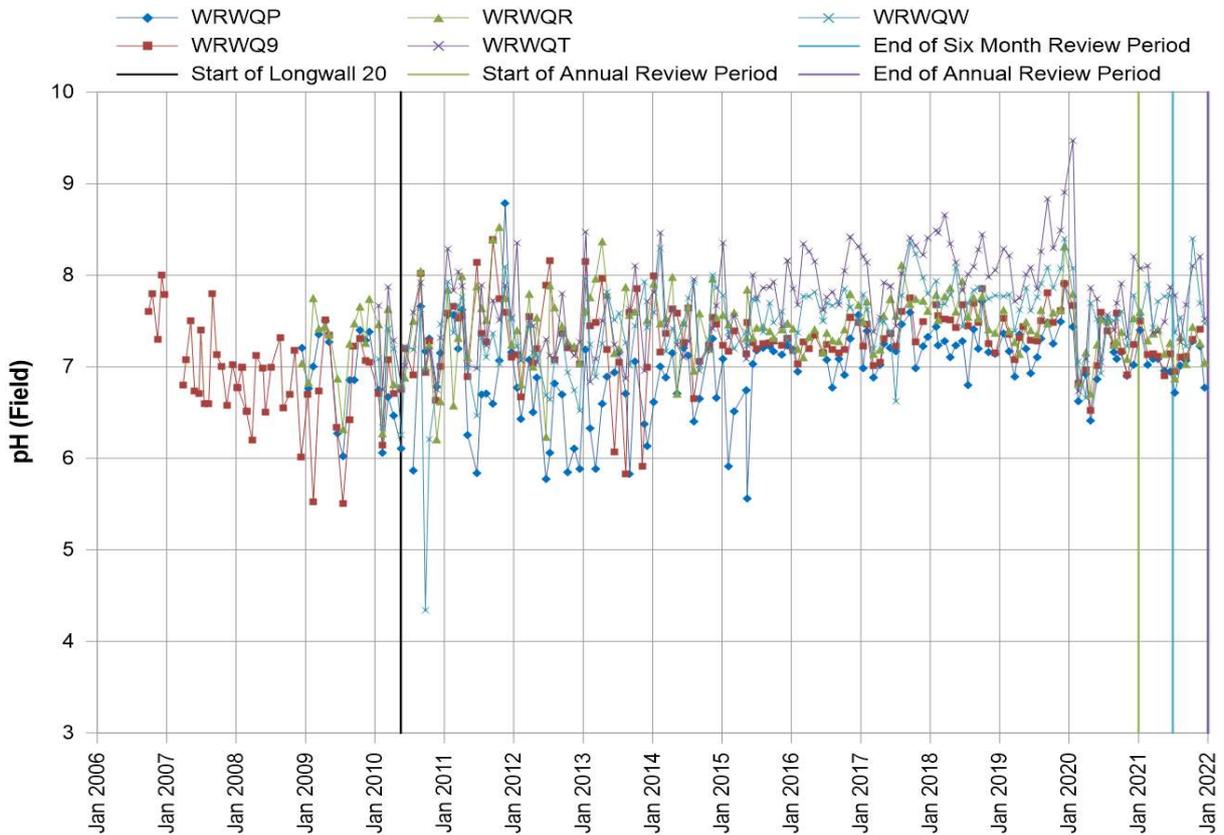
Chart 13 pH Levels Waratah Rivulet – Lower Reach Sites

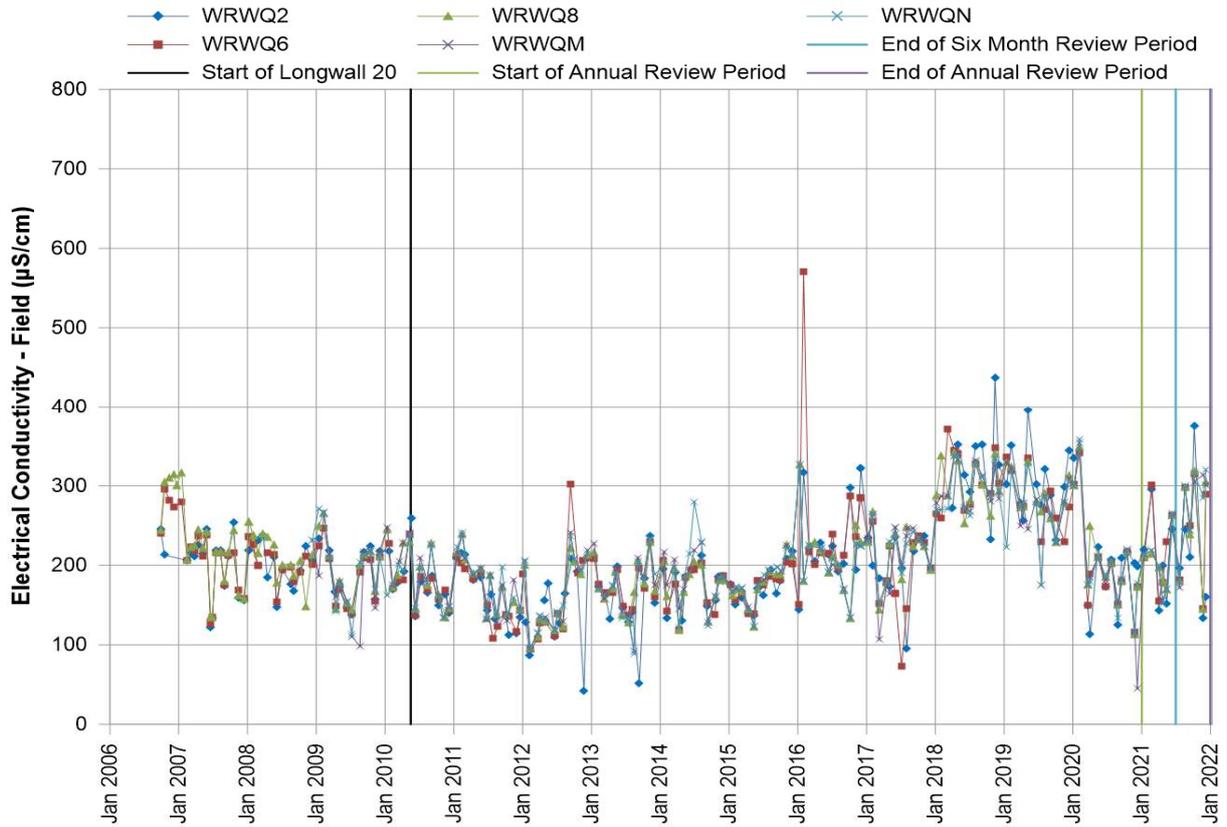
Chart 14 EC Waratah Rivulet – Upper to Middle Reach Sites

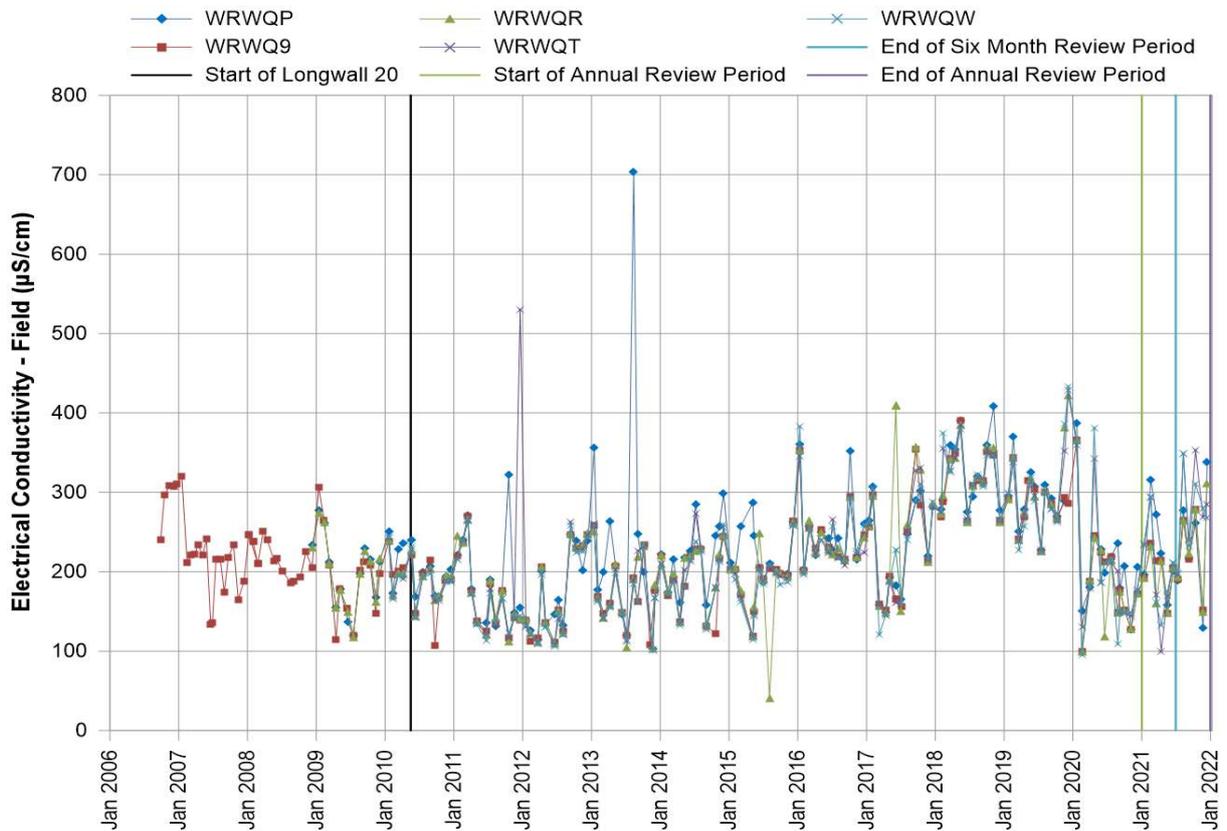
Chart 15 EC Waratah Rivulet – Lower Reach Sites

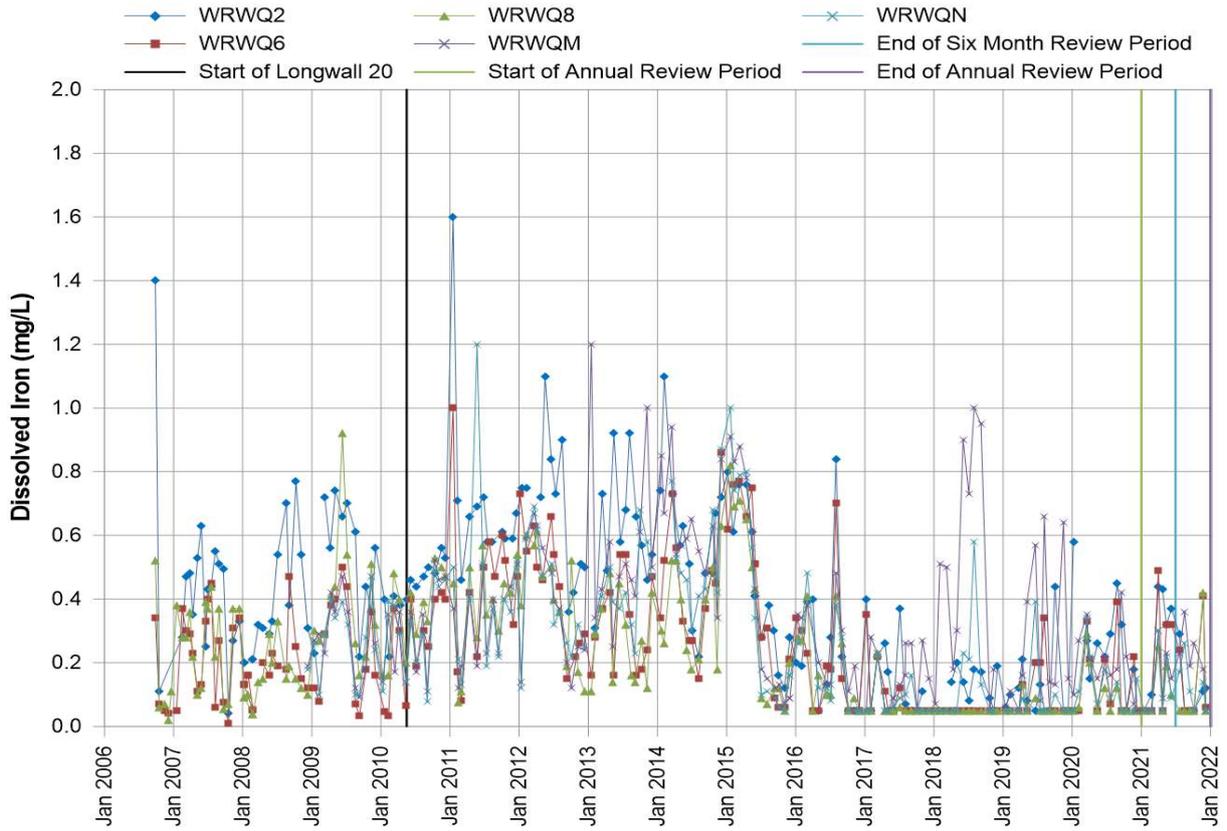
Chart 16 Dissolved Iron Waratah Rivulet – Upper and Middle Reach Sites

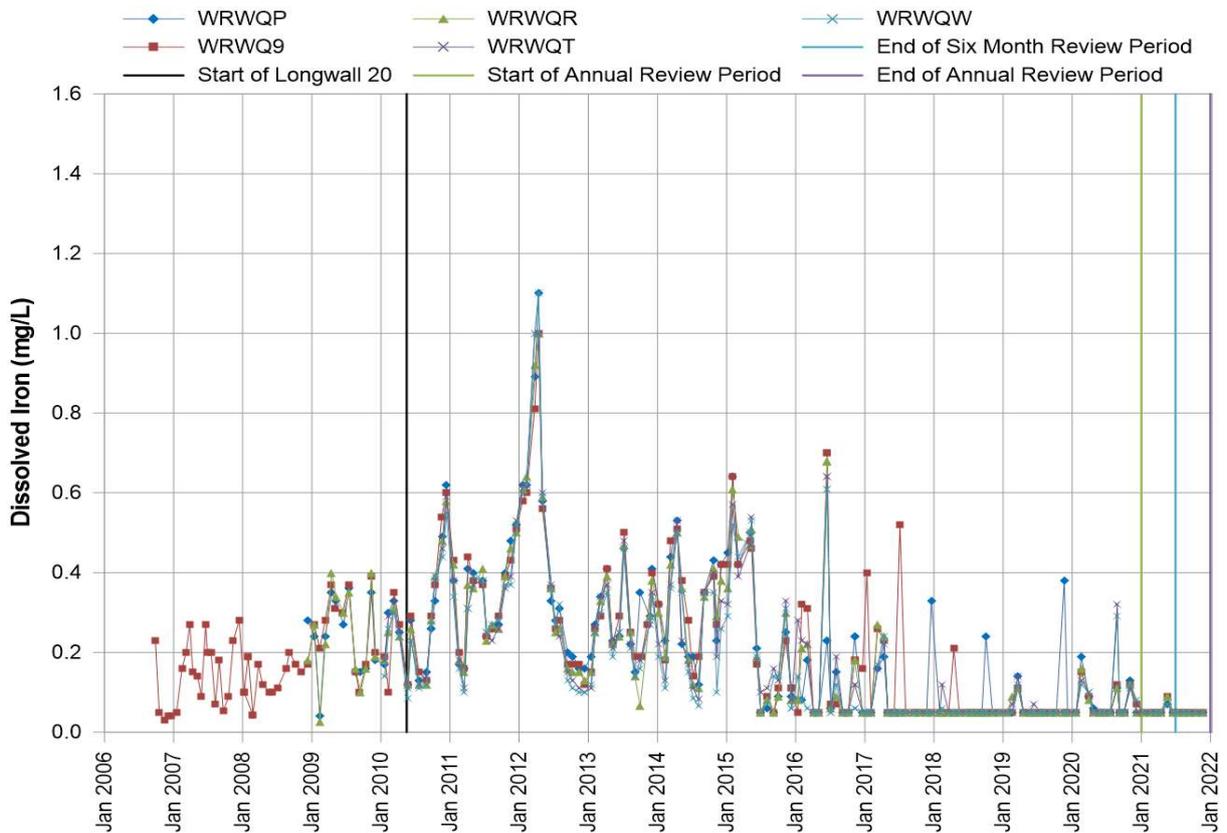
Chart 17 Dissolved Iron Waratah Rivulet – Lower Reach Sites

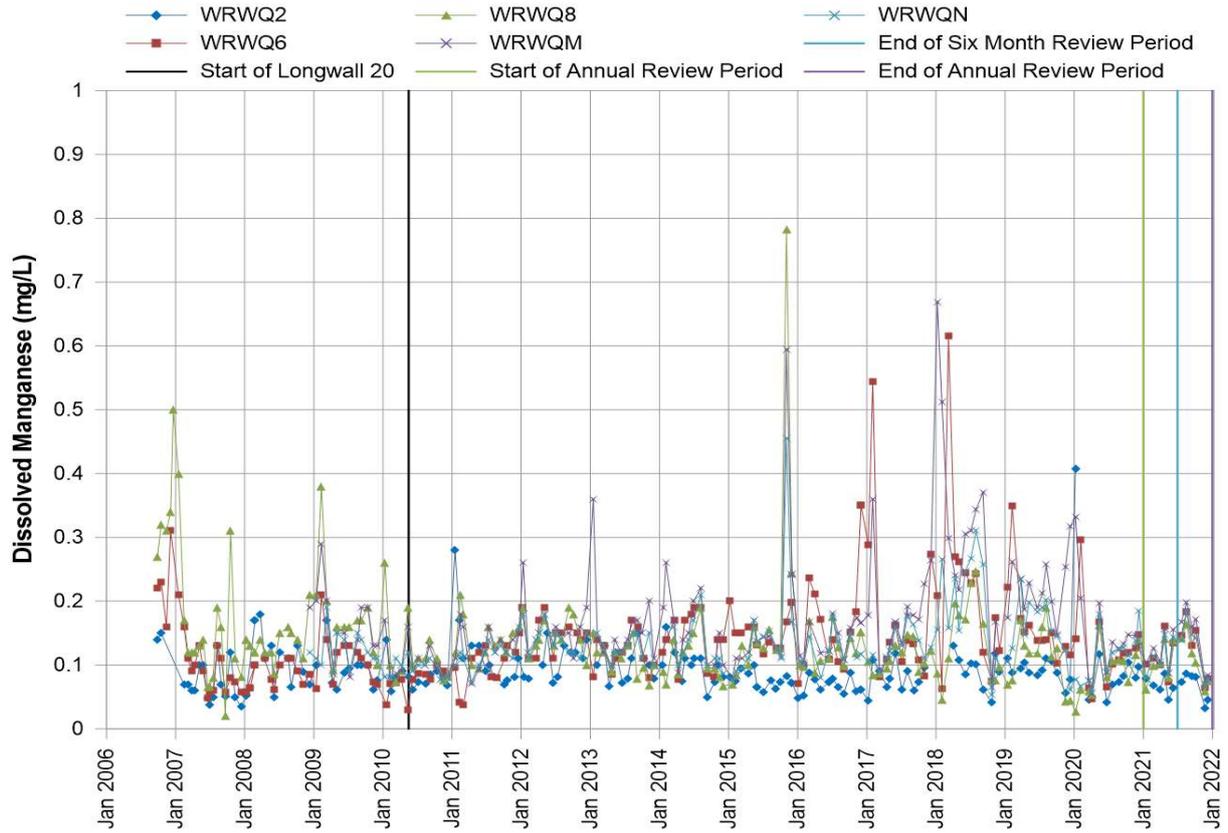
Chart 18 Dissolved Manganese Waratah Rivulet – Upper to Middle Reach Sites

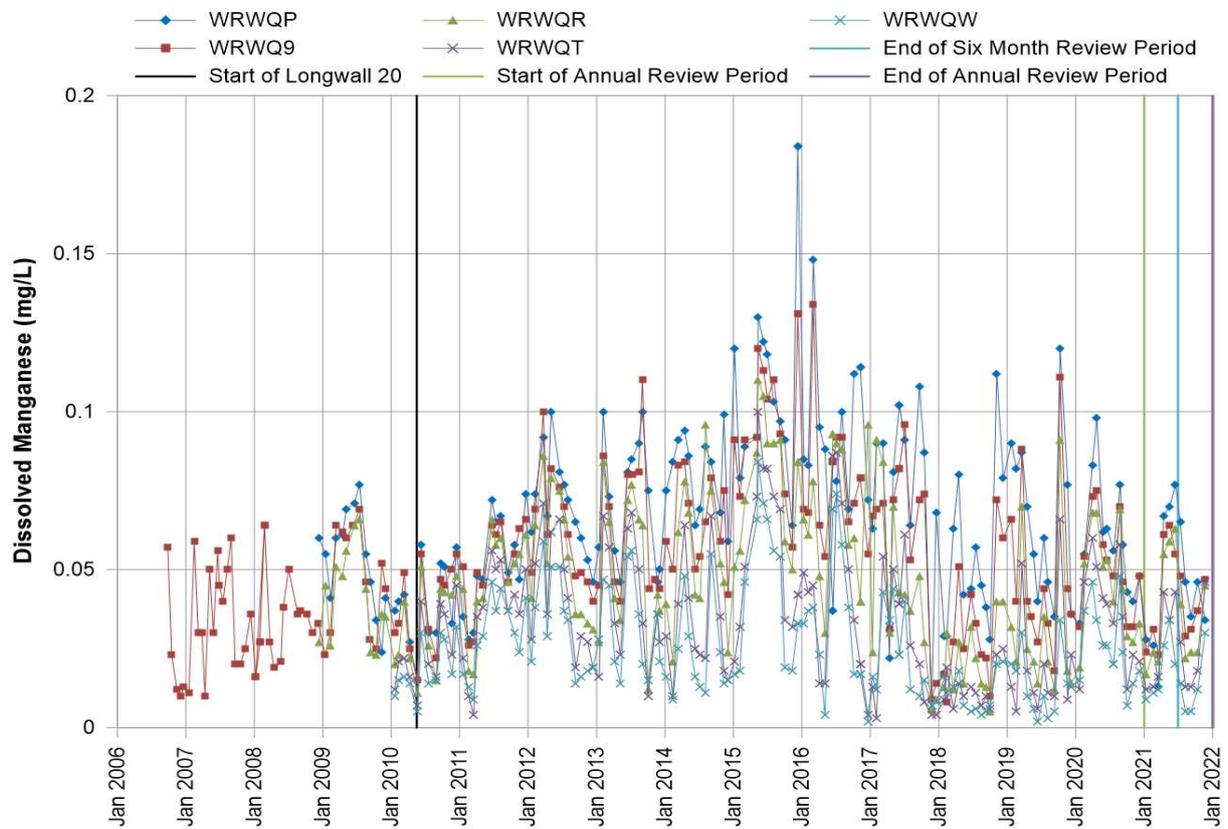
Chart 19 Dissolved Manganese Waratah Rivulet – Lower Reach Sites

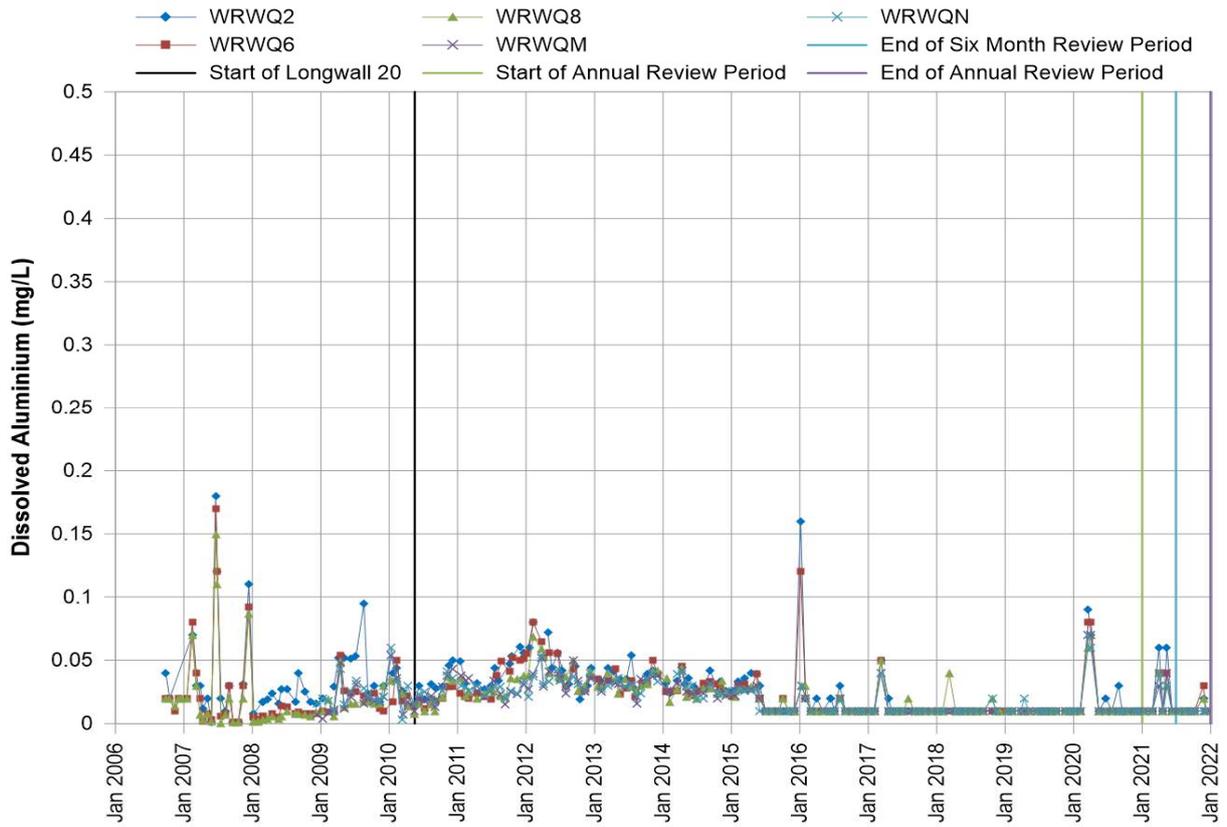
Chart 20 Dissolved Aluminium Waratah Rivulet – Upper to Middle Reach Sites

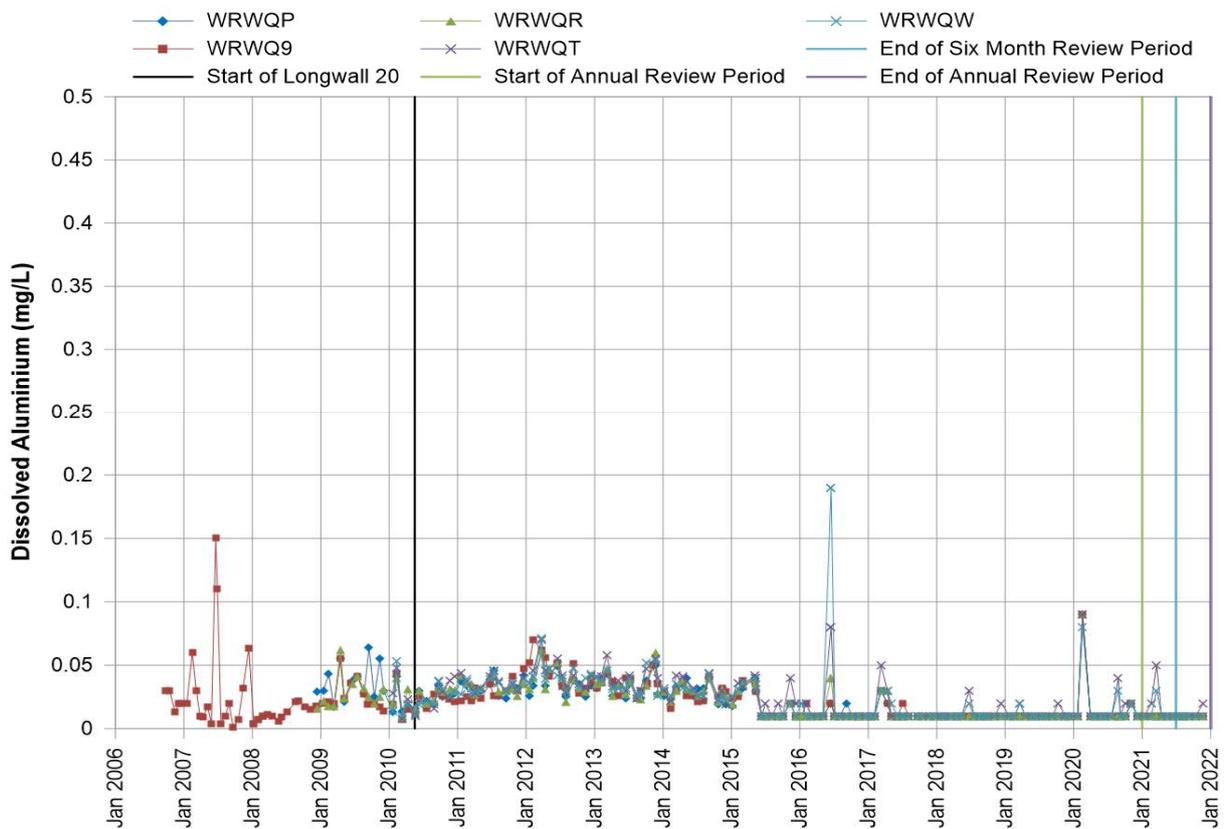
Chart 21 Dissolved Aluminium Waratah Rivulet – Lower Reach Sites

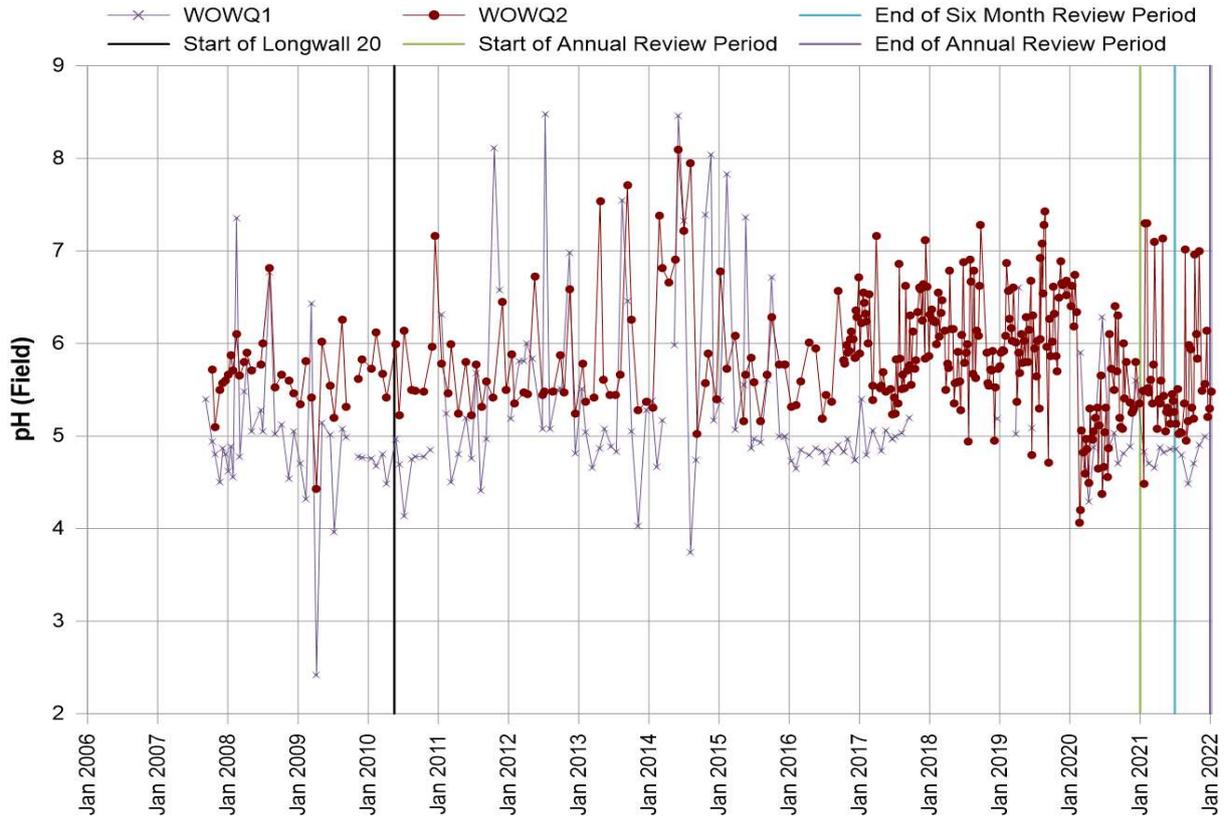
Chart 22 pH Levels Woronora River⁵

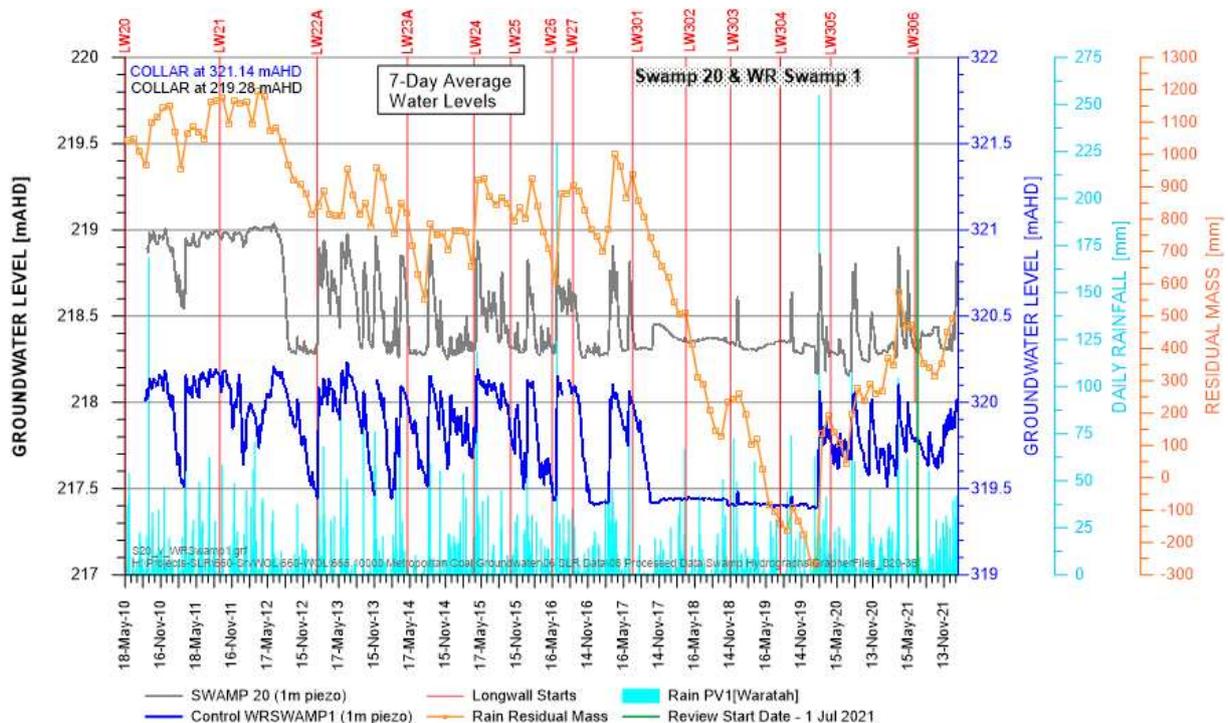
The upland swamp groundwater performance indicator has been exceeded at Swamp 20 since 2012. Swamp 20 substrate water levels changed from being permanently saturated to being periodically saturated as a result of the passing of Longwall 21 (Chart 47 and Appendices C1 and C2). There is a very strong correlation with rainfall trend at Swamp 20 and control swamp Woronora River Swamp 1 over the period of record. As the rate of decline in the two piezometers is similar between 2013 and 2016, but different in 2012, it is likely that Longwall 21 caused a mining effect at Swamp 20, but the effects have not been exacerbated by Longwalls 22-27 or Longwalls 301-306 (Appendices C1 and C2). In 2018 and 2019, both swamps reported water levels at the base of the substrate dataloggers for the full period apart from the short period of saturation recorded in Swamp 20 in September 2019. Both swamps increased in water levels after the large rain event in February 2020. However, following rainfall events throughout 2020 and 2021, Swamp 20 exhibited a decrease in groundwater levels whereas the WRSWAMP1 water levels remained at near-saturated levels. During the current reporting period both swamps water levels were concordant with rainfall, both experiencing upward trends towards the end of the reporting period (Chart 47 and Appendices C1 and C2).

Chart 47 Comparison of Piezometer Responses at Swamp 20 and Woronora River 1 Control Swamp

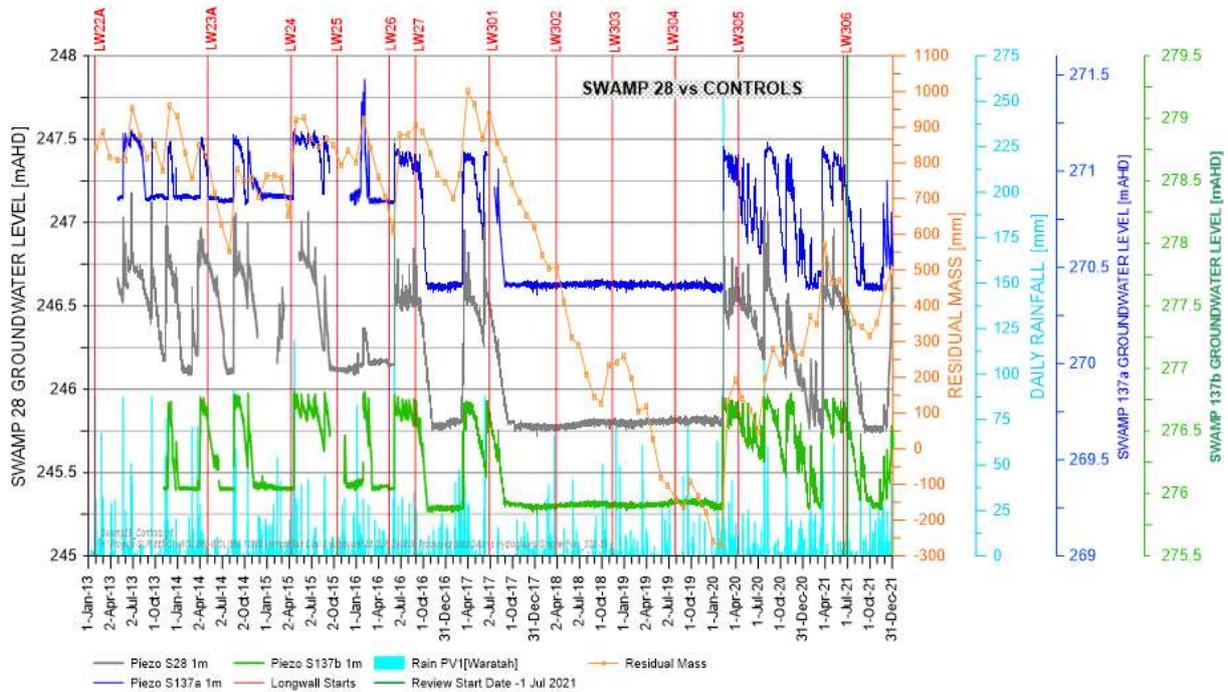
A mining effect to the substrate water levels of Swamp 28 (overlying Longwall 24) was identified in 2016 based on the incomplete recovery of substrate water levels following rainfall events (Chart 48 and Appendices C1 and C2). Swamp 28 is considered to have an impact from mining of Longwall 25, although no effect on swamp substrate water levels occurred when Longwall 24 passed directly beneath the monitoring site (Appendices C1 and C2). The substrate piezometer at Swamp 28 returned to dry conditions from September 2017, remaining so until February 2020, as did the two control swamp piezometers (Swamps 137a and 137b; Chart 48). During the current reporting period all three swamps were at low levels intermittently saturated during January and February 2021 and have, since March 2021, increased in water level and have stayed at that level.

Chart 48 Groundwater Hydrographs at Swamp 28 and Two Control Swamps (137a and 137b)

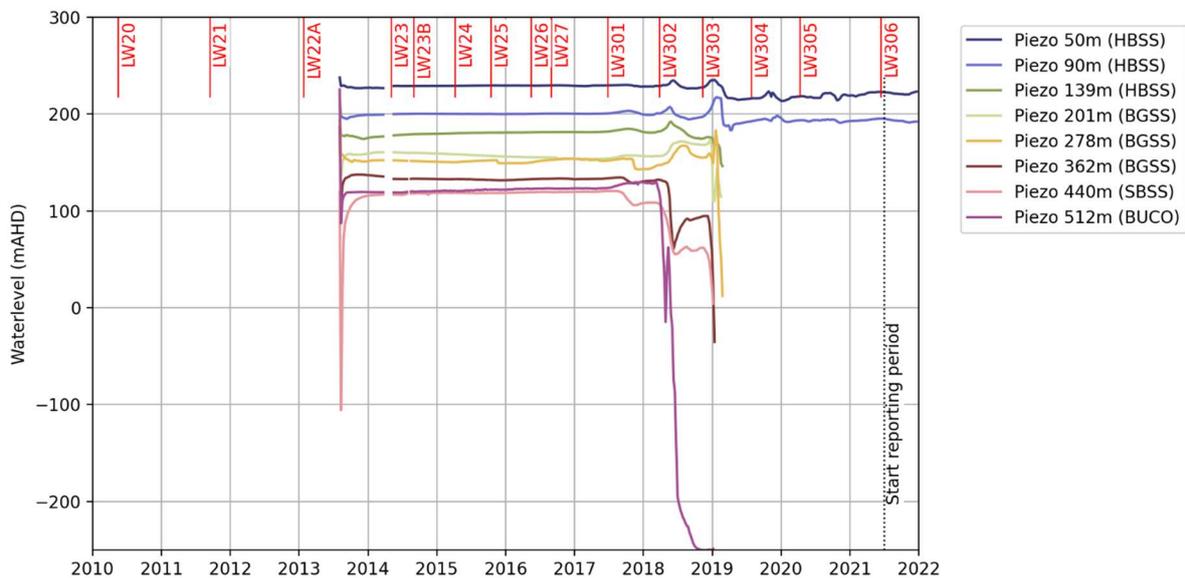
Bore F6GW4A overlies the chain pillars between Longwalls 303 and 304. The time-series record for bore F6GW4A is shown on Chart 56. This bore is two panel widths from Longwall 301 and one panel width from Longwall 302. The respective mining faces came closest to the bore in late-September 2017 and late-May 2018, at which times distinct features are evident on all hydrographs. The passage of Longwall 301 caused mild responses, generally short-term increases in head, while the passage of Longwall 302 caused sharp cusp-like features on the Hawkesbury Sandstone hydrographs, sustained rises in the upper and mid Bulgo Sandstone, and strong declines in the three deepest piezometers. In January 2019, F6GW4A was undermined by Longwall 303 causing the depressurisation and disabling of the six lower sensors (i.e. 139 metres below ground level [mbgl], 201 mbgl, 278 mbgl, 362 mbgl, 440 mbgl and 512 mbgl). The upper and mid Hawkesbury Sandstone piezometers (50 mbgl and 90 mbgl) also displayed a lowering of groundwater head following the passage of Longwall 303; however, they showed no significant decline after the passage of Longwall 304, 305 and 306. Both piezometers showed a slight decreasing trend, followed by an increasing trend at the end of this reporting period.

Chart 56 Time Variations in Potentiometric Heads at F6GW4A

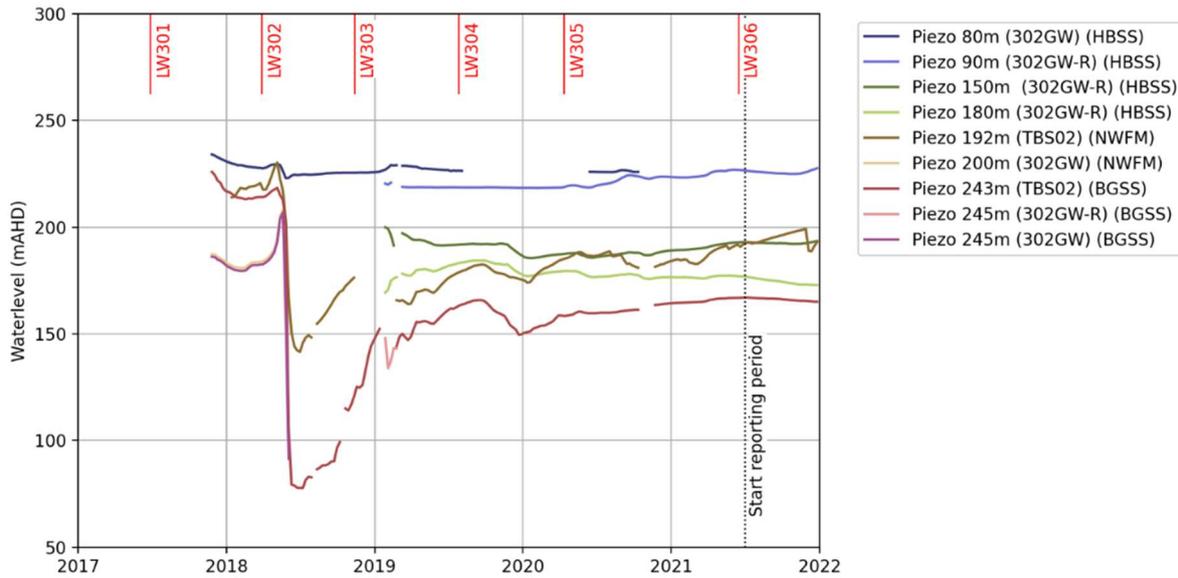
Metropolitan Coal also installed additional bores over Longwall 302 (TBS02 80, TBS02 250 and TBS02 15) and Longwall 303 (TBS03 230 and TBS03 15). The two deep holes each have vibrating wire piezometers installed 15 m above and below the Bald Hill Claystone (192 mbgl and 243 mbgl at TBS02 250, 250 mbgl, 162 mbgl and 213 mbgl at TBS03 230) (Chart 57). Two standpipes at 90 mbgl and 190 mbgl were installed in February 2019 over Longwall 302; currently both are recording data (Chart 57).

Chart 57 Time Variations in Potentiometric Heads at 302GW01 and TBS02

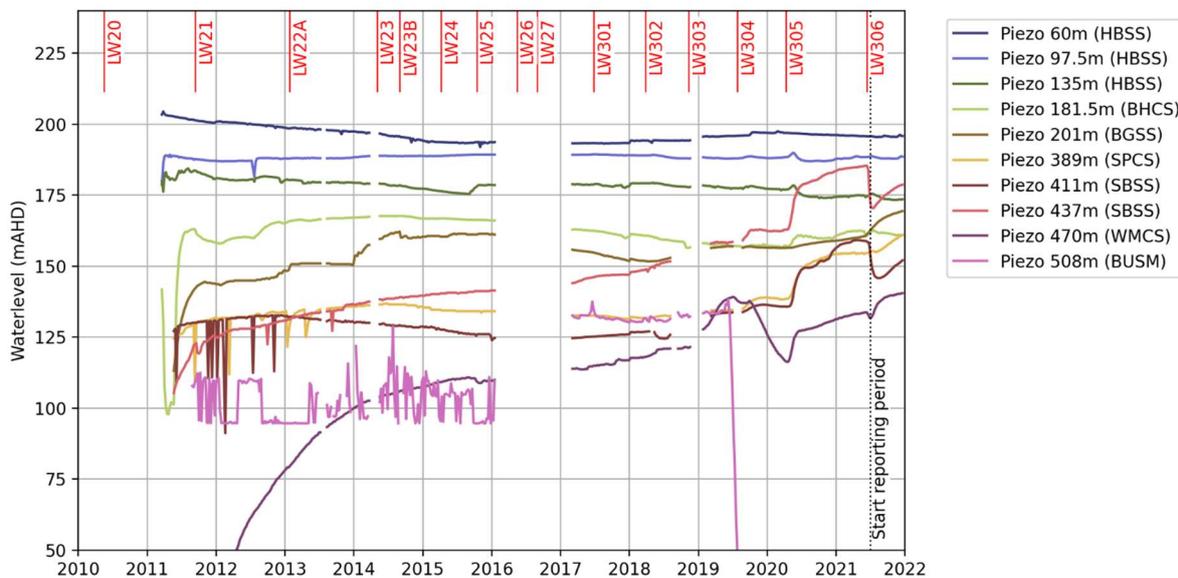
Chart 58 shows the groundwater levels at site PHGW2A, located about 200 m due north of the commencement of Longwall 306. A connection failure prevented upload of data for sensors in PHGW2A in 2016. Sensors have now been reinstated. All VVPs, except for the shallowest 60 mbgl piezometer, had a compressive response to the commencement of Longwall 305, about 400 m away. At the start of the reporting period, the three deepest piezometers (piezometers at 411 mbgl, 437 mbgl, 470 mbgl) showed a depressurisation, likely linked to the start of mining of Longwall 306. After this rapid depressurisation, the water levels showed a recovery with the 470 mbgl piezometer showing a higher head at the end of the reporting period than that at the start. Piezometer 135 mbgl (Hawkesbury Sandstone) and piezometer 181.5 mbgl (Bald Hill Claystone) showed a small decrease over this reporting period. The 437 mbgl piezometer has had a long period of rising head since installation, and now has a head that is greater than, and consistent with, the heads of several shallower sensors.

Chart 58 Time Variations in Potentiometric Heads at PHGW2A

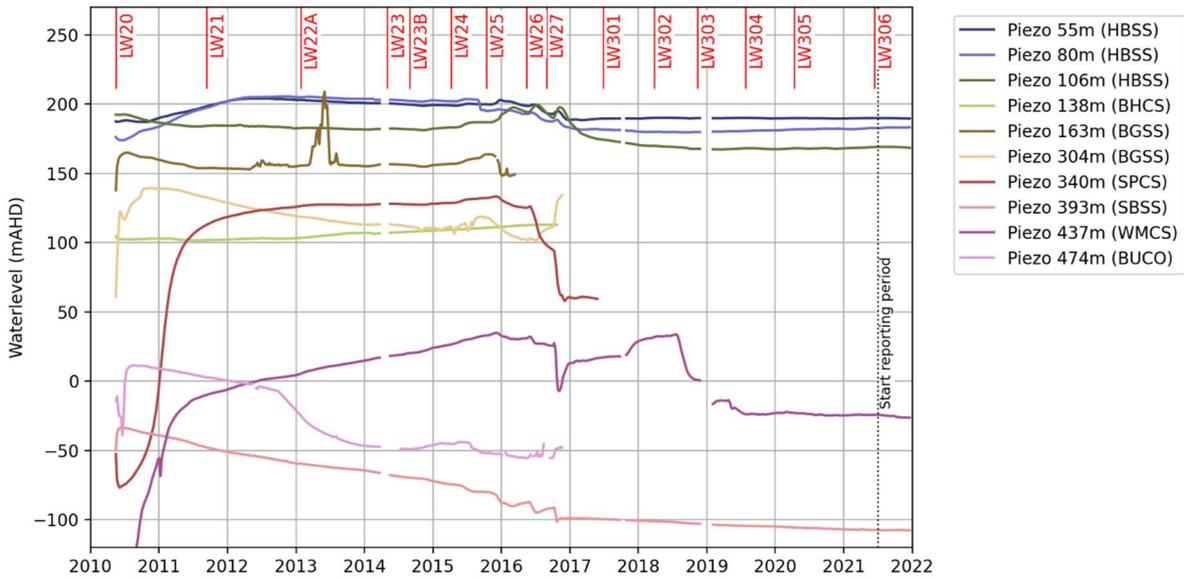
The time-series record for bore 9GGW2B (over the 300-series mains) is shown on Chart 59. As the hydrographs show inconsistent head variations with depth, some of the piezometers are deemed unreliable. During the passage of Longwall 24 (>600 m away), minor drawdowns were observed in the Bulli Coal Seam and the Scarborough Sandstone, but other sensors exhibited no effect or a rise in head. The passage of Longwall 25 (>400 m away) caused distinct drawdowns in the Scarborough Sandstone, Wombarra Claystone, Stanwell Park Claystone and upper Bulgo Sandstone. Characteristic arcuate segments between cusps associated with subsequent longwall crossings are evident in the Scarborough Sandstone, Wombarra Claystone and Stanwell Park Claystone, but not in the Bulli Coal Seam. The lower Bulgo Sandstone shows rising head arcuate segments for Longwall 26 and Longwall 27 crossings, due to compression at that level. Sympathetic drawdowns are also exhibited in the three Hawkesbury Sandstone piezometers at the times of the Longwall 26 and Longwall 27 crossings. The 138 mbgl, 163 mbgl, 304 mbgl and 474 mbgl piezometers have not recorded data since the end of 2016, due to presumed shearing. The 340 mbgl piezometer has not recorded data since June 2017. The upper, mid and lower Hawkesbury Sandstone piezometers (55 mbgl, 80 mbgl and 106 mbgl) remained stable during the reporting period. The same is true for the two deep piezometers at 393 mbgl and 437 mbgl.

Chart 59 Time Variations in Potentiometric Heads at 9GGW2B

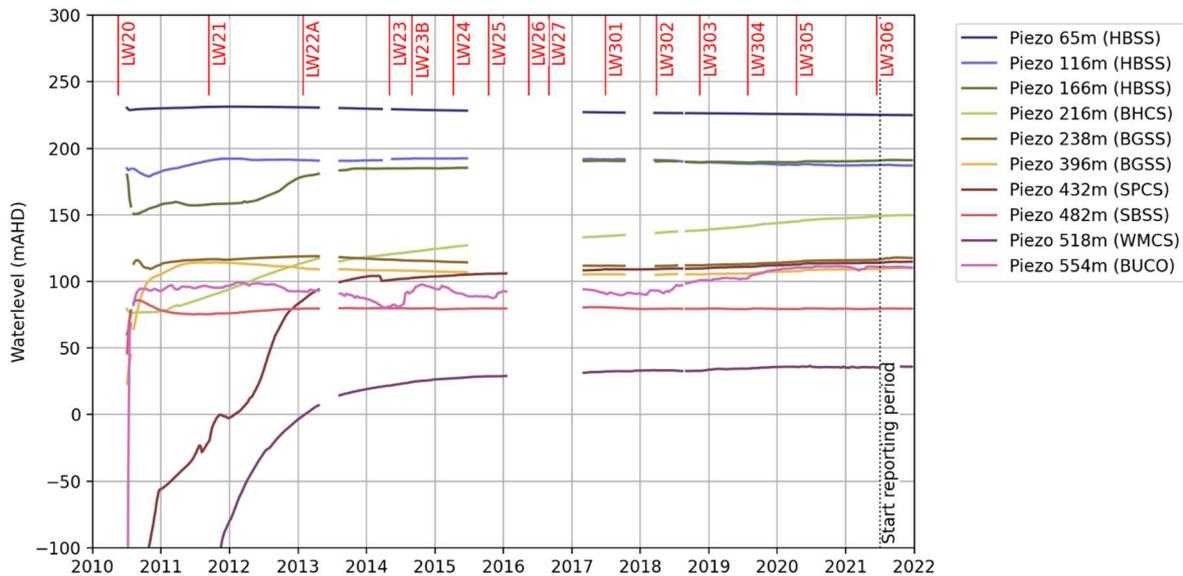
Chart 61 shows the water levels at bore PHGW1B. The piezometers are located approximately 750 m north of Longwall 305. A connection failure prevented the upload of data for sensors in PHGW1B in 2016. Sensors have now been reinstated. During the reporting period, all piezometers showed steady water pressures and no response to mining of Longwall 305.

Chart 61 Time Variations in Potentiometric Heads at PHGW1B

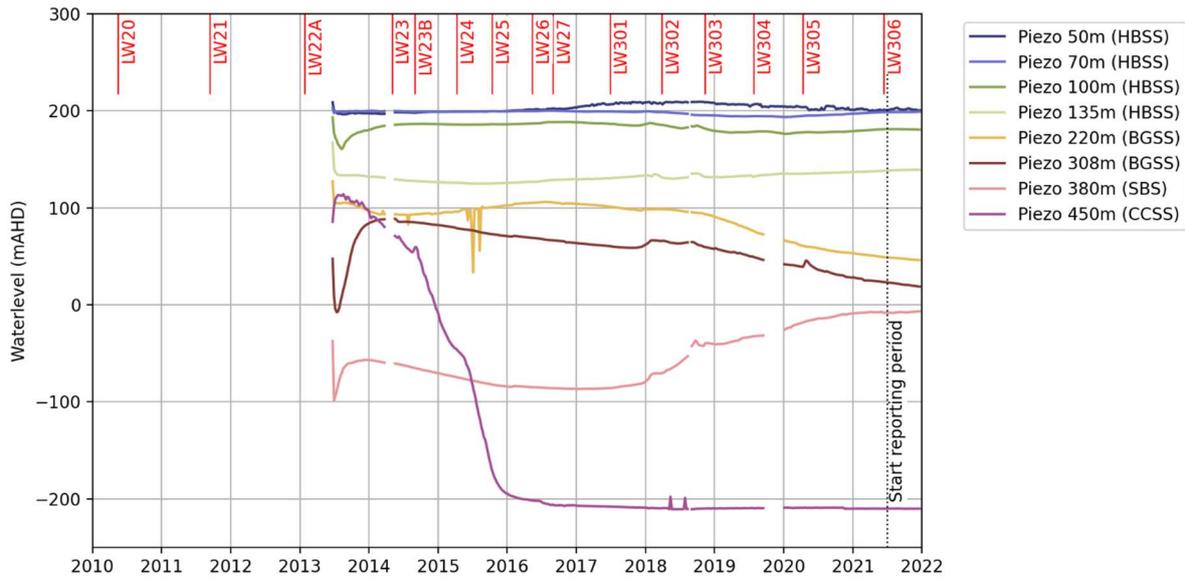
Chart 62 shows the groundwater levels at bore F6GW3A. Bore F6GW3A is located adjacent to Longwall 301 about 150 m beyond its southern end, and at about 800 m from Longwall 27. Significant depressurisation has occurred from historical workings to the east at about 500 m distance. The 450 mbgl deep piezometer at the base of the Coal Cliff Sandstone displays significant depressurisation continuing from the mining of the first heading in the 300 mains in November 2013. The rise in pressure in the 380 mbgl piezometer, noted in the previous reporting periods as potentially related to compression from the adjacent Longwall 302 beginning in March 2018, continued at a slight rate during the current reporting period. The sustained rise at the 380 mbgl piezometer is no longer attributed to compression, but short jumps on the hydrographs for the 100 mbgl to 380 mbgl piezometers, near the ends of Longwalls 301 and 302, are probably short-term compression effects. Communications were lost due to the vandalised aerial cable for four piezometers at 220 mbgl, 308 mbgl, 380 mbgl and 450 mbgl on 22 September 2019. The cables have since been re-instated. In this reporting period, five piezometers (50 mbgl, 70 mbgl, 100 mbgl, 135 mbgl and 450 mbgl) showed stable water levels during this reporting period. The piezometers at 220 mbgl and 308 mbgl showed a continuous decrease. The piezometer at 380 mbgl continued to increase in water levels, though at a slower rate than in the last reporting period.

Chart 62 Time Variations in Potentiometric Heads at F6GW3A
